Maintenance Rating Program

Triangle Expressway

2025 Second Quarter Report

NCTA Triangle Expressway Roadway Maintenance Performance Rating Program; Q2, 2025 Rating

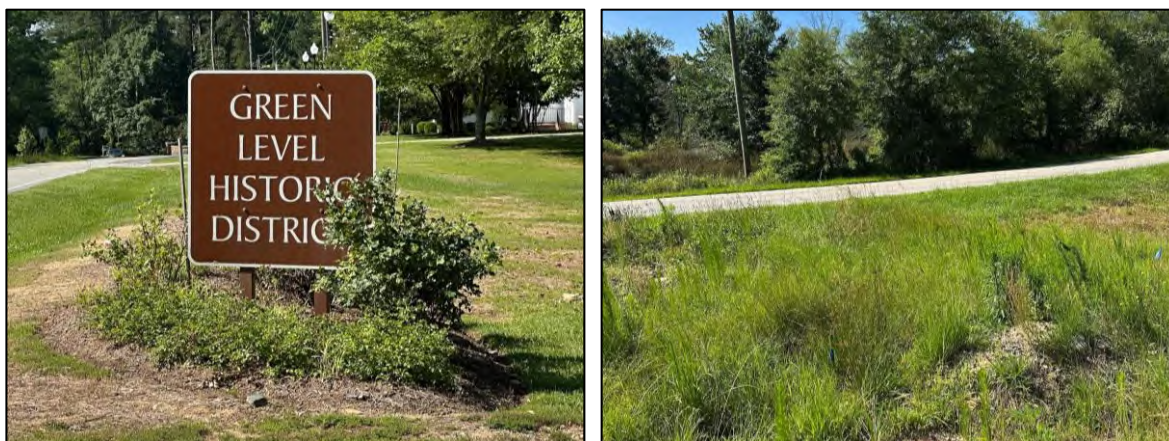
Figure 4: Green Level West Historic District Signs, Landscape Areas

In addition, the report provides findings of the Green Level Historic District signs inspection. This quarter, two signs were inspected. One of the signs was in good physical condition, while the other has been removed after being struck and down for some time. The landscaped area around the erected sign was maintained in accordance with NCTA MRP standards.

This quarter, one of the two Green Level Historic District signs inspected was found to be in good condition, and the other has been removed. The landscaped area surrounding the erected sign was found to be well maintained.

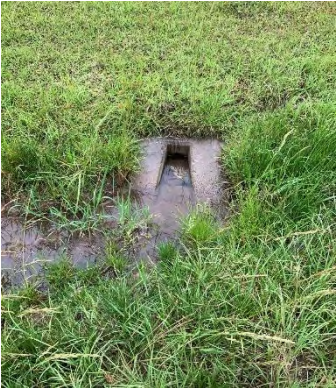
#	Material Type	Object ID	Failure Type	Photo	GIS Reference Page
1	Shoulder Drain	MDP_28	Obstruction

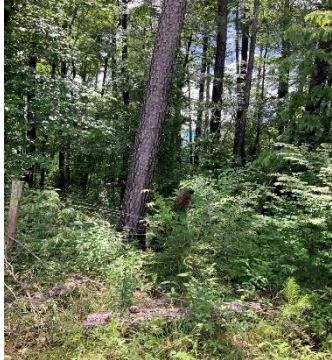
#	Material Type	Object ID	Failure Type	Photo	GIS Reference Page
1	Woven	FN_246	Hole Height

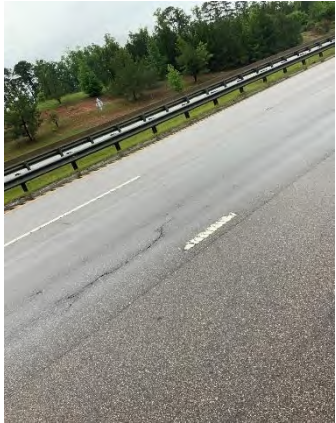
#	Material Type	Object ID	Failure Type	Photo	GIS Reference Page
1	Asphalt	LS_387	Asphalt – Unsealed Cracks

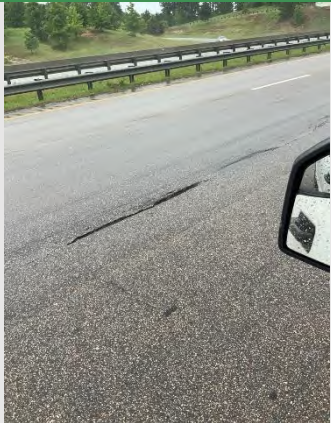
A24
2	Asphalt	LS_532	Asphalt – Unsealed Cracks

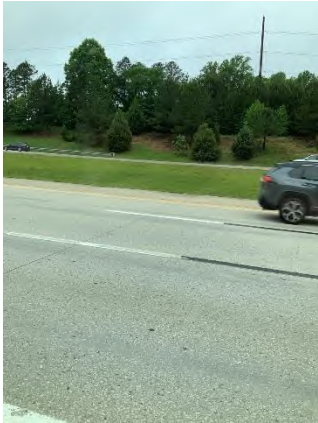
#	Material Type	Object ID	Failure Type	Photo	GIS Reference Page
1	Concrete	LS_102	Concrete – Missing Striping

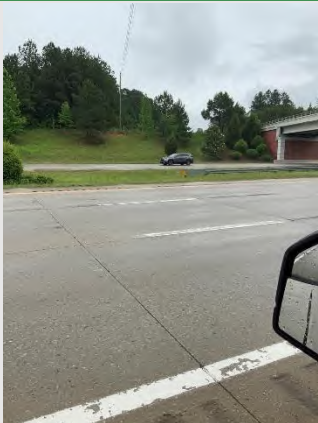
A14
2	Concrete	LS_167	Concrete – Missing Striping

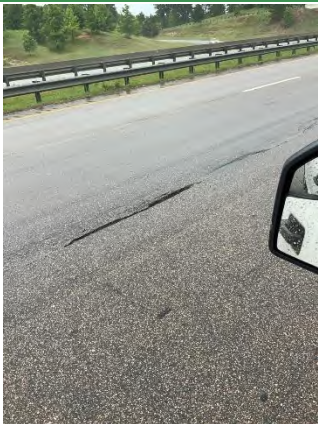
A14
3	Asphalt	LS_532	Asphalt – Missing Striping
