# Maintenance Rating Program Monroe Expressway

Quarter 2 MRP Assessment

August 2025

### NCTA Monroe By-Pass Roadway Maintenance Performance Rating Program; Q2, 2025 Rating

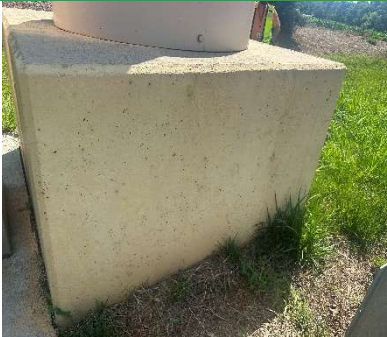
#	Material Type	Object ID	Failure Type	Photo	GIS Reference Page
1	Concrete	GN_14	Scaling

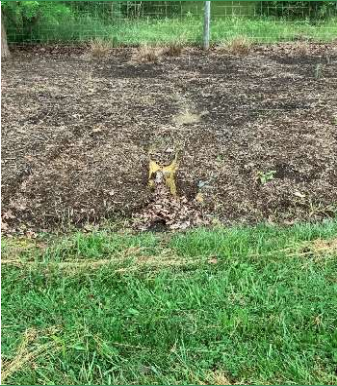
#	Material Type	Object ID	Failure Type	Photo	GIS Reference Page
1	Concrete	DP_73	Erosion

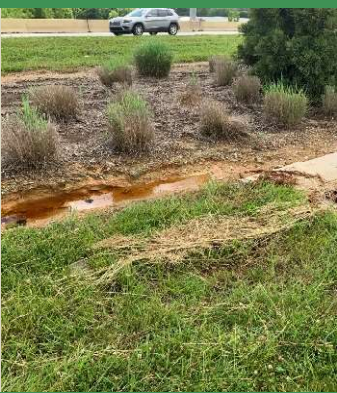
B6
2	Concrete	DP_389	Erosion

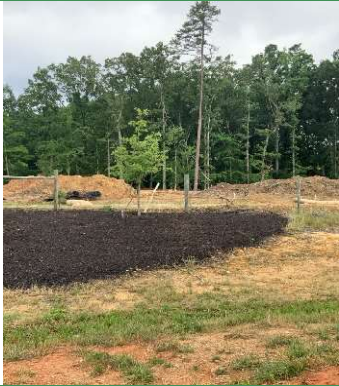
#	Material Type	Object ID	Failure Type	Photo	GIS Reference Page
1	Woven	FN_217	Functional Damage

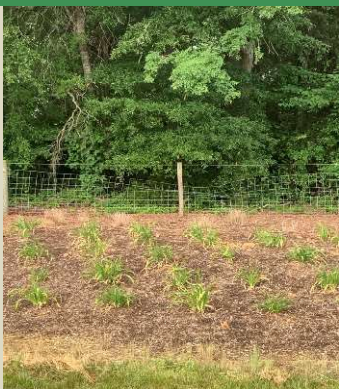
B1 & B2
2	Woven	FN_287	Hole Height

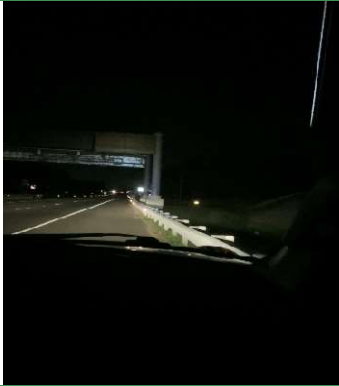
Highway Lighting scored a 33 in the survey. Deficiencies of highway lighting were directly related to nighttime luminaries not functioning properly. The MRP Maintenance and Evaluation Standards V7 are below.

#	Material Type	Object ID	Failure Type	Photo	GIS Reference Page
1	Street Lighting	HL_1	Functional Damage

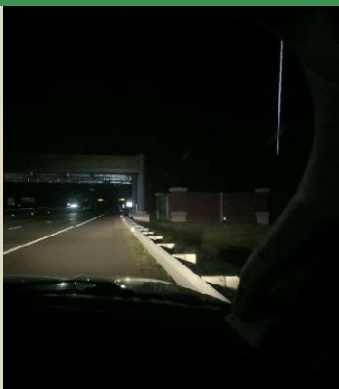
B11
2	Street Lighting	HL_10	Functional Damage

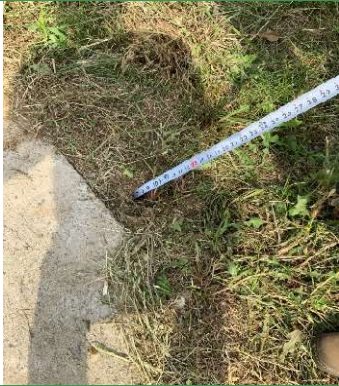
#	Material Type	Object ID	Failure Type	Photo	GIS Reference Page
1	Concrete	IN_82	Erosion

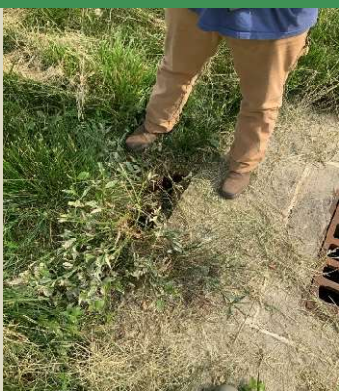
B26
2	Concrete	IN_94	Erosion

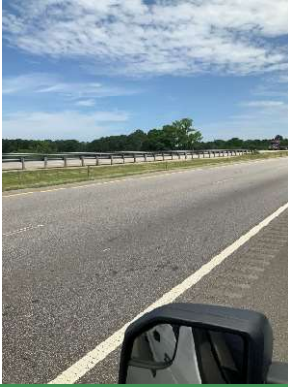
#	Material Type	Object ID	Failure Type	Photo	GIS Reference Page
1	Asphalt	LS_166	Marker Missing

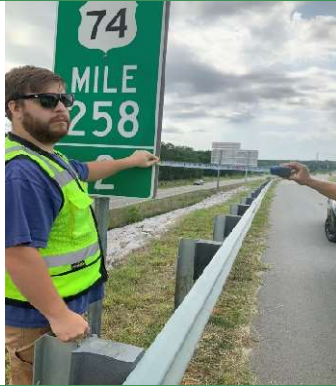
#	Sign Type	Object ID	Failure Type	Photo	GIS Reference Page
1	Mile Marker	SN_152	Lateral Clearance

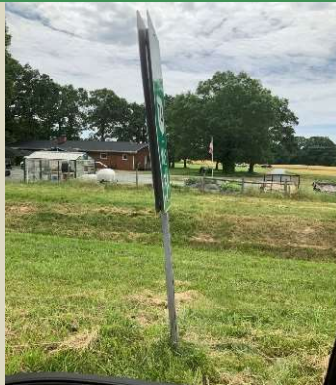
B5
2	Mile Marker	SN_400	Sign Support

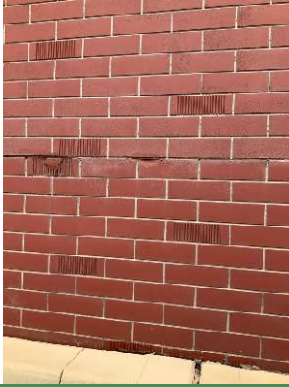
#	Material Type	Object ID	Failure Type	Photo	GIS Reference Page
1	Brick	WL_70	Spalling
