# Maintenance Rating Program

Triangle Expressway

2026 First Quarter Report

### NCTA Triangle Expressway Roadway Maintenance Performance Rating Program; Q1, 2026 Rating

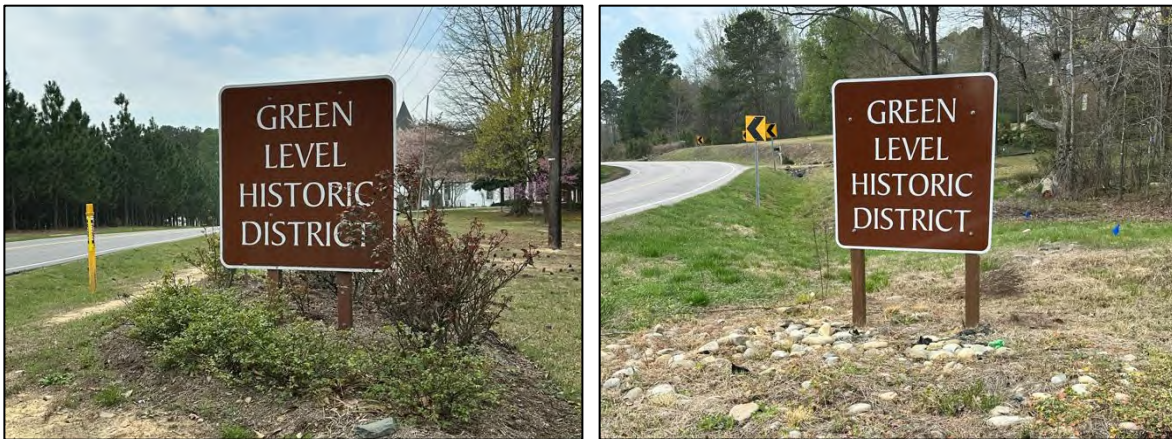
Figure 4: Green Level West Historic District Signs, Landscape Areas

As part of each quarterly inspection, an assessment team visits the two remaining Green Level Historic District signs to conduct a visual inspection of each sign and ensure they are in good standing. Both two signs included in the inspection inventory were found to be in good condition, while one of the landscaping beds around a recently re-erected sign needs attention. *Figure 4* shows the two areas assessed.

This quarter, both two Green Level Historic District signs inspected were found to be in good condition. The landscaped area surrounding the recently erected sign needs attention, while the other has been well maintained.

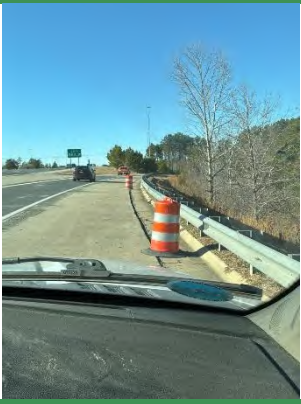
#	Material Type	Object ID	Failure Type	Photo	GIS Reference Page
1	Other	CG_16	Settlement

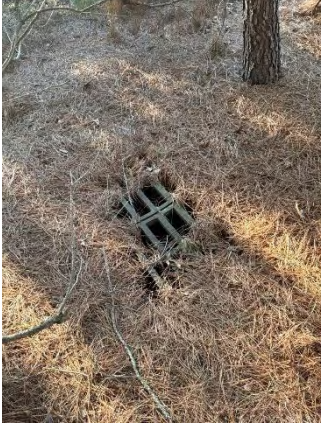
#	Material Type	Object ID	Failure Type	Photo	GIS Reference Page
1	Drain	DP_897	Obstruction

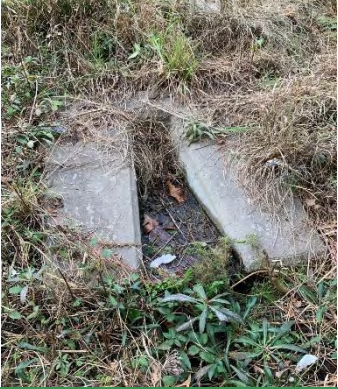
#	Material Type	Object ID	Failure Type	Photo	GIS Reference Page
1	Shoulder Drain	MDP_140	Rodent Screen

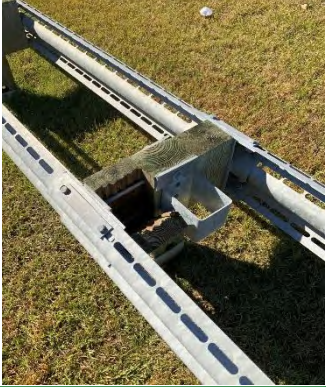
#	Material Type	Object ID	Failure Type	Photo	GIS Reference Page
1	Gating Attenuator	IA_11	Functional Damage

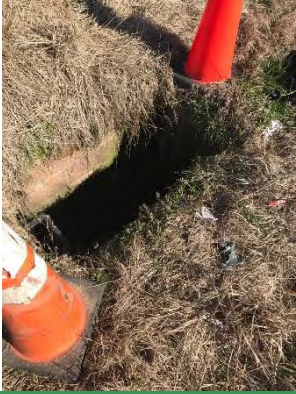
#	Material Type	Object ID	Failure Type	Photo	GIS Reference Page
1	Drop Inlet	IN_980	Obstruction

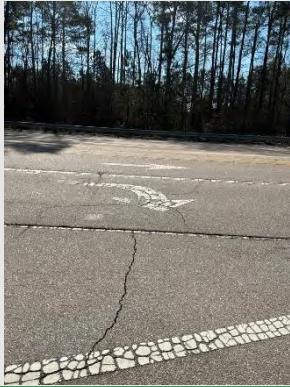
#	Material Type	Object ID	Failure Type	Photo	GIS Reference Page
1	Right Turn	PS_383	Nighttime Reflectivity	No Photo Available	A1
2	Right Turn	PS_482	Daytime Assessment / Nighttime Reflectivity
