Maintenance Rating Program Monroe Expressway

Quarter 1 MRP Assessment

May 2026

NCTA Monroe By-Pass Roadway Maintenance Performance Rating Program; Q1, 2026 Rating

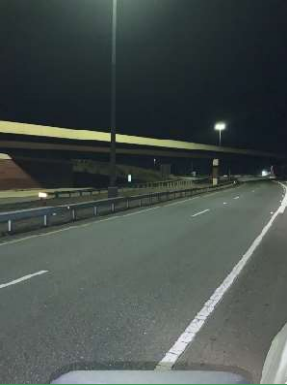
#	Material Type	Object ID	Failure Type	Photo	GIS Reference Page
1	Polycarbonate	BR_230	Missing Parts

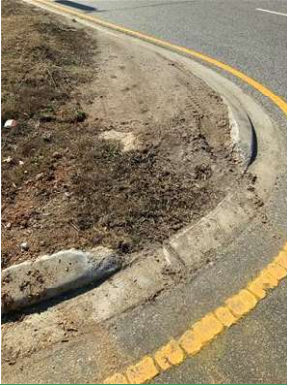
#	Material Type	Object ID	Failure Type	Photo	GIS Reference Page
1	Concrete	CG_71	Structural Damage

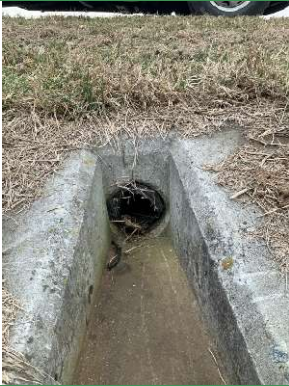
#	Material Type	Object ID	Failure Type	Photo	GIS Reference Page
1	Concrete	MDD_40	Part Missing

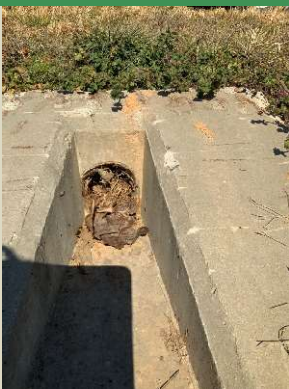
B15
2	Concrete	MDD_127	Obstruction

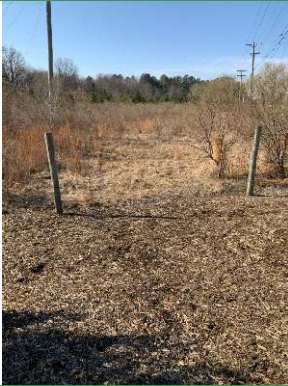
#	Material Type	Object ID	Failure Type	Photo	GIS Reference Page
1	Woven	FN_326	Functional Damage

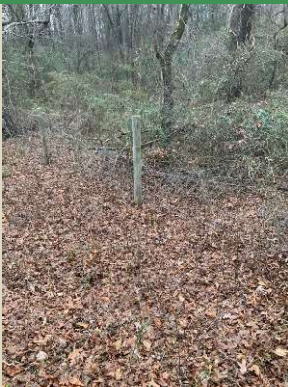
B4
2	Woven	FN_508	Functional Damage

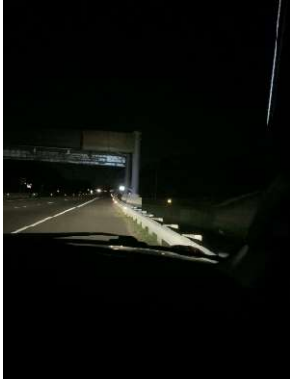
Highway Lighting scored a 33 in the survey. Deficiencies of highway lighting were directly related to nighttime luminaries not functioning properly. The MRP Maintenance and Evaluation Standards V7 are below.

#	Material Type	Object ID	Failure Type	Photo	GIS Reference Page
1	Street Lighting	HL_1	Functional Damage

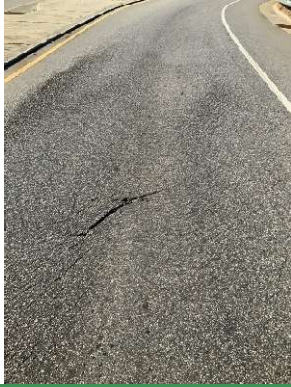
#	Material Type	Object ID	Failure Type	Photo	GIS Reference Page
1	Asphalt	LS_582	Detrimental Transverse Settlement

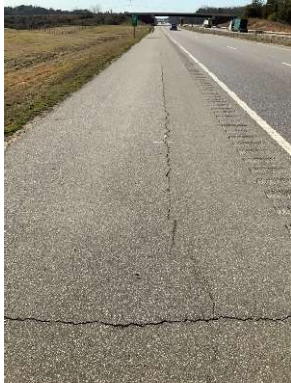
#	Material Type	Object ID	Failure Type	Photo	GIS Reference Page
1	Asphalt	LS_607	Unsealed Cracks

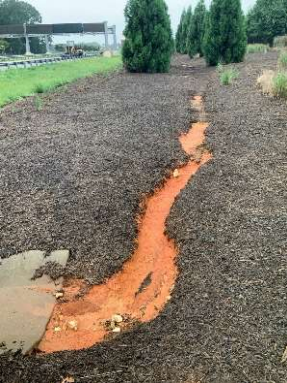
#	Material Type	Object ID	Failure Type	Photo	GIS Reference Page
1	Concrete	PD_26	Erosion

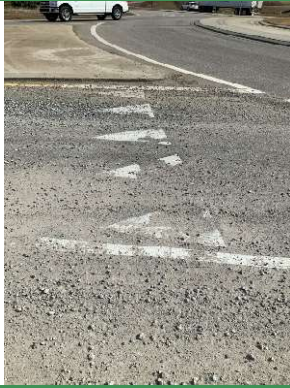
#	Material Type	Object ID	Failure Type	Photo	GIS Reference Page
1	Thermo-plastic	PS_268	Daytime Assessment

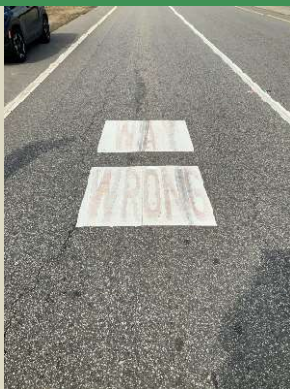
B9
2	Thermo-plastic	PS_280	Daytime Assessment

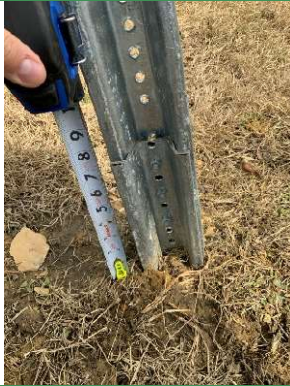
#	Material Type	Object ID	Failure Type	Photo	GIS Reference Page
1	Right Lane Must Turn Right	SN_430	Sign Support

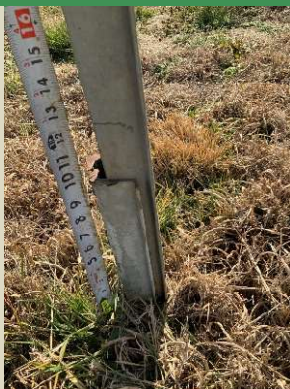
B7
2	Mile Marker	SN_644	Sign Support

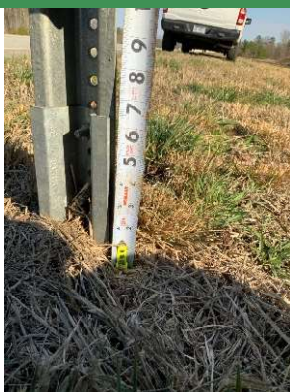
B18
3	Mile Marker	SN_782	Sign Support

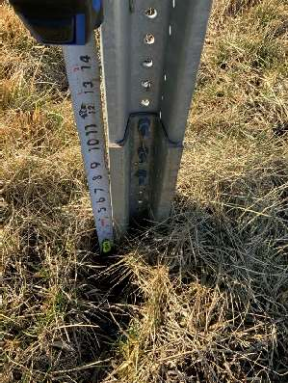
#	Sign Type	Object ID	Failure Type	Photo	GIS Reference Page
4	Speed Limit	SN_1034	Sign Support

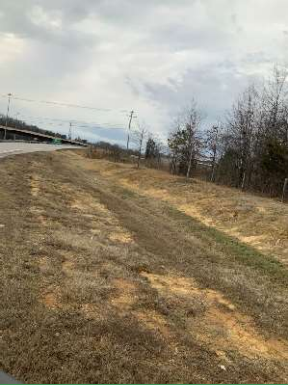
#	Material Type	Object ID	Failure Type	Photo	GIS Reference Page
1	Turf	TF__139	Bare Ground

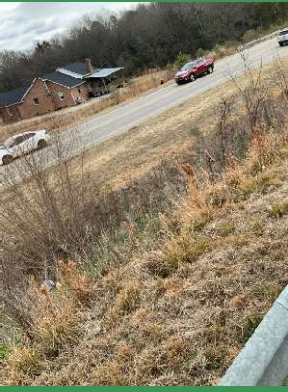
B1
2	Turf	TF_477	Noxious Weeds
