# Maintenance Rating Program

## Triangle Expressway

2026 Second Quarter Report

NCTA Triangle Expressway Roadway Maintenance Performance Rating Program; Q2, FY 2026 Rating

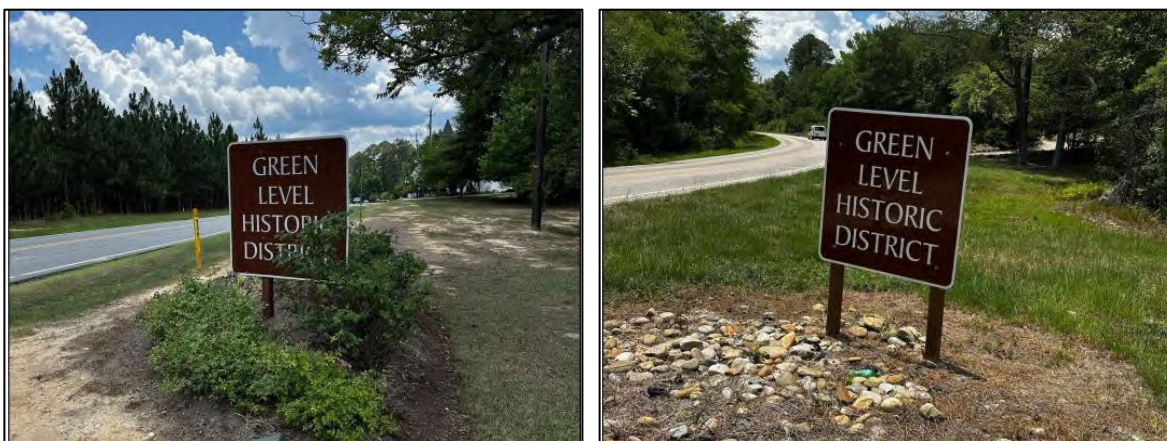
**Figure 4: Green Level West Historic District Signs, Landscape Areas**

In addition, the report provides findings of the Green Level Historic District signs inspection. This quarter, two signs were inspected. Both signs were in good physical condition. The landscaped area around one of the signs was maintained in accordance with NCTA MRP standards, while the landscaping bed around the other sign requires attention.

This quarter, both two Green Level Historic District signs were found to be in good condition. The landscaped area surrounding one of the signs needs attention, while the other has been well maintained.

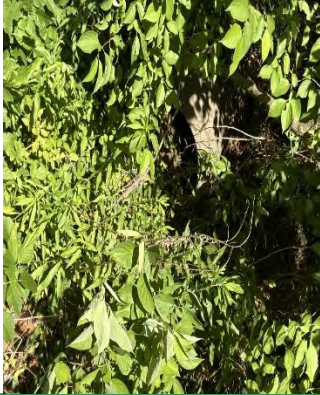
| # | Material Type | Object ID | Failure Type | Photo | GIS Reference Page |
|---|---|---|---|---|---|
| 1 | Cross Pipe | DP_634 | Obstruction | | A13 |

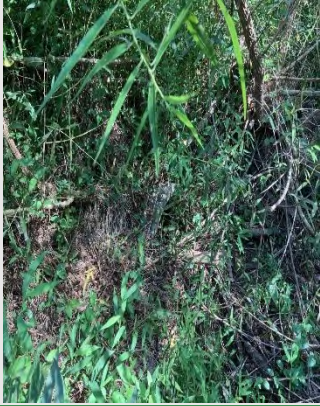
| # | Material Type | Object ID | Failure Type | Photo | GIS Reference Page |
|---|---|---|---|---|---|
| 2 | Drain | DP_725 | Obstruction | | A2 |

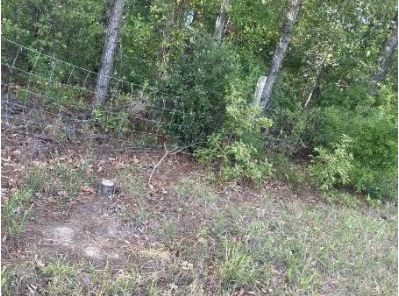
| # | Material Type | Object ID | Failure Type | Photo | GIS Reference Page |
|---|---|---|---|---|---|
| 1 | Woven | FN_65 | Hole Height | | A6 |

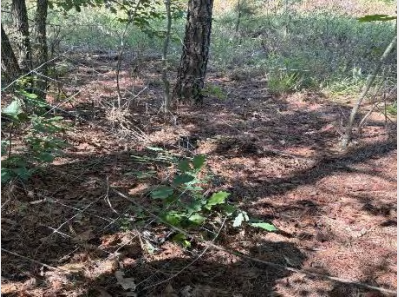
| # | Material Type | Object ID | Failure Type | Photo | GIS Reference Page |
|---|---|---|---|---|---|
| 1 | Woven | FN_112 | Hole Height | | A12 |

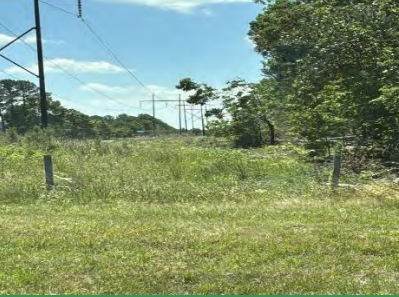
| # | Material Type | Object ID | Failure Type | Photo | GIS Reference Page |
|---|---|---|---|---|---|
| 1 | Woven | FN_219 | Hole Height | | A1 |

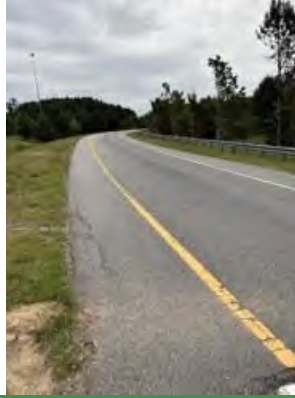
| # | Material Type | Object ID | Failure Type | Photo | GIS Reference Page |
|---|---|---|---|---|---|
| 1 | Asphalt | LS_183 | Cracking | | A17 |

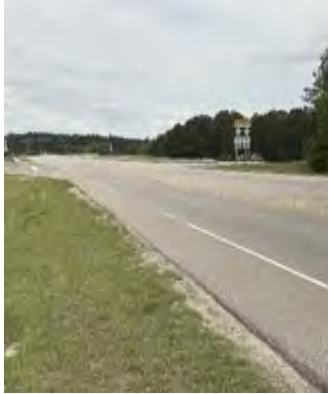
| # | Material Type | Object ID | Failure Type | Photo | GIS Reference Page |
|---|---|---|---|---|---|
| 1 | Asphalt | LS_10 | Nighttime Reflectivity | | A26 |

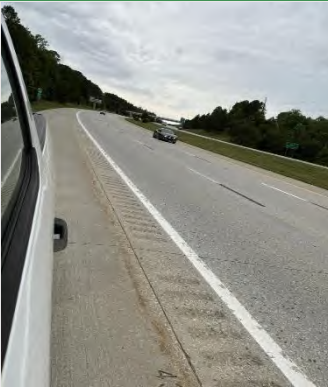
| # | Material Type | Object ID | Failure Type | Photo | GIS Reference Page |
|---|---|---|---|---|---|
| 2 | Concrete | LS_101 | Nighttime Reflectivity | | A14 |

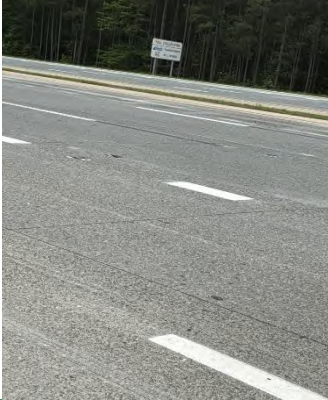
| # | Material Type | Object ID | Failure Type | Photo | GIS Reference Page |
|---|---|---|---|---|---|
| 3 | Concrete | LS_458 | Nighttime Reflectivity | | A25 |

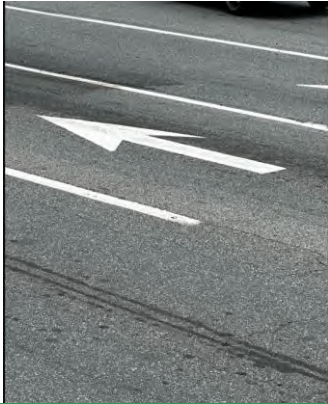
| # | Material Type | Object ID | Failure Type | Photo | GIS Reference Page |
|---|---|---|---|---|---|
| 3 | Thru Lane | PS_412 | Nighttime Reflectivity | | A1 |

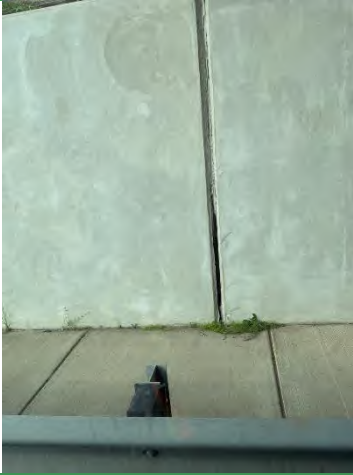
| # | Material Type | Object ID | Failure Type | Photo | GIS Reference Page |
|---|---|---|---|---|---|
| 1 | Bridge Wall | WL_32 | Unsealed Cracks/ Joints | | A6 |
