# Maintenance Rating Program Monroe Expressway

Quarter 2 MRP Assessment

NCTA Monroe Expressway Roadway Maintenance Performance Rating Program; Q2, FY 2026 Rating

2026 Second Quarter (April - June)

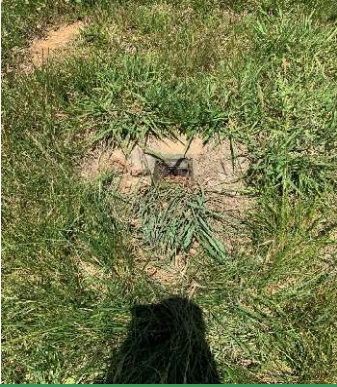
| # | Material Type | Object ID | Failure Type | Photo | GIS Reference Page |
|---|---|---|---|---|---|
| 1 | Concrete | MDD_82 | Blockage | | B3 & B4 |

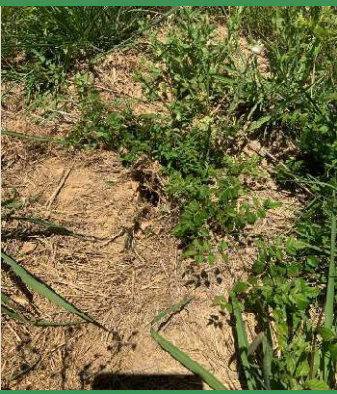
| # | Material Type | Object ID | Failure Type | Photo | GIS Reference Page |
|---|---|---|---|---|---|
| 2 | Concrete | MDD_96 | Blockage | | B9 |

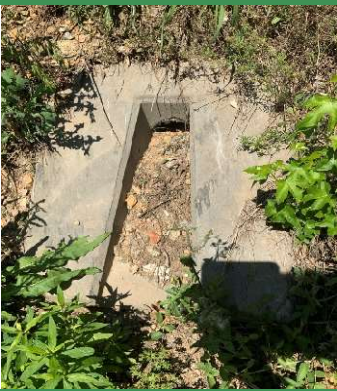
| # | Material Type | Object ID | Failure Type | Photo | GIS Reference Page |
|---|---|---|---|---|---|
| 3 | Concrete | MDD_102 | Blockage | | B13 |

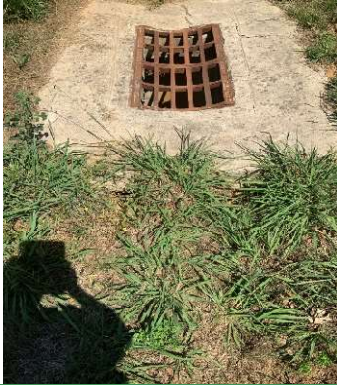
| # | Material Type | Object ID | Failure Type | Photo | GIS Reference Page |
|---|---|---|---|---|---|
| 1 | Concrete | IN_200 | Erosion | | B20 |

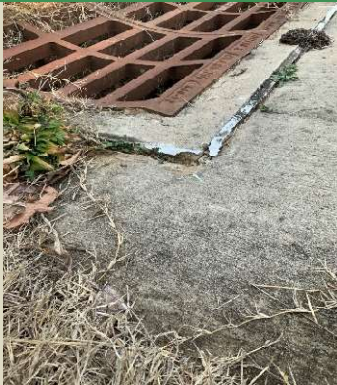
| # | Material Type | Object ID | Failure Type | Photo | GIS Reference Page |
|---|---|---|---|---|---|
| 2 | Concrete | IN_392 | Missing Part | | B14 |

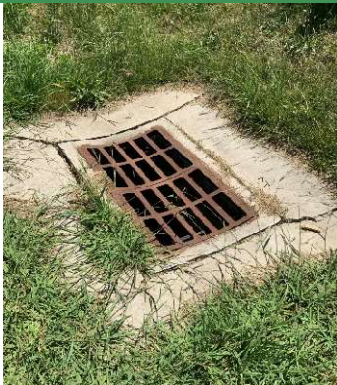
| # | Material Type | Object ID | Failure Type | Photo | GIS Reference Page |
|---|---|---|---|---|---|
| 3 | Concrete | IN_564 | Erosion | | B8 |

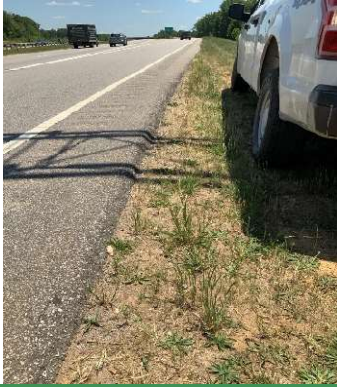
| # | Material Type | Object ID | Failure Type | Photo | GIS Reference Page |
|---|---|---|---|---|---|
| 1 | Asphalt | LS_672 | Shoulder Drop-Off | | B6 & B7 |

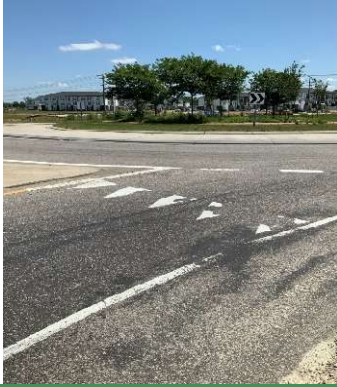
| # | Material Type | Object ID | Failure Type | Photo | GIS Reference Page |
|---|---|---|---|---|---|
| 1 | Thermo-plastic | LS_307 | Striping Missing | | B9 |

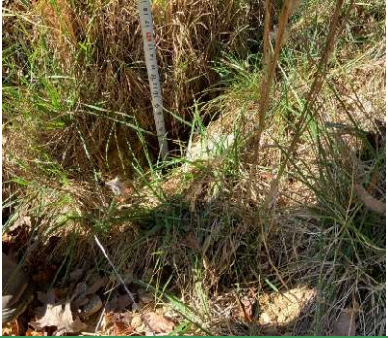
| # | Material Type | Object ID | Failure Type | Photo | GIS Reference Page |
|---|---|---|---|---|---|
| 1 | Concrete | PD_13 | Material Accumulation | | B22 |

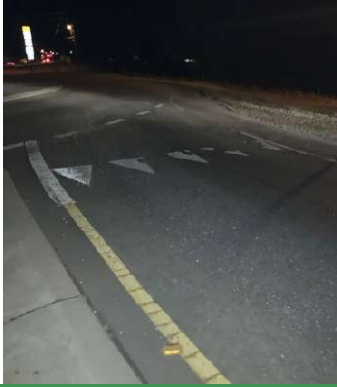
| # | Material Type | Object ID | Failure Type | Photo | GIS Reference Page |
|---|---|---|---|---|---|
| 1 | Asphalt | PS_271 | Nighttime Reflectivity | | B7 |

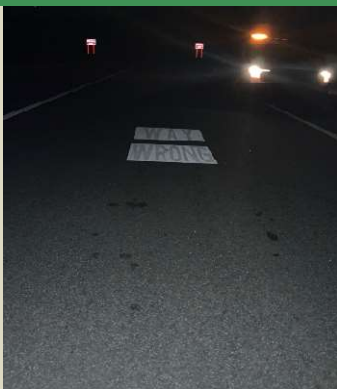
| # | Material Type | Object ID | Failure Type | Photo | GIS Reference Page |
|---|---|---|---|---|---|
| 2 | Asphalt | PS_282 | Nighttime Reflectivity | | B4 |

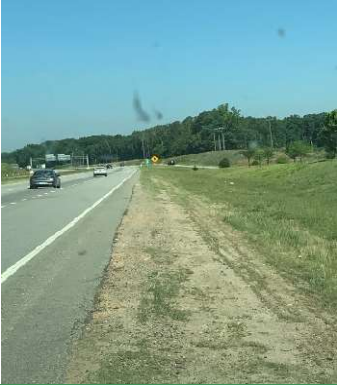
| # | Material Type | Object ID | Failure Type | Photo | GIS Reference Page |
|---|---|---|---|---|---|
| 1 | Turf | TF_634 | Undesirable Vegetation | | B14 & B15 |
