Maintenance Rating Program Monroe Expressway

Quarter 4 MRP Assessment

February 2026

NCTA Monroe By-Pass Roadway Maintenance Performance Rating Program; Q4, 2025 Rating

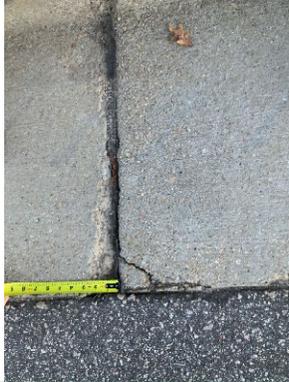
| # | Material Type | Object ID | Failure Type | Photo | GIS Reference Page |
|---|---|---|---|--|---|
| 1 | Concrete | CG_498 | Structural Damage | | B22 |

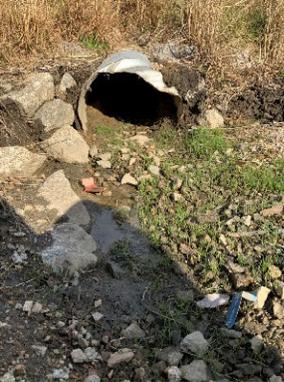
| # | Material Type | Object ID | Failure Type | Photo | GIS Reference Page |
|---|---|---|---|---|---|
| 1 | Concrete | DP_749 | Obstruction | | B10 |

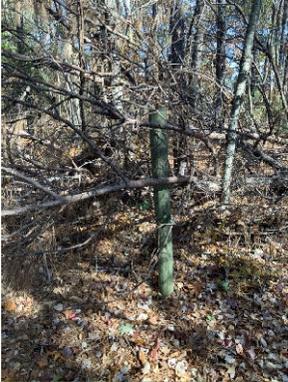
| # | Material Type | Object ID | Failure Type | Photo | GIS Reference Page |
|---|---|---|---|--|---|
| 1 | Woven | FN_160 | Functional Damage | | B15 |

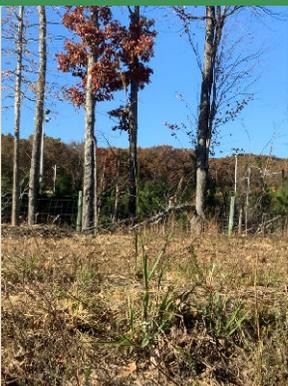
| # | Material Type | Object ID | Failure Type | Photo | GIS Reference Page |
|---|---|---|---|--|---|
| 2 | Woven | FN_259 | Functional Damage | | B2 & B3 |

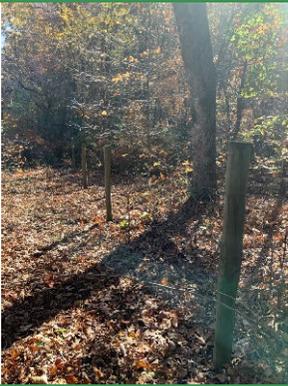
| # | Material Type | Object ID | Failure Type | Photo | GIS Reference Page |
|---|---|---|---|--|---|
| 3 | Woven | FN_541 | Functional Damage | | B21 |

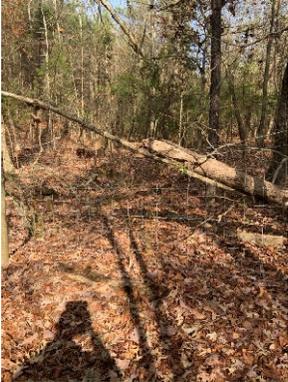
| # | Material Type | Object ID | Failure Type | Photo | GIS Reference Page |
|---|---|---|---|--|---|
| 4 | Woven | FN_561 | Functional Damage | | B19 |

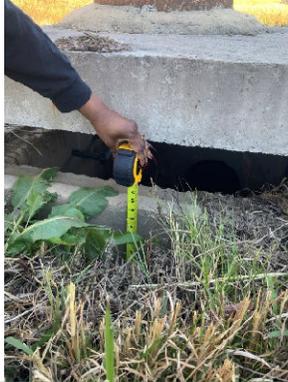
| # | Material Type | Object ID | Failure Type | Photo | GIS Reference Page |
|---|---|---|---|---|---|
| 1 | Concrete | IN_783 | Erosion | | B1 |

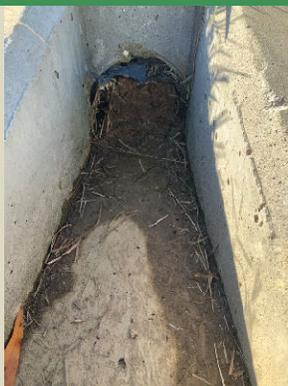
| # | Material Type | Object ID | Failure Type | Photo | GIS Reference Page |
|---|---|---|---|---|---|
| 2 | Concrete | IN_943 | Obstruction | | B18 |

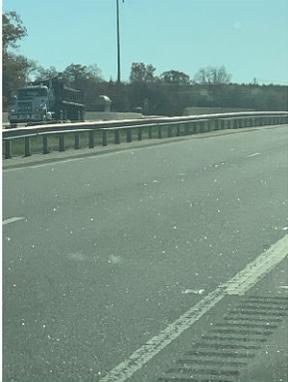
| # | Material Type | Object ID | Failure Type | Photo | GIS Reference Page |
|---|---|---|---|--|---|
| 1 | Thermo-plastic | LS_392 | Line Missing | | B14 |

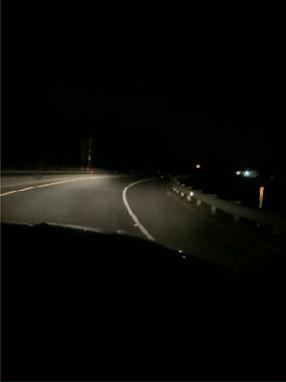
| # | Material Type | Object ID | Failure Type | Photo | GIS Reference Page |
|---|---|---|---|--|---|
| 1 | Thermo-plastic | LS_587 | Missing Marker | | B22 & B23 |

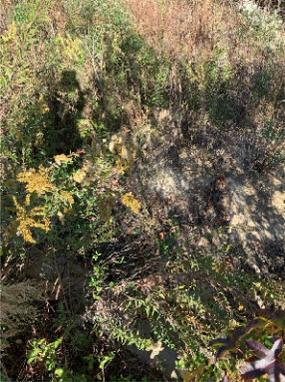
| # | Material Type | Object ID | Failure Type | Photo | GIS Reference Page |
|---|---|---|---|---|---|
| 1 | Concrete | PD_13 | Material Accumulation | | B22 |

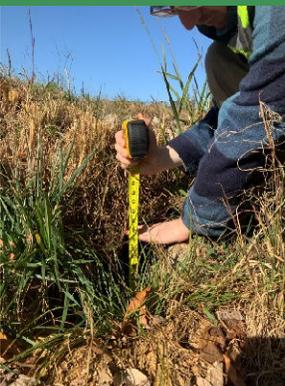
| # | Material Type | Object ID | Failure Type | Photo | GIS Reference Page |
|---|---|---|---|---|---|
| 2 | Concrete | PD_17 | Erosion | | B19 |

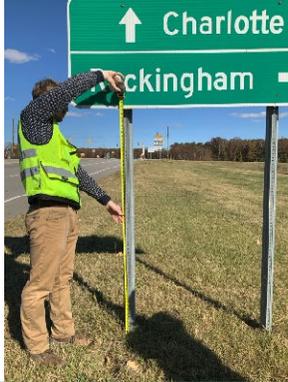
| # | Material Type | Object ID | Failure Type | Photo | GIS Reference Page |
|---|---|---|---|--|---|
| 1 | Guide Sign | SN_429 | Height Requirement | | B7 |

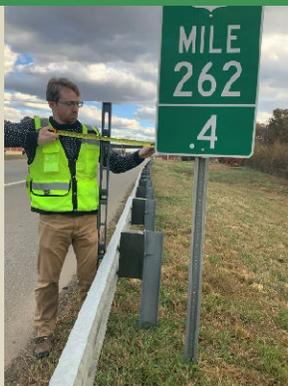
| # | Material Type | Object ID | Failure Type | Photo | GIS Reference Page |
|---|---|---|---|--|---|
| 2 | Mile Marker | SN_497 | Lateral Clearance | | B11 |

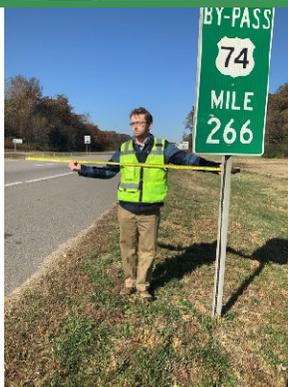
| # | Material Type | Object ID | Failure Type | Photo | GIS Reference Page |
|---|---|---|---|--|---|
| 3 | Mile Marker | SN_698 | Lateral Clearance | | B16 |

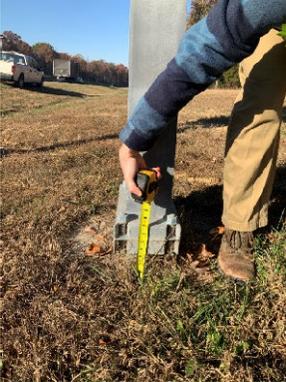
| # | Sign Type | Object ID | Failure Type | Photo | GIS Reference Page |
|---|---|---|---|--|---|
| 4 | Toll Rate | SN_873 | Slip Base | | B21 |

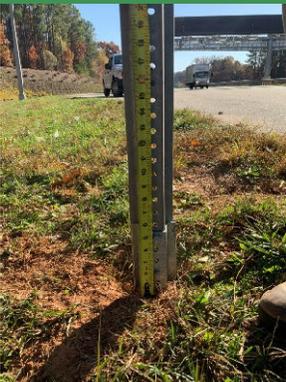
| # | Sign Type | Object ID | Failure Type | Photo | GIS Reference Page |
|---|---|---|---|--|---|
| 5 | Authorized Vehicles Only | SN_885 | Sign Support | | B19 |

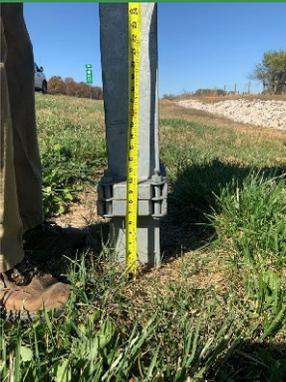
| # | Sign Type | Object ID | Failure Type | Photo | GIS Reference Page |
|---|---|---|---|--|---|
| 6 | Payments Accepted | SN_1054 | Slip Base | | B13 |

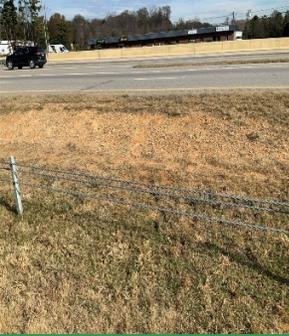
| # | Material Type | Object ID | Failure Type | Photo | GIS Reference Page |
|---|---|---|---|--|---|
| 1 | Turf | TF__113 | Bare Ground | | B1 |

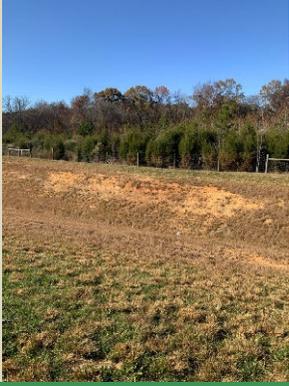
| # | Material Type | Object ID | Failure Type | Photo | GIS Reference Page |
|---|---|---|---|--|---|
| 2 | Turf | TF_215 | Bare Ground | | B4 |

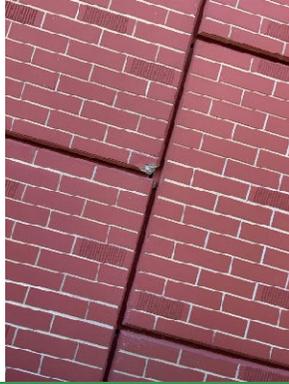
| # | Material Type | Object ID | Failure Type | Photo | GIS Reference Page |
|---|---|---|---|--|---|
| 1 | Brick | WL_g1 | Spalling | | B26 |
