Maintenance Rating Program

Triangle Expressway

November 2025

2025 Third Quarter Report

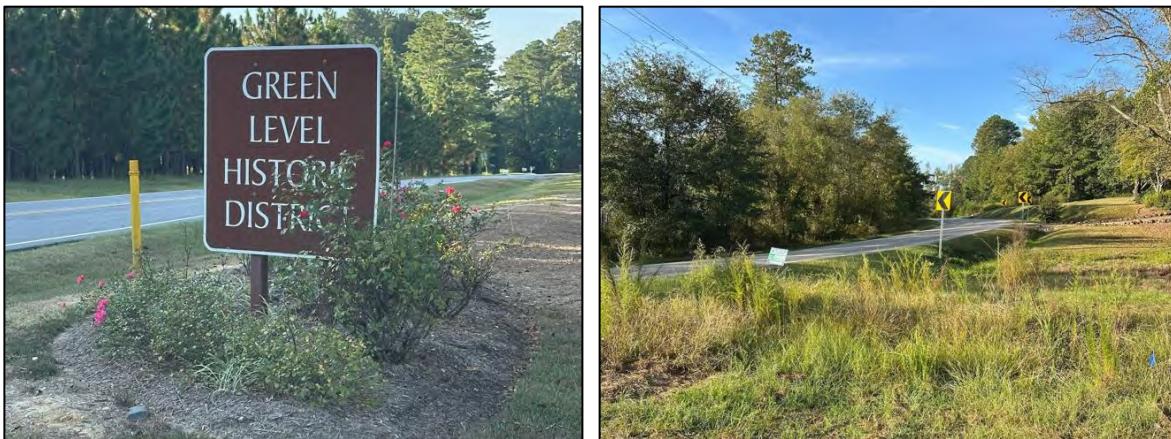
Figure 4: Green Level West Historic District Signs, Landscape Areas

In addition, the report provides findings of the Green Level Historic District signs inspection. This quarter, two signs were inspected. One of the signs was in good physical condition, while the other has been removed after being struck and down for some time. The landscaped area around the erected sign was maintained in accordance with NCTA MRP standards.

This quarter, one of the two Green Level Historic District signs inspected was found to be in good condition, and the other has been removed. The landscaped area surrounding the erected sign was found to be well maintained.

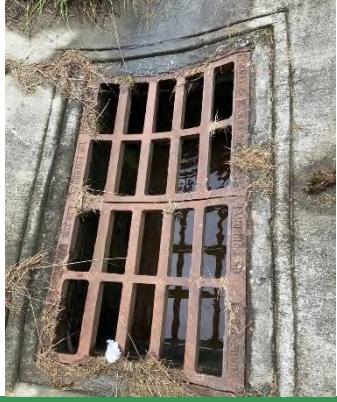
#	Material Type	Object ID	Failure Type	Photo	GIS Reference Page
1	Drainage Pipe	DP_64	Obstruction

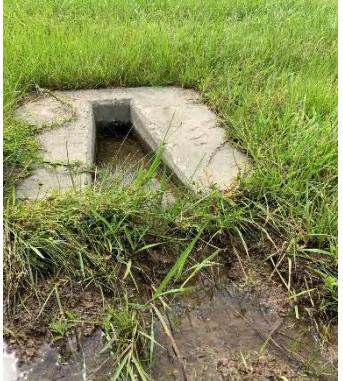
#	Material Type	Object ID	Failure Type	Photo	GIS Reference Page
1	Shoulder Drain	MDP_22	Obstruction

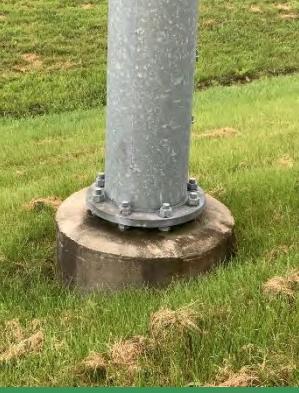
#	Material Type	Object ID	Failure Type	Photo	GIS Reference Page
1	Double Roadway	HL_4	Functional Damage (Out at Night)	No Photo Provided	A34
2	High Mast	HL_74	Functional Damage (Out at Night)	No Photo Provided	A13
3	High Mast	HL_217	Rodent Screen

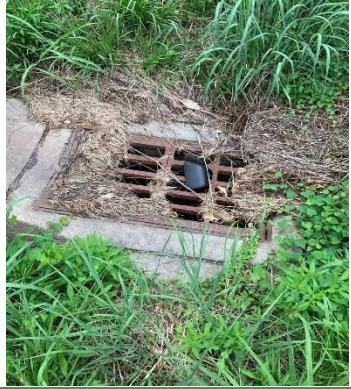
#	Material Type	Object ID	Failure Type	Photo	GIS Reference Page
1	Drop Inlet	IN_469	Obstruction

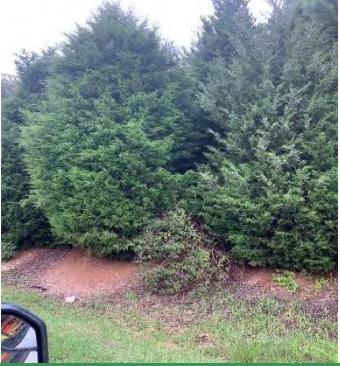
#	Material Type	Object ID	Failure Type	Photo	GIS Reference Page
1	Plant Bed	PB_296	Obstruction

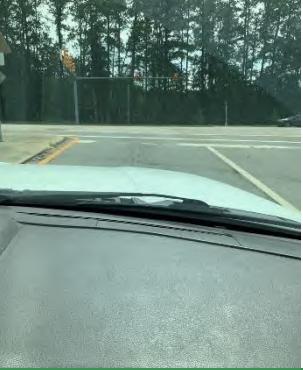
#	Material Type	Object ID	Failure Type	Photo	GIS Reference Page
1	Stop Bar	PS_34	Daytime Assessment / Nighttime Reflectivity

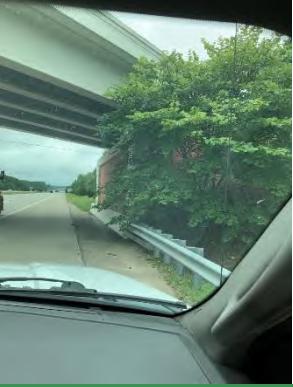
#	Material Type	Object ID	Failure Type	Photo	GIS Reference Page
1	Tree & Brush	TB_336	Barrier Clearance

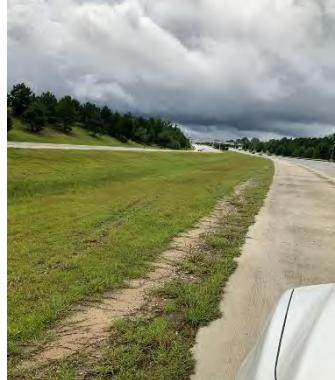
#	Material Type	Object ID	Failure Type	Photo	GIS Reference Page
1	Turf	TF_539	Bare Ground
