# Maintenance Rating Program

Triangle Expressway

2025 Fourth Quarter Report

### NCTA Triangle Expressway Roadway Maintenance Performance Rating Program; Q4, 2025 Rating

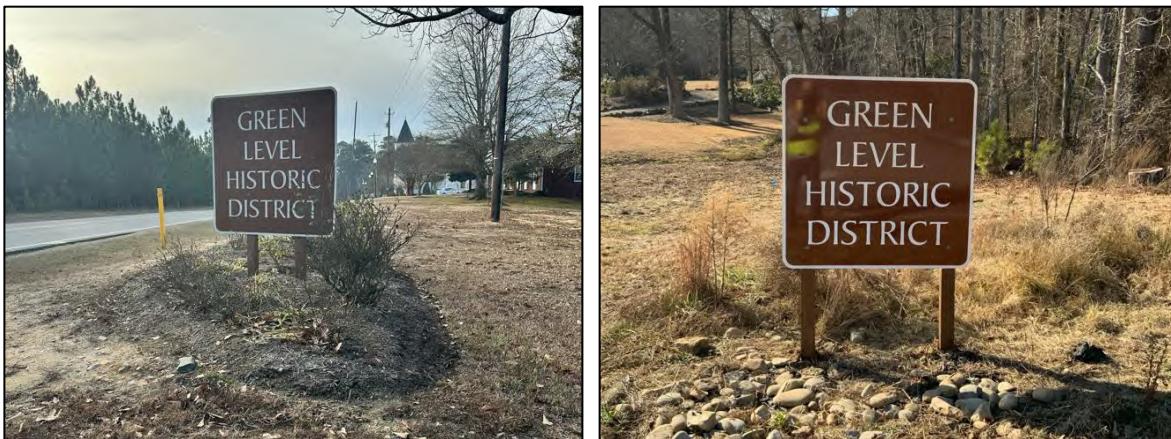
**Figure 4: Green Level West Historic District Signs, Landscape Areas**

As part of each quarterly inspection, an assessment team visits the two remaining Green Level Historic District signs to conduct a visual inspection of each sign and ensure they are in good standing. Both two signs included in the inspection inventory were found to be in good condition, while one of the landscaping beds around a recently re-erected sign needs attention. *Figure 4* shows the two areas assessed.

This quarter, both two Green Level Historic District signs inspected were found to be in good condition. The landscaped area surrounding the recently erected sign needs attention, while the other has been well maintained.

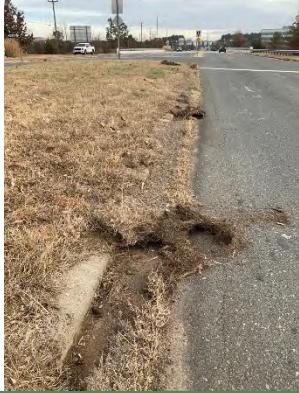
A30

#	Material Type	Object ID	Failure Type	Photo	GIS Reference Page
1	Other	CG_129	Settlement

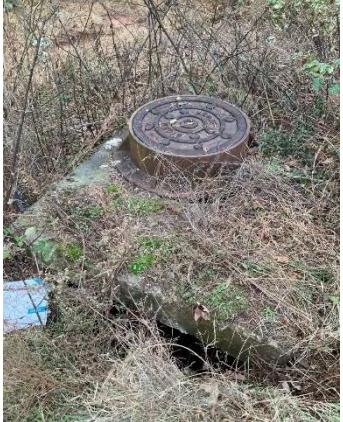
#	Material Type	Object ID	Failure Type	Photo	GIS Reference Page
1	Drain	DP_4	Obstruction

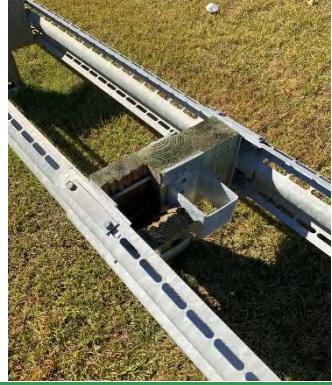
A17

#	Material Type	Object ID	Failure Type	Photo	GIS Reference Page
1	Gating Attenuator	IA_28	Part Damage

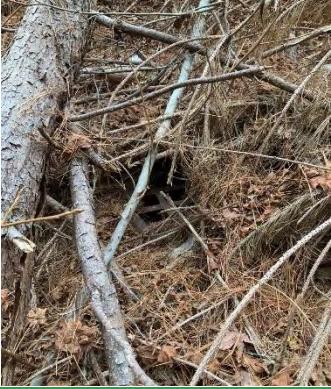
A17

#	Material Type	Object ID	Failure Type	Photo	GIS Reference Page
1	Drop Inlet	IN_571	Obstruction

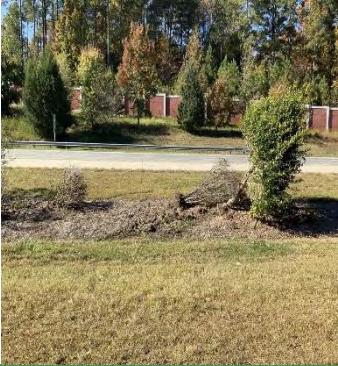
#	Material Type	Object ID	Failure Type	Photo	GIS Reference Page
1	Plant Bed	PB_9	Health

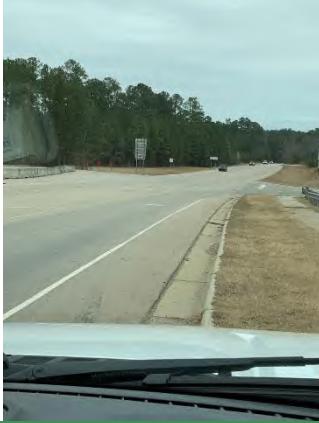
A26

#	Material Type	Object ID	Failure Type	Photo	GIS Reference Page
1	Linear Segment	LS_16	Striping (Line Visibility)

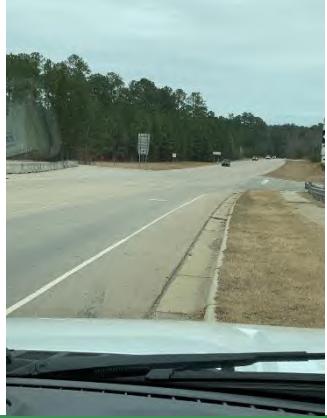
A26

#	Material Type	Object ID	Failure Type	Photo	GIS Reference Page
1	Linear Segment	LS_16	Striping (Reflective Markers)

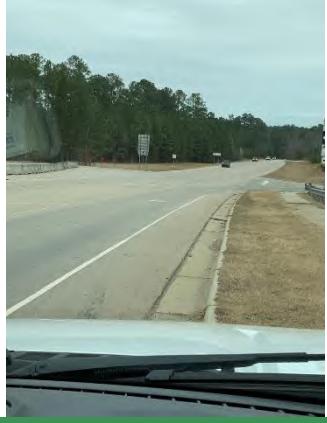
A26

#	Material Type	Object ID	Failure Type	Photo	GIS Reference Page
1	Linear Segment	LS_16	Delineators (Reflective - N)

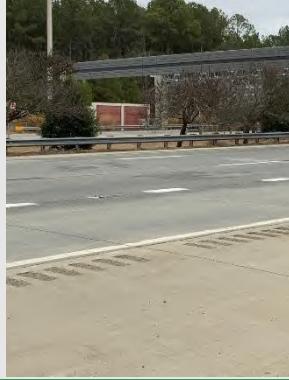
#	Material Type	Object ID	Failure Type	Photo	GIS Reference Page
1	Left Turn	PS_454	Daytime Assessment / Nighttime Reflectivity	No Photo Available	A6
2	Right Turn	PS_543	Daytime Assessment / Nighttime Reflectivity

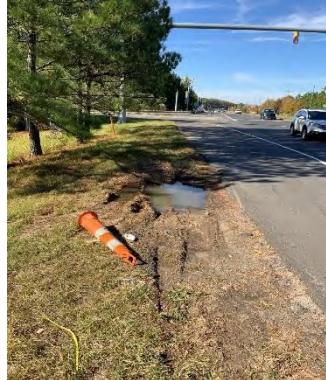
A6

#	Material Type	Object ID	Failure Type	Photo	GIS Reference Page
1	Turf	TF_677	Bare Ground
