NORTH CAROLINA
Turnpike Authority

Triangle Expressway

2016 Fourth Quarter and Annual Report

NCTA Triangle Expressway Roadway Maintenance Performance Rating Program; Q4, 2016 Rating

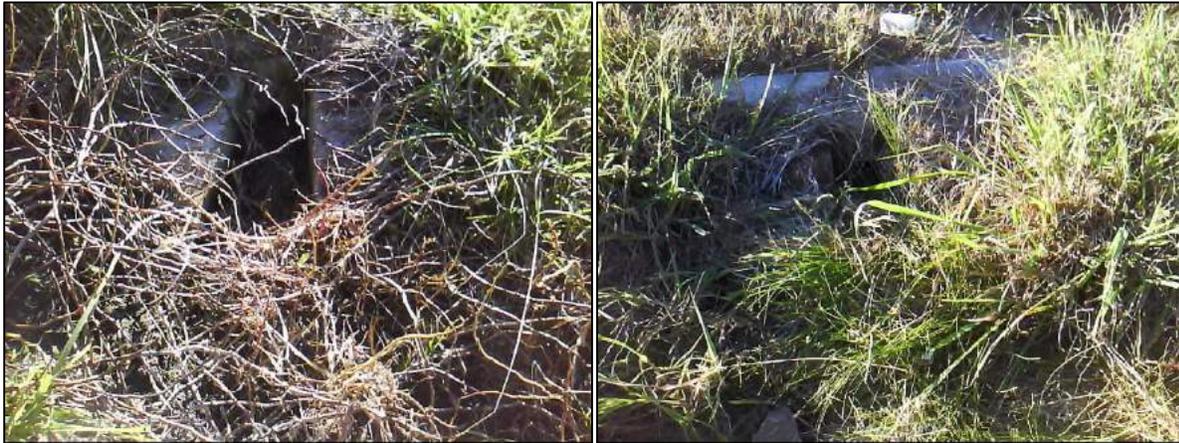
Figure 3: Miscellaneous Drainage Failures

Miscellaneous Drainage (78 rating – 6 of the 27 assets failed). Out of the 27 miscellaneous drainage structures inspected, 6 failed because of obstruction. Two of the failing miscellaneous drainage structures are presented in **Figure 3**.

Most obstruction failures are a result of inadequate gradient flow away from the edge drain outlets. In order to avoid affecting the natural flow of water near the drainage features, it is recommended that outlet elevations be checked against the outflow ditch elevations to ensure positive drainage. Appropriate grading of the ditch line may be necessary to provide positive flow.

In accordance with *NCTA Roadway and Facility Maintenance Standards V4* referenced below, it is recommended that the maintenance provider plan annual cleaning of these drainage features to remove any debris or overgrown vegetation. Additionally, it is recommended that the maintenance provider schedule repairs of the erosion soil buildup problems that have been identified along the ditch line near and adjacent to the outlet.

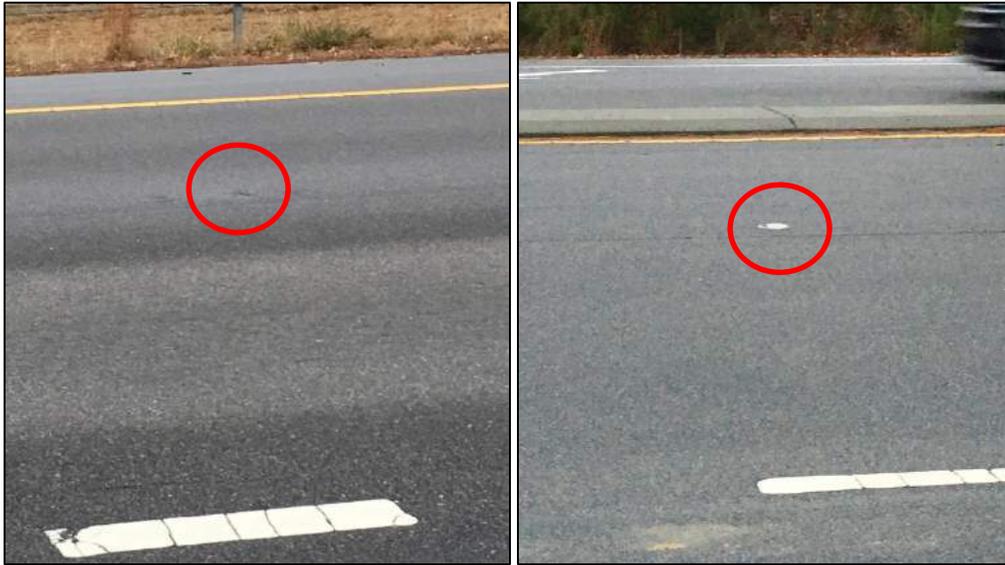
Figure 4: Pavement Marker Failures

Pavement Markers (79 rating – 9 of the 43 assets failed). All 9 pavement marker failures are due to missing markers and insufficient reflectivity during the nighttime inspections. Two examples of the pavement markers failures are represented in *Figure 4*.

In order to maintain a well define lane delineation, especially during inclement weather, throughout the Triangle Expressway, it is recommended that the maintenance provider consider replacing all missing or non-functional markers in accordance with the *NCTA Roadway and Facility Maintenance Standards V4*, referenced below.

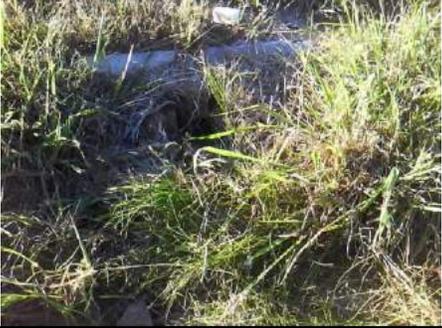
#	Material Type	Object ID	Failure Type	Photo	GIS Reference Page
1	Shoulder Drain	MDP_12	Obstruction

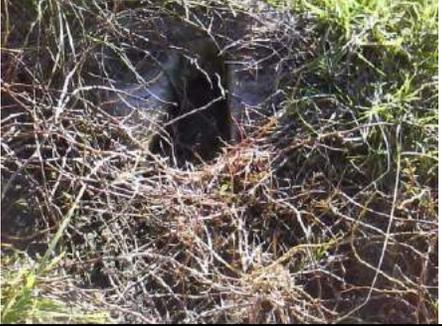
#	Material Type	Object ID	Failure Type	Photo	GIS Reference Page
5	Shoulder Drain	MDP_77	Obstruction

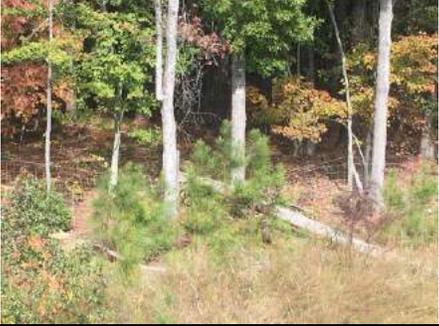
#	Material Type	Object ID	Failure Type	Photo	GIS Reference Page
1	Woven	FN_29	Fence Height

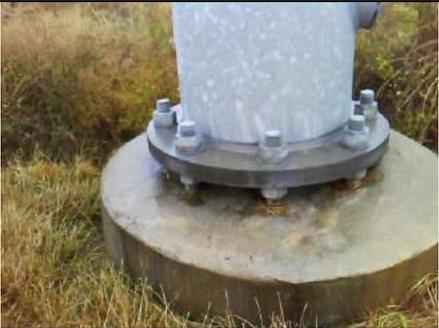
#	Material Type	Object ID	Failure Type	Photo	GIS Reference Page
1	Single Roadway	HL_35	Functional Damage	Not Available for Nighttime Failure	A22
2	Single Roadway	HL_63	Functional Damage	Not Available for Nighttime Failure	A19, A20
3	High Mast	HL_109	Missing Parts

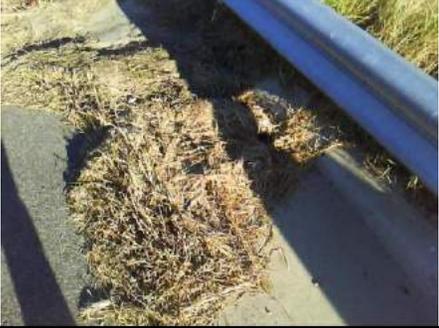
#	Material Type	Object ID	Failure Type	Photo	GIS Reference Page
1	Inlet	IN_353	Obstruction

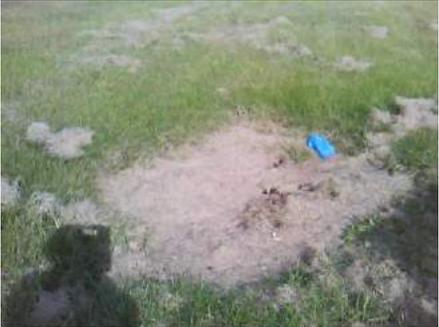
A6
2	Inlet	IN_377	Obstruction

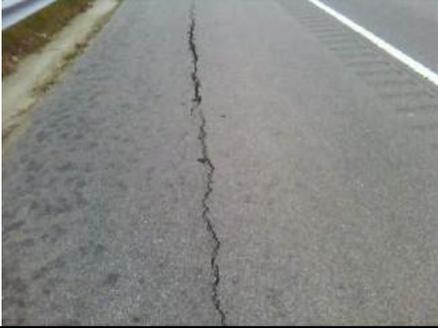
#	Material Type	Object ID	Failure Type	Photo	GIS Reference Page
1	Asphalt	LS_224	Unsealed Cracks

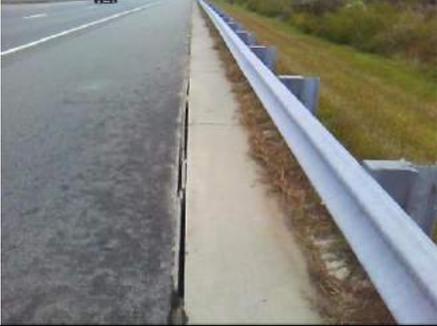
#	Material Type	Object ID	Failure Type	Photo	GIS Reference Page
1	Asphalt	LS_224	Paved Shoulder Joint Separation

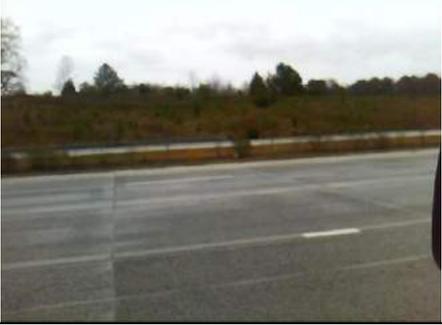
#	Material Type	Object ID	Failure Type	Photo	GIS Reference Page
1	Asphalt	LS_305	Nighttime Line Visibility	Not Available for Nighttime Failure	A3
2	Concrete	LS_331	Nighttime Line Visibility	Not Available for Nighttime Failure	A8
3	Concrete	LS_444	Missing Line

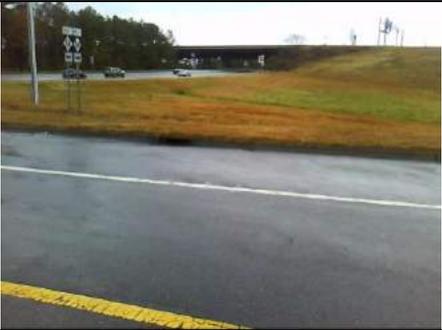
#	Material Type	Object ID	Failure Type	Photo	GIS Reference Page
1	Asphalt	LS_219	Marker Reflectivity	Not Available for Nighttime Failure	A47
2	Asphalt	LS_224	Marker Reflectivity	Not Available for Nighttime Failure	A47
3	Asphalt	LS_305	Marker Reflectivity, Missing Markers

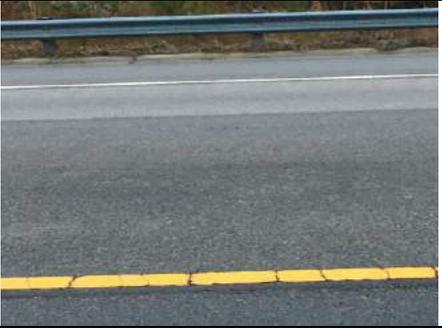
A3
4	Concrete	LS_335	Marker Reflectivity	Not Available for Nighttime Failure	A10
5	Asphalt	LS_395	Marker Reflectivity, Missing Markers, Continuous Markers

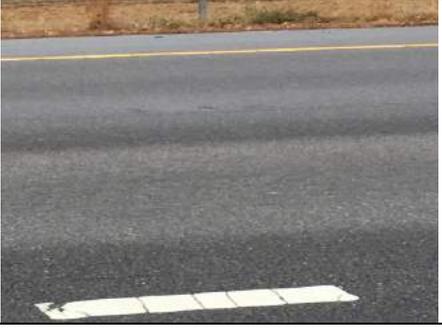
A29
6	Concrete	LS_444	Marker Reflectivity	Not Available for Nighttime Failure	A37
7	Asphalt	LS_576	Marker Reflectivity, Missing Markers, Continuous Markers

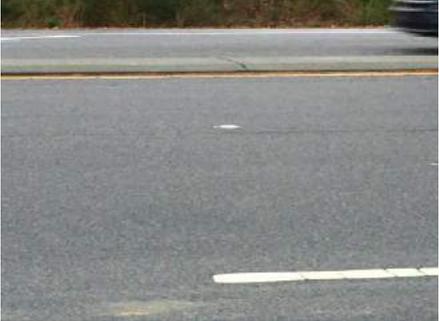
#	Material Type	Object ID	Failure Type	Photo	GIS Reference Page
8	Asphalt	LS_595	Missing Markers, Continuous Markers

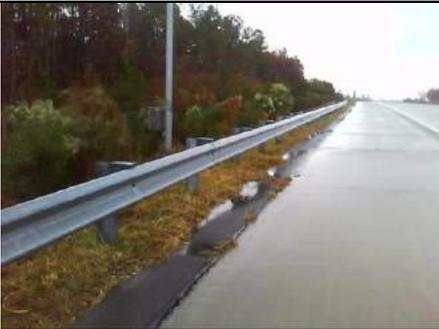
#	Material Type	Object ID	Failure Type	Photo	GIS Reference Page
1	Concrete	LS_38	Missing Markers, Nighttime Reflectivity

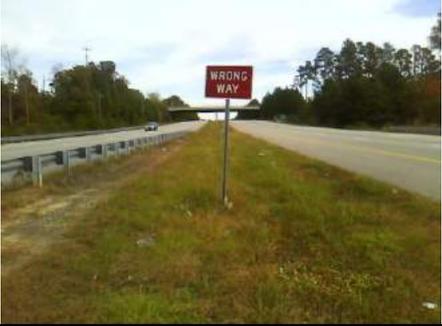
#	Sign Type	Object ID	Failure Type	Photo	GIS Reference Page
1	Wrong Way	SN_50	Leaning

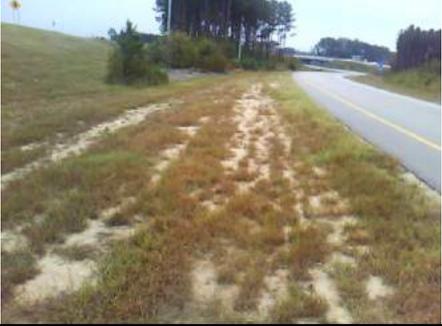
#	Material Type	Object ID	Failure Type	Photo	GIS Reference Page
1	Turf	TF_207	Bareground

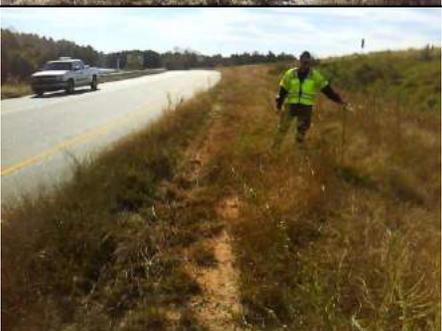
A39
4	Turf	TF_356	Height

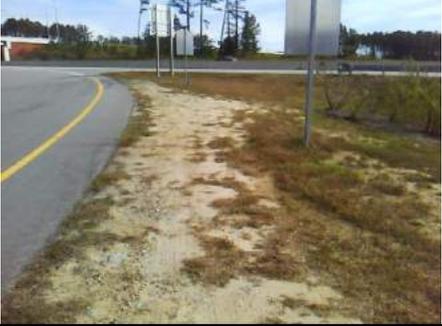
#	Material Type	Object ID	Failure Type	Photo	GIS Reference Page
5	Turf	TF_382	Bareground

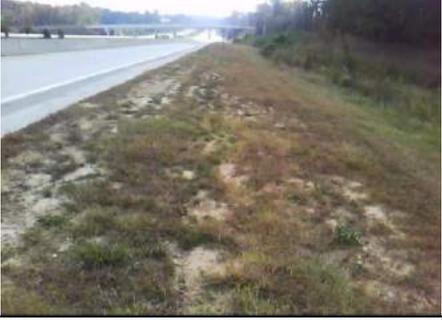
A36
8	Turf	TF_504	Bareground

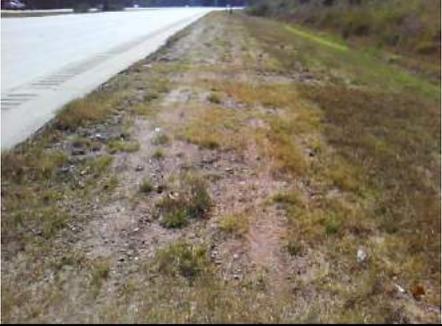
#	Material Type	Object ID	Failure Type	Photo	GIS Reference Page
9	Turf	TF_571	Bareground

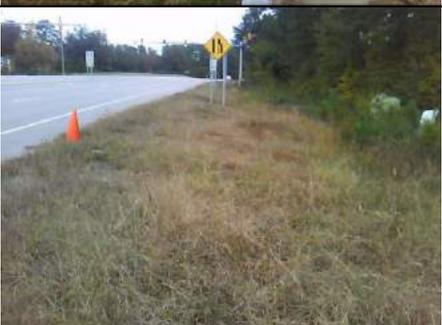
A5, A6
12	Turf	TF_1006	Height

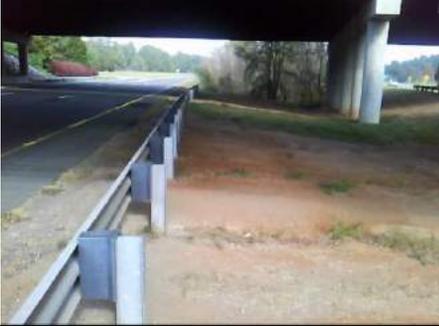
#	Material Type	Object ID	Failure Type	Photo	GIS Reference Page
13	Turf	TF_1007	Bareground

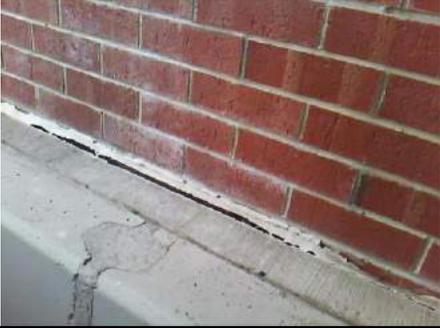
#	Material Type	Object ID	Failure Type	Photo	GIS Reference Page
1	Bridge Wall	WL_5	Joints and Cracks

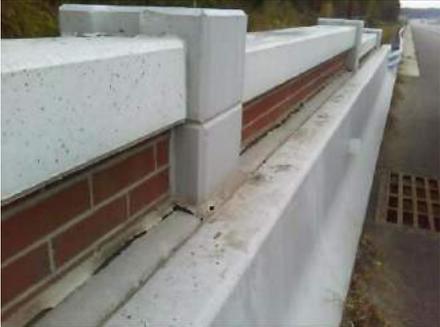
A42
2	Sound Wall	WL_7	Joints and Cracks
