NORTH CAROLINA
Turnpike Authority

Maintenance Rating Program

Triangle Expressway

2017 Second Quarter Report

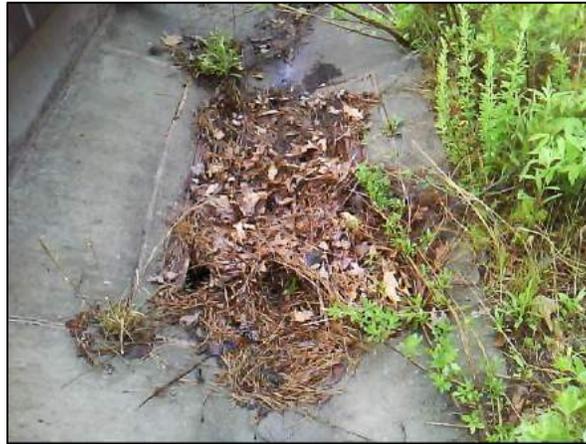
Figure 3: Paved Ditch Failure

Paved Ditches (0 rating – 1 of the 1 asset failed): During this inspection, the paved ditch failed for material accumulation, as presented in **Figure 3**.

- 1) Accumulation of material greater than 25% of the depth of the ditch.
- 2) Undermining or erosion is present at either end or along the parallel edges that threatens the structural integrity.
- 3) Settlement or misalignment greater than 2 inches.
- 4) More than 10% of the surface area has cracking exceeding 0.5 inches in width.

To prevent future paved ditch material accumulation failures, it is recommended that the maintenance provider inspect this asset regularly, pursuant to the *NCTA Roadway and Facility Maintenance Standards V4*, referenced below. During each inspection, it is also recommended that the maintenance provider remove any debris accumulation observed.

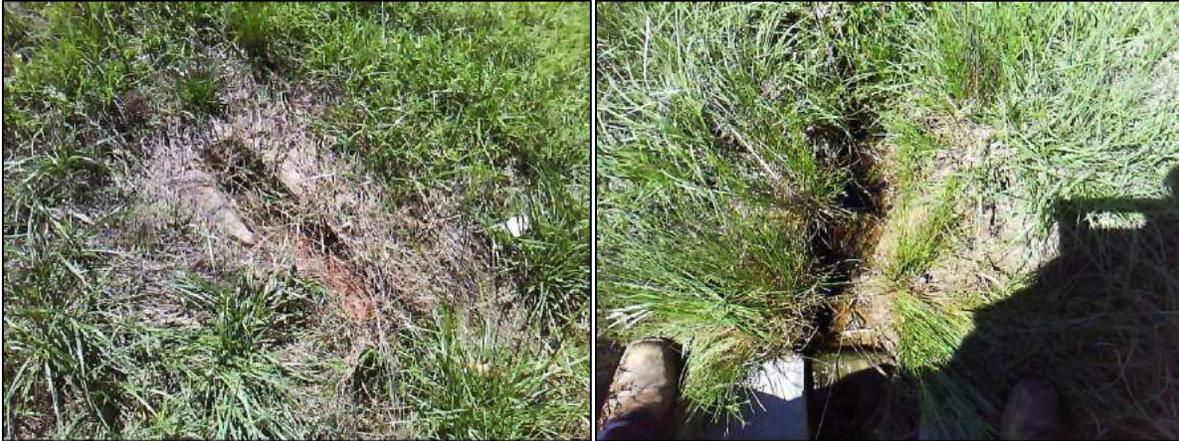
Figure 4: Miscellaneous Drainage Failures

Miscellaneous Drainage (72 rating – 8 of the 29 assets failed): Out of the 8 miscellaneous drainage failures, 5 occurred due to obstruction and 3 occurred due to erosion. Two of the failing miscellaneous drainage structures are presented in **Figure 4**.

It should be noted that some of the obstruction failures are a result of inadequate gradient flow away from the edge drain outlets. To avoid affecting the natural flow of water near the drainage features and potential pavement failures, it is recommended that outlet elevations be checked against the outflow ditch elevations to ensure positive drainage. Appropriate grading of the ditch line may be necessary to provide positive flow.

In accordance with *NCTA Roadway and Facility Maintenance Standards V4*, referenced below, it is recommended that the maintenance provider plan annual cleaning of these drainage features to remove any debris or overgrown vegetation. It is also recommended that the maintenance provider continues to follow the new routine patrol schedule and that repairs of any erosion and soil buildup problems along the ditch line near and adjacent to the outlets be scheduled as soon as possible. Shoulder/Under drains are a critical component of extending the life cycle of pavements as they provide a means for water to drain away from the subgrade and base.

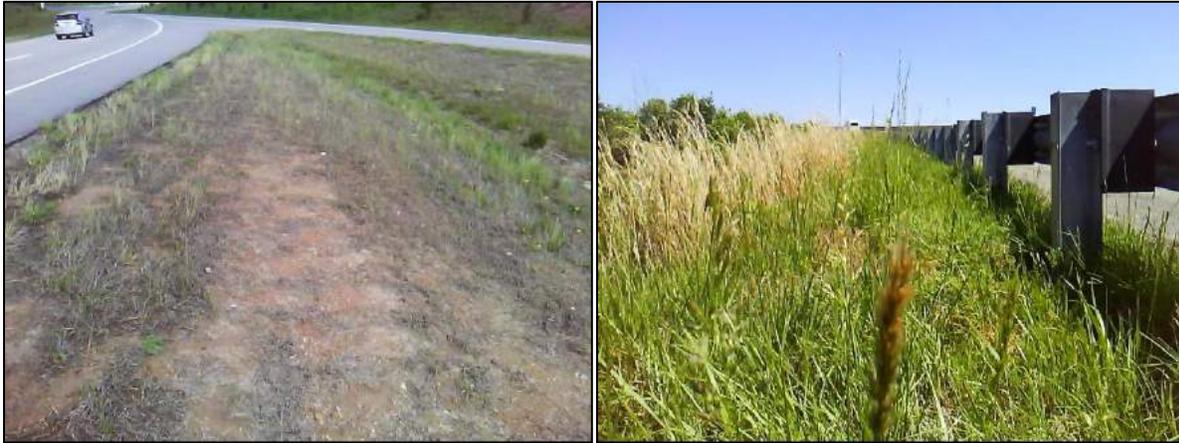
Figure 5: Turf Failures

Turf Condition (54 rating – 24 of the 52 assets failed): Out of the 24 turf failures, 18 occurred due to high grass and 6 occurred due to bare ground. Two of the failing turf areas are presented in **Figure 5**.

High grass was the dominant failure observed during this quarterly inspection. This was due to the inspection taking place days prior to the beginning of the mowing cycle scheduled for the month of May. To continue to improve Turf's rating, it is recommended that the maintenance provider continue the seeding process of bare ground areas with warm season grasses during the summer. In addition, it is recommended that the maintenance provider continue to monitor mowing heights during the 2017 mowing cycle pursuant to the *NCTA Roadway and Facility Maintenance Standards V4*, referenced below.

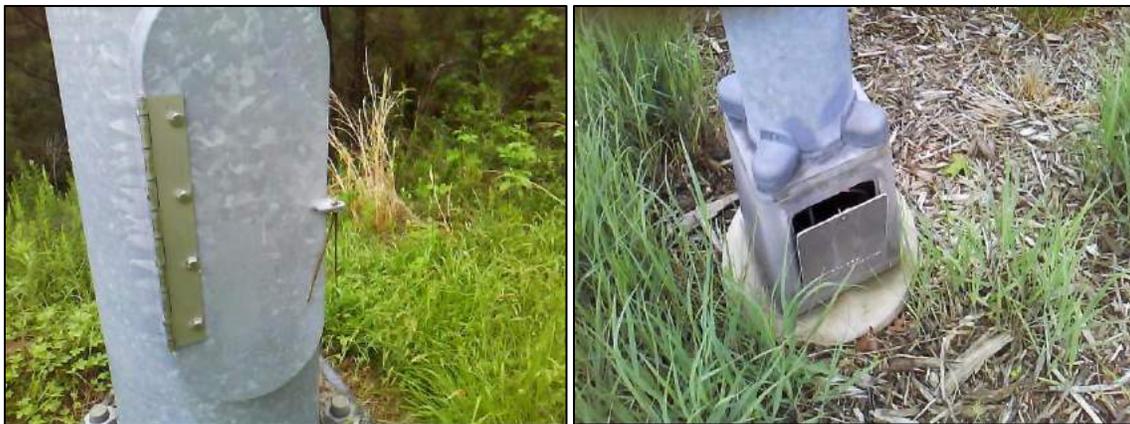
Figure 6: Highway Lighting Failures

Highway Lighting (78 rating – 9 of the 40 assets failed): Out of the 40 highway lights inspected, 3 failed due to functional damage, 3 failed due to damaged parts, and 3 failed due to missing parts. Two of the failing highway lights are presented in **Figure 6**.

To increase this asset's rating, it is recommended that all non-functioning or damaged highway lights noted during the inspection be repaired and/or replaced in accordance with the *NCTA Roadway and Facility Maintenance Standards V4*, referenced below.

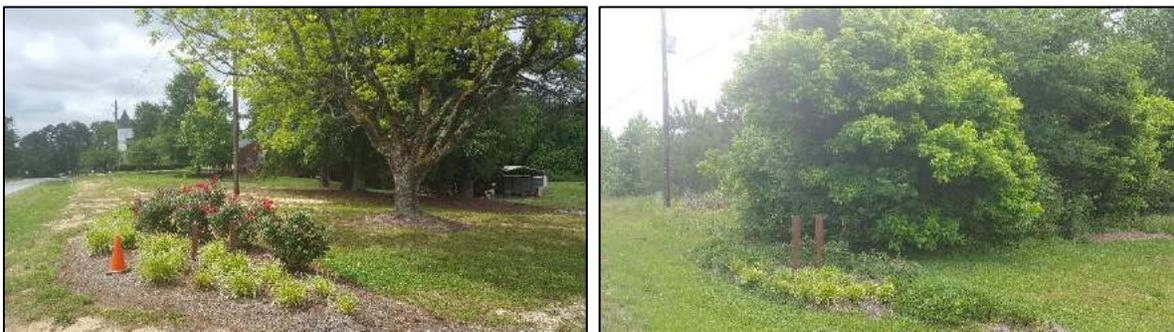
Figure 7: Green Level West Historic District Signs, Landscape Areas

As part of each quarterly inspection, assessors visit the four Green Level Historic District signs to conduct a visual inspection of each sign and ensure they are in good standing. During this quarter, the sign located near the intersection of Green Level Church Road and Green Level West Road was excluded from the inspection inventory due construction work in the area. The three signs included in the inspection inventory were only inspected for landscape appearance because two of the three signs were vandalized and the other sign was temporarily removed to be used as a sample to replace the vandalized signs. All landscaped areas at the location of the signs were found to be well maintained (*Figure 7*).

It should be noted that as of July 24th, 2017, three of the four Green Level Historic District signs have been replaced.

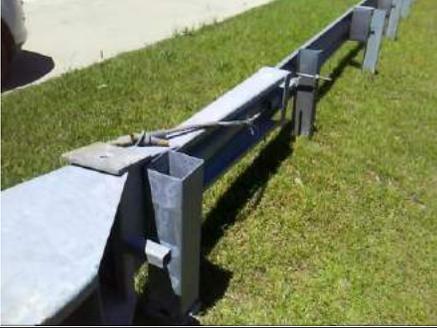
#	Material Type	Object ID	Failure Type	Photo	GIS Reference Page
1	Guardrail	BR_97	Functional Damage

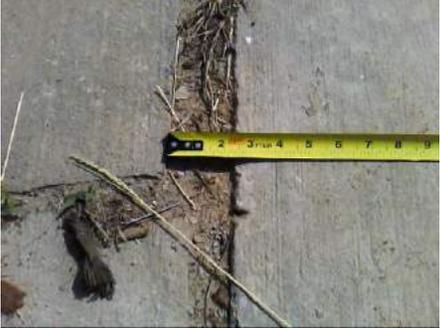
#	Material Type	Object ID	Failure Type	Photo	GIS Reference Page
1	Valley	CG_5	Misalignment

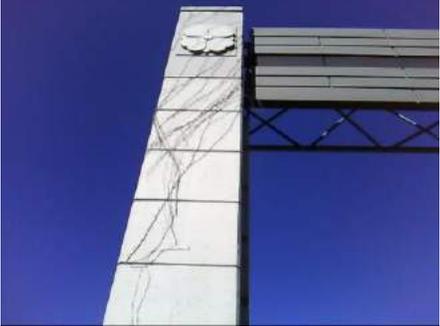
#	Material Type	Object ID	Failure Type	Photo	GIS Reference Page
1	Gantry Support	DS_60	Vegetation

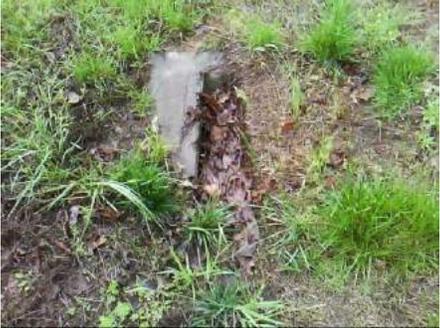
#	Material Type	Object ID	Failure Type	Photo	GIS Reference Page
1	Shoulder Drain	MDP_6	Obstruction

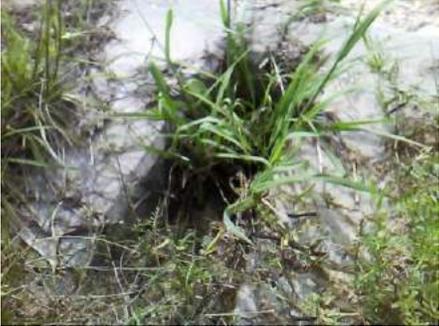
#	Material Type	Object ID	Failure Type	Photo	GIS Reference Page
5	Shoulder Drain	MDP_87	Obstruction

A photograph showing a concrete shoulder drain partially blocked by a dense clump of tall green grass and weeds.	A24
6	Shoulder Drain	MDP_119	Erosion

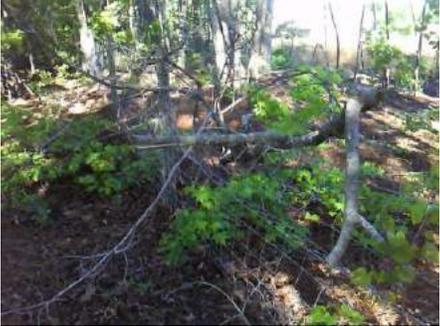
#	Material Type	Object ID	Failure Type	Photo	GIS Reference Page
1	Woven	FN_258	Hole Height

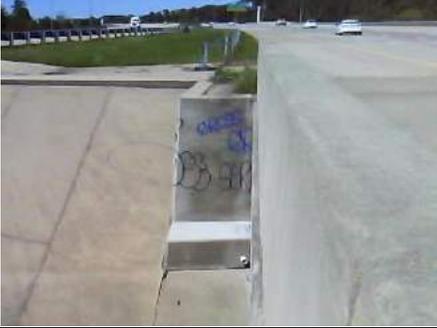
#	Material Type	Object ID	Failure Type	Photo	GIS Reference Page
1	Bridge Wall	GR_1	Graffiti

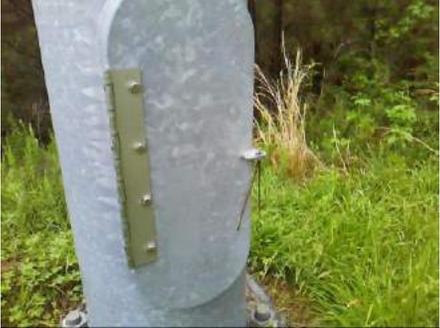
#	Material Type	Object ID	Failure Type	Photo	GIS Reference Page
1	High Mast	HL_71	Missing Part

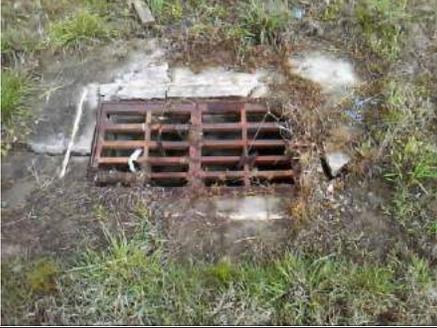
#	Material Type	Object ID	Failure Type	Photo	GIS Reference Page
1	Inlets	IN_819	Surface Damage

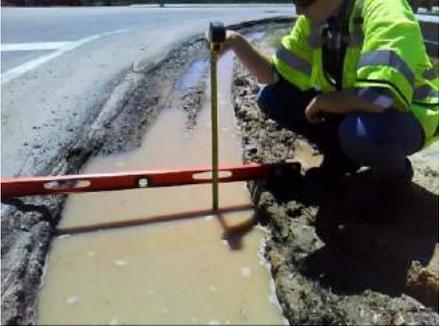
#	Material Type	Object ID	Failure Type	Photo	GIS Reference Page
1	Asphalt	LS_173	Shoulder Drop Off

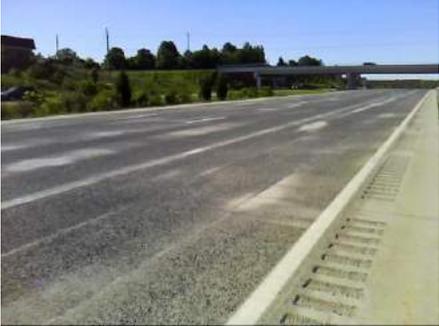
#	Material Type	Object ID	Failure Type	Photo	GIS Reference Page
1	Concrete	LS_405	Missing Line

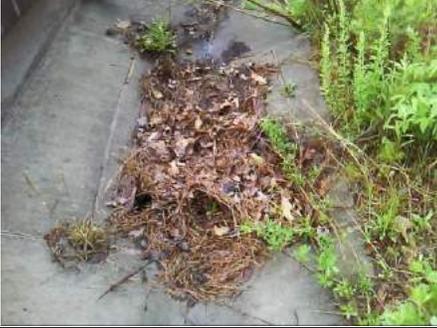
#	Material Type	Object ID	Failure Type	Photo	GIS Reference Page
1	Concrete	PD_11	Material Accumulation

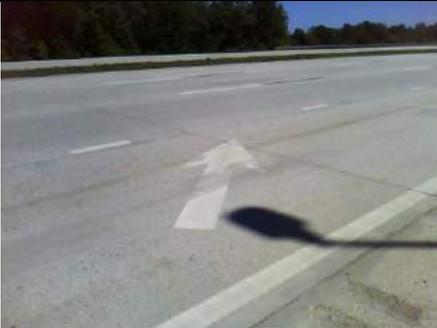
#	Material Type	Object ID	Failure Type	Photo	GIS Reference Page
1	Merge Left	PS_47	Day Time Assessment

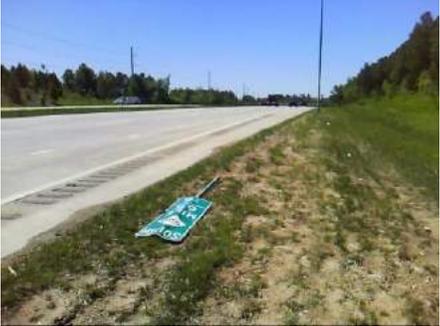
#	Sign Type	Object ID	Failure Type	Photo	GIS Reference Page
1	Mile Post	SN_102	Sign Support, Missing Part

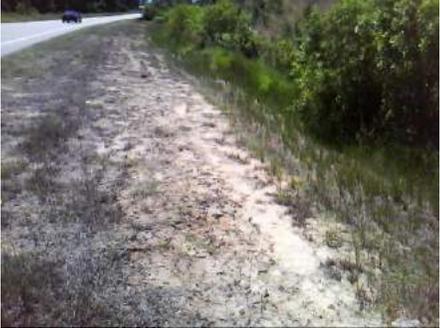
#	Material Type	Object ID	Failure Type	Photo	GIS Reference Page
1	Turf	TF_42	Bare Ground
