Maintenance Rating Program

Triangle Expressway

2018 First Quarter Report

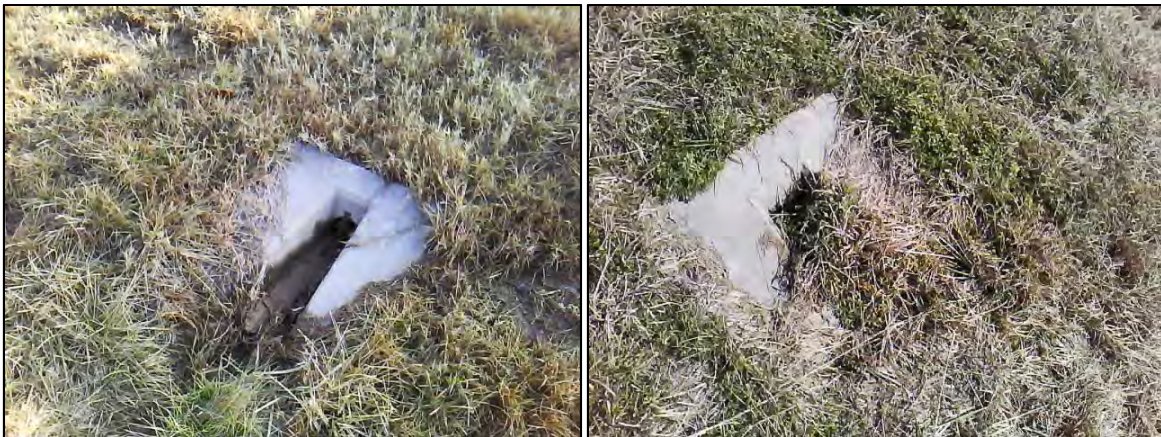
Figure 3: Miscellaneous Drainage

Miscellaneous Drainage (59 rating – 12 of the 29 assets failed). Out of the 12 miscellaneous drainage structures that did not pass the inspection, 9 were obstructed and 3 had missing rodent screens. Two of these structures are presented in **Figure 3**.

In accordance with *NCTA Roadway and Facility Maintenance Standards V4*, referenced below, the maintenance provider shall plan annual cleaning of these drainage features to remove any debris or overgrown vegetation. It is also recommended that the maintenance provider continue to follow the routine patrol schedule and repair any erosion or soil buildup problems along the ditch line near the outlets. Edge drains are a critical component of extending the life cycle of pavement as they provide a means for water to drain from the subgrade and base.

- 1) Miscellaneous Drainage Structures shall be inspected during routine patrols.
- 2) Clear all outlets to edge drains annually.
- 3) Schedule cleanouts and repairs during inspections.

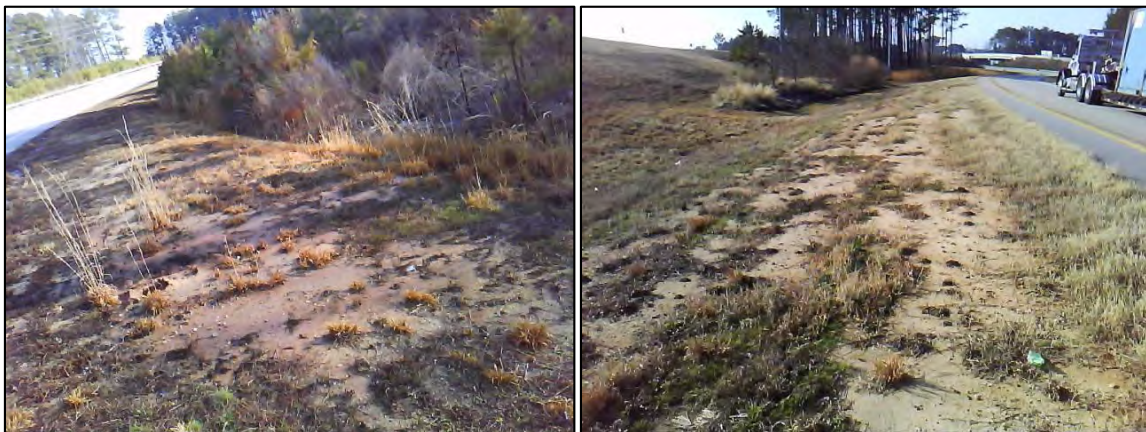
Figure 4: Turf Areas

Turf Condition (79 rating – 13 of the 62 assets failed). All 13 turf areas that did not pass the inspection had bare ground conditions. Two of these turf areas are presented in **Figure 4**.

To continue to improve the Turf Condition rating, it is recommended that the maintenance provider continue with an aggressive schedule for seeding and fertilization cycles of bare ground areas during the spring and early summer. As part of their routine, the maintenance provider should closely monitor mowing heights during the 2018 mowing cycle pursuant to the NCTA Roadway and Facility Maintenance Standards V4, referenced below.

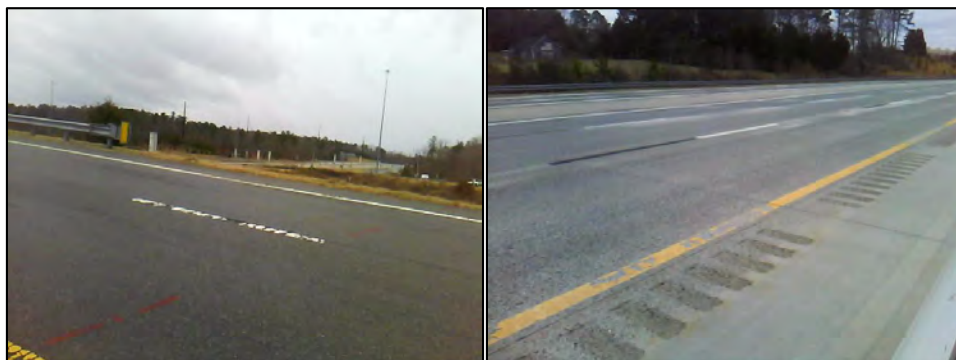
Figure 5: Pavement Striping/Marking

Pavement Striping/Marking (77 rating – 10 of the 44 assets failed). All 10 pavement striping/marketing segments that did not pass the inspection had missing sections exceeding the minimum threshold requirement. Two of these segments are presented in **Figure 5**.

The original pavement striping/markings were installed along portions of Triangle Expressway over 5 years ago. Recognizing that the lifespan of epoxy paint is 3 to 5 years, NCTA has included in its capital budget and work schedule the replacement of pavement striping/markings with Polyurea, a long-life pavement marking material recommended in a 2015 cost-benefit analysis study by NCDOT. A pavement striping replacement contract for Toll NC-540 is scheduled to be awarded in May of 2018, and work is anticipated to be completed by the end of 2018.

To maintain a well-defined lane delineation throughout the Triangle Expressway, the maintenance provider should schedule pavement striping/marketing replacement cycles in accordance with the *NCTA Roadway and Facility Maintenance Standards V4* (referenced below), and industry life-cycle specifications for the installed material.

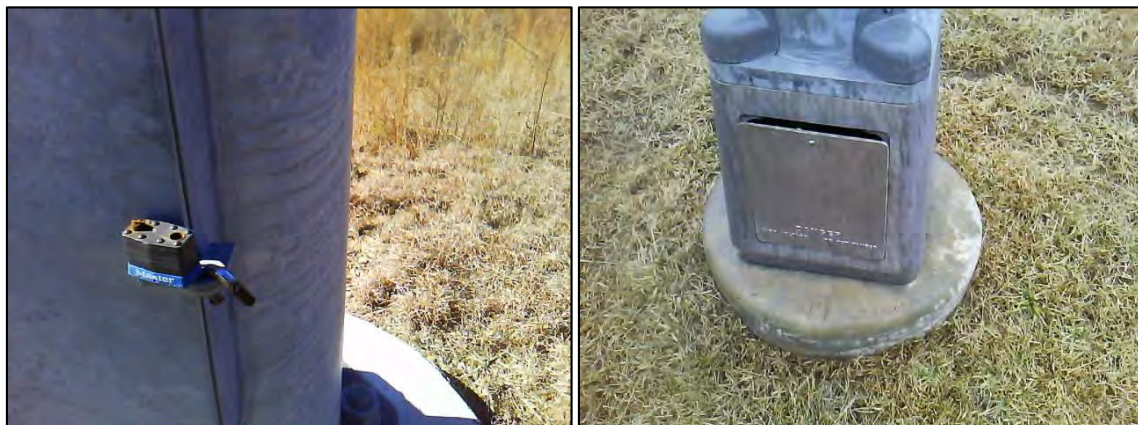
Figure 6: Highway Lighting

Highway Lighting (68 rating – 16 of the 50 assets failed). Out of the 16 highway lights that did not pass inspection, 10 had functional damage and 6 had damaged parts. Two of these highway lights are presented in **Figure 6**.

To increase this asset's rating, it is recommended that all non-functioning or damaged highway lights noted during the inspection be repaired and/or replaced in accordance with the *NCTA Roadway and Facility Maintenance Standards V4*, referenced below.

- 1) Perform night patrol once a month, and identify any outages. A monthly "Lighting Outage Report" shall be submitted by the maintenance provider to the NCTA by the 30th of each month. All bulb outages must be replaced within 48 hours.
- 2) Perform cleaning of glassware at the same time as any routine maintenance function or diagnostic action is performed.
- 3) Replace any light poles damaged by traffic within 5 days or within 14 days if any foundations need pouring.

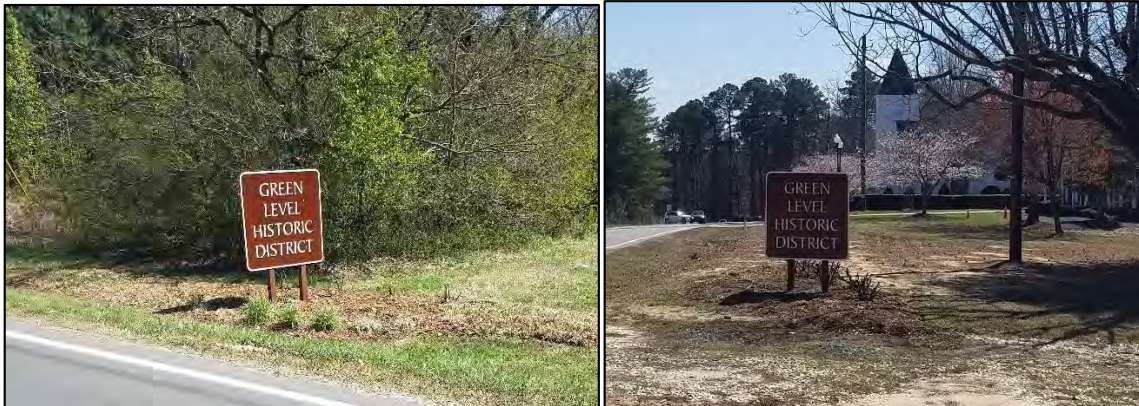
Figure 7: Green Level West Historic District Signs, Landscape Areas

As part of each quarterly inspection, an assessment team visits the four Green Level Historic District signs to conduct a visual inspection of each sign and ensure they are in good standing. During this quarter, the sign located at the intersection of Green Level Church Road and Green Level West Road was excluded from the inspection inventory due to its removal during the completion of a Town of Cary development project near the intersection. The three signs included in the inspection inventory were found to be in good condition, with the landscaped areas being well maintained. **Figure 7** shows two of these signs.

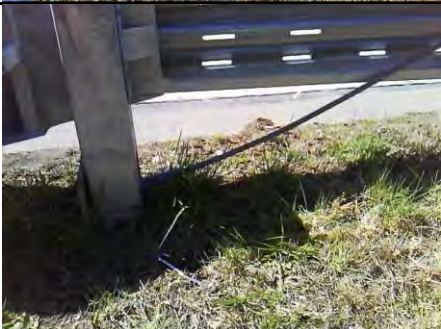
A16, A17
2	Guardrail	BR_77	Functional Damage, Missing Parts

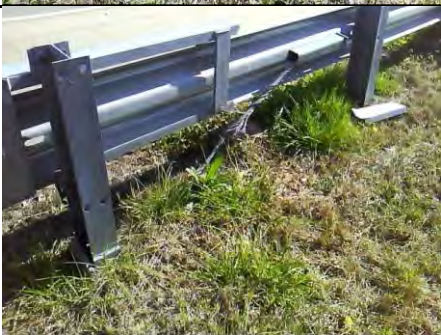
A22, A23
3	Guardrail	BR_237	Functional Damage, Missing Parts

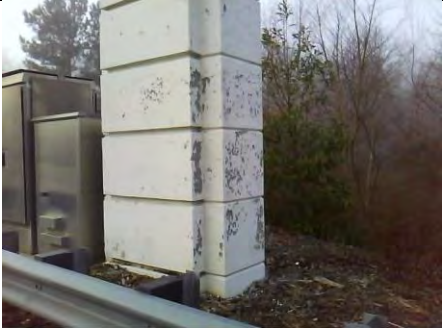
#	Material Type	Object ID	Failure Type	Photo	GIS Reference Page
1	Gantry Support	DS_144	Paint Scaling

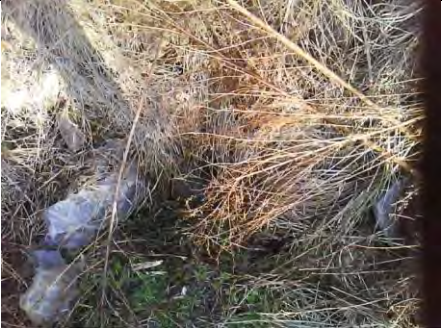
#	Material Type	Object ID	Failure Type	Photo	GIS Reference Page
1	Lateral Pipe	DP_65	Obstruction

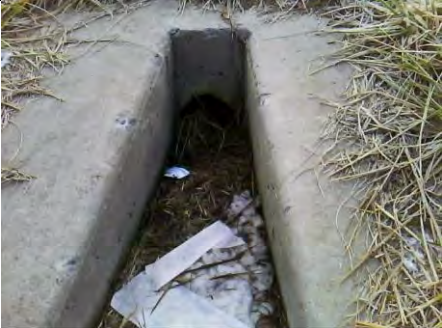
#	Material Type	Object ID	Failure Type	Photo	GIS Reference Page
1	Shoulder Drain	MDP_986	Missing Rodent Screen

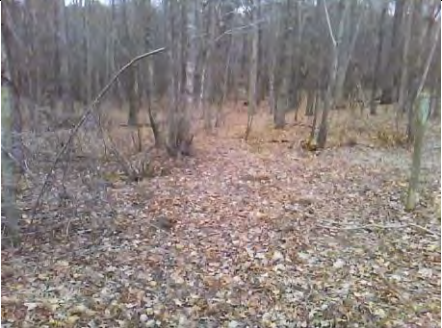
#	Material Type	Object ID	Failure Type	Photo	GIS Reference Page
1	Woven	FN_115	Fence Hole

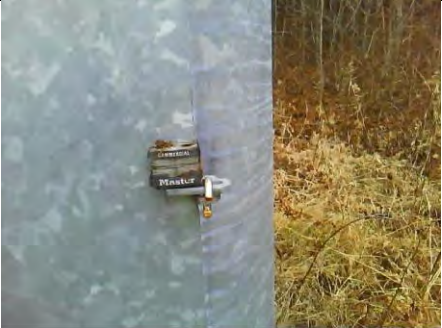
#	Material Type	Object ID	Failure Type	Photo	GIS Reference Page
1	Single Roadway	HL_3	Part Damage

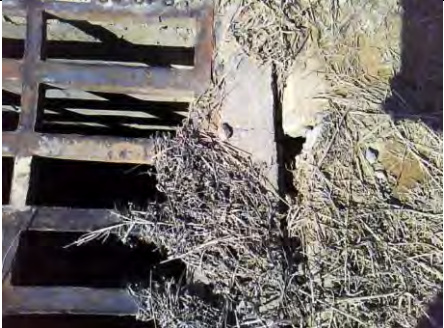
#	Material Type	Object ID	Failure Type	Photo	GIS Reference Page
1	Inlets	IN_808	Surface Damage

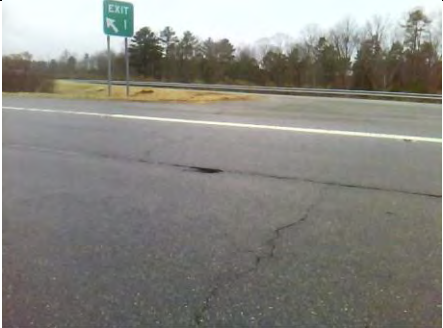
#	Material Type	Object ID	Failure Type	Photo	GIS Reference Page
1	Asphalt	LS_289	Pothole

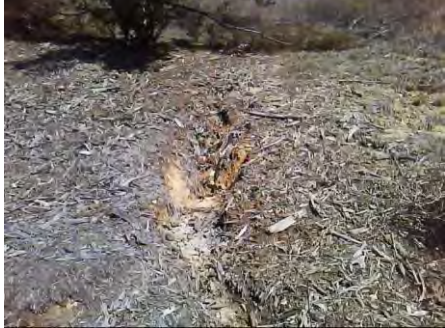
#	Material Type	Object ID	Failure Type	Photo	GIS Reference Page
1	Concrete	LS_89	Slope

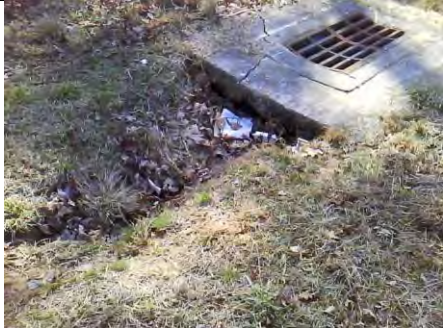
#	Material Type	Object ID	Failure Type	Photo	GIS Reference Page
1	Asphalt	LS_547	Erosion
