NORTH CAROLINA
Turnpike Authority

Maintenance Rating Program

Triangle Expressway

2018 Fourth Quarter and Annual Report

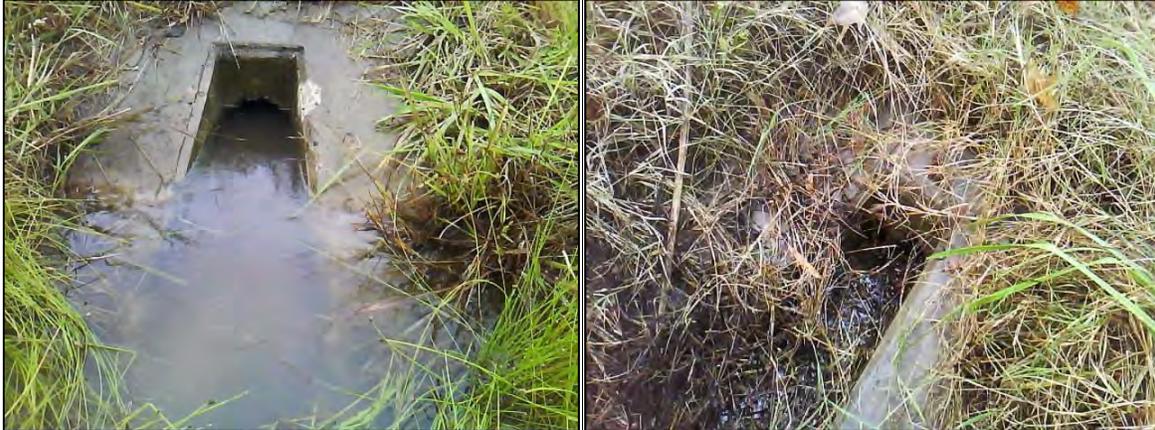
Figure 3: Miscellaneous Drainage Inspection Results Sample

Miscellaneous Drainage (65 rating – 11 of the 31 assets did not pass): Out of the 11 miscellaneous drainage structures that did not pass inspection, 2 were obstructed and 9 had a missing or damaged screen at the outlet. Two of the miscellaneous drainage structures (shoulder underdrains) that did not pass inspection are presented in **Figure 3**.

To avoid affecting the natural flow of water near the drainage features and reducing the design life of pavement performance, it is recommended that outlet elevations be checked against the outflow ditch elevations to ensure positive drainage. Appropriate grading of the ditch line may be necessary to provide positive flow.

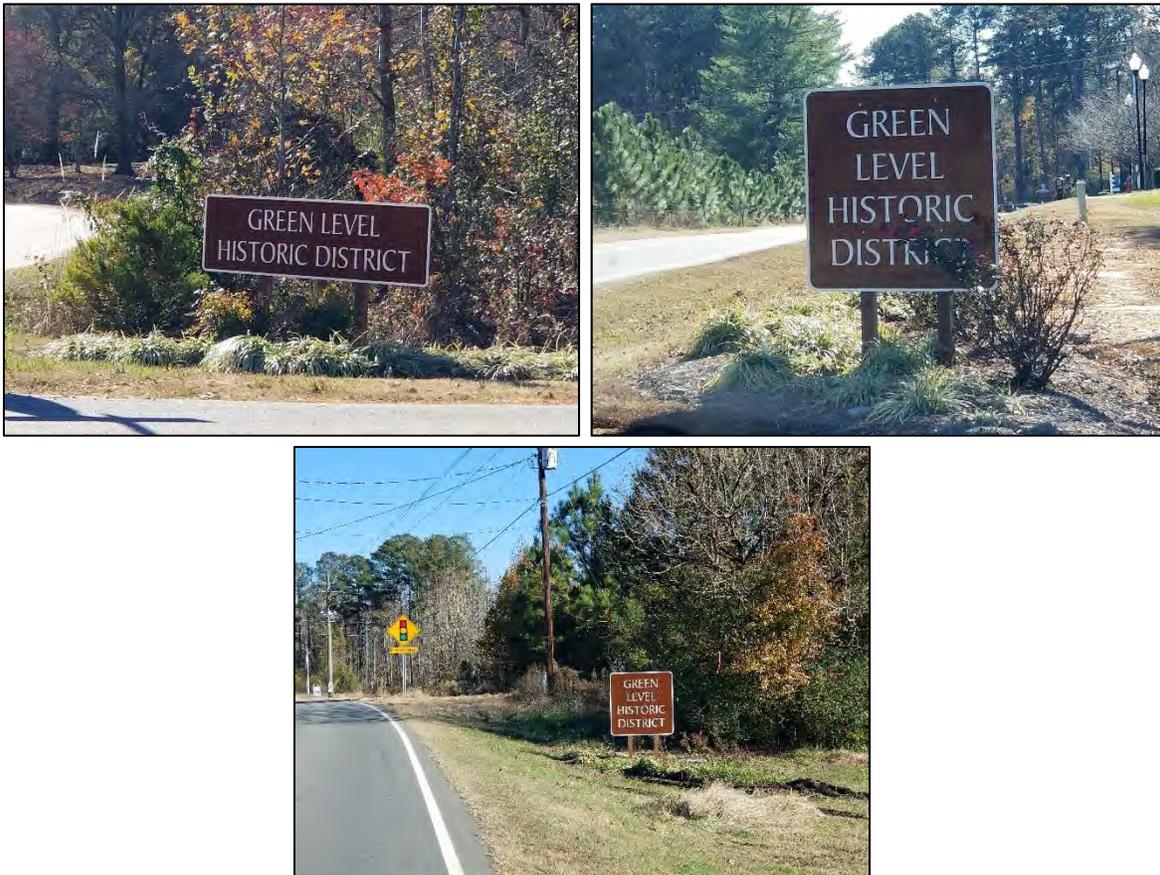
Figure 4: Green Level West Historic District Signs, Landscape Areas

As part of each quarterly inspection, an assessment team visits the three Green Level Historic District signs to conduct a visual inspection of each sign and ensure they are in good standing. The three signs included in the inspection inventory were found to be in good condition, with the landscaped areas being well maintained. **Figure 4** shows these signs.

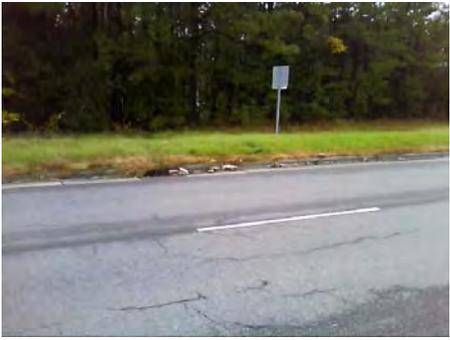
#	Material Type	Object ID	Failure Type	Photo	GIS Reference Page
1	Curb and Gutter	CG_97	Obstruction

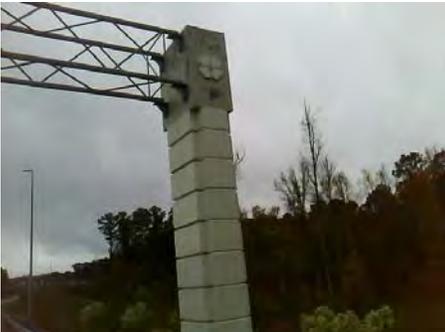
#	Material Type	Object ID	Failure Type	Photo	GIS Reference Page
1	Overhead Sign Support	DS_167	Scaling

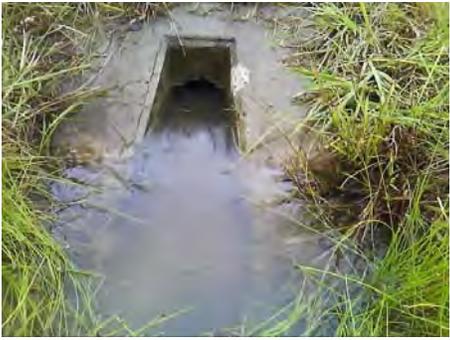
#	Material Type	Object ID	Failure Type	Photo	GIS Reference Page
1	Shoulder Drain	MDP_4	Obstruction & Missing Rodent Screen

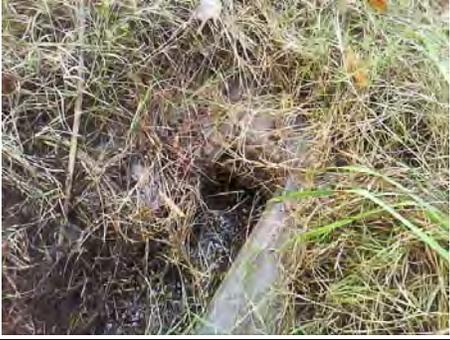
A25
2	Shoulder Drain	MDP_49	Missing Rodent Screen

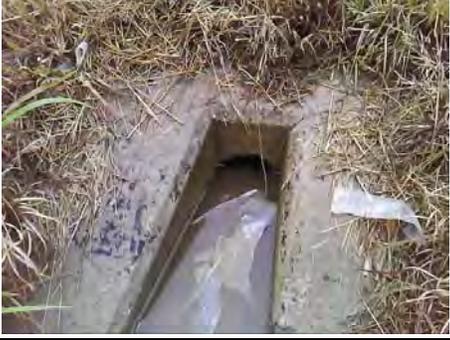
A21
3	Shoulder Drain	MDP_59	Obstruction & Missing Rodent Screen

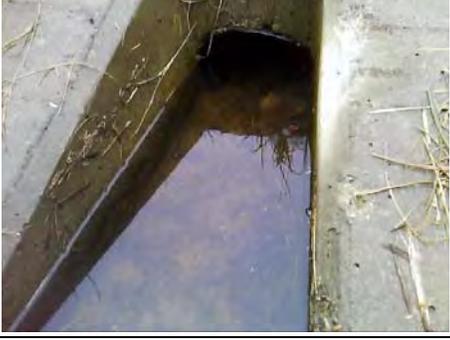
A20
4	Shoulder Drain	MDP_74	Missing Rodent Screen

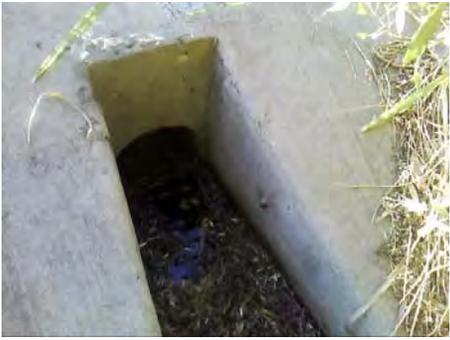
#	Material Type	Object ID	Failure Type	Photo	GIS Reference Page
5	Shoulder Drain	MDP_91	Missing Rodent Screen

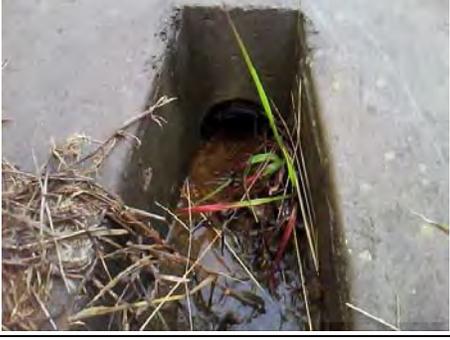
A13
6	Shoulder Drain	MDP_92	Missing Rodent Screen

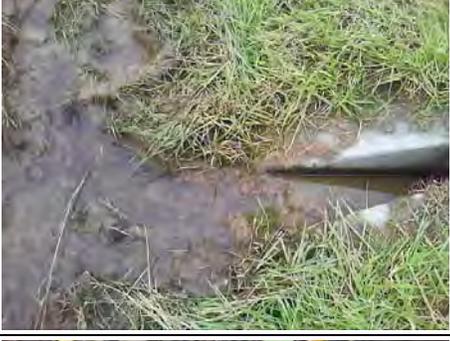
A13
7	Shoulder Drain	MDP_98	Obstruction & Missing Rodent Screen

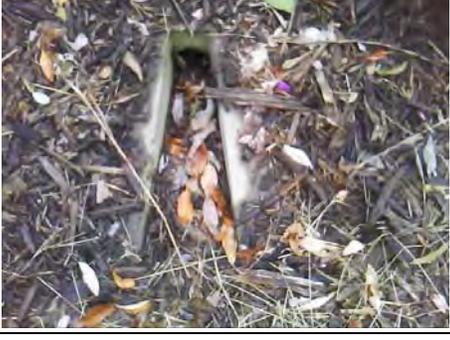
A13
8	Shoulder Drain	MDP_116	Missing Rodent Screen

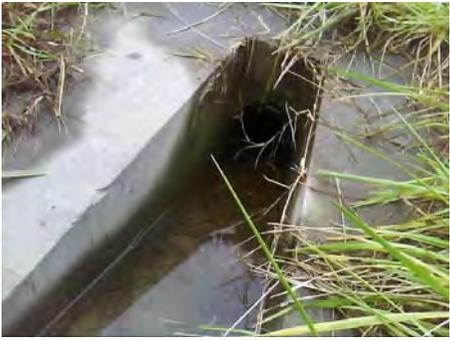
#	Material Type	Object ID	Failure Type	Photo	GIS Reference Page
9	Shoulder Drain	MDP_119	Missing Rodent Screen

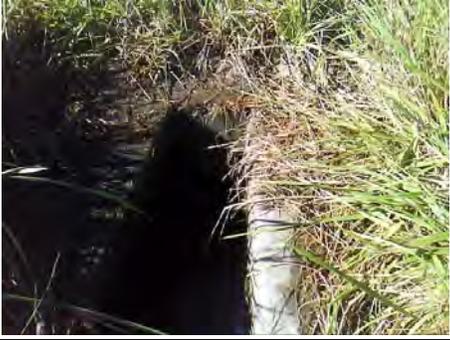
A10
10	Shoulder Drain	MDP_126	Missing Rodent Screen

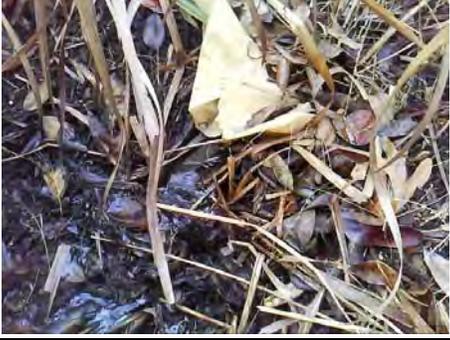
A9
11	Shoulder Drain	MDP_150	Obstruction & Missing Rodent Screen

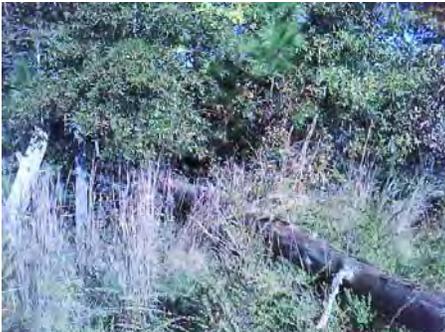
#	Material Type	Object ID	Failure Type	Photo	GIS Reference Page
1	Woven	FN_65	Hole Height

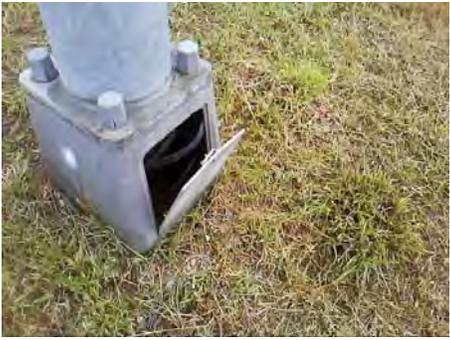
#	Material Type	Object ID	Failure Type	Photo	GIS Reference Page
1	Single Roadway	HL_20	Part Damage

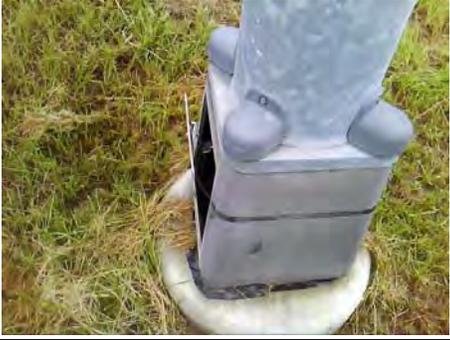
A1
2	Double Roadway	HL_177	Part Damage

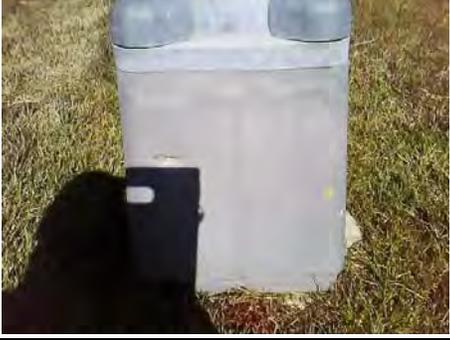
A30
3	Single Roadway	HL_191	Part Damage

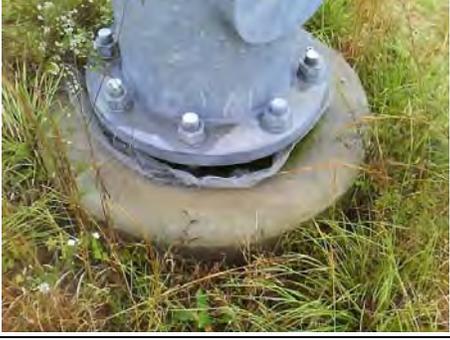
A33
4	High Mast	HL_232	Part Damage

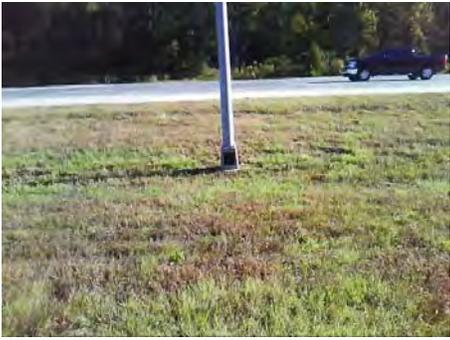
#	Material Type	Object ID	Failure Type	Photo	GIS Reference Page
5	Single Roadway	HL_257	Part Damage

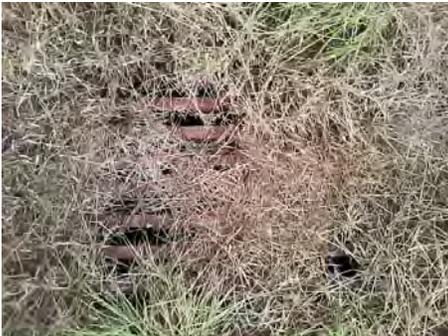
#	Material Type	Object ID	Failure Type	Photo	GIS Reference Page
1	Inlet	IN_980	Obstruction

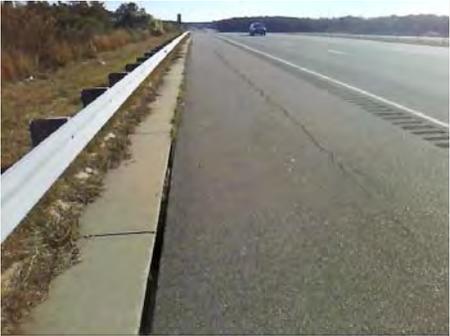
#	Material Type	Object ID	Failure Type	Photo	GIS Reference Page
1	Asphalt	LS_243	Joint Separation

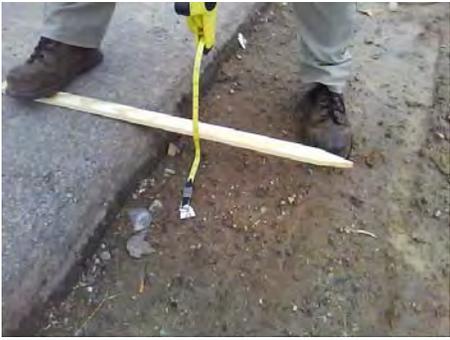
#	Material Type	Object ID	Failure Type	Photo	GIS Reference Page
1	Asphalt	LS_369	Shoulder Drop-Off

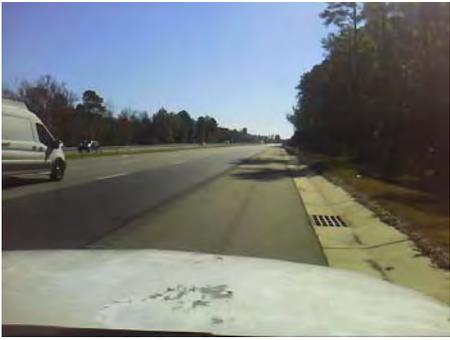
#	Material Type	Object ID	Failure Type	Photo	GIS Reference Page
1	Asphalt	LS_275	Line Missing

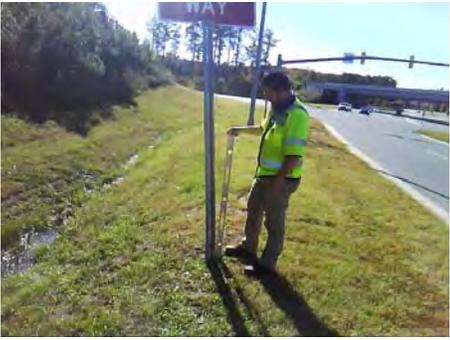
#	Sign Type	Object ID	Failure Type	Photo	GIS Reference Page
1	Wrong Way	SN_1031	Leaning & Surface Damage

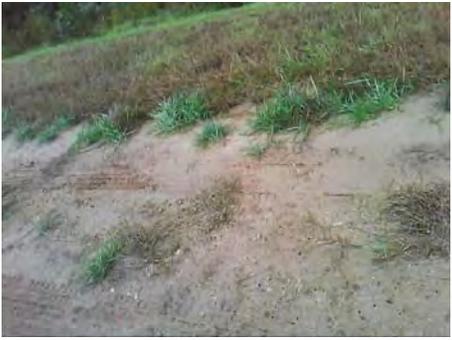
#	Material Type	Object ID	Failure Type	Photo	GIS Reference Page
1	Turf	TF_409	Bare Ground

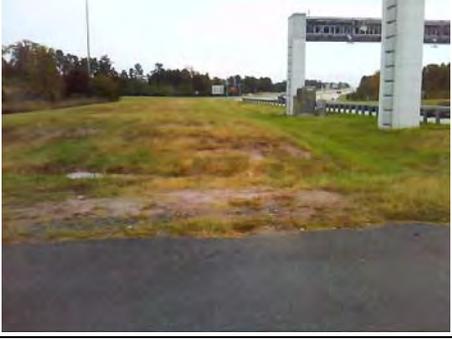
A22
4	Turf	TF_778	Bare Ground
