NORTH CAROLINA
Turnpike Authority

Maintenance Rating Program

Triangle Expressway

2019 First Quarter Report

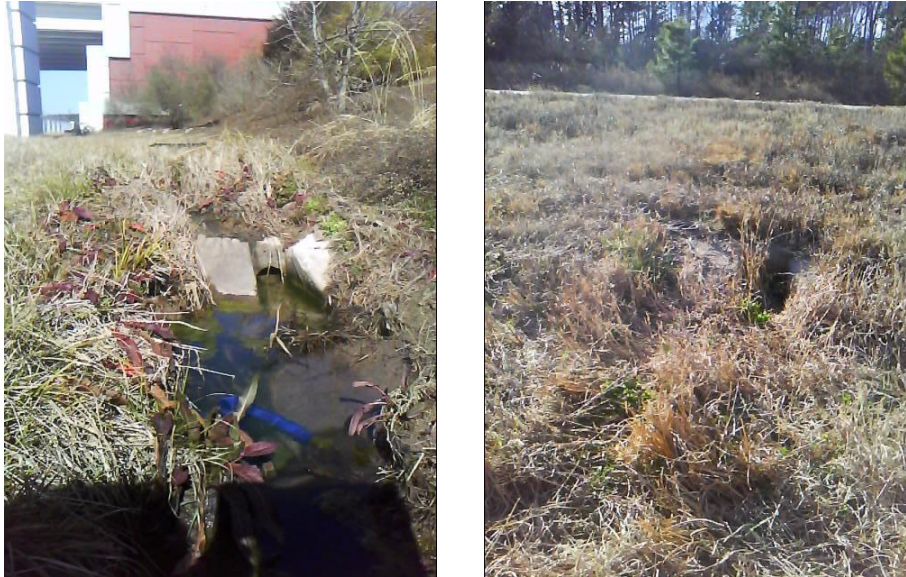
Figure 3: Miscellaneous Drainage Inspection Results Sample

Miscellaneous Drainage (65 rating – 22 of the 34 assets passed): Out of the 12 miscellaneous drainage structures that did not pass inspection, 7 were obstructed and 5 had a missing or damaged screen at the outlet. Two of the miscellaneous drainage structures (shoulder underdrains) that did not pass inspection are presented in **Figure 3**.

Miscellaneous Drainage Structures do not meet the maintenance standards when any of the following criteria is observed:

- 1) More than 50% of the structure (length and depth) is obstructed or blocked.
- 2) End protection has deteriorations, erosions, washouts or buildups adversely affecting the natural flow of water.

In accordance with *NCTA Roadway and Facility Maintenance Standards V6*, referenced below, the maintenance provider shall plan annual cleaning of these drainage features to remove any debris or overgrown vegetation. It is also recommended that the maintenance provider continue to follow the routine patrol schedule and repair any erosion or soil buildup problems along the ditch line near the outlets. Given the subsurface Triassic soil conditions encountered on this project, the edge drain system is a critical component of maintaining the design life of pavements as it provides a conduit to channel water away from the subgrade and base.

To avoid affecting the natural flow of water near the drainage features and reducing the design life of pavement performance, it is recommended that outlet elevations be checked against the outflow ditch elevations to ensure positive drainage. Appropriate grading of the ditch line may be necessary to provide positive flow.

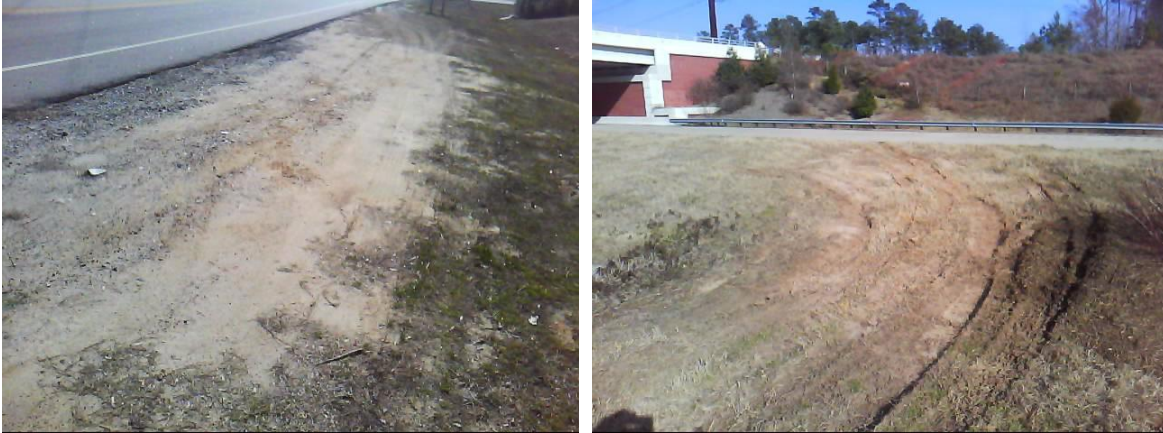
Figure 4: Turf Inspection Results Sample

Turf Condition (76 rating – 25 of the 33 assets passed). All 8 turf areas that did not pass the inspection had bare ground conditions. Two of these turf areas are presented in **Figure 4**.

To continue to improve the Turf Condition rating, it is recommended that the maintenance provider continue with an aggressive schedule for seeding and fertilization cycles of bare ground areas during the spring and early summer. As part of their routine, the maintenance provider should closely monitor mowing heights during the 2019 mowing cycle pursuant to the NCTA Roadway and Facility Maintenance Standards V6, referenced below.

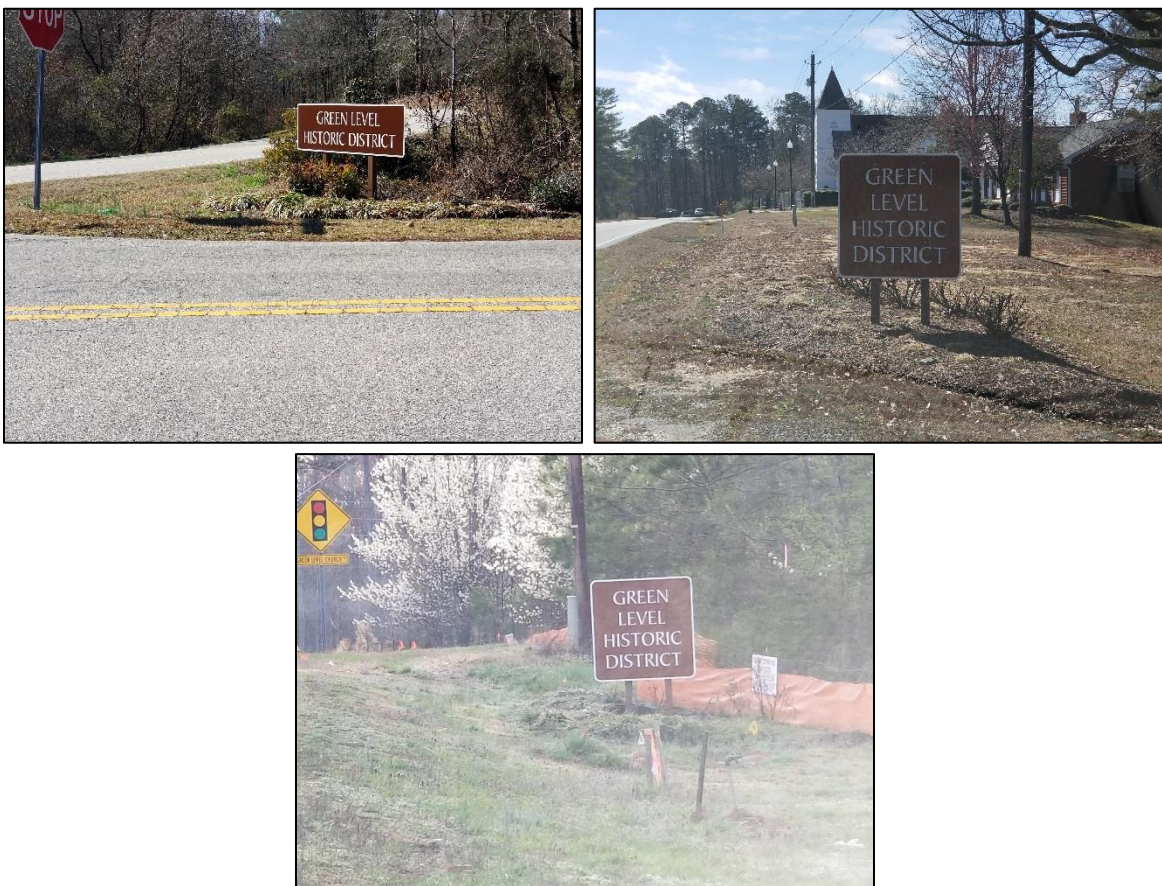
Figure 5: Green Level West Historic District Signs, Landscape Areas

As part of each quarterly inspection, an assessment team visits the three Green Level Historic District signs to conduct a visual inspection of each sign and ensure they are in good standing. The three signs included in the inspection inventory were found to be in good condition, with the landscaped areas being well maintained. Construction activities were identified adjacent to the eastbound sign on Green Level West Road (3 of 3); however, the plant bed was not disturbed. **Figure 4** shows these signs.

This quarter, the three Green Level Historic District signs inspected were found to be in good standing condition. Additionally, the landscaped areas surrounding the signs were found to be well maintained.

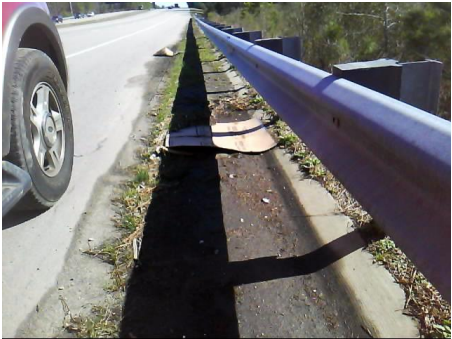
#	Material Type	Object ID	Failure Type	Photo	GIS Reference Page
1	Shoulder Berm	CG_180	Material Accumulation

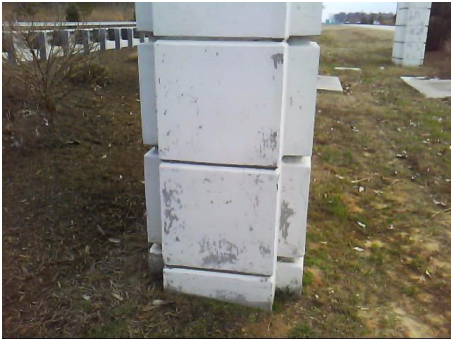
#	Material Type	Object ID	Failure Type	Photo	GIS Reference Page
1	Gantry Support	DS_47	Paint Scaling

To continue to improve upon characteristic ratings that have scored a rating below 80 in the last four quarters, it was recommended that the maintenance provider address wall paint scaling issues. A painting contract is currently being developed and will be let soon. This contract will alleviate further deterioration of this asset and maintain the facility's intended aesthetics.

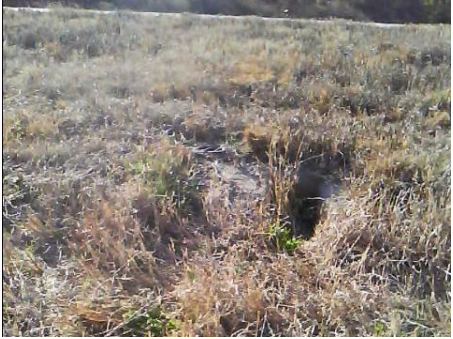
#	Material Type	Object ID	Failure Type	Photo	GIS Reference Page
1	Shoulder Drain	MDP_45	Obstruction

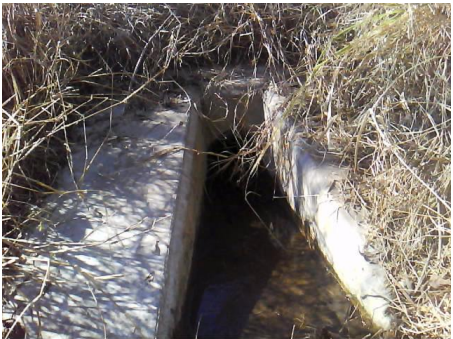
A12
2	Shoulder Drain	MDP_49	Missing Rodent Screen

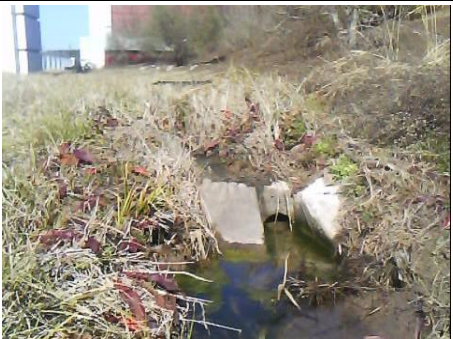
A12
3	Shoulder Drain	MDP_55	Erosion/Missing Rodent Screen

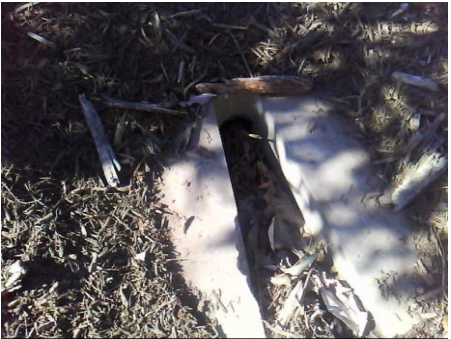
#	Material Type	Object ID	Failure Type	Photo	GIS Reference Page
5	Shoulder Drain	MDP_116	Obstruction/ Missing Rodent Screen

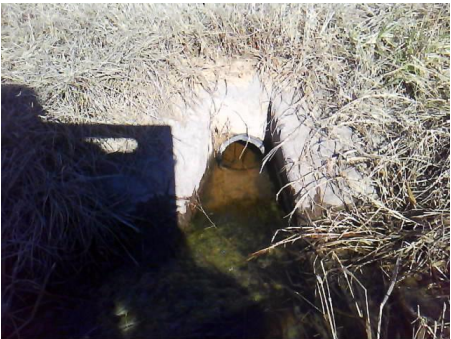
A23
6	Shoulder Drain	MDP_130	Missing Rodent Screen

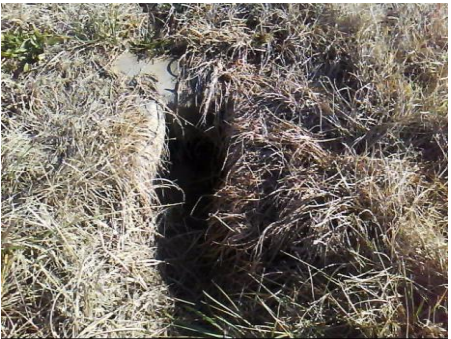
A25
7	Shoulder Drain	MDP_142	Obstruction

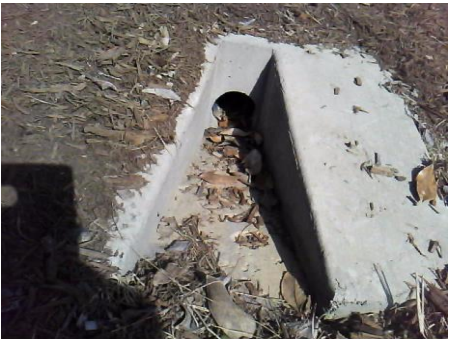
A27
8	Shoulder Drain	MDP_153	Missing Rodent Screen

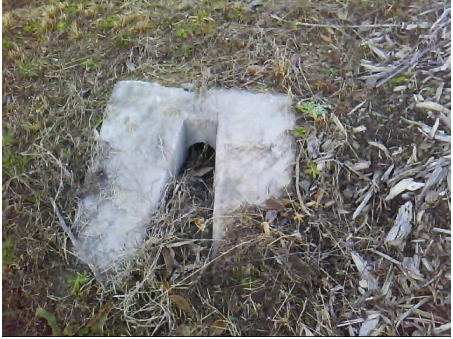
#	Material Type	Object ID	Failure Type	Photo	GIS Reference Page
9	Shoulder Drain	MDP_188	Missing Rodent Screen

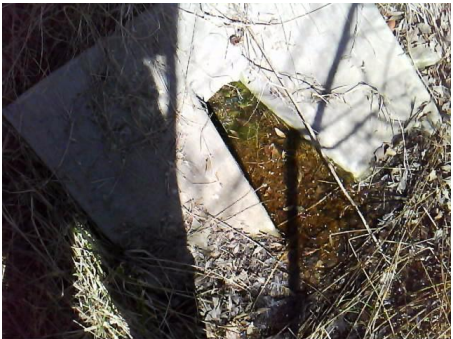
A27
10	Shoulder Drain	MDP_199	Obstruction/Missing Rodent Screen

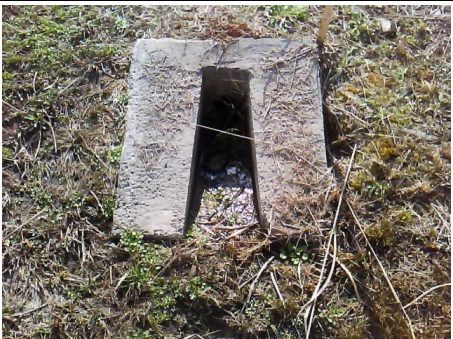
A19
11	Shoulder Drain	MDP_210	Missing Rodent Screen

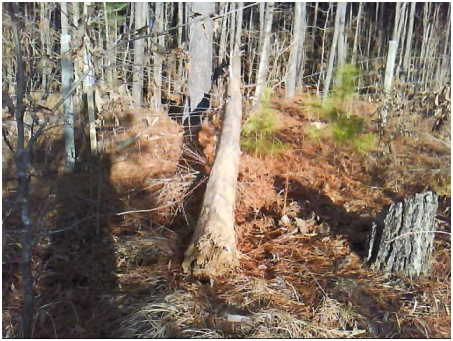
#	Material Type	Object ID	Failure Type	Photo	GIS Reference Page
1	Woven	FN_179	Fence Hole

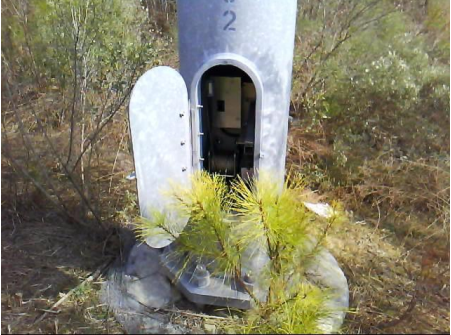
#	Material Type	Object ID	Failure Type	Photo	GIS Reference Page
5	High Mast	HL_321	Part Damage

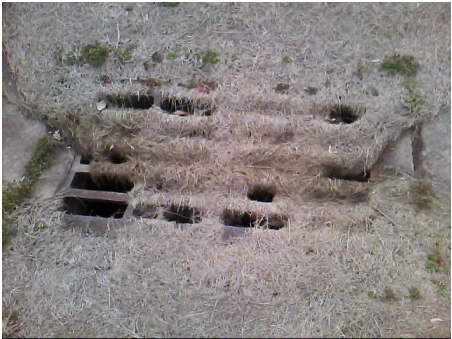
#	Material Type	Object ID	Failure Type	Photo	GIS Reference Page
1	Inlets	IN_373	Obstruction

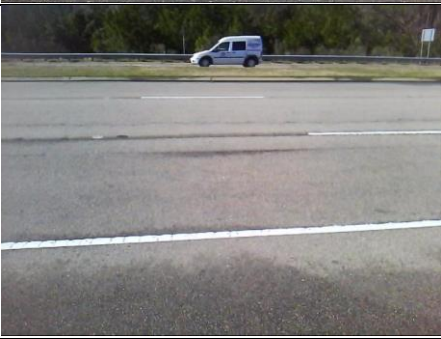
A17
2	Asphalt	LS_727	Pavement Cracking

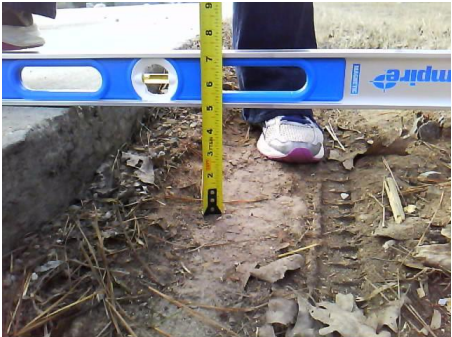
#	Material Type	Object ID	Failure Type	Photo	GIS Reference Page
1	Concrete	LS_159	Shoulder Drop-Off

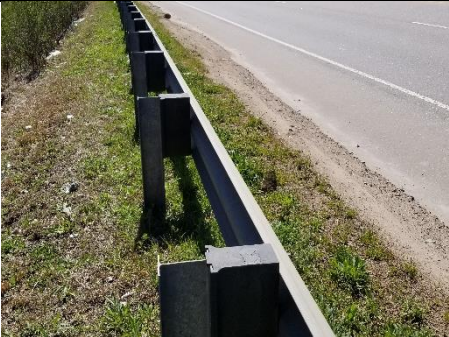
#	Material Type	Object ID	Failure Type	Photo	GIS Reference Page
1	Asphalt	LS_391	Material Accumulation

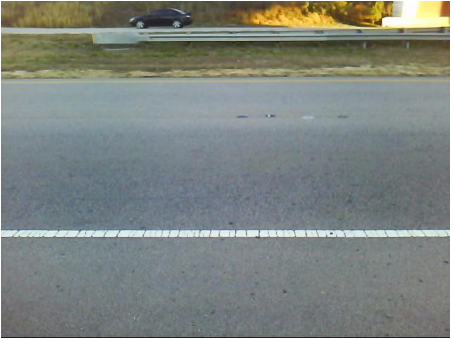
#	Material Type	Object ID	Failure Type	Photo	GIS Reference Page
1	Asphalt	LS_377	Missing Markers

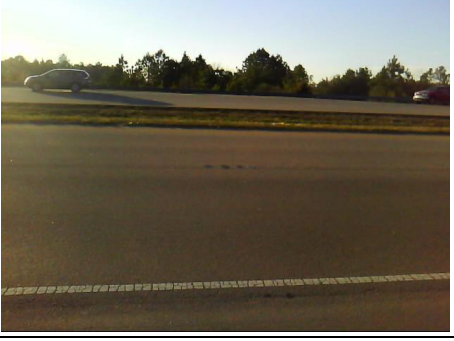
A32
2	Asphalt	LS_391	Missing Markers

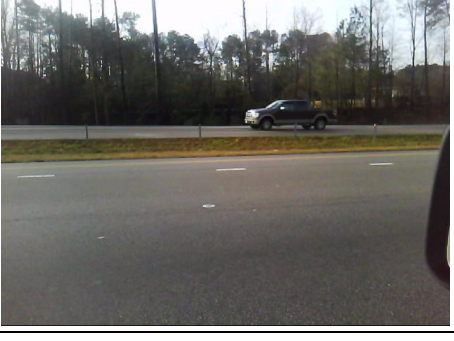
A32
3	Asphalt	LS_554	Missing Markers

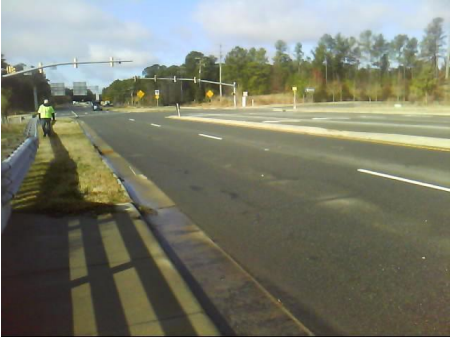
A17
4	Asphalt	LS_727	Nighttime Reflectivity	Not available for Nighttime failure.	A7
5	Asphalt	LS_759	Missing Markers

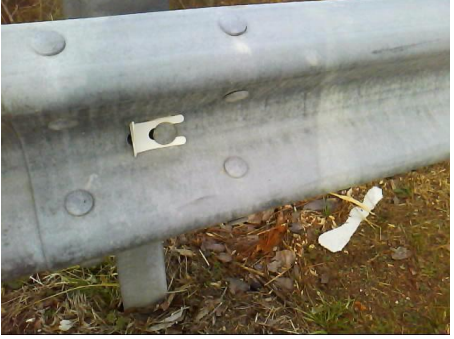
#	Material Type	Object ID	Failure Type	Photo	GIS Reference Page
1	Concrete	LS_130	Missing Delineators

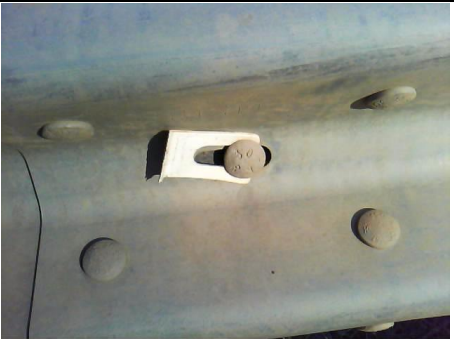
A9
2	Asphalt	LS_377	Nighttime Reflectivity	Not available for Nighttime failure.	A32
3	Asphalt	LS_391	Missing Delineators

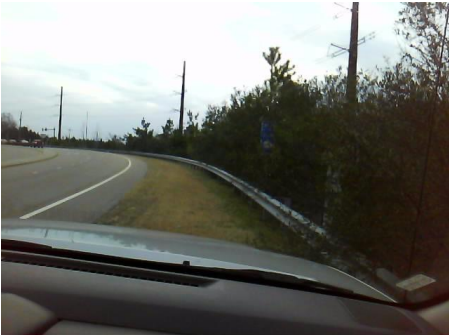
#	Sign Type	Object ID	Failure Type	Photo	GIS Reference Page
1	Mile Post	SN_368	Visibility

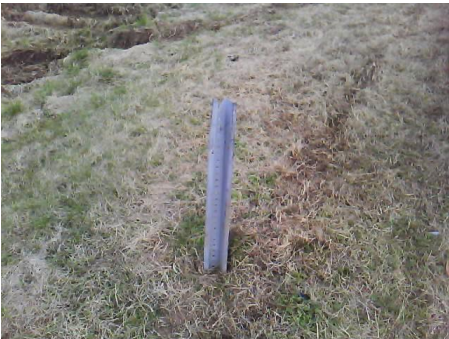
A13
2	Chevron	SN_1041	Missing

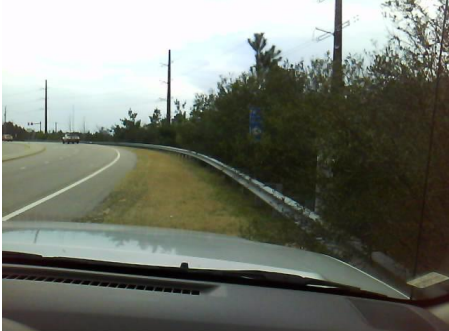
#	Material Type	Object ID	Failure Type	Photo	GIS Reference Page
1	Tree and Brush	TB_307	Clearance

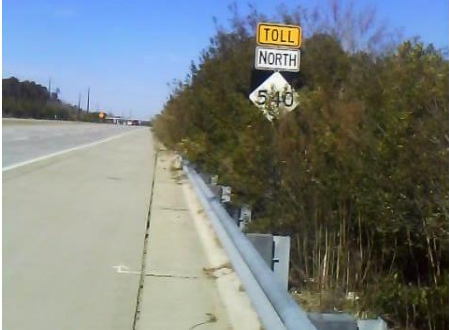
A13
2	Tree and Brush	TB_325	Clearance
