NORTH CAROLINA
Turnpike Authority

Maintenance Rating Program

Triangle Expressway

2020 Third Quarter Report

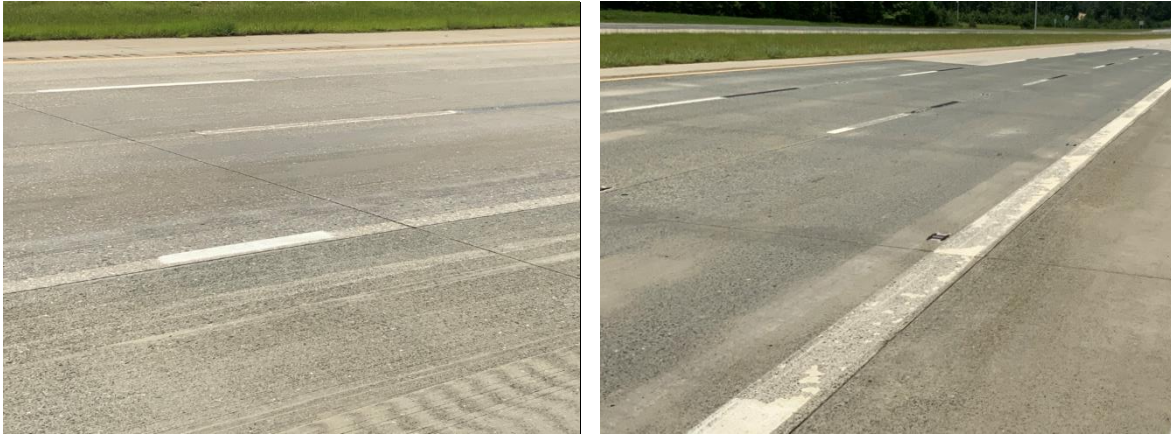
Figure 3: Pavement Striping Inspection Results Sample

Pavement Striping (74 rating – 20 of the 27 assets passed): There were 7 pavement striping/markings segments that did not pass inspection, these segments were identified as missing sections, not meeting the required line width, or not reflecting during the nighttime inspection. Two of the pavement striping and marking segments that did not pass inspection are presented in **Figure 3**.

To maintain a well-defined lane delineation throughout the Triangle Expressway, it is recommended that the maintenance provider consider scheduling pavement striping/markings replacement cycles in accordance with the *NCTA Roadway and Facility Maintenance Standards V6*, referenced below.

Pavement striping/markings were installed along Toll NC-540 in the Summer of 2018. NCTA has let a contract in the Summer 2020 for the replacement of pavement striping/markings following asphalt pavement resurfacing.

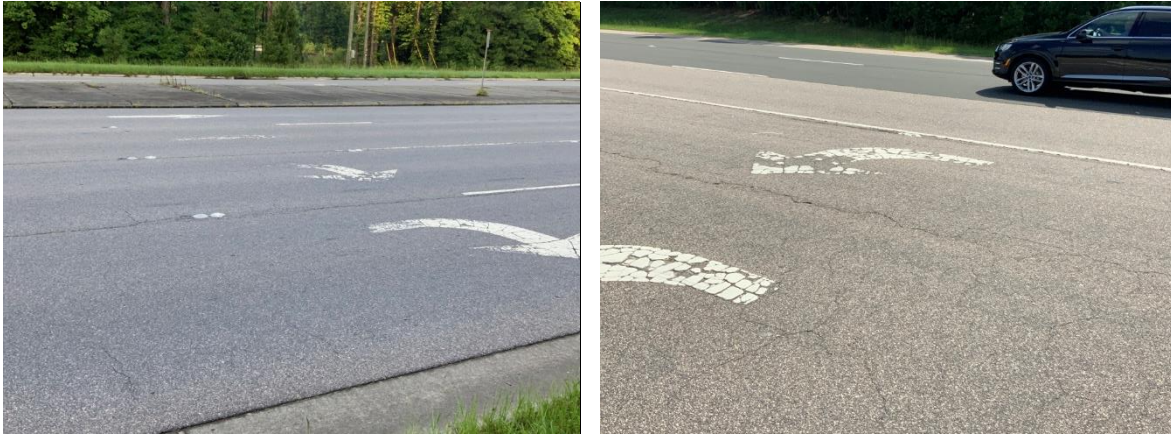
Figure 4: Pavement Symbol Inspection Results Sample

Words and Symbols (79 rating – 22 of the 28 assets passed): There were 6 pavement symbols that did not pass inspection, these symbols were identified as missing sections and/or not reflecting during the nighttime inspection. Two of the pavement symbols that did not pass inspection are presented in **Figure 4**.

Pavement striping/markings were installed along Toll NC-540 in the Summer of 2018. Replacement of pavement symbols on asphalt pavement surfaces including Toll NC-147 mainline and asphalt pavement ramps and loops are included in the resurfacing contract let in Summer 2020.

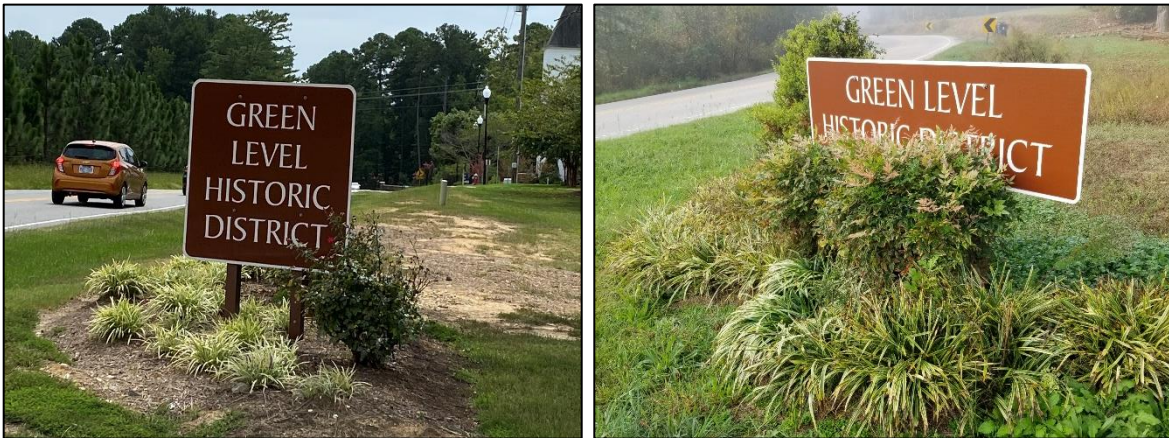
Figure 5: Green Level West Historic District Signs, Landscape Areas

As part of each quarterly inspection, an assessment team visits the three Green Level Historic District signs to conduct a visual inspection of each sign and ensure they are in good standing. Two of the three signs included in the inspection inventory were found to be in good condition, with the landscaped areas being well maintained. The third sign had been temporarily removed due to nearby construction activities. **Figure 5** shows the two signs assessed this quarter.

This quarter, the two Green Level Historic District signs inspected were found to be in good condition while the third sign was identified to have been removed for a Town of Cary development project near Green Level West Road. Additionally, the landscaped areas surrounding the signs were found to be well maintained.

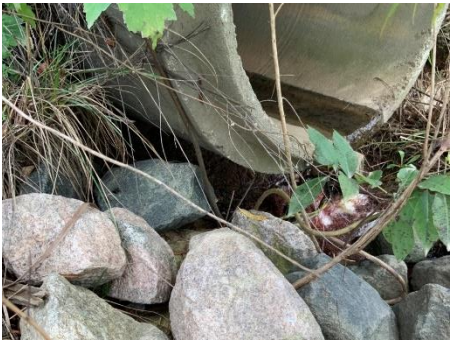
#	Material Type	Object ID	Failure Type	Photo	GIS Reference Page
1	Drain	DP_102	End Protection Damage

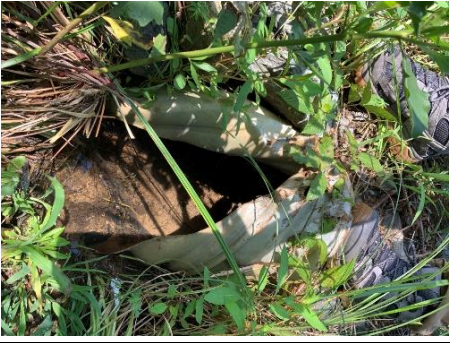
A29
2	Drain	DP_763	End Protection Damage

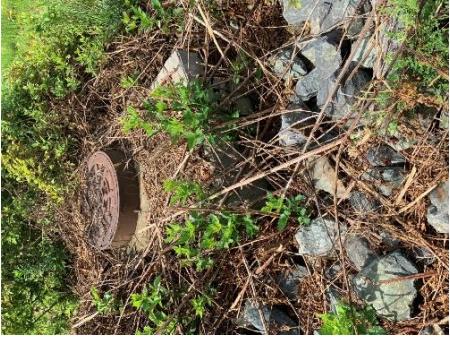
A27
2	Drain	DP_930	End Protection Damage

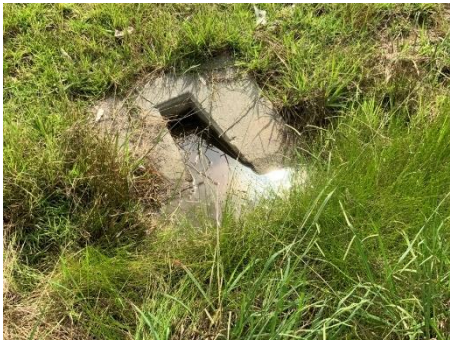
#	Material Type	Object ID	Failure Type	Photo	GIS Reference Page
1	Shoulder Drain	MDP_31	Obstruction & Missing Rodent Screen

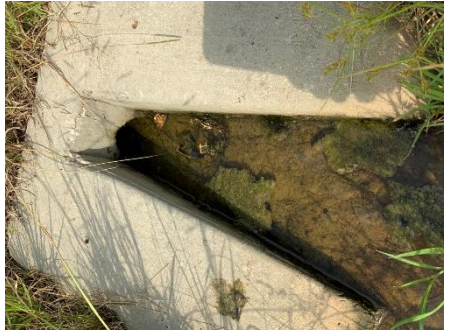
A11
2	Shoulder Drain	MDP_112	End Damage & Missing Rodent Screen

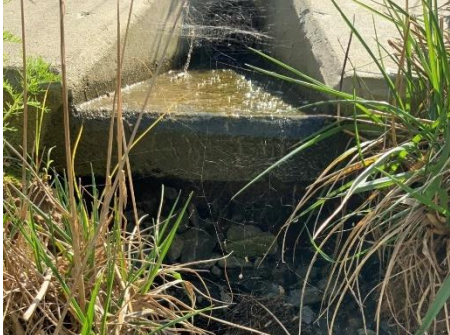
A23
3	Shoulder Drain	MDP_156	End Damage

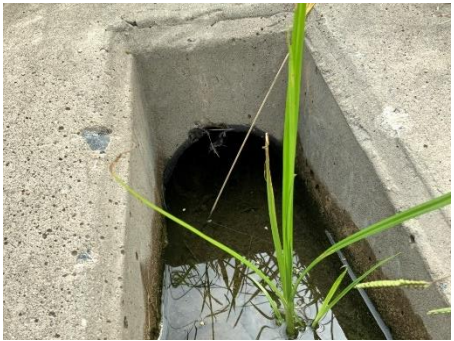
#	Material Type	Object ID	Failure Type	Photo	GIS Reference Page
5	Shoulder Drain	MDP_216	Missing Rodent Screen

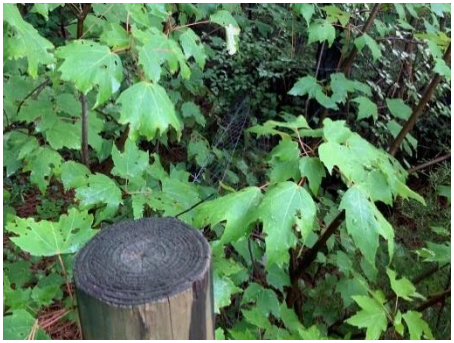
#	Material Type	Object ID	Failure Type	Photo	GIS Reference Page
1	Woven	FN_222	Fence Height

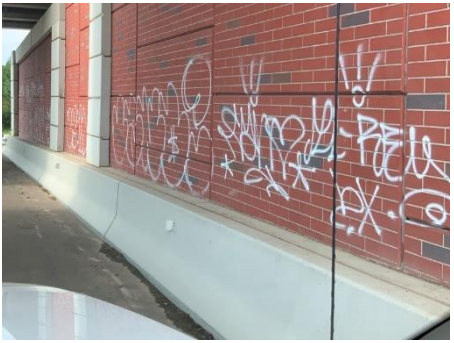
#	Material Type	Object ID	Failure Type	Photo	GIS Reference Page
1	Bridge Wall	GR_1	Graffiti

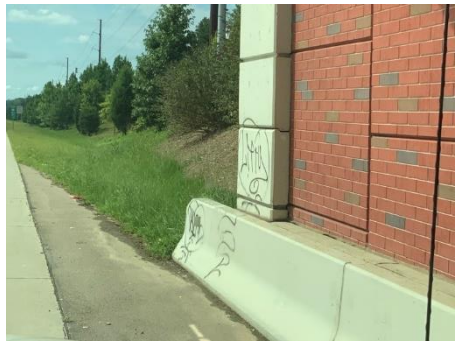
#	Material Type	Object ID	Failure Type	Photo	GIS Reference Page
5	Bridge Wall	GR_5	Graffiti

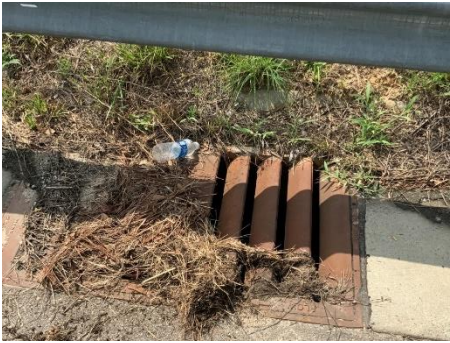
#	Material Type	Object ID	Failure Type	Photo	GIS Reference Page
1	Drop Inlet	IN_161	Obstruction

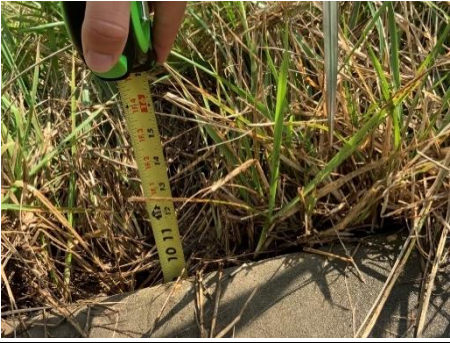
A14
2	Drop Inlet	IN_257	Eroded Area

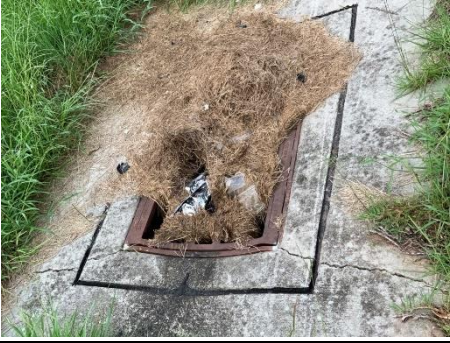
A37
3	Drop Inlet	IN_306	Obstruction & Surface Damage

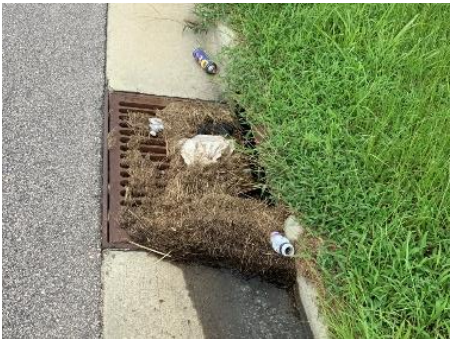
#	Material Type	Object ID	Failure Type	Photo	GIS Reference Page
5	Drop Inlet	IN_752	Obstruction

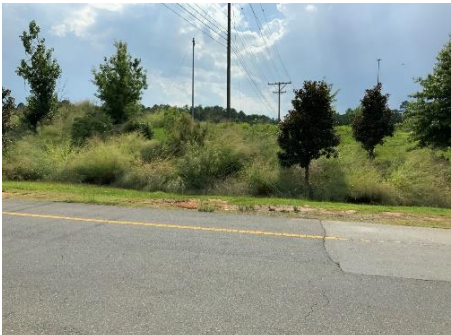
#	Material Type	Object ID	Failure Type	Photo	GIS Reference Page
1	Plant Bed	PB_21	Health

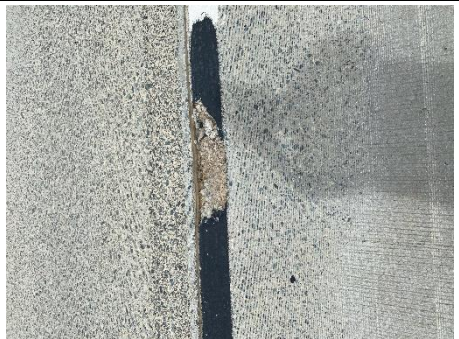
#	Material Type	Object ID	Failure Type	Photo	GIS Reference Page
1	Concrete	LS_462	Pothole

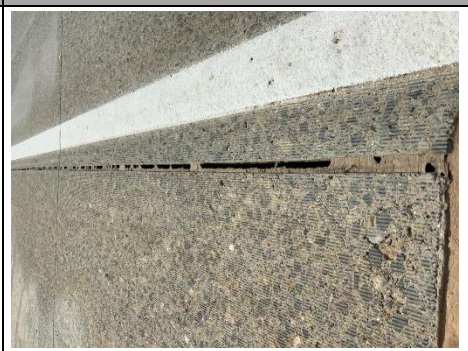
#	Material Type	Object ID	Failure Type	Photo	GIS Reference Page
1	Concrete	LS_569	Joint Separation

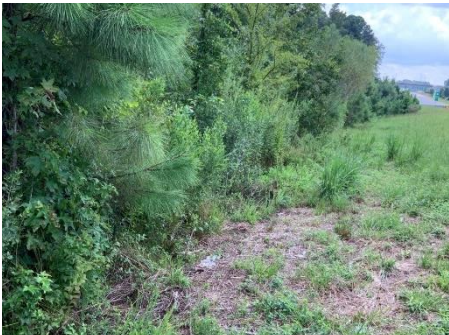
#	Material Type	Object ID	Failure Type	Photo	GIS Reference Page
1	Concrete	LS_421	Blocked Ditch

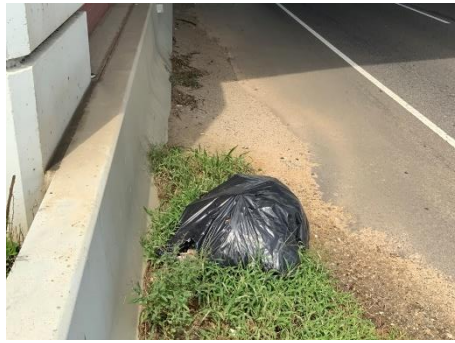
#	Material Type	Object ID	Failure Type	Photo	GIS Reference Page
1	Asphalt	LS_377	Litter

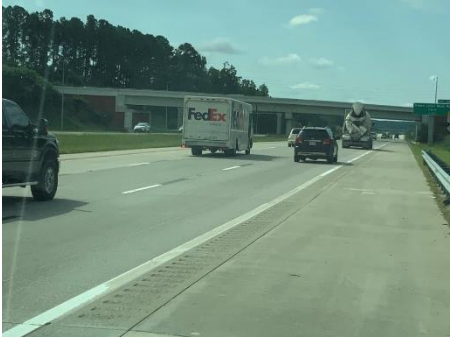
#	Material Type	Object ID	Failure Type	Photo	GIS Reference Page
5	Concrete	LS_143	Line Missing

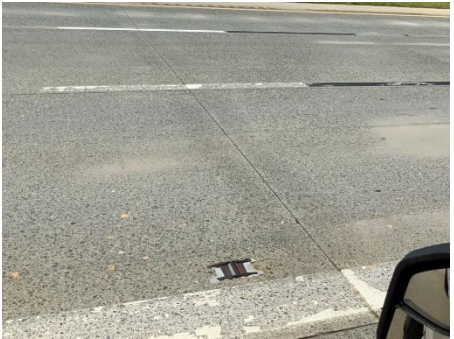
A11
6	Concrete	LS_437	Line Missing

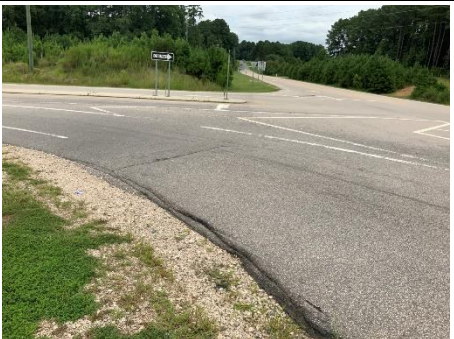
A25
7	Asphalt	LS_553	Line Missing

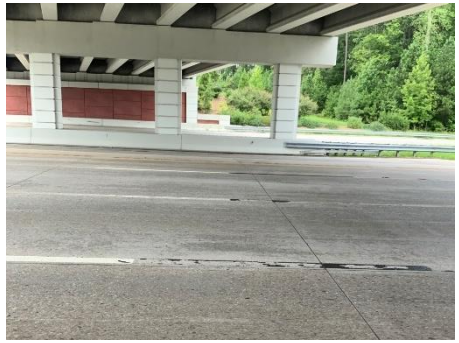
#	Material Type	Object ID	Failure Type	Photo	GIS Reference Page
1	Concrete	LS_95	Nighttime Reflectivity

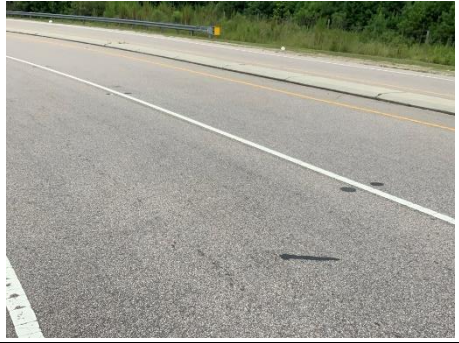
A14
2	Asphalt	LS_553	Reflective Marker Missing & Nighttime Reflectivity

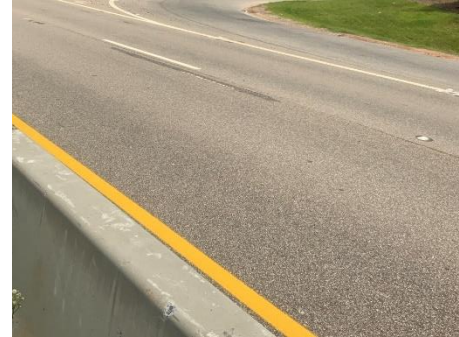
A19
3	Asphalt	LS_683	Reflective Marker Missing & Nighttime Reflectivity

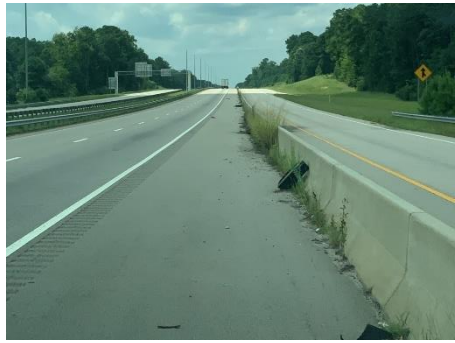
#	Material Type	Object ID	Failure Type	Photo	GIS Reference Page
1	Asphalt	LS_537	Delineators Missing

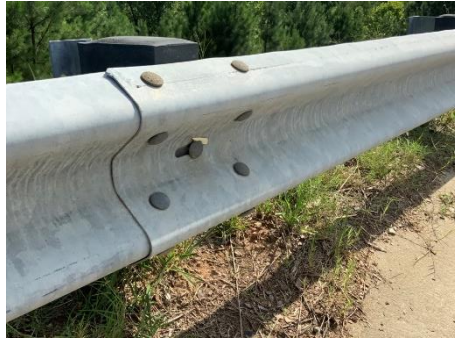
A27
2	Concrete	LS_595	Delineators Missing

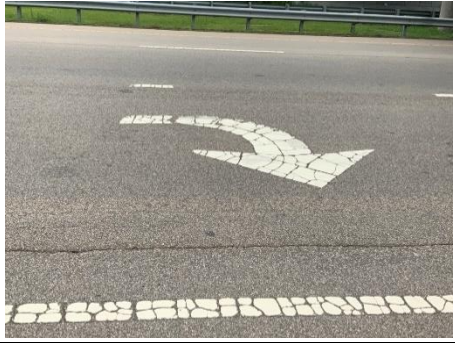
#	Symbol Type	Object ID	Failure Type	Photo	GIS Reference Page
1	Merge Left	PS_240	Nighttime Reflectivity	Not Available for Nighttime Failure	A19
2	Right Turn	PS_247	Nighttime Reflectivity

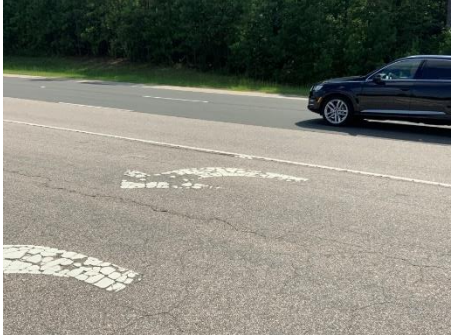
#	Symbol Type	Object ID	Failure Type	Photo	GIS Reference Page
12	Left Turn	PS_431	Daytime Assessment & Nighttime Reflectivity

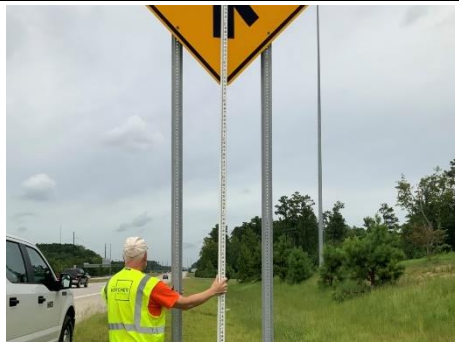
#	Sign Type	Object ID	Failure Type	Photo	GIS Reference Page
1	Merge	SN_219	Height Requirement

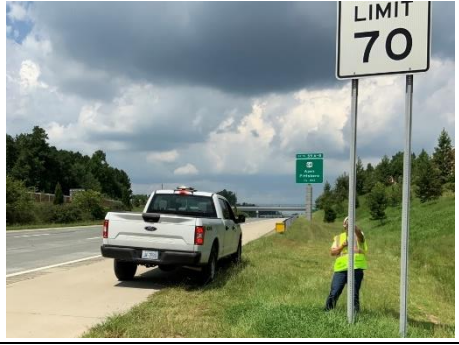
A14
2	Speed Limit Interstate	SN_700	Height Requirement

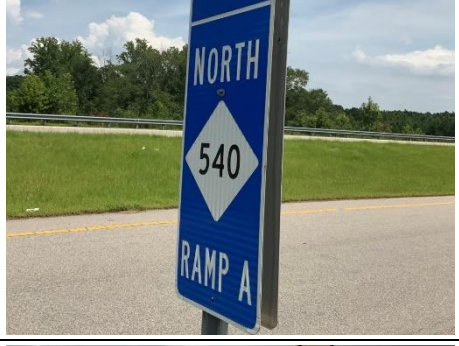
A22
3	Exit	SN_925	Missing Parts

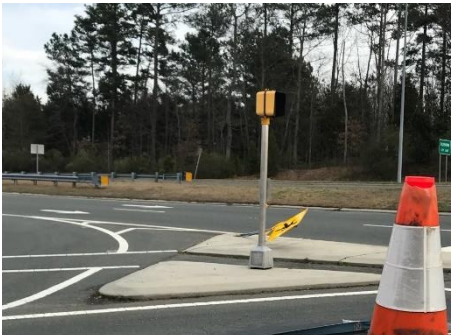
#	Sign Type	Object ID	Failure Type	Photo	GIS Reference Page
5	Pedestrian Xing	SN_1033	Surface Damage

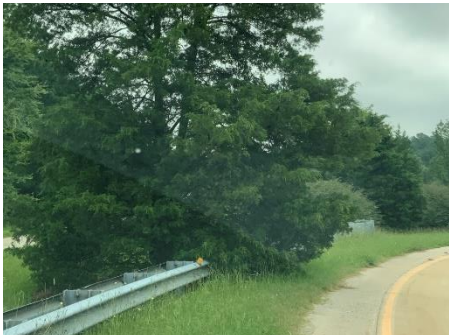
#	Material Type	Object ID	Failure Type	Photo	GIS Reference Page
1	Tree and Brush	TB_5	Barrier Clearance

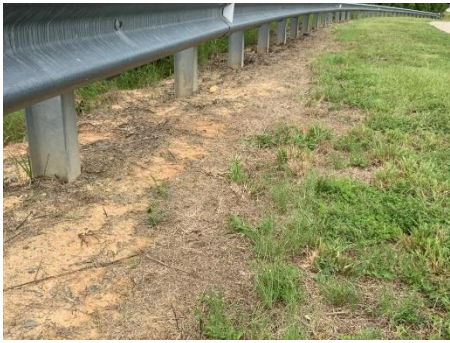
#	Material Type	Object ID	Failure Type	Photo	GIS Reference Page
1	Turf	TF_101	Bare Ground

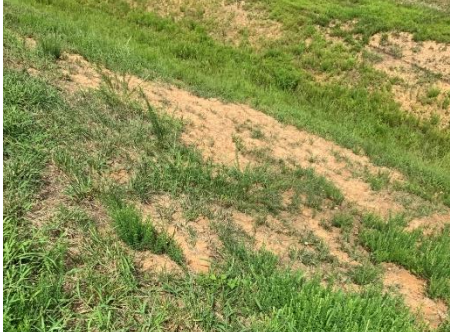
A27
4	Turf	TF_330	Bare Ground

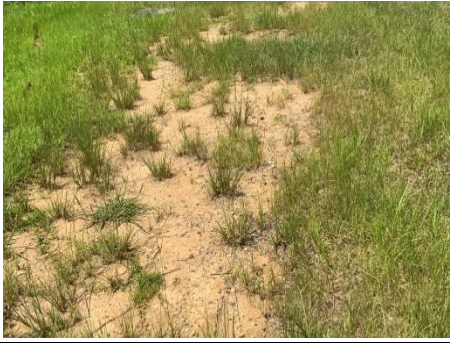
#	Material Type	Object ID	Failure Type	Photo	GIS Reference Page
5	Turf	TF_359	Bare Ground	 	A28
6	Turf	TF_425	Bare Ground

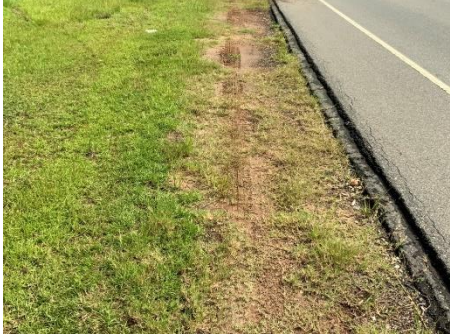
A37
8	Turf	TF_902	Bare Ground

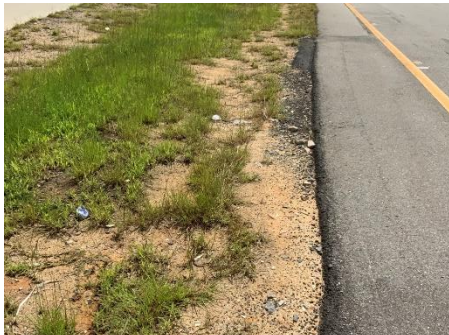
#	Material Type	Object ID	Failure Type	Photo	GIS Reference Page
9	Turf	TF_1016	Bare Ground

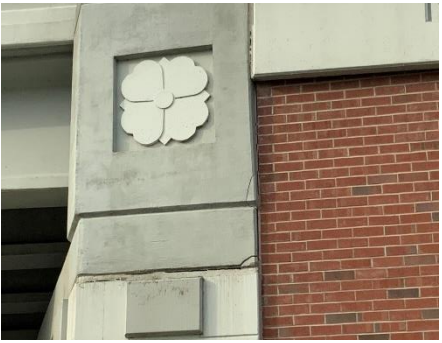
#	Material Type	Object ID	Failure Type	Photo	GIS Reference Page
1	Bridge Wall	WL_5	Unsealed Cracks

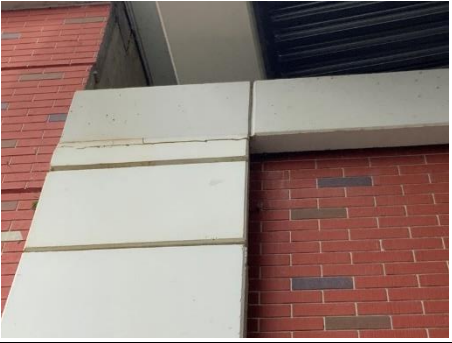
A32
2	Bridge Wall	WL_36	Unsealed Cracks
