NORTH CAROLINA
Turnpike Authority

Maintenance Rating Program

Triangle Expressway

2016 First Quarter Report

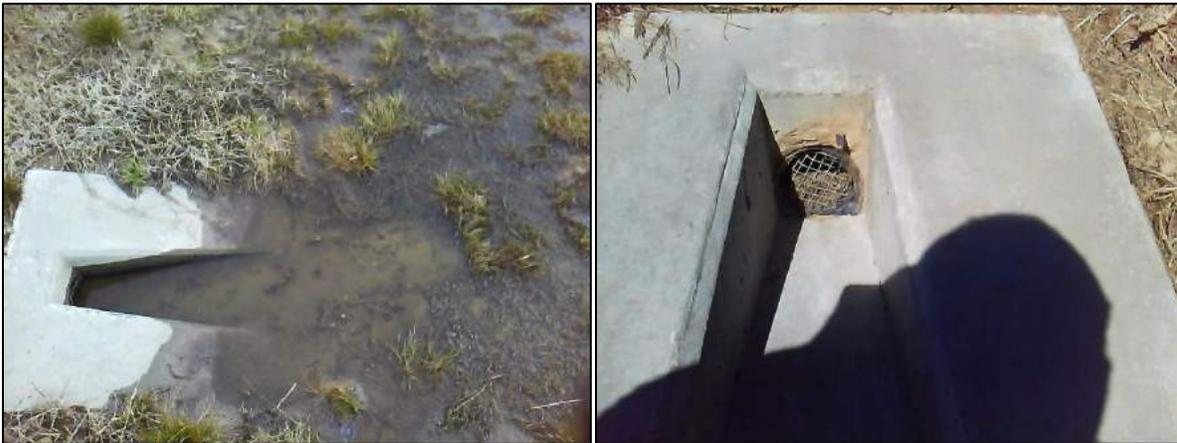
Figure 3: Miscellaneous Drainage Structure Failures

Miscellaneous Drainage Structure (66 rating – 10 of the 29 assets failed). Out of the 10 miscellaneous drainage failures, 7 occurred because of obstruction and 3 occurred because of buildups affecting the flow of water near and adjacent to the structure. Two of the failing miscellaneous drainage structures are presented in **Figure 3**.

Some of the obstruction failures are a result of inadequate gradient flow away from the edge drain outlets. In order to avoid affecting the natural flow of water near the drainage features, it is recommended that outlet elevations be checked against the outflow ditch elevations to ensure positive drainage. Appropriate grading of the ditch line may be necessary to provide positive flow.

In accordance with *NCTA Roadway and Facility Maintenance Standards V4* referenced below, it is recommended that the maintenance provider plan annual cleaning of these drainage features to

remove any debris or overgrown vegetation. Additionally, it is recommended that the maintenance provider schedule repairs of the erosion soil buildup problems that have been identified along the ditch line near and adjacent to the outlet.

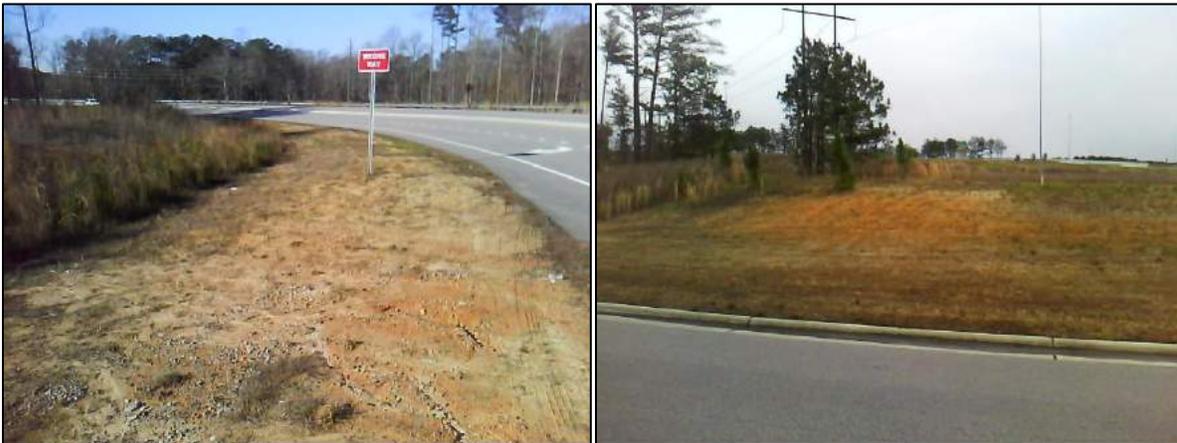
Figure 4: Turf Failures

Turf Condition (73 rating – 21 of the 77 assets failed). All 21 turf areas failed because of bare ground. Two of the failing turf areas are presented in *Figure 4*.

As per the NCDOT Division 5 Landscape Unit Plan presented in the 2015 second quarter report, selected bare ground areas (test areas) were hydro-seeded with warm season grasses during the summer of 2015. As of this report, positive results have been observed in all areas tested; grass is growing and establishing well, especially in those test areas that were fertilized near NC 55 Bypass.

Based on these results, the NCDOT Division 5 Landscape Unit is planning to lead a reseeding effort throughout the Expressway with centipede grass using a drill seeding method. This reseeding effort is expected to start by the end of May, 2016. Additionally, the landscape unit has started preparations for two rounds of fertilization throughout the facility that are scheduled to take place in May and July of 2016. It is important to recognize that results from these efforts may not be immediate as it may take several years for the centipede turf to be fully established.

In order to prevent affecting new growth and scalping of the turf surface, it is further recommended that mowing heights continue to be closely monitored during the each mowing cycle, pursuant to the *NCTA Roadway and Facility Maintenance Standards V4*, referenced below.

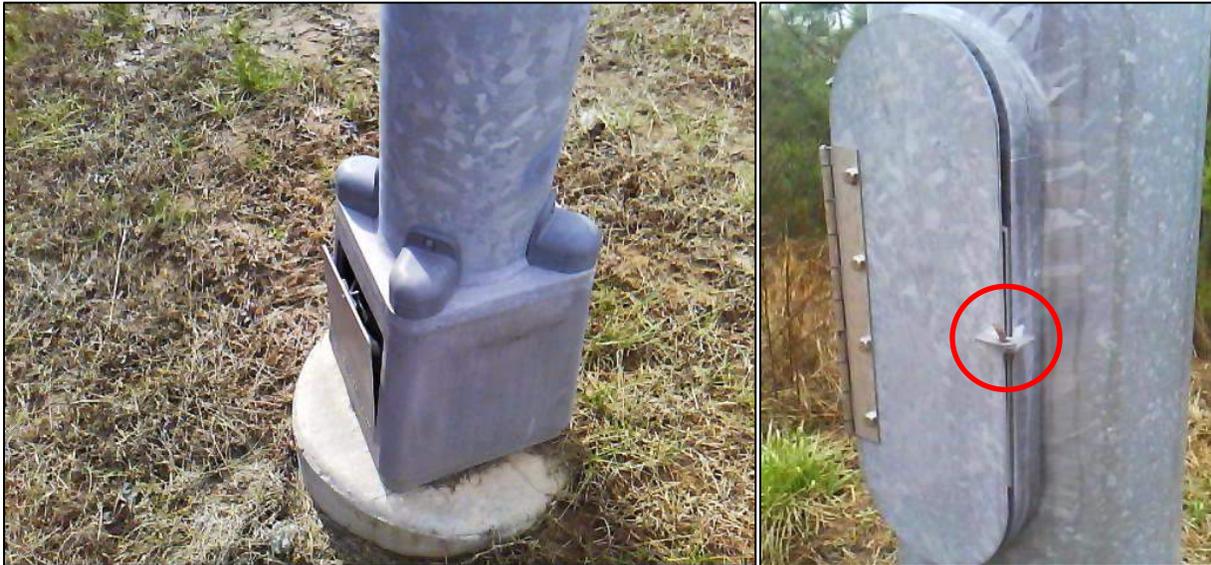
Figure 5: Highway Lighting Failures

Highway Lighting (69 rating – 11 of the 35 assets failed). Out of the 35 highway lights inspected, 8 failed because of functional damage and 3 failed for missing or damaged parts. Two of the failing highway lights are presented in *Figure 5*.

In order to avoid future functional damage, it is recommended that all damaged or missing parts noted be repaired and/or replaced in accordance with the *NCTA Roadway and Facility Maintenance Standards V4*, referenced below.

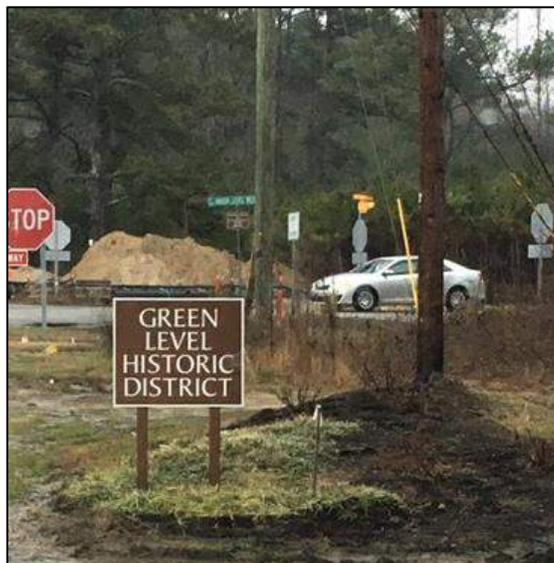
Figure 6: Green Level West Historic District Signs

As part of each quarterly inspection, assessors visit the four Green Level Historic District signs to conduct a visual inspection of each sign to ensure they are in good standing. During this quarterly inspection, all signs were found to be in good condition, with the landscaped areas being well maintained. **Figure 6** shows one of these signs.

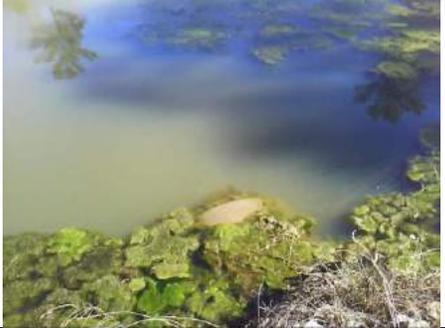
#	Material Type	Object ID	Failure Type	Photo	GIS Reference Page
1	Drain	DP_936	Obstruction

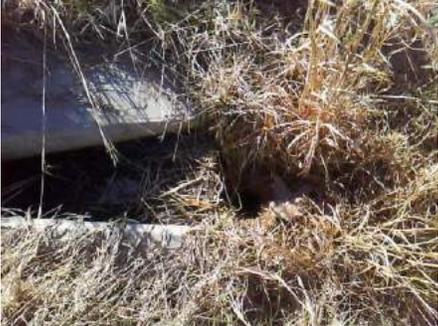
#	Material Type	Object ID	Failure Type	Photo	GIS Reference Page
1	Shoulder Drain	MDP_8	Erosion

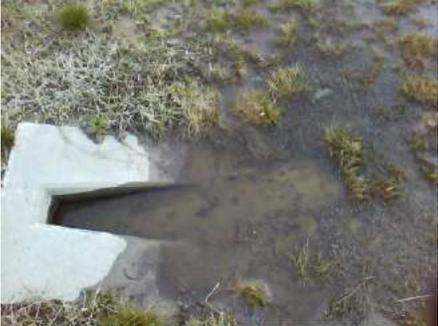
#	Material Type	Object ID	Failure Type	Photo	GIS Reference Page
5	Shoulder Drain	MDP_39	Erosion

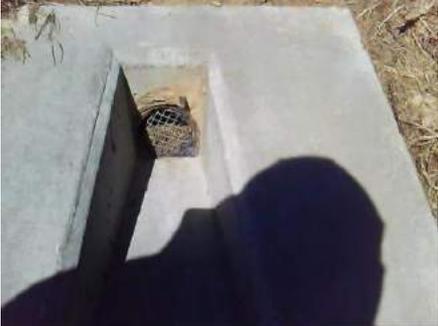
#	Material Type	Object ID	Failure Type	Photo	GIS Reference Page
9	Shoulder Drain	MDP_168	Obstruction

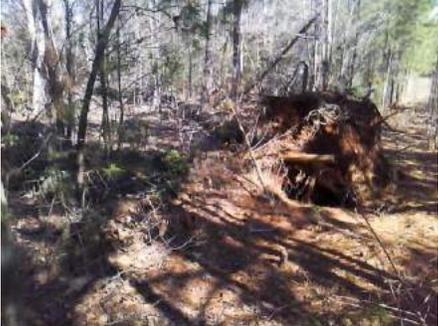
#	Material Type	Object ID	Failure Type	Photo	GIS Reference Page
1	Woven	FN_178	Hole Height

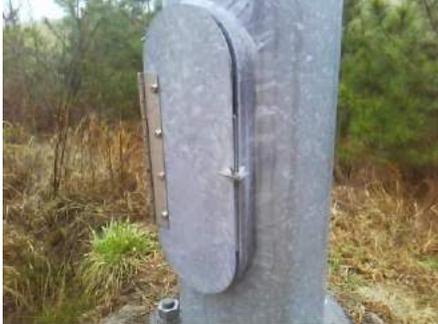
#	Material Type	Object ID	Failure Type	Photo	GIS Reference Page
1	Single Roadway	HL_32	Functional Damage	Not Available for Nighttime Failure.	A22, A23, A24
2	Single Roadway	HL_33	Functional Damage	Not Available for Nighttime Failure.	A22, A23, A24
3	High Mast	HL_71	Part Damage

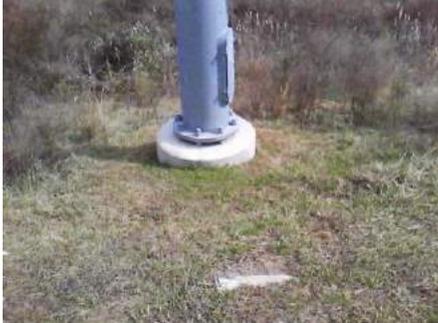
A10
4	High Mast	HL_90	Part Damage

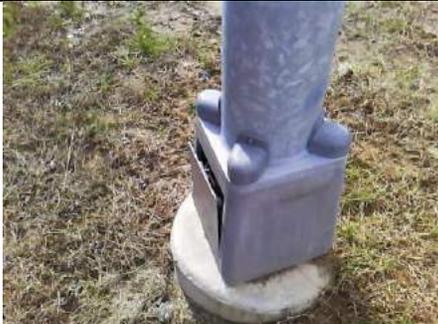
A56
5	Single Roadway	HL_101	Functional Damage	Not Available for Nighttime Failure.	A58
6	Single Roadway	HL_162	Part Damage and Functional Damage

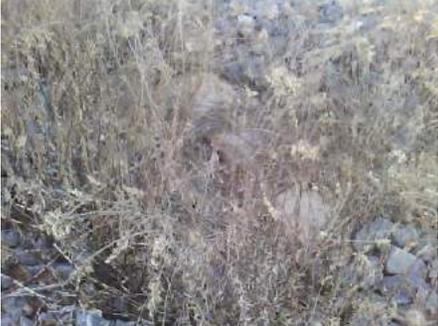
#	Material Type	Object ID	Failure Type	Photo	GIS Reference Page
1	Inlets	IN_451	Obstruction

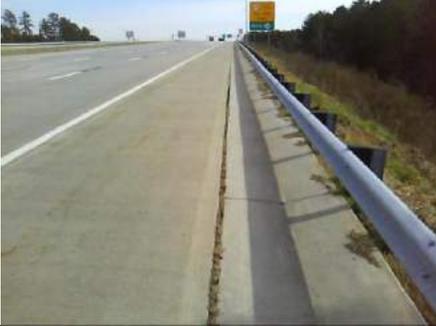
#	Material Type	Object ID	Failure Type	Photo	GIS Reference Page
1	Concrete	LS_309	Paved Shoulder Joint Separation

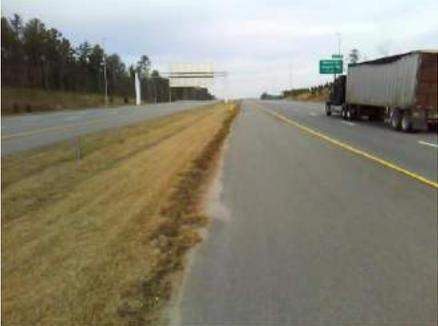
#	Material Type	Object ID	Failure Type	Photo	GIS Reference Page
1	Asphalt	LS_211	Shoulder Build Up

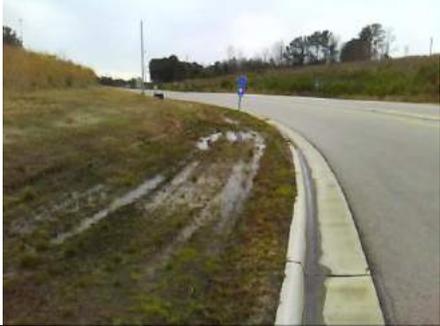
#	Material Type	Object ID	Failure Type	Photo	GIS Reference Page
1	Asphalt	LS_165	Slope Failure

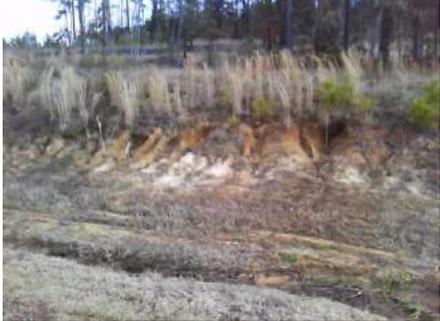
A30, A31
2	Asphalt	LS_223	Slope Failure

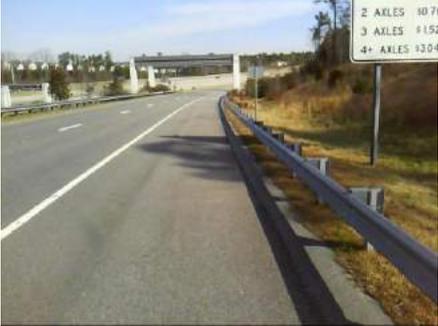
#	Material Type	Object ID	Failure Type	Photo	GIS Reference Page
1	Asphalt	LS_200	Missing Markers

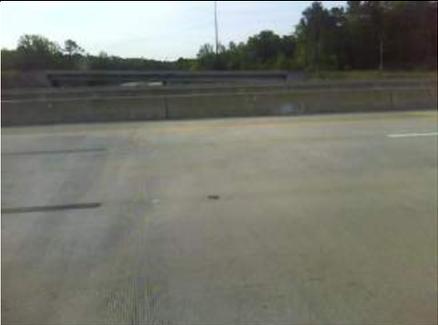
A photograph showing a road with a metal guardrail on the right side. The road surface is asphalt. A sign on the right side of the road lists vehicle weight limits: 2 AXLES 10 71, 3 AXLES 11 52, and 4+ AXLES 13 04. The road appears to be missing markers.	A5
2	Asphalt	LS_244	Missing Markers

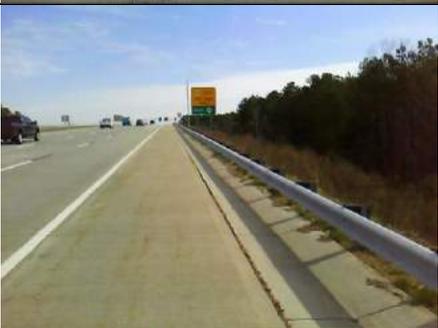
A photograph showing a road with a metal guardrail on the right side. The road surface is asphalt. The road appears to be missing markers.	A51, A52
3	Concrete	LS_309	Missing Markers

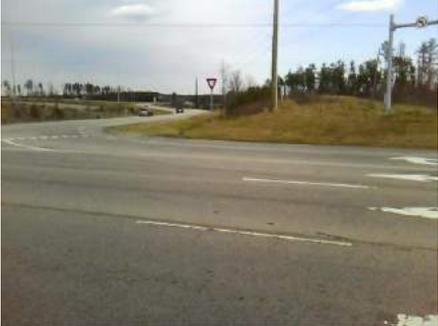
#	Sign Type	Object ID	Failure Type	Photo	GIS Reference Page
1	Yield	SN_205	Height Requirement

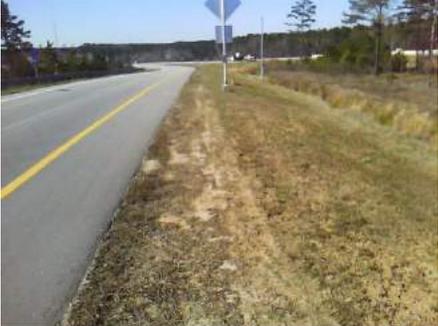
#	Material Type	Object ID	Failure Type	Photo	GIS Reference Page
1	Turf	TF_99	Bareground

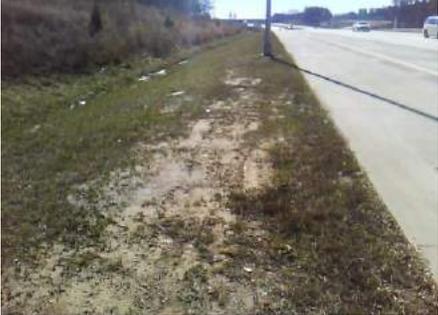
A30, A32
4	Turf	TF_124	Bareground

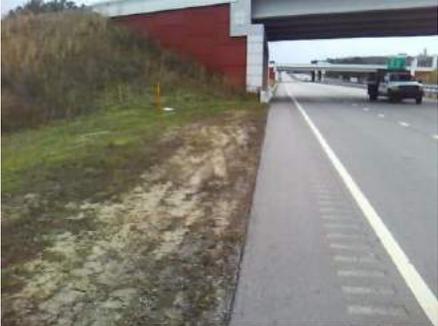
#	Material Type	Object ID	Failure Type	Photo	GIS Reference Page
5	Turf	TF_189	Bareground

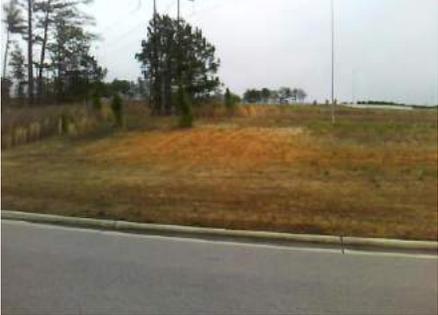
A29, A30, A31
8	Turf	TF_241	Bareground

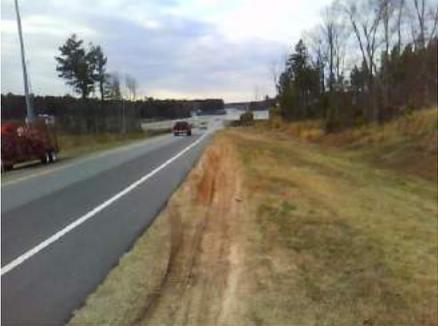
#	Material Type	Object ID	Failure Type	Photo	GIS Reference Page
9	Turf	TF_263	Bareground

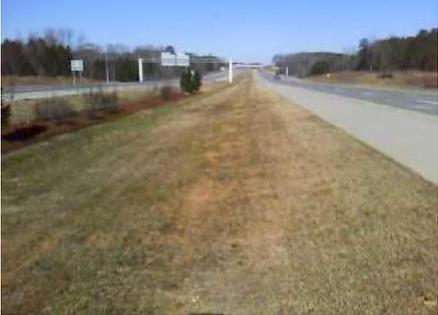
A45, A46
12	Turf	TF_397	Bareground

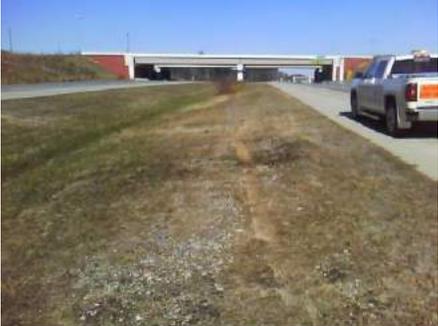
#	Material Type	Object ID	Failure Type	Photo	GIS Reference Page
13	Turf	TF_410	Bareground

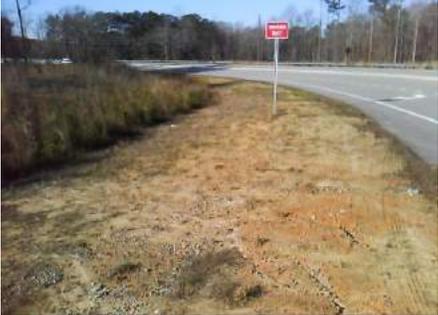
A49, A50
16	Turf	TF_522	Bareground

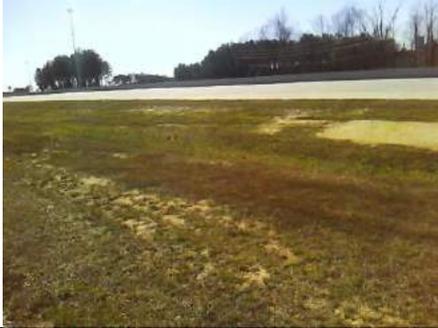
#	Material Type	Object ID	Failure Type	Photo	GIS Reference Page
17	Turf	TF_533	Bareground

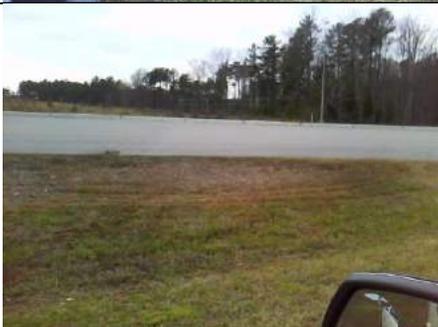
A5, A6
20	Turf	TF_984	Bareground

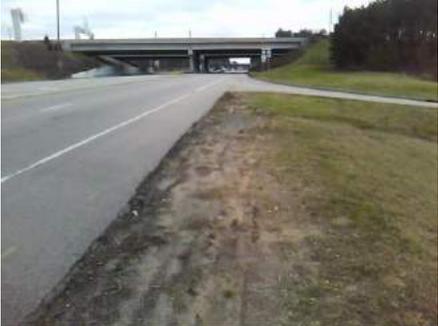
#	Material Type	Object ID	Failure Type	Photo	GIS Reference Page
21	Turf	TF_998	Bareground

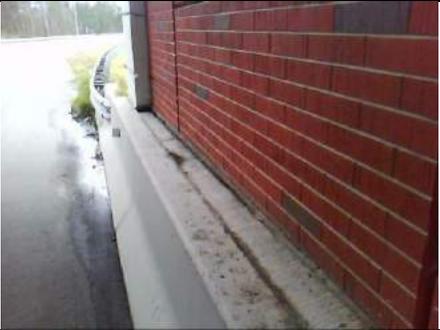
#	Material Type	Object ID	Failure Type	Photo	GIS Reference Page
1	Sound Wall	WL_63	Joints and Cracks

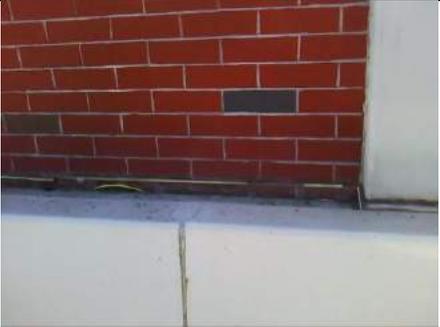
A42, A43
2	Sound Wall	WL_95	Joints and Cracks
