NORTH CAROLINA
Turnpike Authority

Maintenance Rating Program

Triangle Expressway

2016 Second Quarter Report

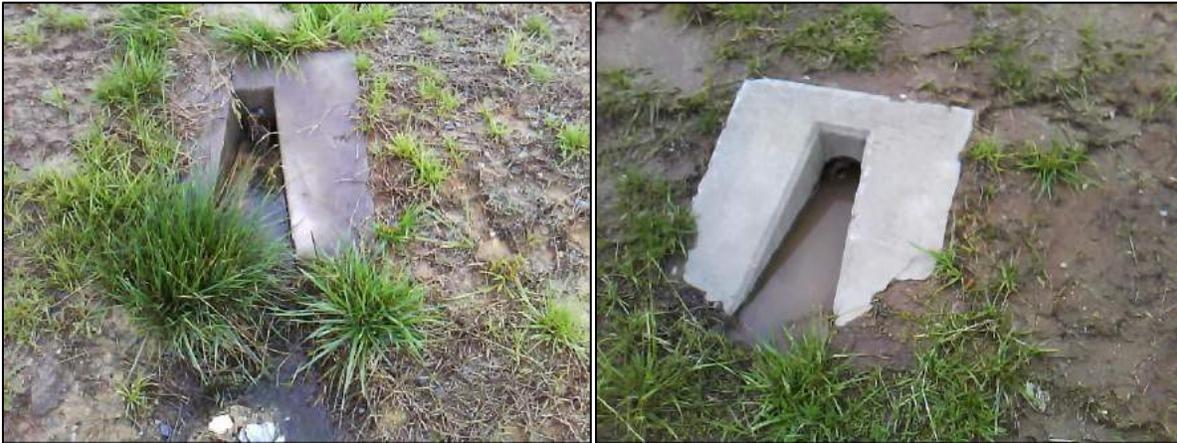
Figure 3: Miscellaneous Drainage Structure Failures

Miscellaneous Drainage (63 rating – 9 of the 26 assets failed). All nine failures occurred because of obstruction. Two of the failing miscellaneous drainage structures are presented in **Figure 3**.

Some of the obstruction failures are a result of inadequate gradient flow away from the edge drain outlets. In order to avoid affecting the natural flow of water near the drainage features, it is recommended that outlet elevations be checked against the outflow ditch elevations to ensure positive drainage. Appropriate grading of the ditch line may be necessary to provide positive flow.

In accordance with *NCTA Roadway and Facility Maintenance Standards V4* reference below, it is recommended that the maintenance provider plan annual cleaning of these drainage features to remove any debris or overgrown vegetation. Additionally, it is recommended that the maintenance provider schedule repairs of the erosion soil buildup problems that have been identified along the ditch line near and adjacent to the outlet.

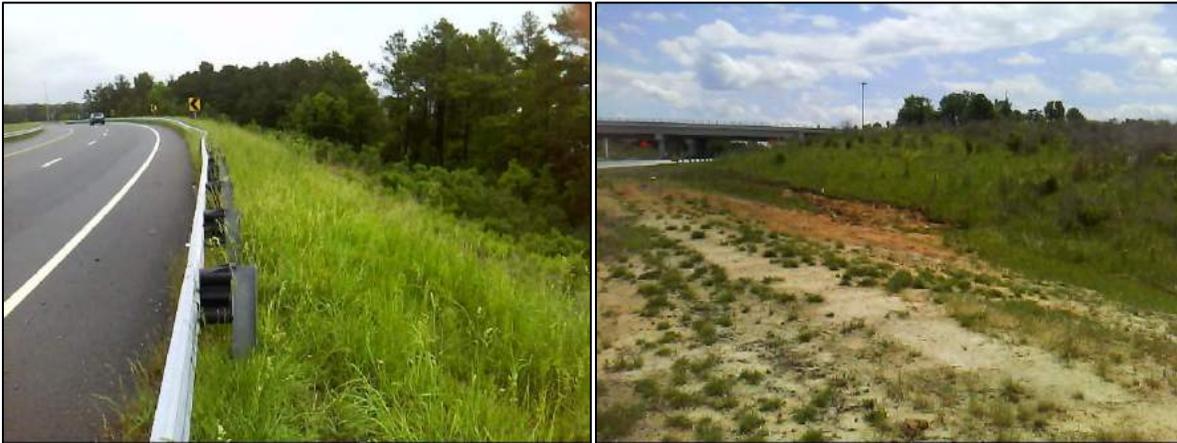
Figure 4: Turf Failures

Turf Condition (44 rating – 41 of the 73 assets failed). Out of the 73 turf areas inspected, 7 failed because of height and 34 failed because of bare ground. Two of the failing turf areas are presented in *Figure 4*.

In order to reduce overgrown turf areas and prevent scalping of the turf surface, it is recommended that mowing heights continue to be closely monitored during each mowing cycle, pursuant to the *NCTA Roadway and Facility Maintenance Standards V4*, referenced below.

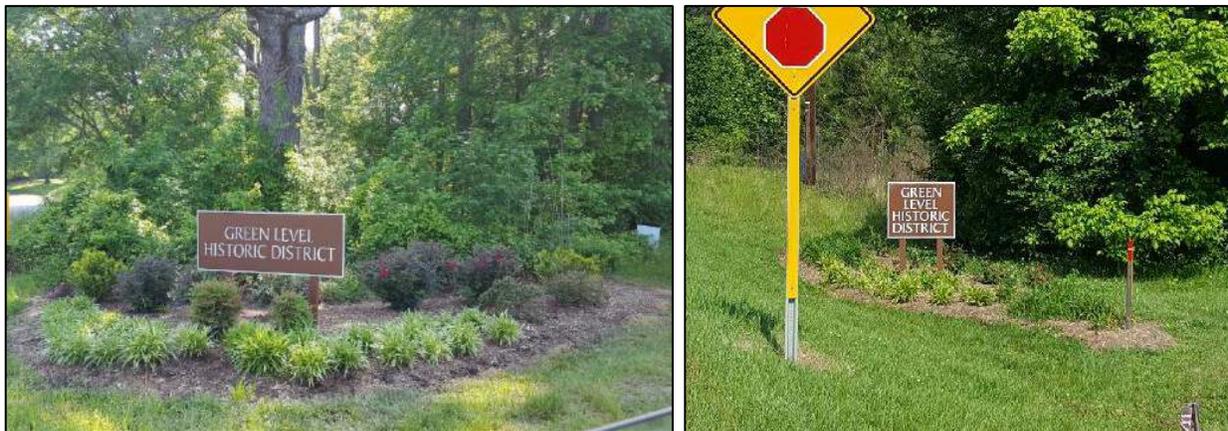
Figure 5: Green Level West Historic District Signs, in Good Standing

As part of each quarterly inspection, assessors visit the four Green Level Historic District signs to conduct a visual inspection of each sign to ensure they are in good standing. During this quarterly inspection, two of the four signs were found to be in good condition, with the landscaped areas being well maintained. *Figure 5* shows these signs.

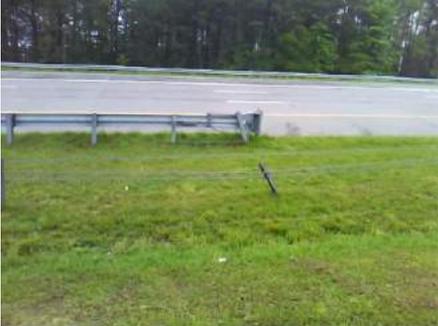
#	Material Type	Object ID	Failure Type	Photo	GIS Reference Page
1	Cable Guardrail	BR_313	Functional Damage

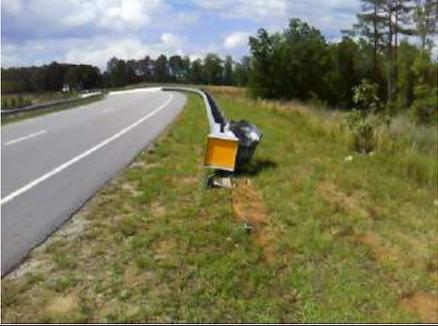
A2
2	Guardrail	BR_463	Functional Damage

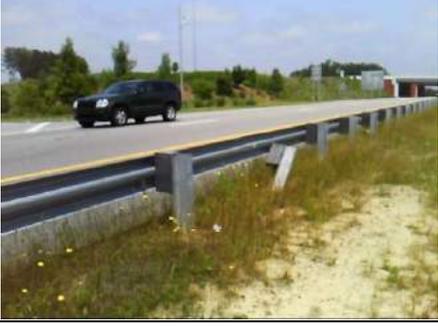
A43
3	Guardrail	BR_562	Missing Parts

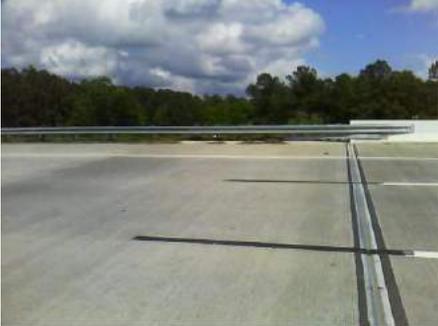
#	Material Type	Object ID	Failure Type	Photo	GIS Reference Page
1	Valley	CG_51	Material Accumulation

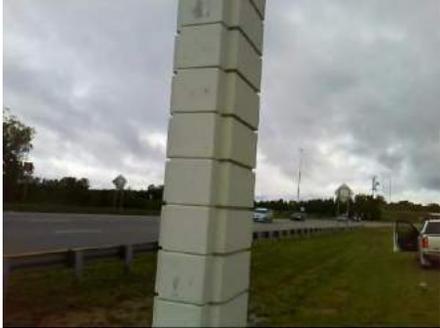
#	Material Type	Object ID	Failure Type	Photo	GIS Reference Page
1	Overhead Sign Support	DS_266	Paint Scaling

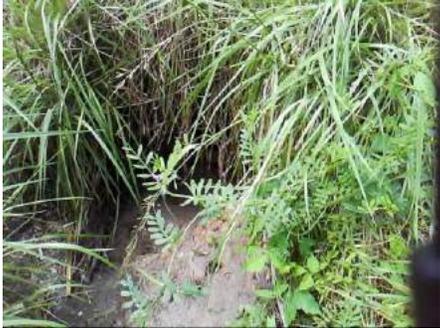
#	Material Type	Object ID	Failure Type	Photo	GIS Reference Page
1	Drain	DP_15	Erosion

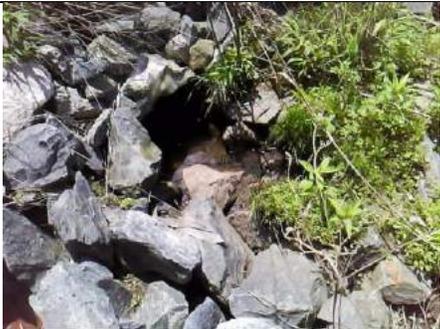
A21, A22, A23
2	Drain	DP_218	Pipe Damage

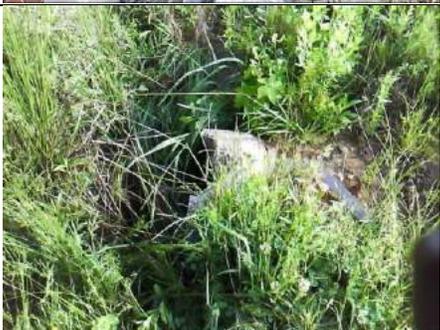
A53
3	Cross Pipe	DP_1000	Pipe Damage

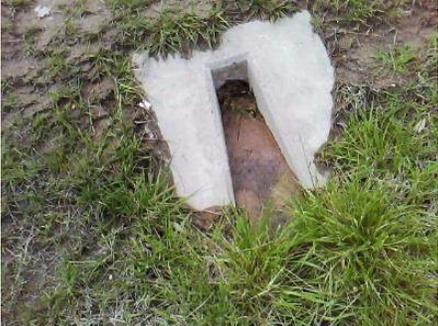
#	Material Type	Object ID	Failure Type	Photo	GIS Reference Page
1	Shoulder Drain	MDP_22	Obstruction

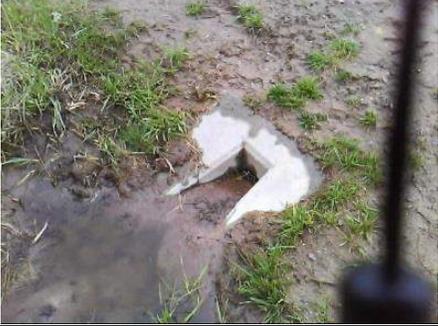
A14
2	Shoulder Drain	MDP_42	Obstruction and Grate Damage

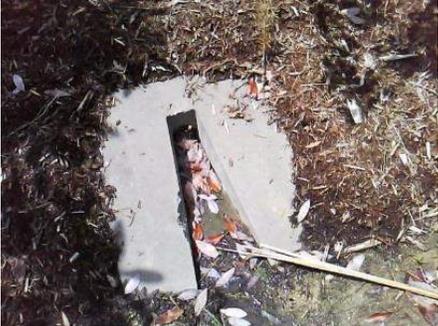
#	Material Type	Object ID	Failure Type	Photo	GIS Reference Page
5	Shoulder Drain	MDP_126	Obstruction

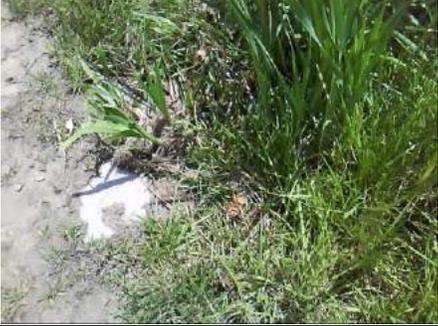
A37
6	Shoulder Drain	MDP_139	Obstruction

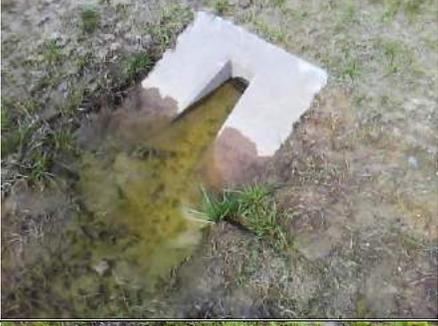
A40
7	Shoulder Drain	MDP_151	Obstruction and Grate Damage

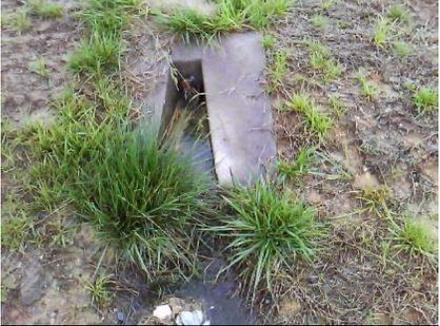
#	Material Type	Object ID	Failure Type	Photo	GIS Reference Page
9	Shoulder Drain	MDP_154	Obstruction

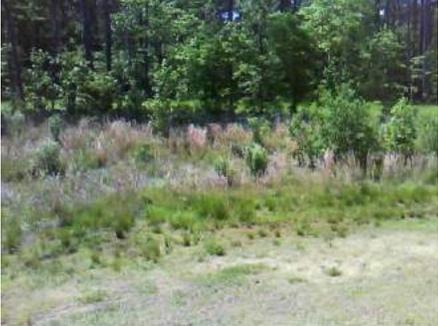
#	Material Type	Object ID	Failure Type	Photo	GIS Reference Page
1	Plant Bed	PB_80	Health

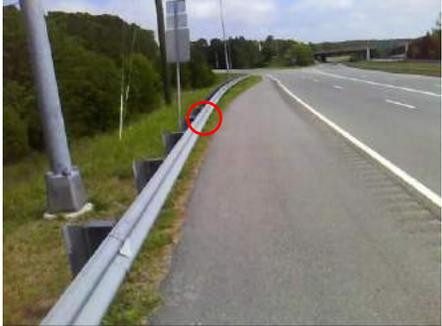
#	Material Type	Object ID	Failure Type	Photo	GIS Reference Page
1	Asphalt	LS_257	Missing Markers

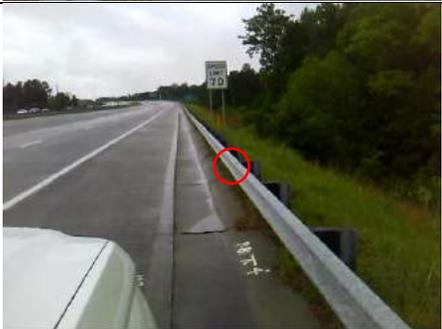
A47, A48
2	Concrete	LS_334	Missing Markers

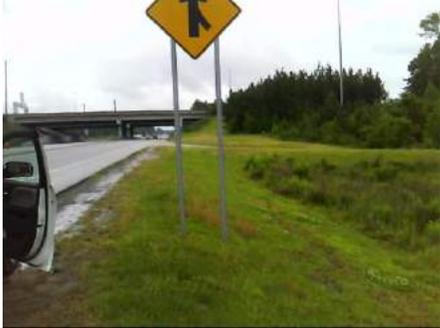
#	Sign Type	Object ID	Failure Type	Photo	GIS Reference Page
1	Merge	SN_218	Height Requirement

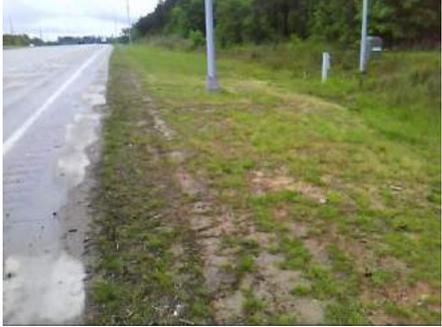
#	Material Type	Object ID	Failure Type	Photo	GIS Reference Page
1	Turf	TF_34	Bareground

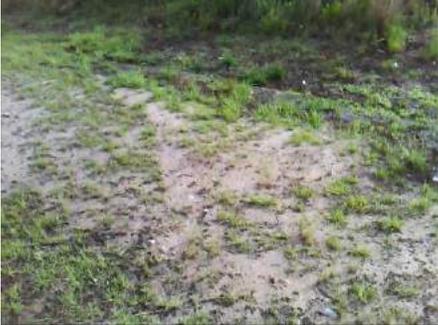
#	Material Type	Object ID	Failure Type	Photo	GIS Reference Page
5	Turf	TF_95	Bareground

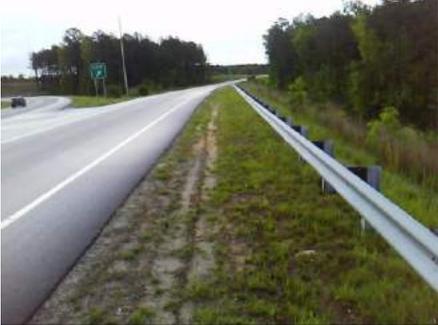
#	Material Type	Object ID	Failure Type	Photo	GIS Reference Page
9	Turf	TF_150	Bareground

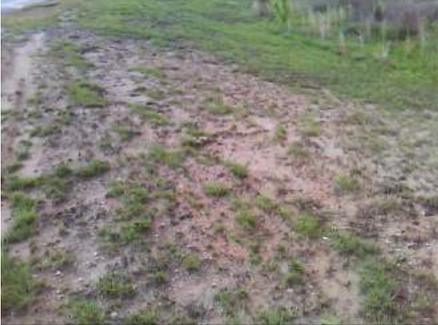
#	Material Type	Object ID	Failure Type	Photo	GIS Reference Page
13	Turf	TF_235	Bareground

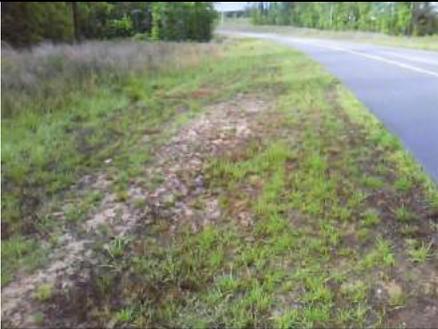
#	Material Type	Object ID	Failure Type	Photo	GIS Reference Page
17	Turf	TF_358	Bareground

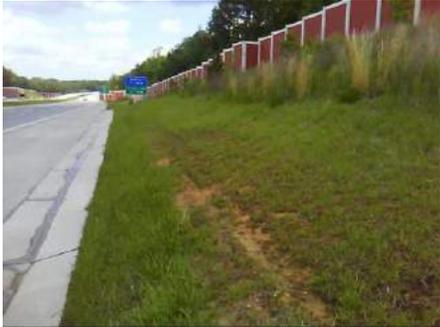
#	Material Type	Object ID	Failure Type	Photo	GIS Reference Page
21	Turf	TF_450	Bareground

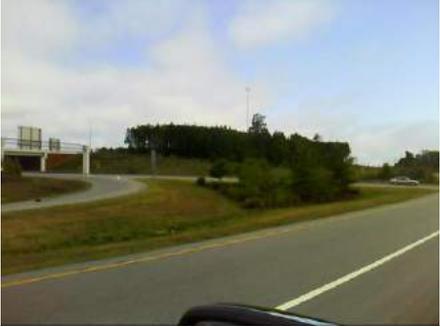
#	Material Type	Object ID	Failure Type	Photo	GIS Reference Page
25	Turf	TF_514	Bareground

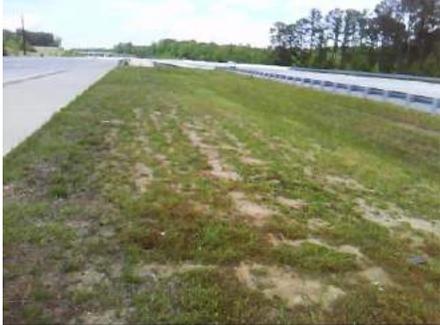
#	Material Type	Object ID	Failure Type	Photo	GIS Reference Page
29	Turf	TF_662	Bareground

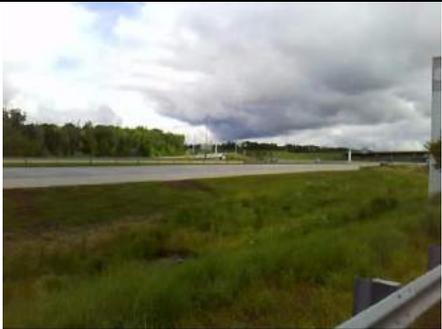
#	Material Type	Object ID	Failure Type	Photo	GIS Reference Page
33	Turf	TF_742	Height

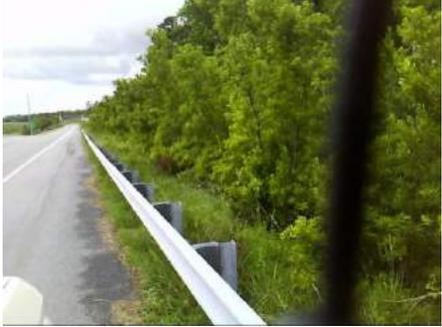
#	Material Type	Object ID	Failure Type	Photo	GIS Reference Page
37	Turf	TF_799	Height

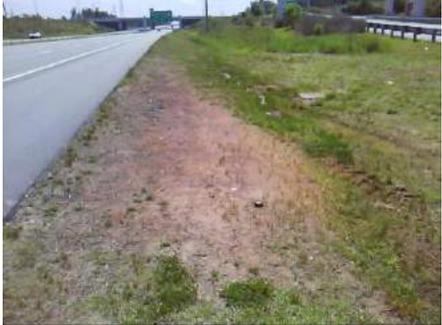
#	Material Type	Object ID	Failure Type	Photo	GIS Reference Page
41	Turf	TF_929	Bareground

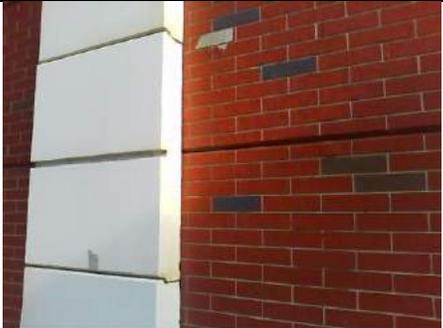
#	Material Type	Object ID	Failure Type	Photo	GIS Reference Page
1	MSE/ Retaining Wall	WL_36	Paint Scaling
