NORTH CAROLINA
Turnpike Authority

Maintenance Rating Program

Triangle Expressway

2016 Third Quarter Report

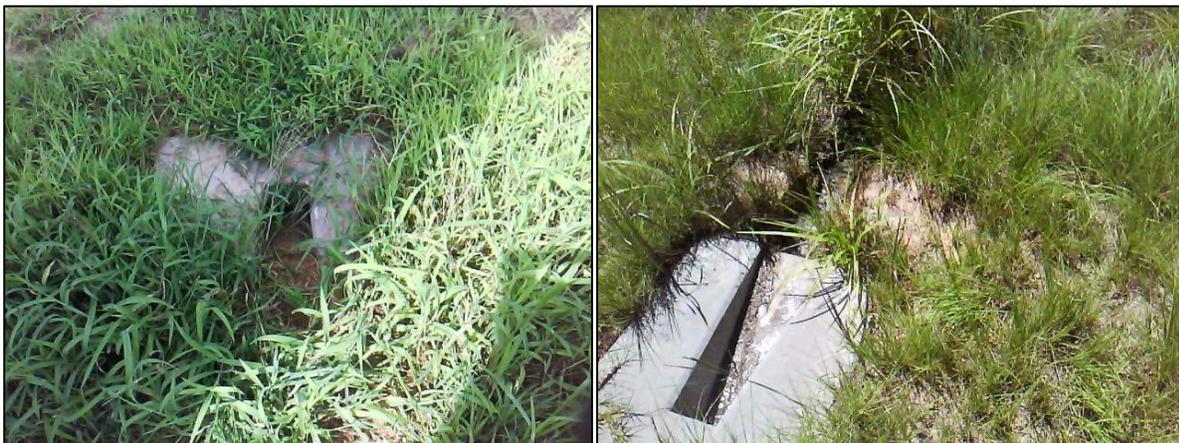
Figure 3: Miscellaneous Drainage Failures

Miscellaneous Drainage (64 rating – 10 of the 28 assets failed). Out of the 28 miscellaneous drainage structures inspected 9 failed because of obstruction and 1 failed because of erosion. Two of the failing miscellaneous drainage structures are presented in **Figure 3**.

Most obstruction failures are a result of inadequate gradient flow away from the edge drain outlets. In order to avoid affecting the natural flow of water near the drainage features, it is recommended that outlet elevations be checked against the outflow ditch elevations to ensure positive drainage. Appropriate grading of the ditch line may be necessary to provide positive flow.

In accordance with *NCTA Roadway and Facility Maintenance Standards V4* reference below, it is recommended that the maintenance provider plan annual cleaning of these drainage features to remove any debris or overgrown vegetation. Additionally, it is recommended that the maintenance provider schedule repairs of the erosion soil buildup problems that have been identified along the ditch line near and adjacent to the outlet.

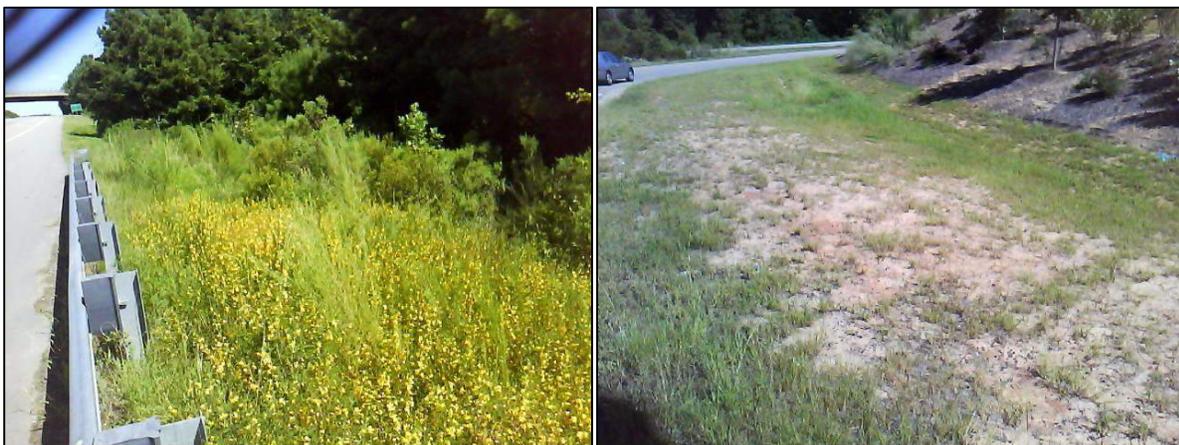
Figure 4: Turf Failures

Turf Condition (63 rating – 28 of the 75 assets failed). Out of the 75 turf areas inspected, 10 failed because of height and 19 failed because of bare ground. Two of the failing turf areas are presented in *Figure 4*.

In order to reduce overgrown turf areas and prevent scalping of the turf surface, it is recommended that mowing heights continue to be closely monitored during each mowing cycle, pursuant to the *NCTA Roadway and Facility Maintenance Standards V4*, referenced below.

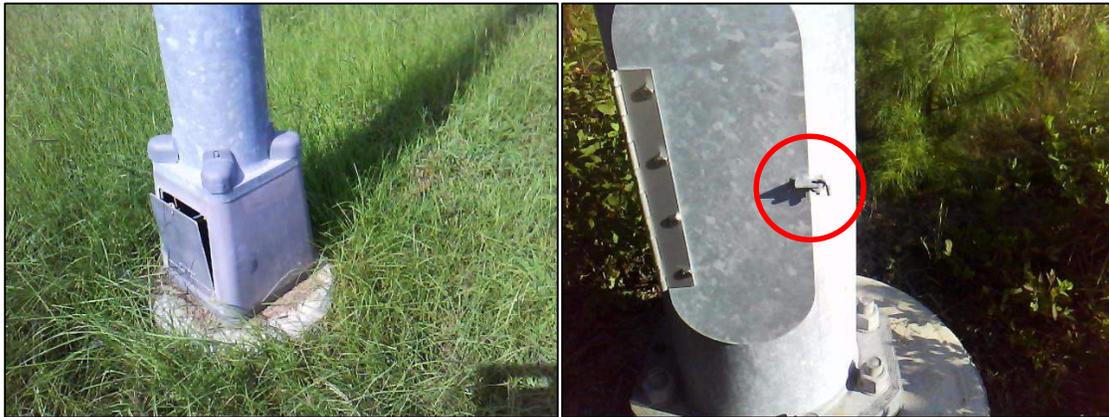
Figure 5: Highway Lighting Failures

Highway Lighting (66 rating – 12 of the 35 assets failed). Out of the 35 highway lights inspected, 10 failed because of non-functioning luminaries and 2 failed for missing or damaged parts. Two of the failing highway lights are presented in *Figure 5*.

In order to avoid future damage, mowers should be advised to use caution in and around lighting appurtenances. All non-functioning or damaged highway lights noted by inspectors shall be repaired and/or replaced in accordance with the *NCTA Roadway and Facility Maintenance Standards V4*, referenced below.

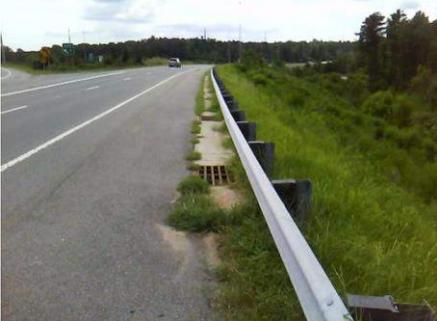
#	Material Type	Object ID	Failure Type	Photo	GIS Reference Page
1	Valley	CG_125	Obstruction

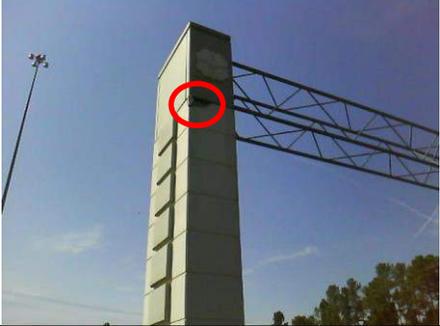
#	Material Type	Object ID	Failure Type	Photo	GIS Reference Page
1	Overhead Sign Support	DS_30	Spalls

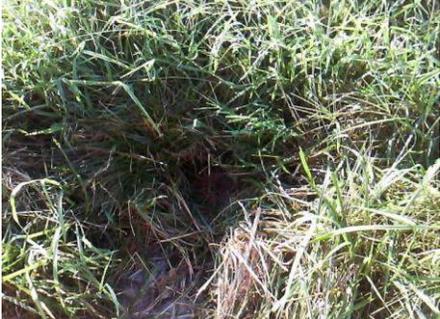
#	Material Type	Object ID	Failure Type	Photo	GIS Reference Page
1	Drain	DP_11	Obstruction

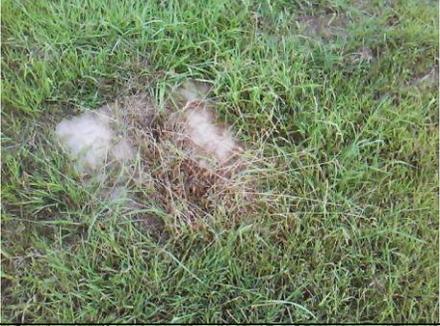
#	Material Type	Object ID	Failure Type	Photo	GIS Reference Page
1	Shoulder Drain	MDP_2	Obstruction

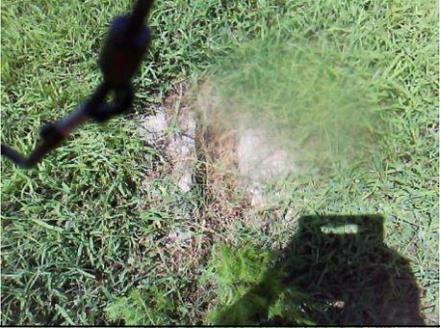
#	Material Type	Object ID	Failure Type	Photo	GIS Reference Page
5	Shoulder Drain	MDP_89	Obstruction

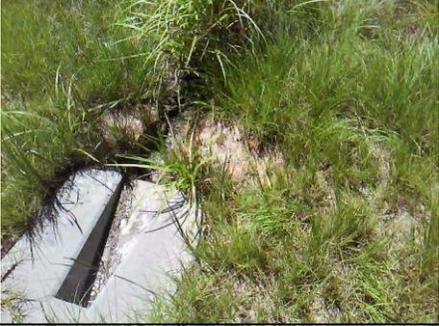
#	Material Type	Object ID	Failure Type	Photo	GIS Reference Page
9	Shoulder Drain	MDP_155	Erosion

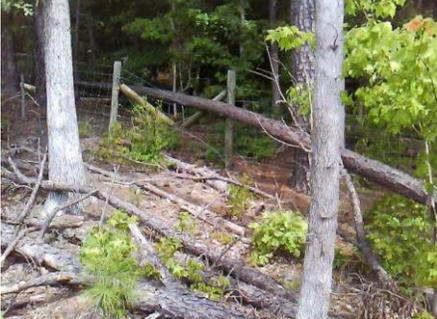
#	Material Type	Object ID	Failure Type	Photo	GIS Reference Page
1	Woven	FN_192	Fence Height

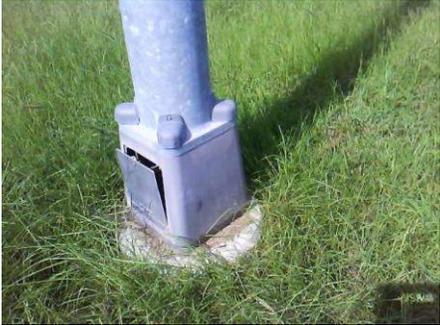
#	Material Type	Object ID	Failure Type	Photo	GIS Reference Page
1	Single Roadway	HL_78	Functional Damage	Not Available for Nighttime Failure	A45, A46
2	Single Roadway	HL_106	Functional Damage	Not Available for Nighttime Failure	A53
3	Single Roadway	HL_120	Functional Damage	Not Available for Nighttime Failure	A9, A10, A11
4	Single Roadway	HL_149	Functional Damage	Not Available for Nighttime Failure	A4
5	Single Roadway	HL_151	Part Damage

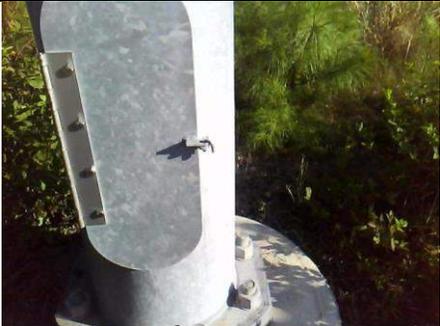
12	High Mast	HL_345	Part Damage

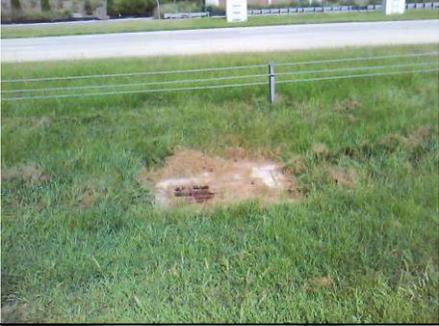
#	Material Type	Object ID	Failure Type	Photo	GIS Reference Page
1	Inlet	IN_273	Obstruction

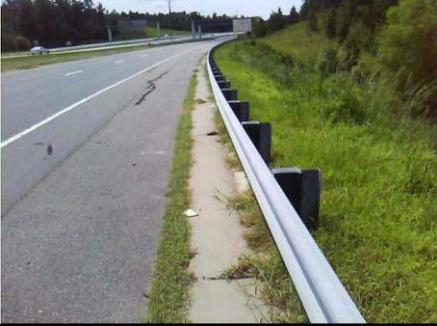
#	Material Type	Object ID	Failure Type	Photo	GIS Reference Page
1	Asphalt	LS_293	Paved Shoulder Joint

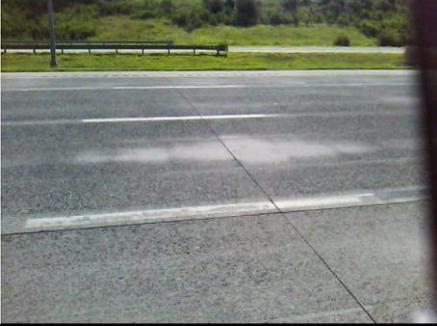
#	Material Type	Object ID	Failure Type	Photo	GIS Reference Page
1	Concrete	LS_405	Missing Line

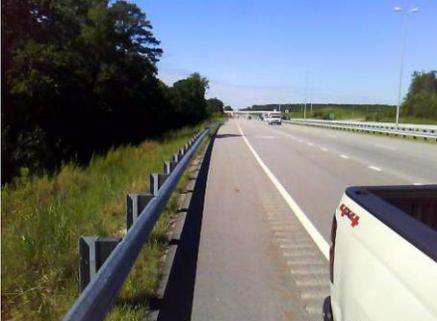
#	Material Type	Object ID	Failure Type	Photo	GIS Reference Page
1	Asphalt	LS_359	Missing Markers

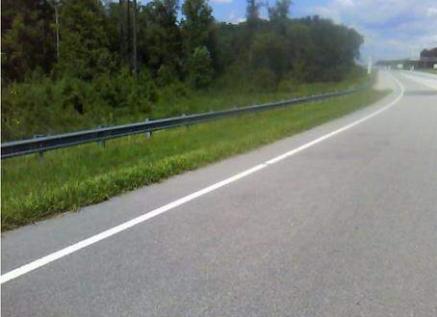
A44
2	Asphalt	LS_503	Missing Markers

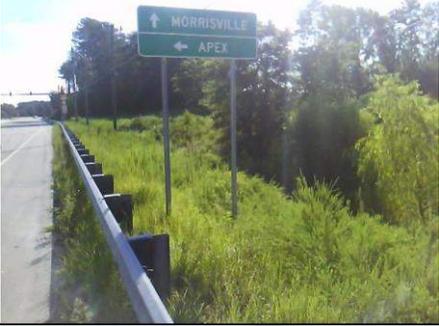
#	Sign Type	Object ID	Failure Type	Photo	GIS Reference Page
1	Destination	SN_192	Height Requirement

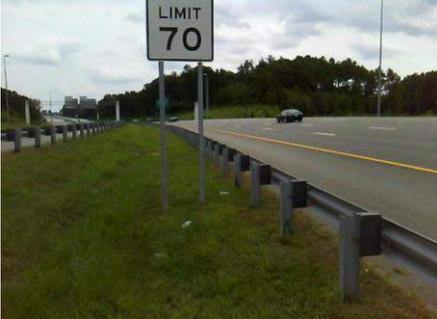
#	Sign Type	Object ID	Failure Type	Photo	GIS Reference Page
5	Speed Limit	SN_1024	Height Requirement

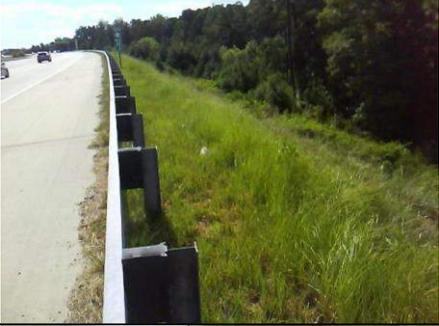
#	Material Type	Object ID	Failure Type	Photo	GIS Reference Page
1	Turf	TF_5	Height

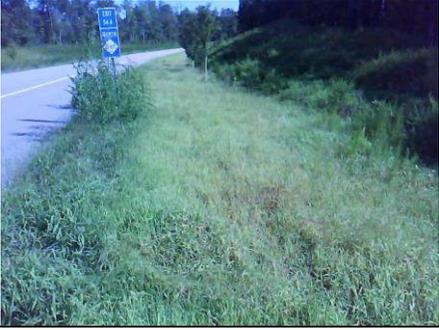
A20, A21
4	Turf	TF_146	Height

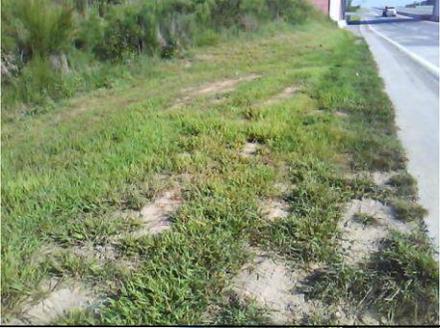
#	Material Type	Object ID	Failure Type	Photo	GIS Reference Page
5	Turf	TF_167	Bareground

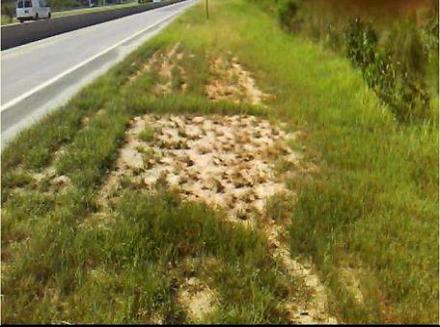
A30, A31
8	Turf	TF_220	Bareground

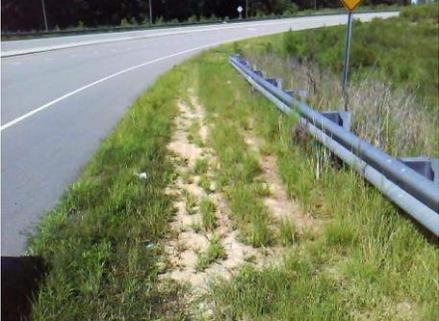
#	Material Type	Object ID	Failure Type	Photo	GIS Reference Page
9	Turf	TF_222	Bareground

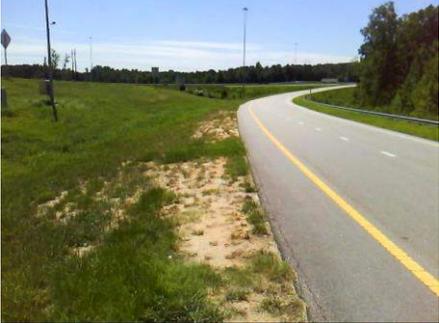
A44
12	Turf	TF_387	Bareground

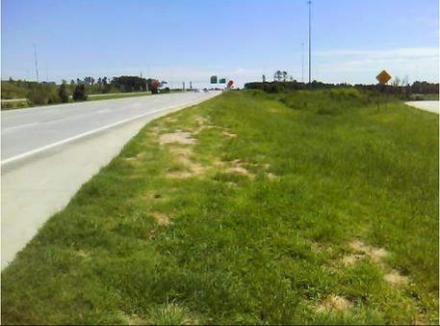
#	Material Type	Object ID	Failure Type	Photo	GIS Reference Page
13	Turf	TF_390	Bareground

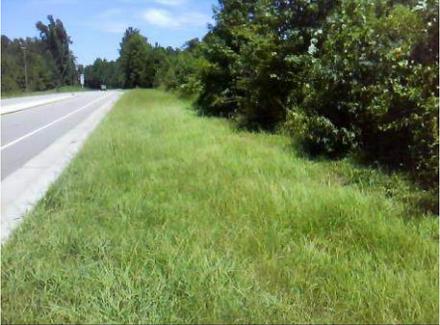
A37, A38, A39
16	Turf	TF_423	Height

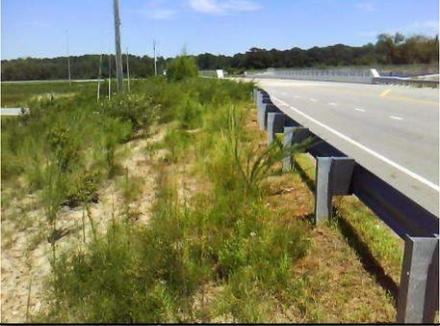
#	Material Type	Object ID	Failure Type	Photo	GIS Reference Page
17	Turf	TF_473	Height, Bareground

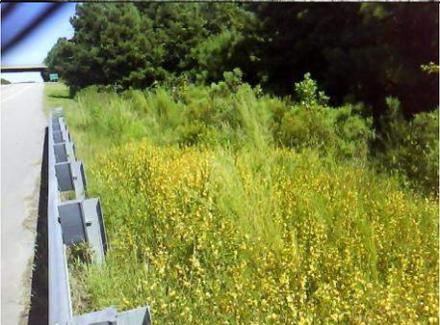
A30, A31
20	Turf	TF_515	Height

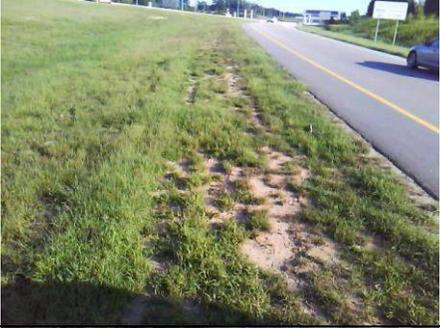
#	Material Type	Object ID	Failure Type	Photo	GIS Reference Page
21	Turf	TF_519	Bareground

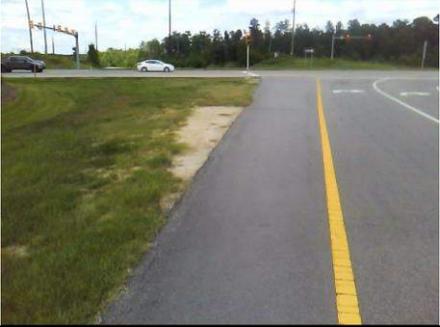
A21
24	Turf	TF_691	Bareground

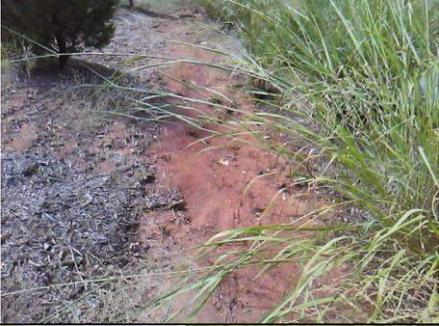
#	Material Type	Object ID	Failure Type	Photo	GIS Reference Page
25	Turf	TF_740	Bareground
