NORTH CAROLINA
Turnpike Authority

Maintenance Rating Program

Triangle Expressway

2015 Fourth Quarter and Annual Report

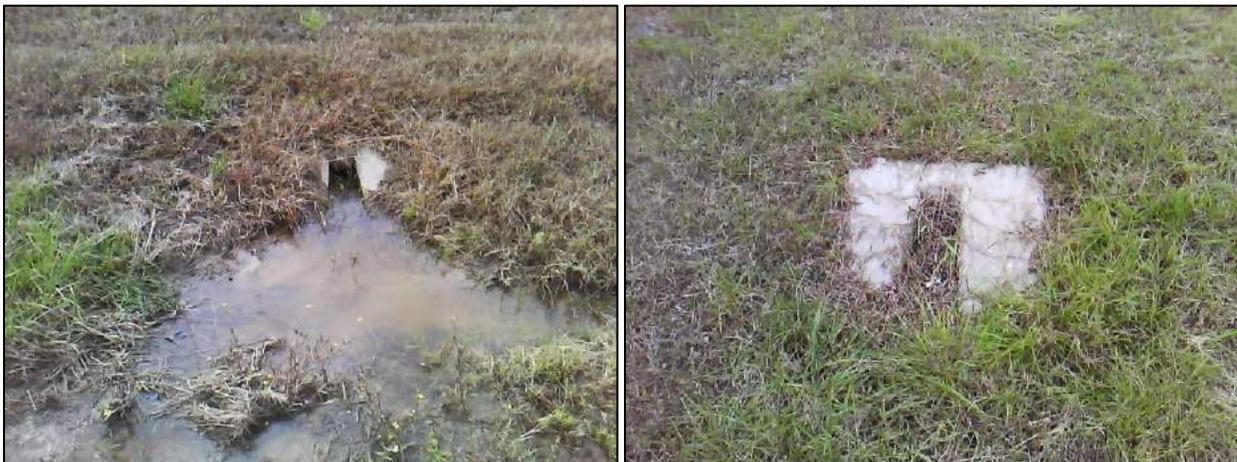
Figure 3: Miscellaneous Drainage Structures Failures

Miscellaneous Drainage (63 rating – 12 of the 32 assets failed). Out of the 12 miscellaneous drainage structures that failed, 11 failed because of obstruction and 1 failed because of erosion. Two of the failing miscellaneous drainage structures are presented in **Figure 3**.

Many of the obstructions are a result of inadequate gradient flow away from the edge drain outlets. In order to avoid affecting the natural flow of water near the drainage features, it is recommended that outlet elevations be checked against the outflow ditch elevations to ensure positive drainage. Appropriate grading of the ditch line may be necessary to provide positive flow. It is also recommended that the maintenance provider plan routine (once per year in accordance with the *NCTA Roadway and Facility Maintenance Standards V4* referenced below) cleaning of these drainage features to remove any debris or overgrown vegetation.

- 1) Miscellaneous Drainage Structures shall be inspected during routine patrols
- 2) Clear all outlets to edge drains annually
- 3) Schedule cleanouts and repairs during inspections

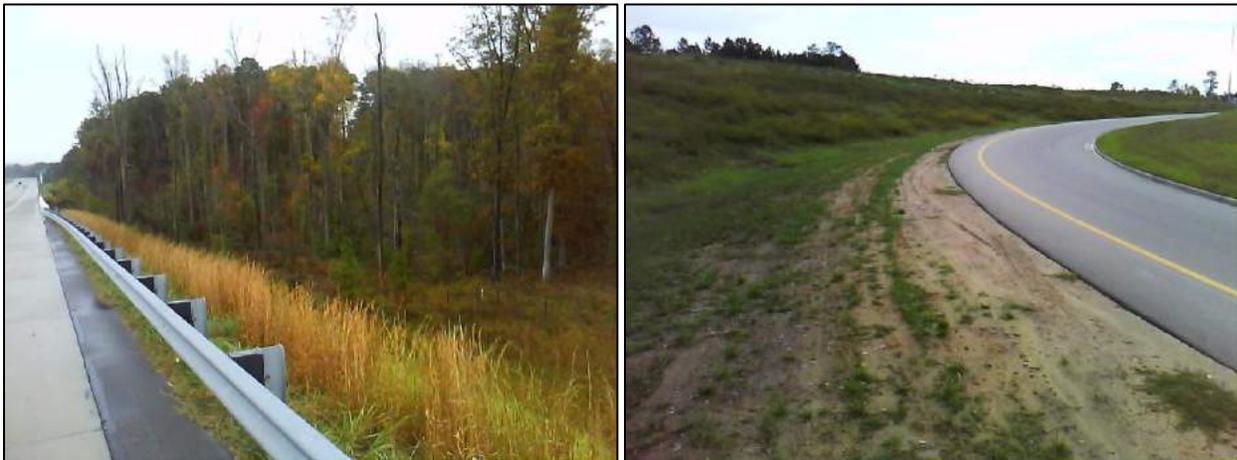
Figure 4: Turf Failures

Turf Condition (66 rating – 25 of the 74 assets failed). Out of the 74 turf areas inspected, 22 failed due to bare ground and 3 failed due to overgrown turf area. Two of the failing turf areas can be seen in the **Figure 4**.

In order to reduce overgrown turf areas throughout the facility, it is recommended that mowing cycles and mowing heights continue to be closely monitored. Special attention should be placed in turf areas behind guardrails, where the *NCTA Roadway and Facility Maintenance Standards V4* require that no vegetation grow taller than 8 inches within five feet from the back of guardrail.

As per the NCDOT Division 5 Landscape Unit Plan presented during the second quarter, the hydro-seeding process of selected bare ground areas with warm season grasses began during the third quarter. As of this report, positive results have been observed in all tested areas; grass is growing and establishing well. Based on these results, the NCDOT Division 5 Landscape Unit is planning to reseed all bare ground spots with centipede grass using a drill seeding method. This reseeding effort is expected to start during the spring of 2016. Additionally, the landscape unit is planning to fertilize the entire facility twice during the summer of 2016, in June and August. It is important to recognize that results from these efforts may not be immediate as it may take several years for the turf to be fully established.

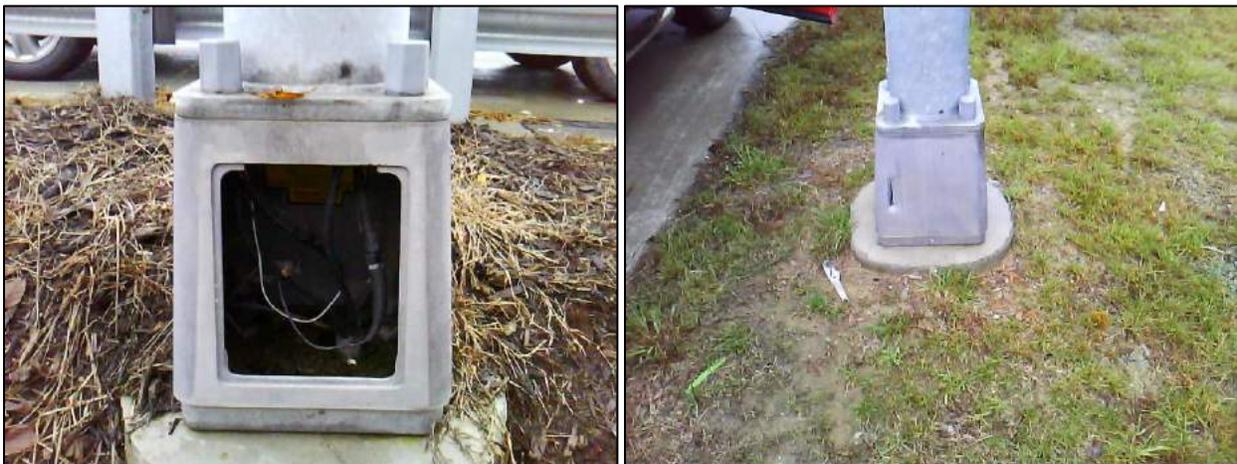
Figure 5: Highway Lighting Failures

Highway Lighting (78 rating – 6 of the 27 assets failed). Out of the 27 highway lights inspected, 3 failed for functional damage and 3 failed for missing or damaged parts. Two of the failing highway lights can be seen in the *Figure 5*.

In order to avoid future functional damage, it is recommended that all damaged or missing parts noted be repaired and/or replaced in accordance with the NCTA Maintenance Program Standards, referenced below.

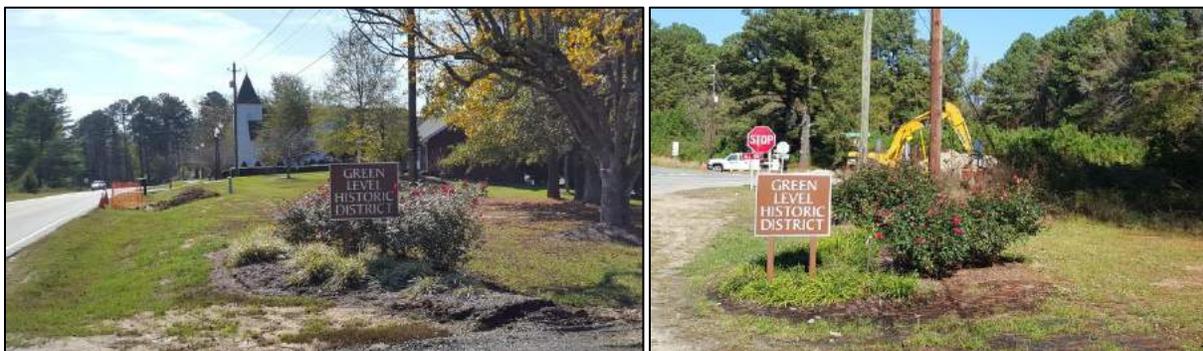
Figure 6: Green Level West Historic District Signs

As part of each quarterly inspection, assessors visit the four Green Level Historic District signs to conduct a visual inspection of each sign to ensure they are in good standing. During this quarterly inspection, all signs were found to be in good condition, with the landscaped areas being well maintained. **Figure 6** shows two of these signs.

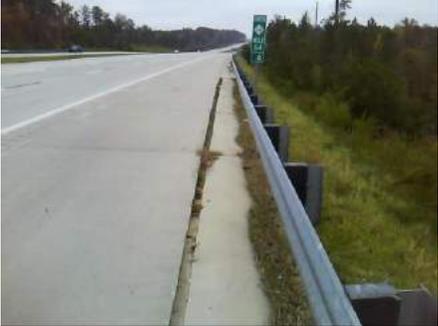
#	Material Type	Object ID	Failure Type	Photo	GIS Reference Page
1	Valley	CG_42	Misalignment, Obstruction and Material Accumulation

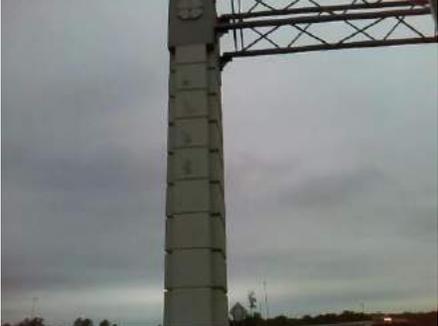
#	Material Type	Object ID	Failure Type	Photo	GIS Reference Page
1	Overhead Sign Support	DS_266	Paint Scaling

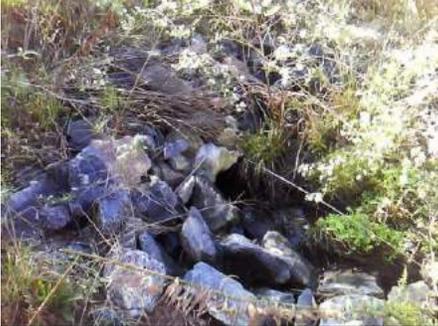
#	Material Type	Object ID	Failure Type	Photo	GIS Reference Page
1	Drain	DP_218	End Treatment Damaged

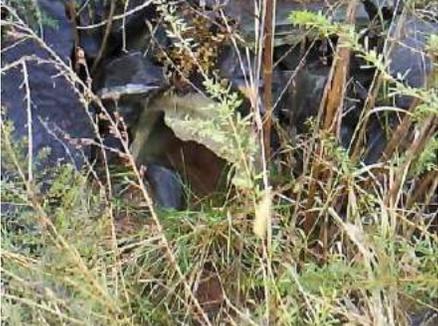
A55
2	Lateral Pipe	DP_233	End Treatment Damaged

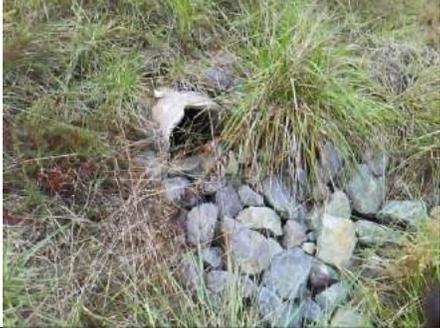
#	Material Type	Object ID	Failure Type	Photo	GIS Reference Page
5	Cross Pipe	DP_1051	End Treatment Damaged

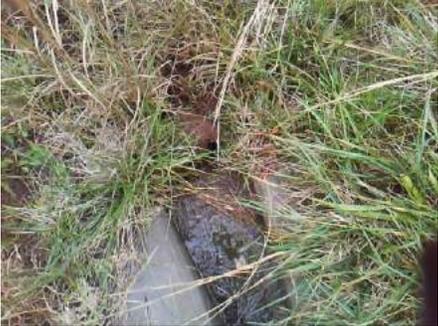
#	Material Type	Object ID	Failure Type	Photo	GIS Reference Page
1	Shoulder Drain	MDP_8	Erosion

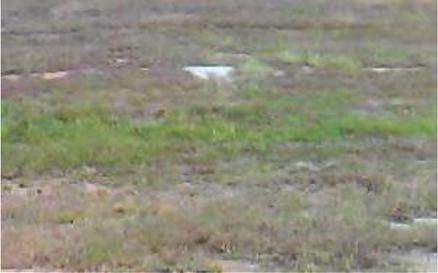
#	Material Type	Object ID	Failure Type	Photo	GIS Reference Page
5	Shoulder Drain	MDP_70	Obstruction

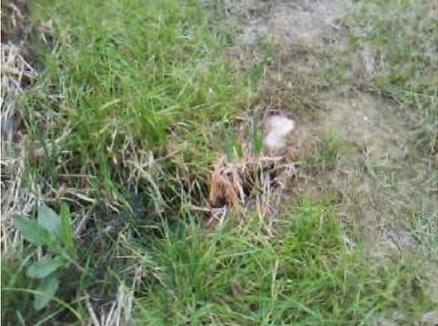
#	Material Type	Object ID	Failure Type	Photo	GIS Reference Page
10	Shoulder Drain	MDP_139	Obstruction

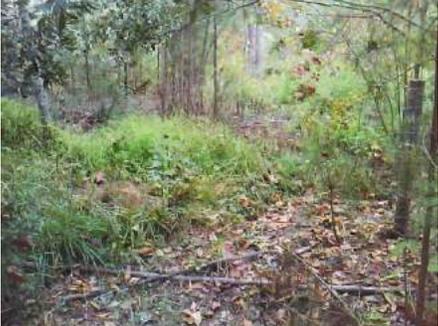
#	Material Type	Object ID	Failure Type	Photo	GIS Reference Page
1	Woven	FN_142	Fence Height

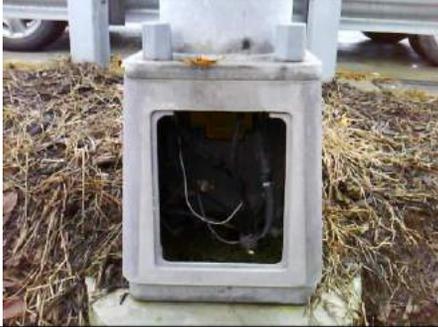
#	Material Type	Object ID	Failure Type	Photo	GIS Reference Page
1	Single Roadway	HL_145	Functional Damage	Not Available for Nighttime Failure	A4
2	Underpass Lighting	HL_205	Functional Damage	Not Available for Nighttime Failure	A57
3	Single Roadway	HL_228	Functional Damage and Part Damage

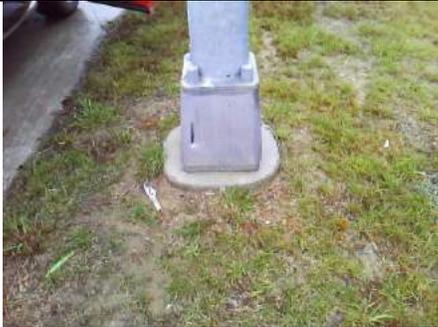
A46
4	Single Roadway	HL_246	Functional Damage	Not Available for Nighttime Failure	A38
5	Single Roadway	HL_251	Functional Damage and Part Damage

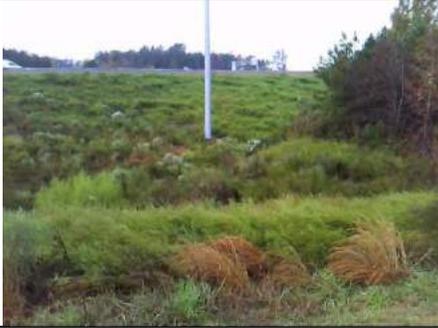
A36
6	High Mast	HL_343	Missing Part

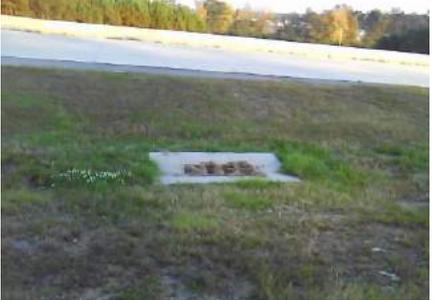
#	Material Type	Object ID	Failure Type	Photo	GIS Reference Page
1	Inlet	IN_562	Obstruction

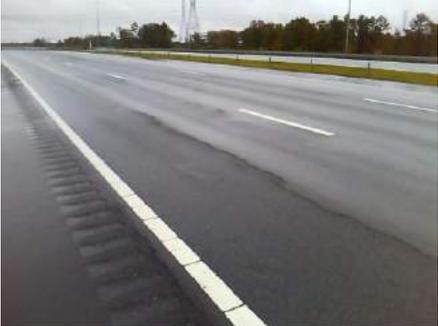
#	Material Type	Object ID	Failure Type	Photo	GIS Reference Page
1	Asphalt	LS_280	Pavement Crack

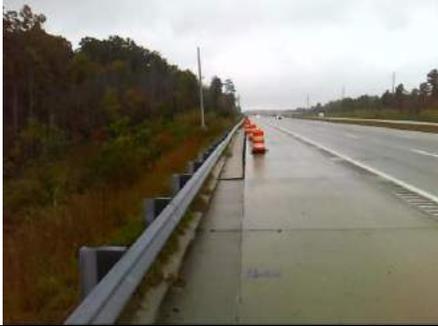
#	Material Type	Object ID	Failure Type	Photo	GIS Reference Page
1	Concrete	LS_50	Paved Shoulder Joint

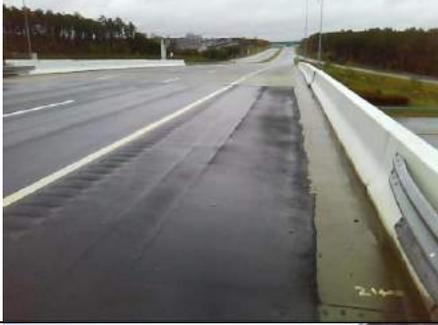
A16, A17
2	Asphalt	LS_280	Paved Shoulder Crack

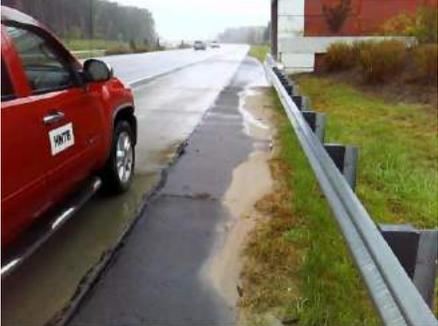
#	Material Type	Object ID	Failure Type	Photo	GIS Reference Page
1	Concrete	LS_117	Shoulder Build Up

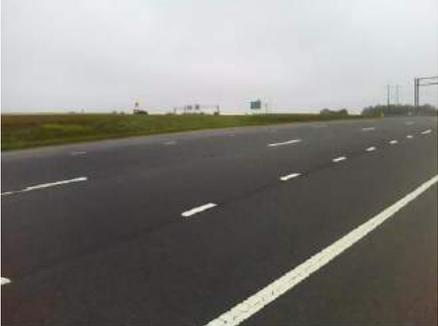
#	Material Type	Object ID	Failure Type	Photo	GIS Reference Page
1	Asphalt	LS_297	Missing Markers

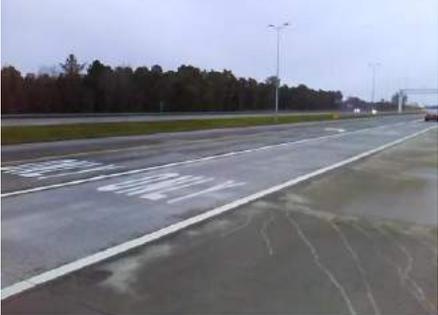
A2
2	Concrete	LS_492	Missing Markers and Continuous Markers

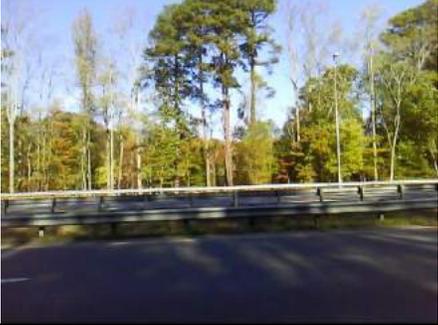
A46
3	Asphalt	LS_547	Marker Reflectivity, Missing Markers and Continuous Markers

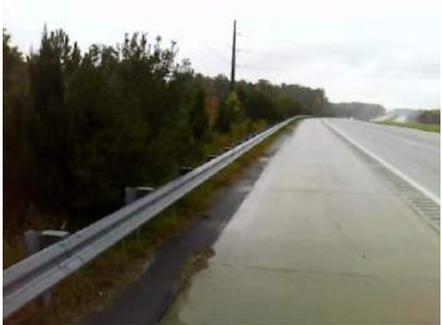
#	Material Type	Object ID	Failure Type	Photo	GIS Reference Page
1	Concrete	LS_47	Nighttime Reflectivity and Missing Parts

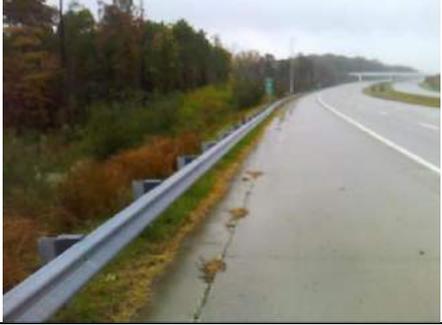
A15, A16
2	Concrete	LS_108	Missing Parts

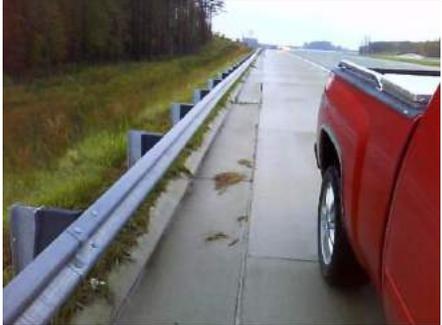
A14, A15
3	Asphalt	LS_194	Nighttime Reflectivity	Not Available for Nighttime Failure	A53, A54
4	Asphalt	LS_257	Nighttime Reflectivity	Not Available for Nighttime Failure	A49, A50
5	Concrete	LS_484	Missing Parts

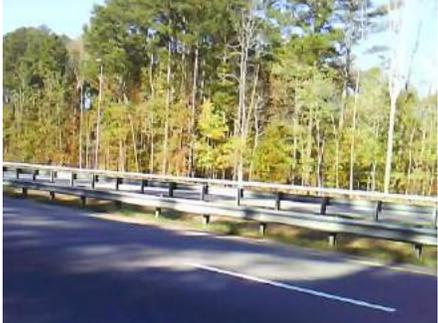
#	Material Type	Object ID	Failure Type	Photo	GIS Reference Page
6	Asphalt	LS_547	Missing Parts

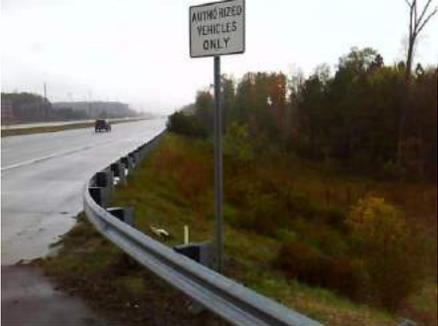
#	Sign Type	Object ID	Failure Type	Photo	GIS Reference Page
1	Authorized Vehicles	SN_61	Height Requirement

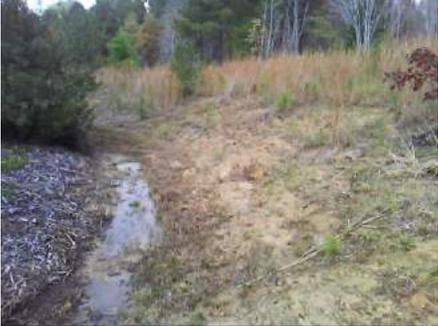
#	Material Type	Object ID	Failure Type	Photo	GIS Reference Page
1	Turf	TF_53	Bareground

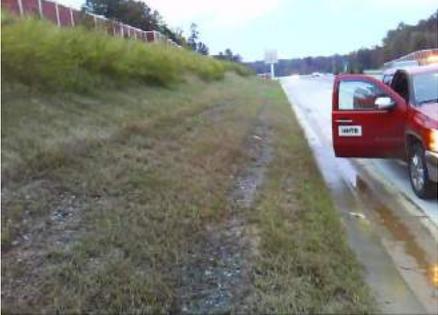
A47, A48
4	Turf	TF_111	Bareground

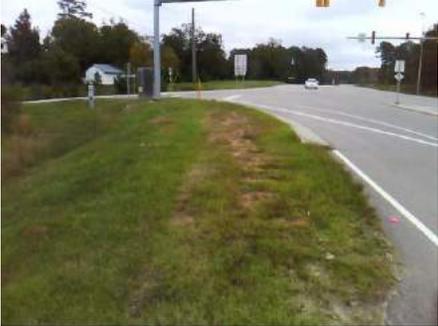
#	Material Type	Object ID	Failure Type	Photo	GIS Reference Page
5	Turf	TF_180	Bareground

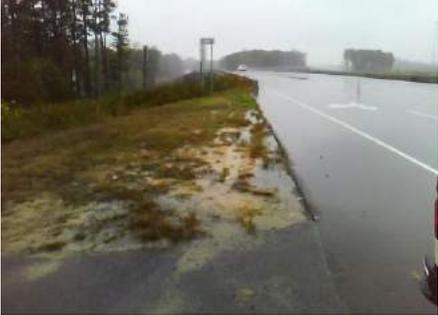
A29, A31
8	Turf	TF_227	Bareground

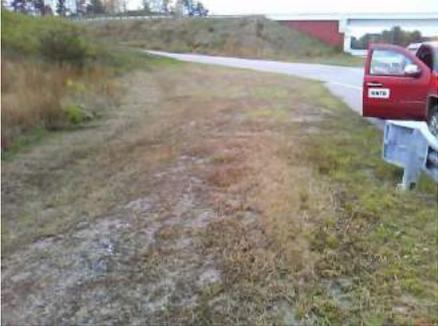
#	Material Type	Object ID	Failure Type	Photo	GIS Reference Page
9	Turf	TF_233	Bareground

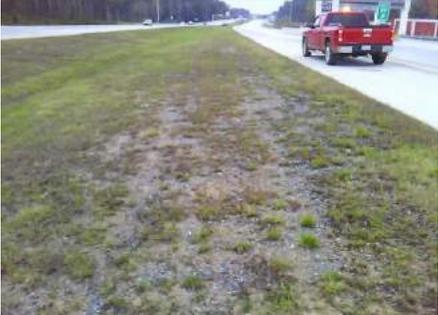
A37, A38
12	Turf	TF_435	Bareground

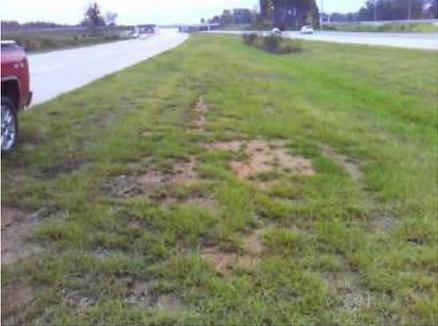
#	Material Type	Object ID	Failure Type	Photo	GIS Reference Page
13	Turf	TF_437	Bareground

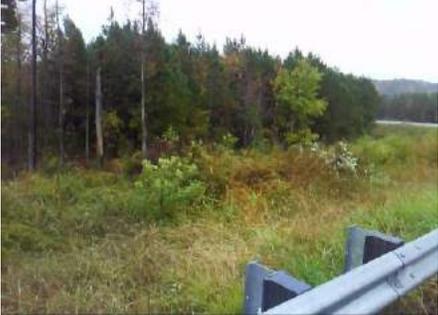
A32, A33
16	Turf	TF_509	Height

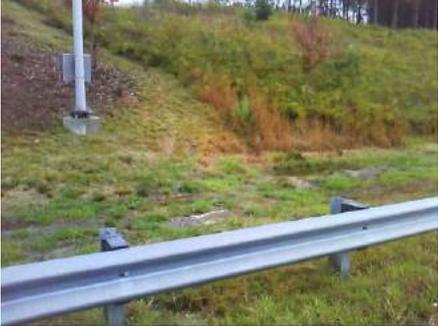
#	Material Type	Object ID	Failure Type	Photo	GIS Reference Page
17	Turf	TF_553	Bareground

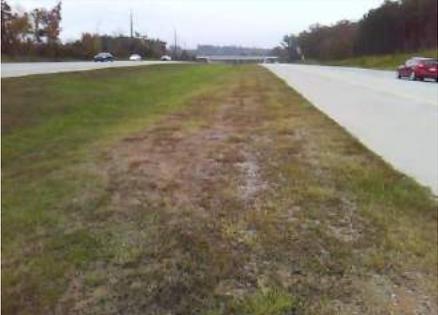
A18
20	Turf	TF_654	Bareground

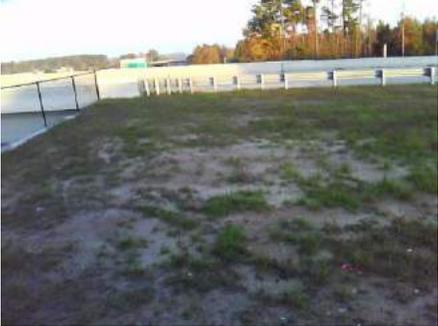
#	Material Type	Object ID	Failure Type	Photo	GIS Reference Page
21	Turf	TF_670	Bareground

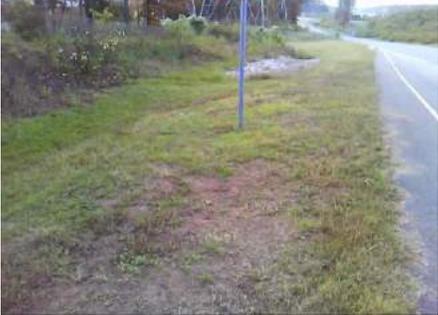
A54, A55
24	Turf	TF_908	Bareground

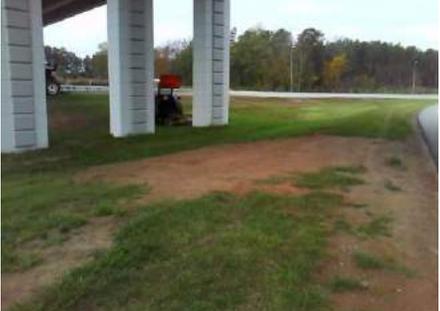
#	Material Type	Object ID	Failure Type	Photo	GIS Reference Page
25	Turf	TF_985	Bareground

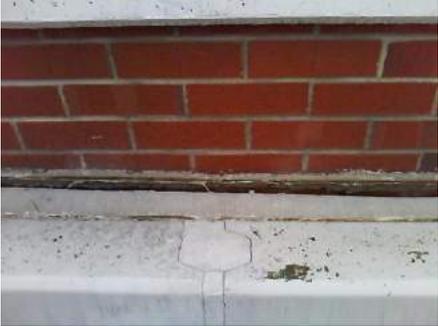
#	Material Type	Object ID	Failure Type	Photo	GIS Reference Page
1	Sound Wall	WL_7	Joint Separation
