NORTH CAROLINA
Turnpike Authority

Maintenance Rating Program

Triangle Expressway

2014 Third Quarter Report

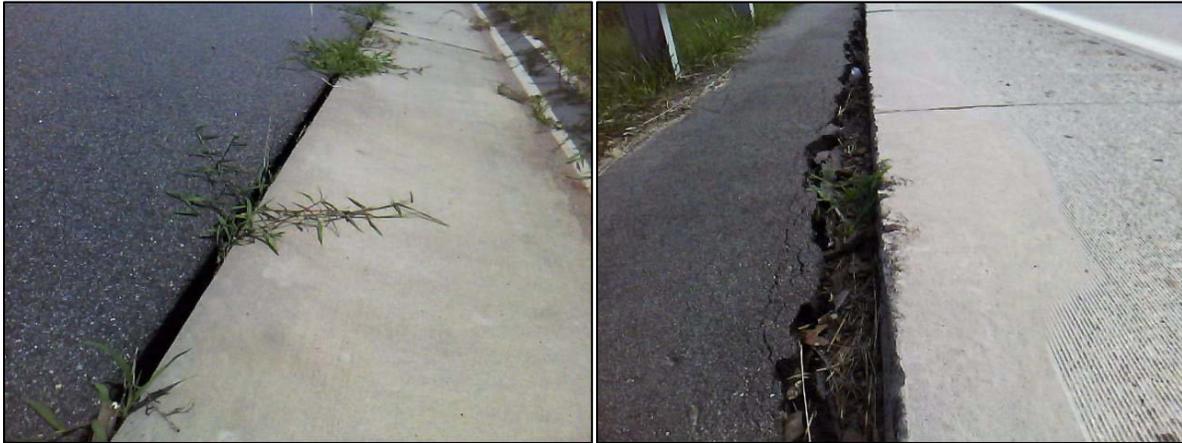
Figure 3: Paved Shoulder Failures

Paved Shoulder (77 rating – 7 of the 31 assets failed). All 7 assets failed due to joint separation. Most of these failures occurred between the shoulder/curb gutter joints. The picture on the right shows a paved shoulder joint failing due to joint separation between asphalt and concrete; this is located along 540 just south of the NC 55 southbound on ramp.

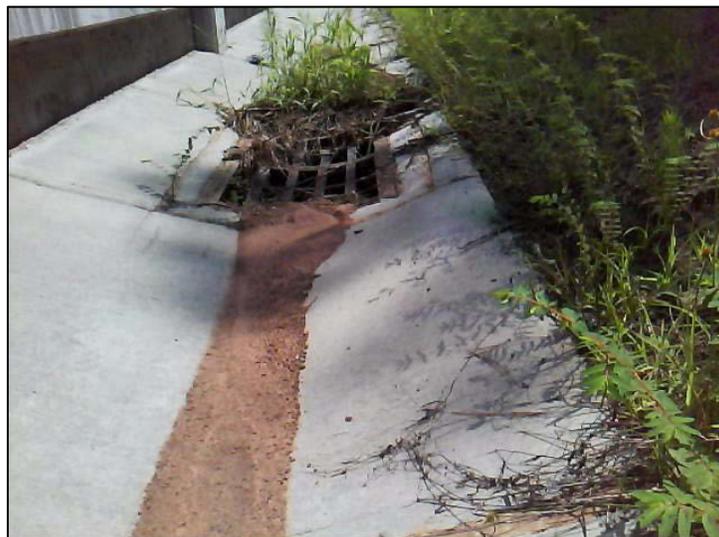
Figure 4: Paved Ditch Failure

Paved Ditches (50 rating – 1 of the 2 assets failed). This failure occurred at the paved ditch behind the jersey barrier/wall along NC-147 southbound (towards I-540).

There are only two paved ditches on the Expressway and each are inspected during every quarter. During this inspection, only one of them failed for material accumulation. This can be seen in **Figure 4** below. There has been very heavy rain this summer and it is recommended that the maintenance provider complete a thorough sweep of the paved ditches on the project regularly to remove any debris that may have been washed down.

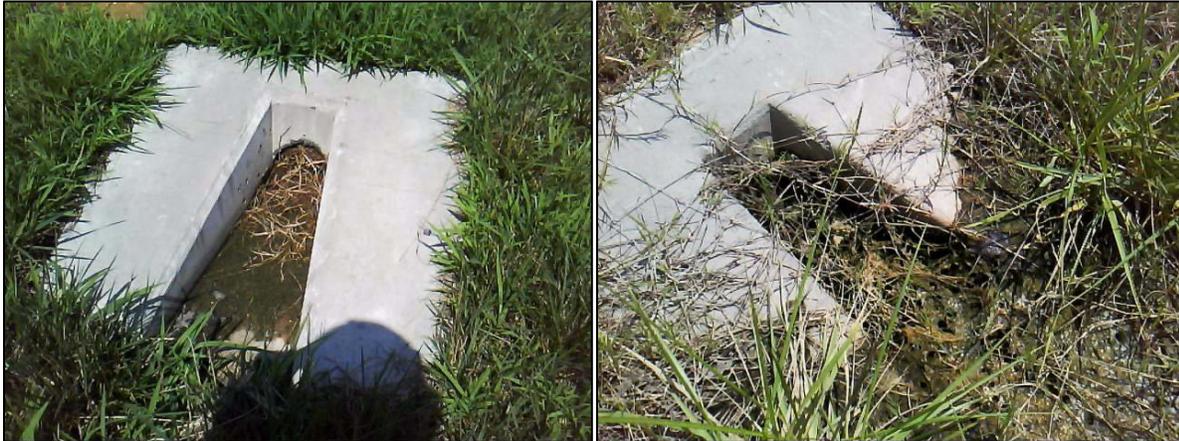
Figure 5: Miscellaneous Drainage Failures

Miscellaneous Drainage (72 rating – 7 of the 25 assets failed). All 7 miscellaneous drainages failed because of obstruction. It is recommended that the maintenance provider plan to routinely clean out these drainage features to remove any debris that may have been washed into the structure or grown up around it.

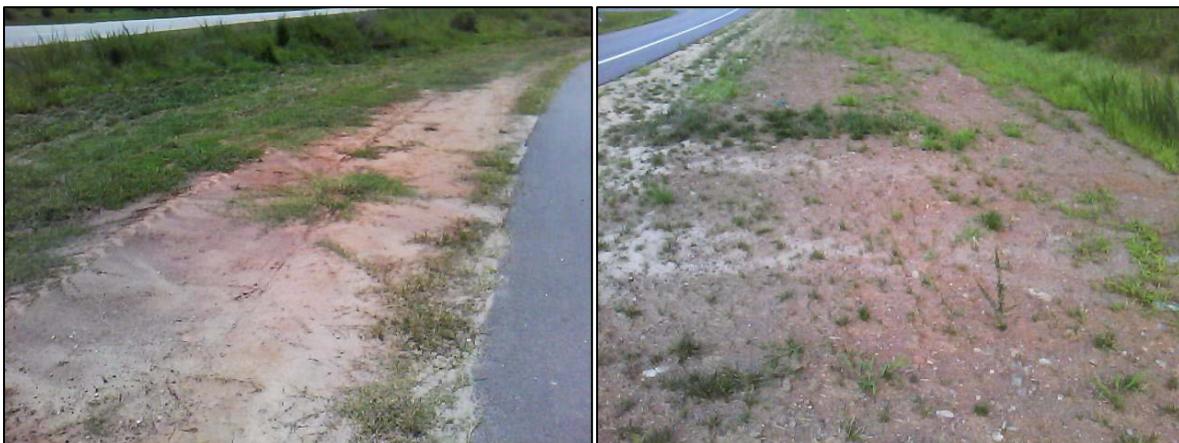
Figure 6: Turf Failures

Turf Condition (61 rating – 24 of the 61 assets failed). All 24 turf areas failed because of bare ground. Some of these can be seen in **Figure 6** below. Many of the bare ground areas previously had active Bermuda and Centipede runners growing that are now dead. It is suspected this was caused by low cutting heights last summer during extreme heat months. With such a noticeable drop over the last few assessments in the turf condition it is recommended that the maintenance provider schedule overseeding of these areas with warm season grasses and possibly add soil enrichment to increase the chances of survival. It is further suggested that mowing heights continue to be closely monitored especially during the months of extreme heat conditions.

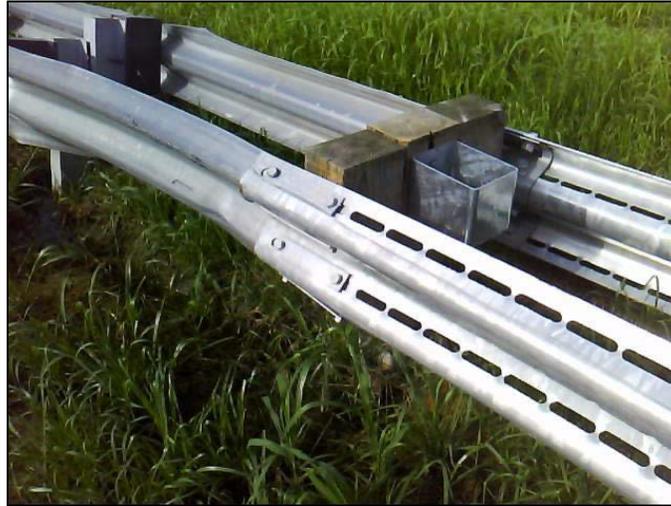
Figure 7: Impact Attenuators Failures

Impact Attenuators (78 rating – 2 of the 9 assets failed). One of the 2 assets failed because of functional damage; the guardrail connected to the impact attenuator had been hit which will affect the functionality of the attenuator. The other impact attenuator failed because the reflective tape along the bulb was not visible during the night time inspection.

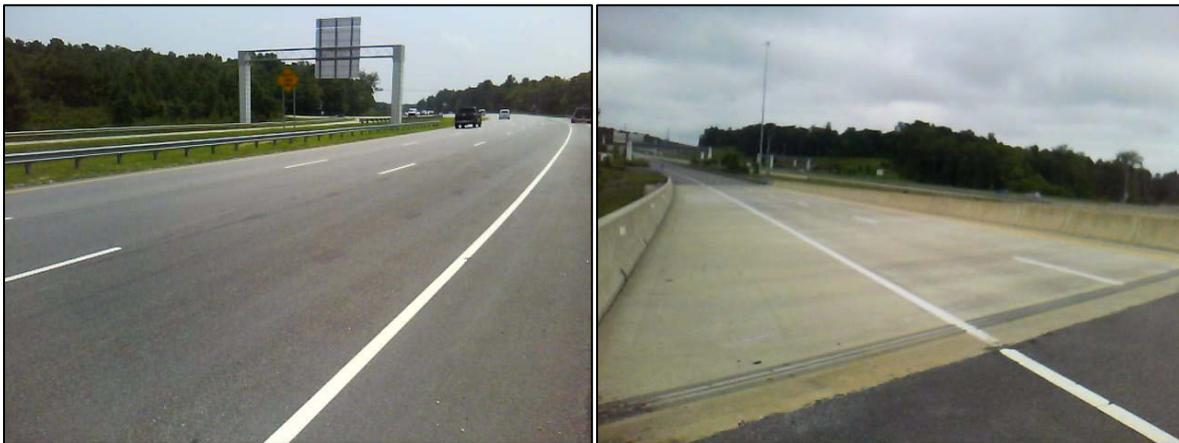
Figure 8: Pavement Markers Failures

Pavement Markers (45 rating – 17 of the 31 assets failed). Out of the 17 linear segments that failed due to pavement markers, 16 did not pass the night time inspection due to lack of markers' reflectivity and 7 of the 17 failed because of missing markers.

The Triangle Expressway saw several rounds of frozen precipitation this past winter where plows removed the non-snowplowable markers from bridge decks. It is recommended that the maintenance provider consider replacing bridge deck markers as soon as practical at the end of each winter season, and prior to the upcoming season at a minimum. With attentive effort toward specific minor deficiencies the overall MRP score can be maintained cost effectively above the 90 percentile threshold.

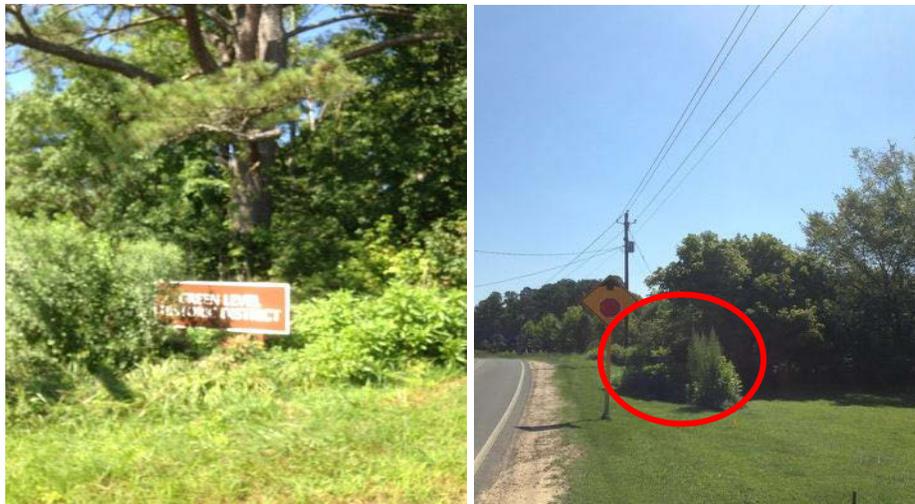
Figure 9: Green Level West Historic District Signs

These signs were visually inspected as part of this quarterly inspection and were found to all be in good condition. However, the landscaped areas surrounding the signs continue to contain numerous weeds and have started to look unsightly and overgrown. In several instances, part or all of the sign's visibility has become blocked by vegetation, which can be seen in *Figure 9*.

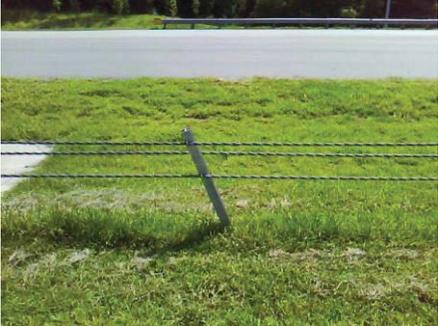
#	Material Type	Object ID	Failure Type	Photo	GIS Reference Page
1	Guardrail	BR_299	Functional Damage

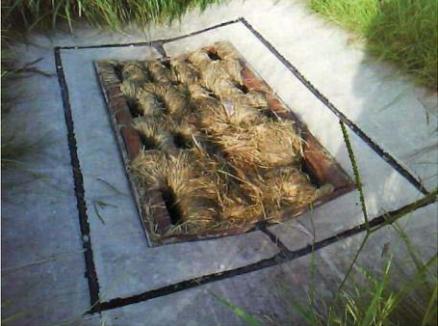
#	Material Type	Object ID	Failure Type	Photo	GIS Reference Page
1	Cross Pipe	DP_345	Obstruction

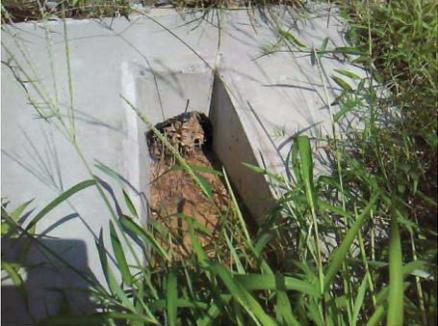
#	Material Type	Object ID	Failure Type	Photo	GIS Reference Page
1	Shoulder Drain	MDP_11	Obstruction

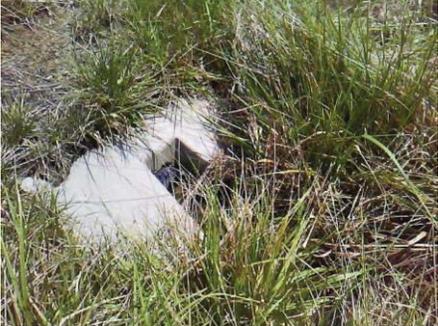
#	Material Type	Object ID	Failure Type	Photo	GIS Reference Page
5	Shoulder Drain	MDP_139	Obstruction

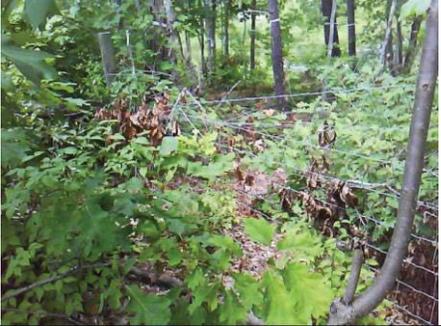
#	Material Type	Object ID	Failure Type	Photo	GIS Reference Page
1	Woven	FN_168	Vegetation Compressing Fence

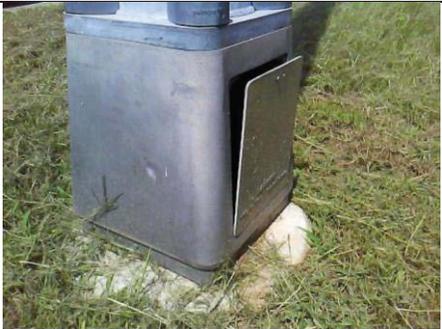
#	Material Type	Object ID	Failure Type	Photo	GIS Reference Page
1	High Mast	HL_71	Nighttime Failure	Not Available for Nighttime Failure.	A10
2	Single Roadway	HL_142	Part Damage

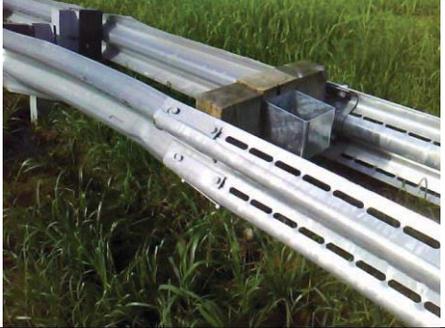
#	Material Type	Object ID	Failure Type	Photo	GIS Reference Page
1	Gating Attenuator	IA_6	Functional Damage

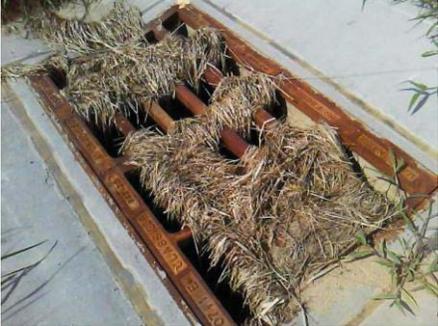
#	Material Type	Object ID	Failure Type	Photo	GIS Reference Page
1	Inlet	IN_111	Obstruction

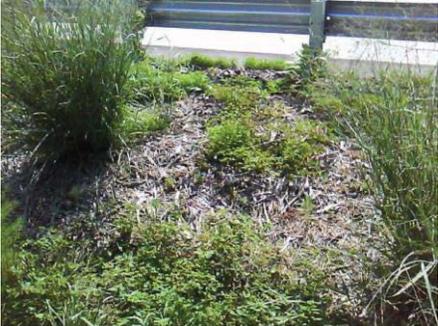
#	Material Type	Object ID	Failure Type	Photo	GIS Reference Page
1	Plant Bed	PB_25	Covered by Weed

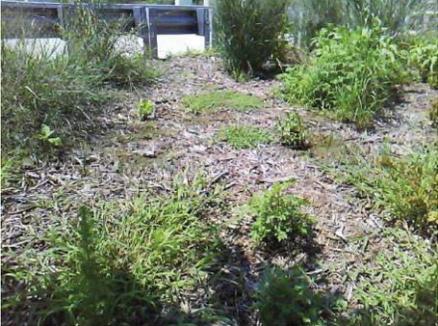
#	Material Type	Object ID	Failure Type	Photo	GIS Reference Page
5	Plant Bed	PB_159	Unhealthy and Covered by Weed

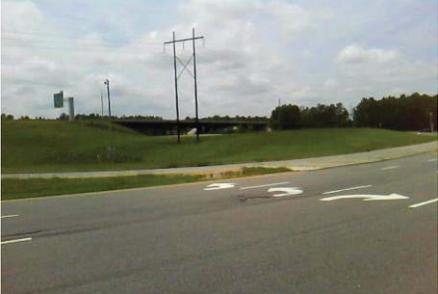
#	Material Type	Object ID	Failure Type	Photo	GIS Reference Page
1	Asphalt	LS_299	Pothole

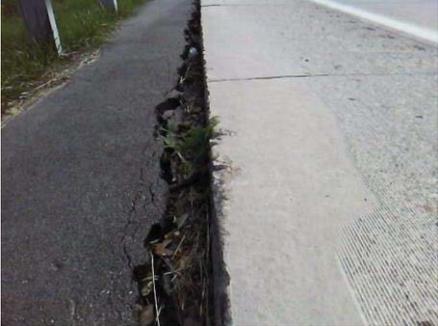
#	Material Type	Object ID	Failure Type	Photo	GIS Reference Page
1	Concrete	LS_100	Paved Shoulder Joint

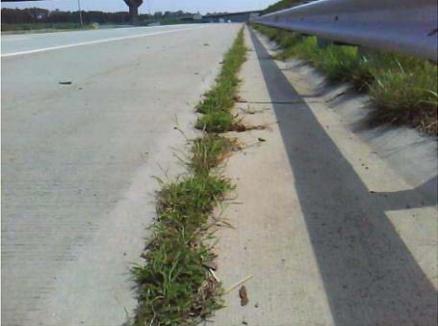
#	Material Type	Object ID	Failure Type	Photo	GIS Reference Page
5	Concrete	LS_348	Paved Shoulder Joint

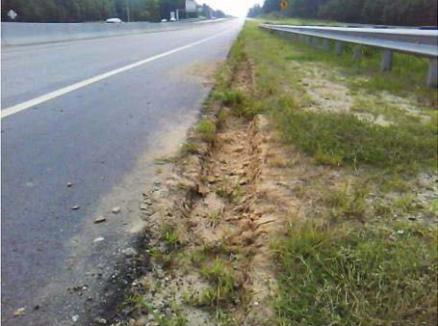
#	Material Type	Object ID	Failure Type	Photo	GIS Reference Page
1	Unpaved Shoulder	LS_372	Elevation Deviation

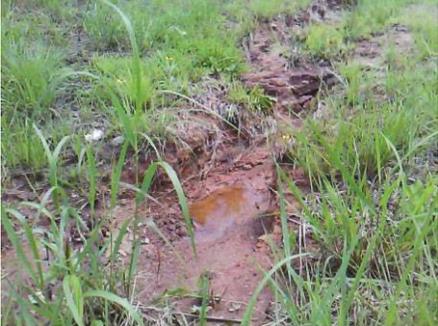
#	Material Type	Object ID	Failure Type	Photo	GIS Reference Page
1	Slope	LS_228	Slope Failure

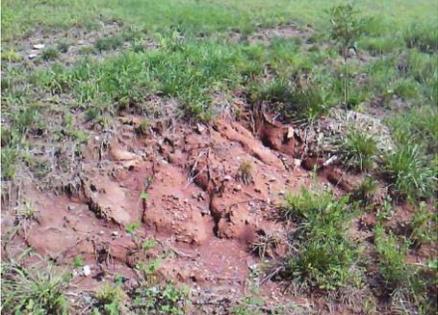
A51
2	Slope	LS_273	Slope Failure

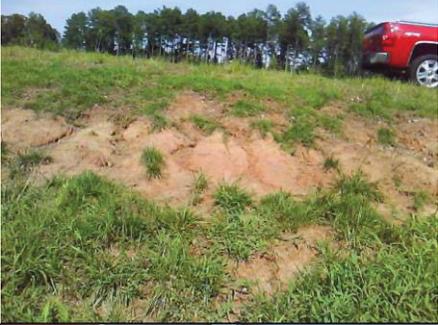
A51, A52
3	Slope	LS_282	Slope Failure

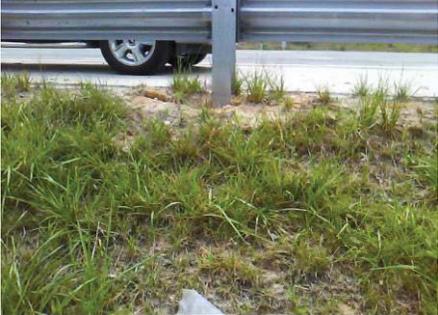
A53
4	Slope	LS_493	Slope Failure

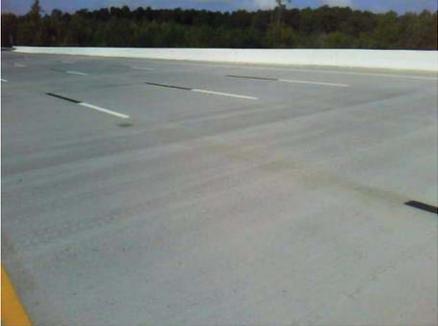
#	Material Type	Object ID	Failure Type	Photo	GIS Reference Page
1	Concrete	LS_100	Reflective Markers and Missing Markers

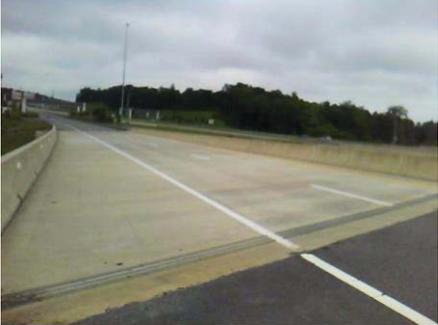
A11, A12
2	Asphalt	LS_187	Reflective Markers	Not Available for Nighttime Failure.	A52, A53
3	Asphalt	LS_197	Reflective Markers and Missing Markers

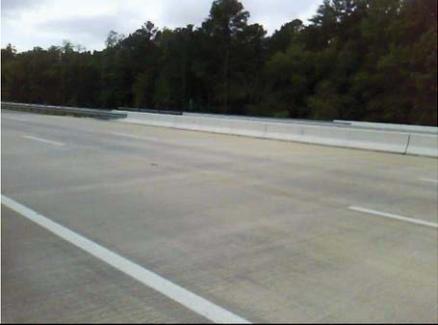
A6
4	Asphalt	LS_224	Reflective Markers	Not Available for Nighttime Failure.	A52
5	Asphalt	LS_228	Reflective Markers	Not Available for Nighttime Failure.	A51
6	Asphalt	LS_235	Reflective Markers	Not Available for Nighttime Failure.	A49, A50
7	Asphalt	LS_237	Reflective Markers and Missing Markers

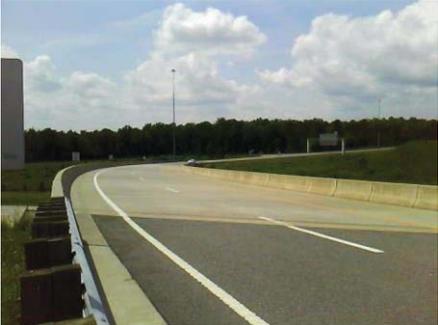
A48, A49
8	Asphalt	LS_238	Reflective Markers	Not Available for Nighttime Failure.	A48
9	Asphalt	LS_273	Reflective Markers	Not Available for Nighttime Failure.	A51, A52
10	Asphalt	LS_289	Reflective Markers and Missing Markers

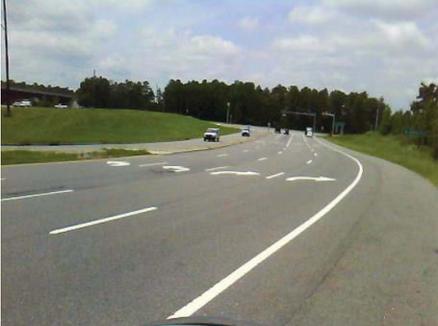
#	Material Type	Object ID	Failure Type	Photo	GIS Reference Page
11	Asphalt	LS_299	Reflective Markers, Missing Markers and Continuous Marker

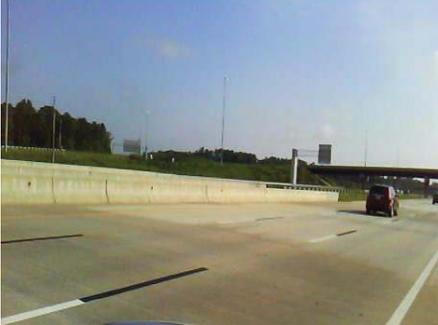
A2
12	Concrete	LS_319	Reflective Markers	Not Available for Nighttime Failure.	A5
13	Concrete	LS_348	Missing Markers

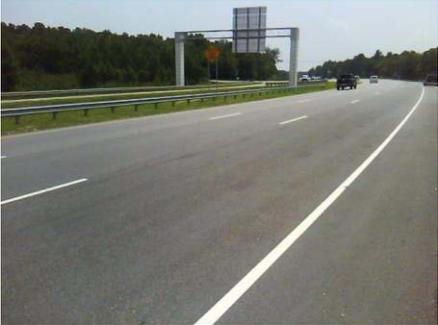
A6
14	Concrete	LS_476	Reflective Markers	Not Available for Nighttime Failure.	A43
15	Concrete	LS_493	Reflective Markers	Not Available for Nighttime Failure.	A45
16	Asphalt	LS_553	Reflective Markers	Not Available for Nighttime Failure.	A41
17	Asphalt	LS_600	Reflective Markers, Missing Markers and Continuous Marker

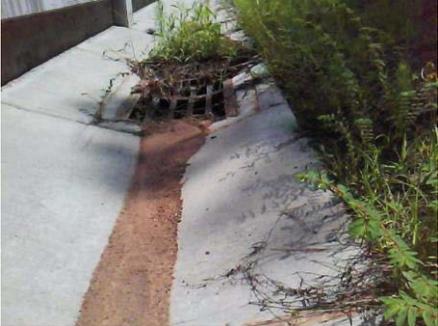
#	Material Type	Object ID	Failure Type	Photo	GIS Reference Page
1	Paved Ditch	PD_11	Material Accumulation

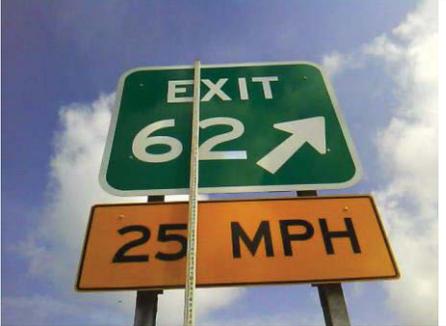
#	Material Type	Object ID	Failure Type	Photo	GIS Reference Page
1	Exit	SN_23	Height Requirement

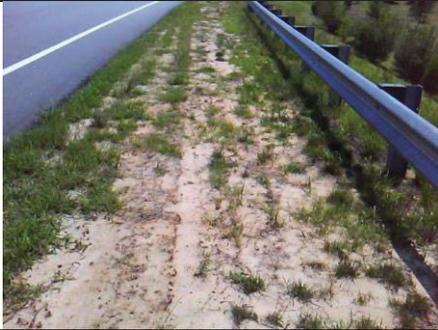
#	Material Type	Object ID	Failure Type	Photo	GIS Reference Page
1	Turf	TF_86	Bareground

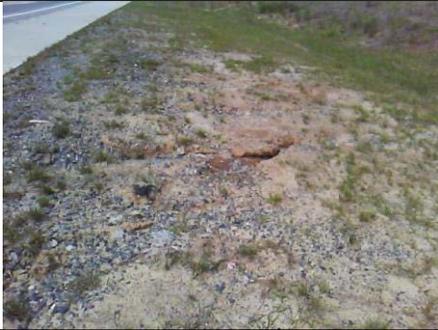
#	Material Type	Object ID	Failure Type	Photo	GIS Reference Page
5	Turf	TF_170	Bareground

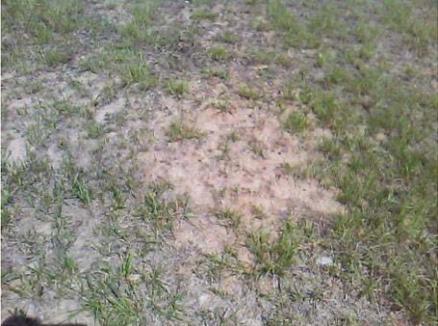
#	Material Type	Object ID	Failure Type	Photo	GIS Reference Page
9	Turf	TF_229	Bareground

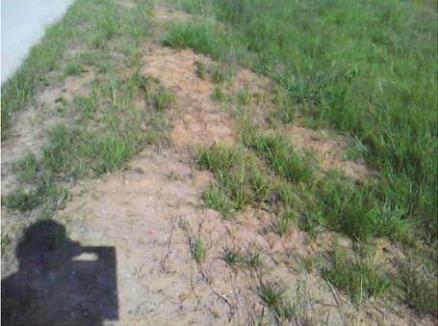
#	Material Type	Object ID	Failure Type	Photo	GIS Reference Page
13	Turf	TF_326	Bareground

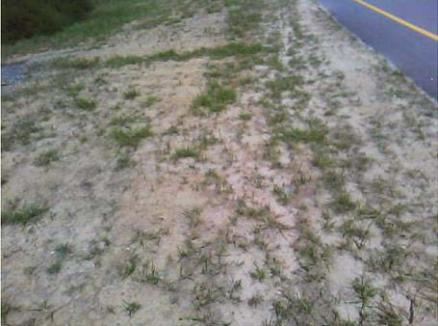
#	Material Type	Object ID	Failure Type	Photo	GIS Reference Page
17	Turf	TF_427	Bareground

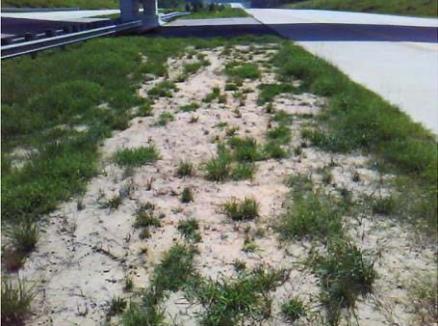
#	Material Type	Object ID	Failure Type	Photo	GIS Reference Page
21	Turf	TF_556	Bareground

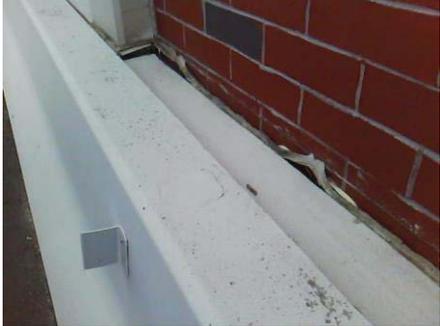
#	Material Type	Object ID	Failure Type	Photo	GIS Reference Page
1	Bridge Wall	WL_49	Cracked joint
