# Maintenance Rating Program

Triangle Expressway

2023 Fourth Quarter Report

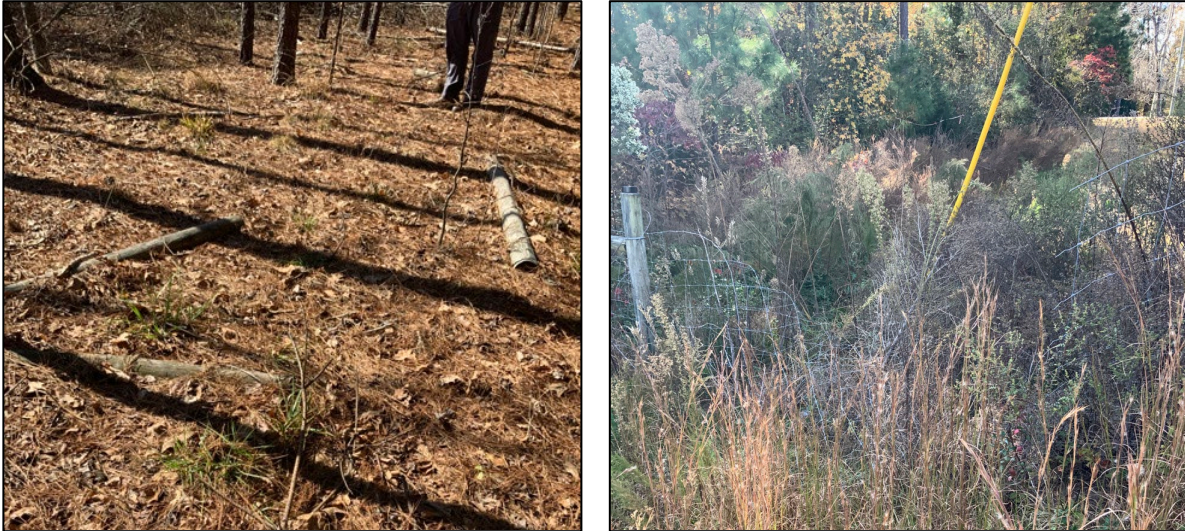
Figure 3: Fences and Control Access Inspection Results Sample

Fence and Control Access (71 rating – 23 of the 29 assets passed): Four of the six sections that did not pass had failed for openings greater than 2 square feet. Two of the sections that did not pass inspection are presented in *Figure 3*.

- 1) Fence shall be inspected every 4 months.
- 2) Areas where fence is adjacent to livestock or known pedestrian traffic must be secured until fence is fully restored.
- 3) Schedule and repair or replace damaged sections within the annual work program.

Fence repair is scheduled through February and March of 2024.

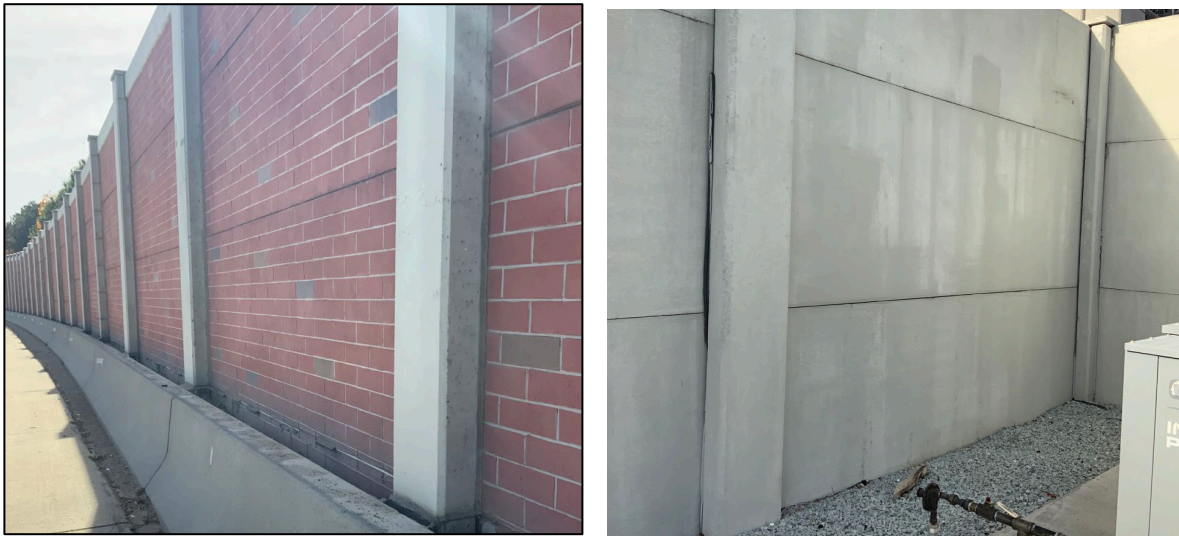
Figure 4: Retaining Walls and Sound Barrier Walls Inspection Results Sample

Retaining Walls and Sound Barrier Walls (72 rating – 13 of the 18 assets passed): All five of the wall sections that did not pass inspection had unsealed cracks/joints. Two of the sections that did not pass inspection are presented in *Figure 3*.

Most failures characterized as 'unsealed joints' are a result of the failed cap that bridges the space between the concrete barrier and the noise wall. Recommend the maintenance provider investigate the purpose for the 'cap' and consider eliminating and backfilling the space with an alternative material filler.

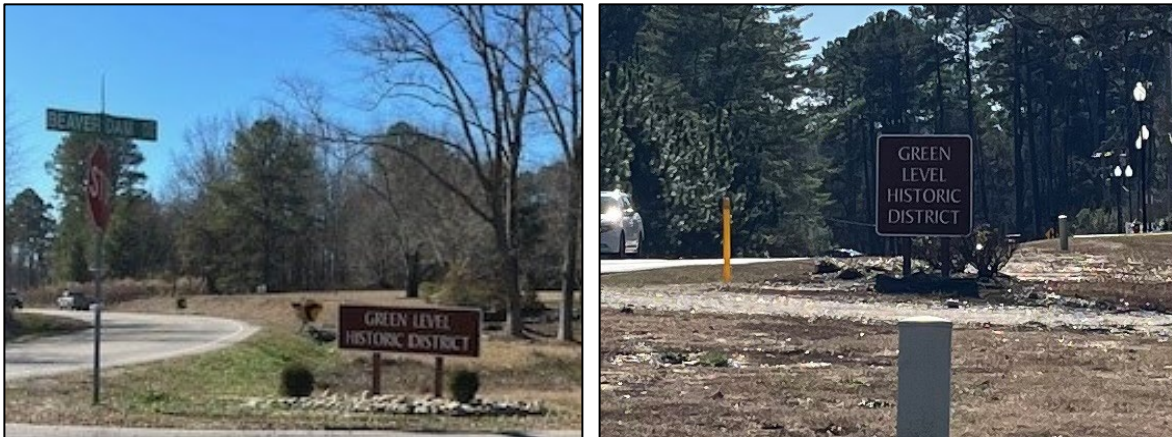
Figure 4: Green Level West Historic District Signs, Landscape Areas

As part of each quarterly inspection, an assessment team visits the two remaining Green Level Historic District signs to conduct a visual inspection of each sign and ensure they are in good standing. The two signs included in the inspection inventory were found to be in good condition. *Figure 4* shows the two signs assessed.

This quarter, the two Green Level Historic District signs inspected were found to be in good condition. Additionally, the landscaped areas surrounding the signs were found to be well maintained.

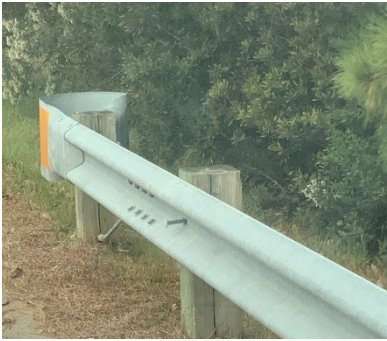
A26
2	Guardrail	BR_116	Missing Part

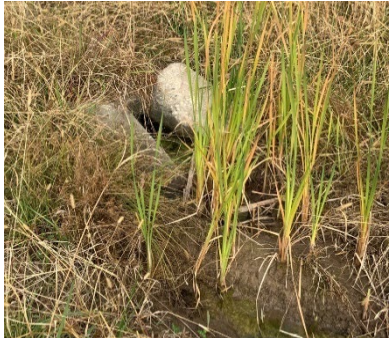
#	Material Type	Object ID	Failure Type	Photo	GIS Reference Page
1	Shoulder Drain	MDP_55	Obstruction

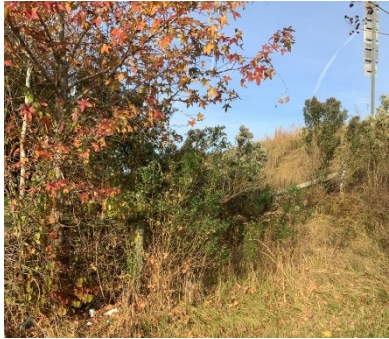
#	Material Type	Object ID	Failure Type	Photo	GIS Reference Page
1	Woven	FN_28	Hole

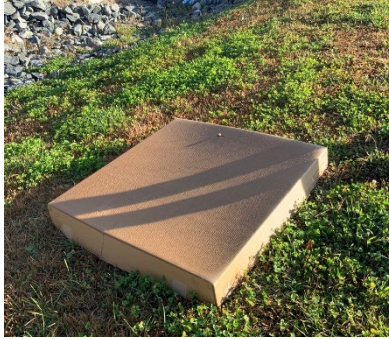
#	Material Type	Object ID	Failure Type	Photo	GIS Reference Page
1	Asphalt	LS_756	Litter

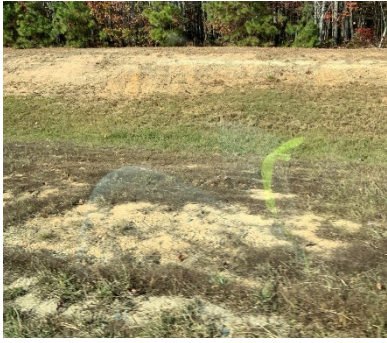
#	Material Type	Object ID	Failure Type	Photo	GIS Reference Page
1	Turf	TF_375	Bare Ground

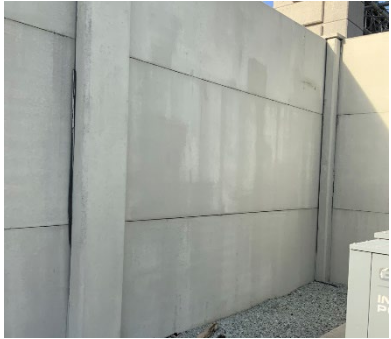
#	Material Type	Object ID	Failure Type	Photo	GIS Reference Page
5	Sound Wall	WL_121	Unsealed Cracks/Joints
