RE: Mid-Currituck Bridge Task Order No. 20

Purpose: Summary information from February 2015 field inspections of Section 404 jurisdictional boundaries relative to potential changes since USACE approval (2009).

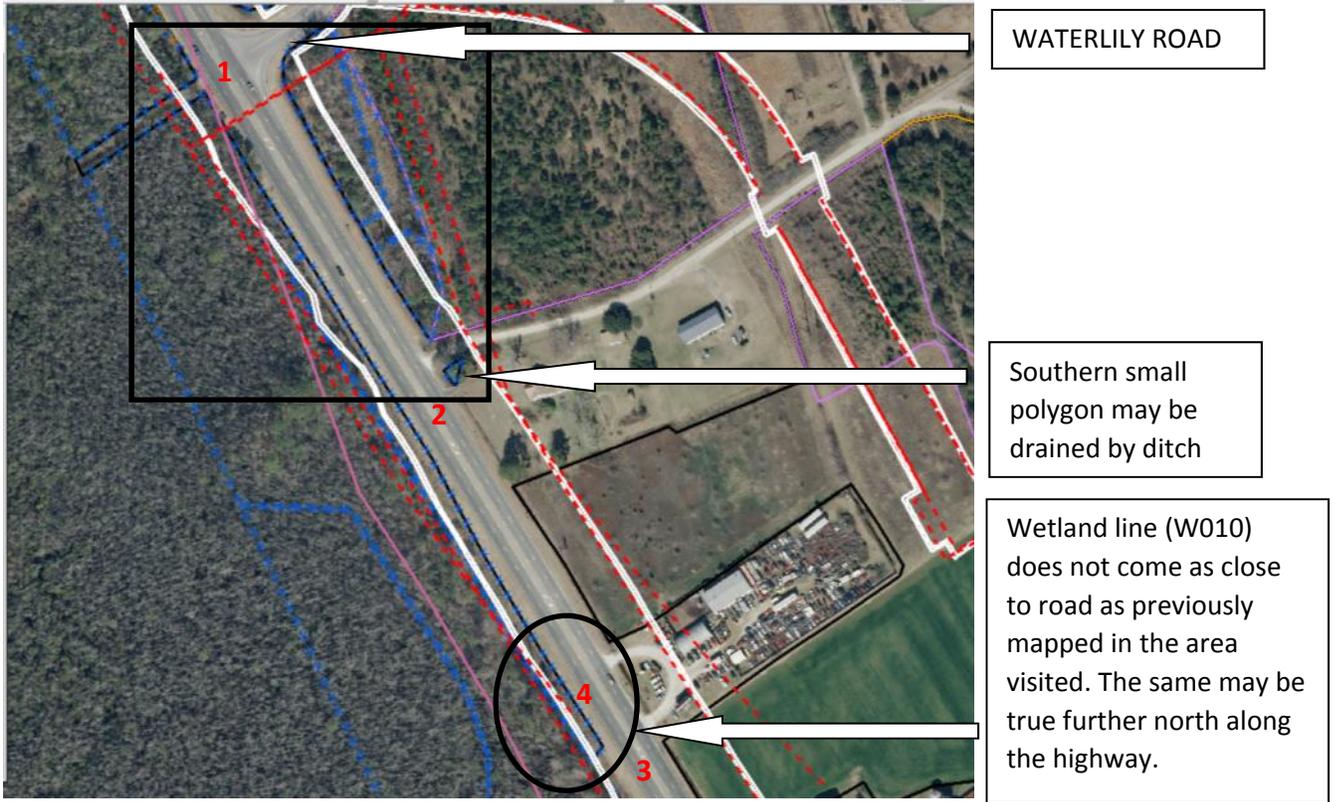
Site 1. US 158 in the vicinity of Waterlily Road.

Southern small polygon may be drained by ditch

Wetland line (W010) does not come as close to road as previously mapped in the area visited. The same may be true further north along the highway.

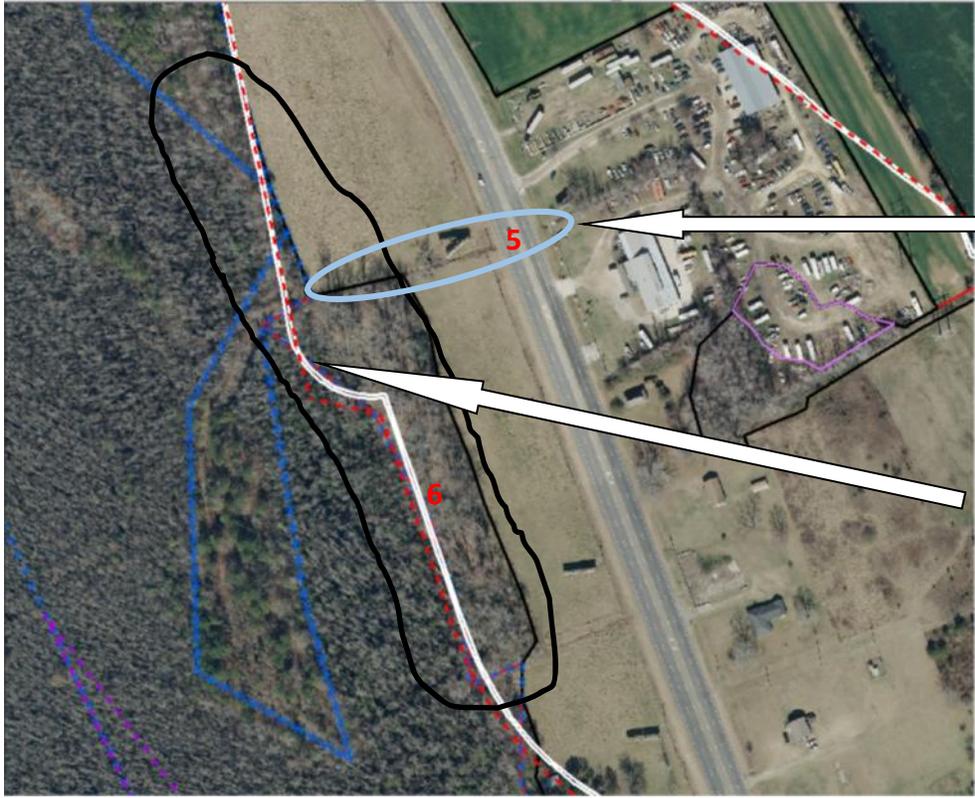
Site 2. US 158 north of Aydlett Road.

A culvert directs water from east side of road to west side through a ditch that leads into the wetland. Some vegetation in the feature, some bare areas, some sediment sorting, flow at time of visit. May/may not be called Waters of US.

There are some sections where the wetland line (W010) needs to be adjusted both ways (too much wetland and not enough wetland).

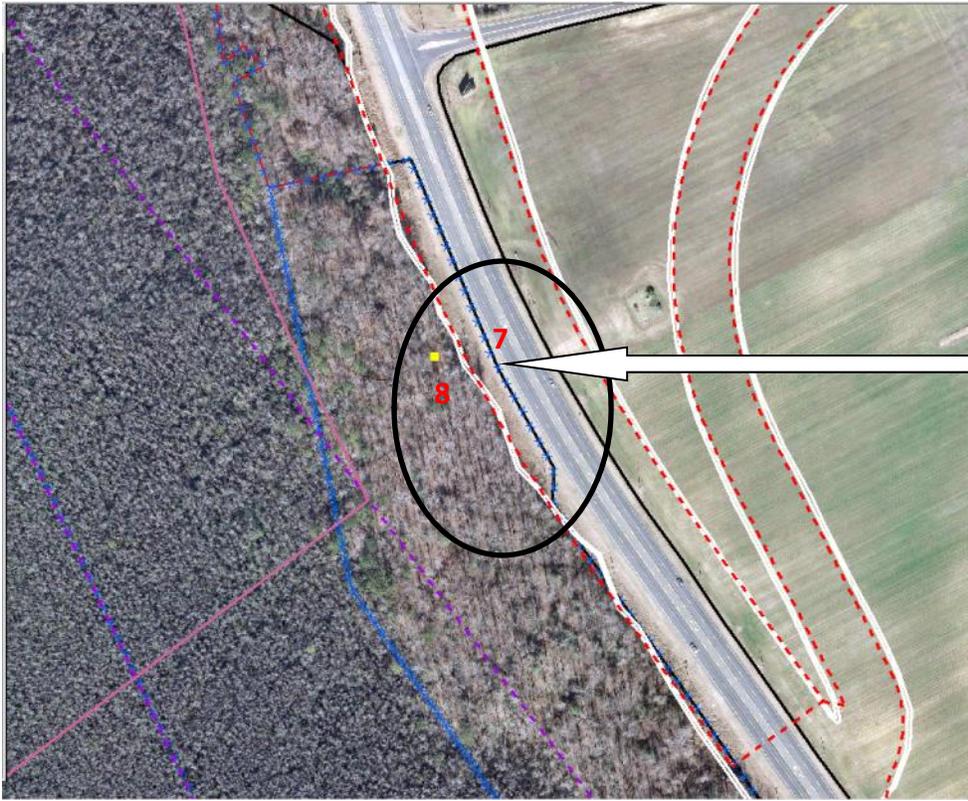
Site 3. US 158 south of Aydlett Road.

Much, or possibly all, of this mapped wetland polygon (portion of W010) within the ROW and SS+25 impact zones should be upland. The yellow square represents the wetland/upland boundary verified/confirmed 3 February 2015 (approx. 97 feet west of mapped wetland line).

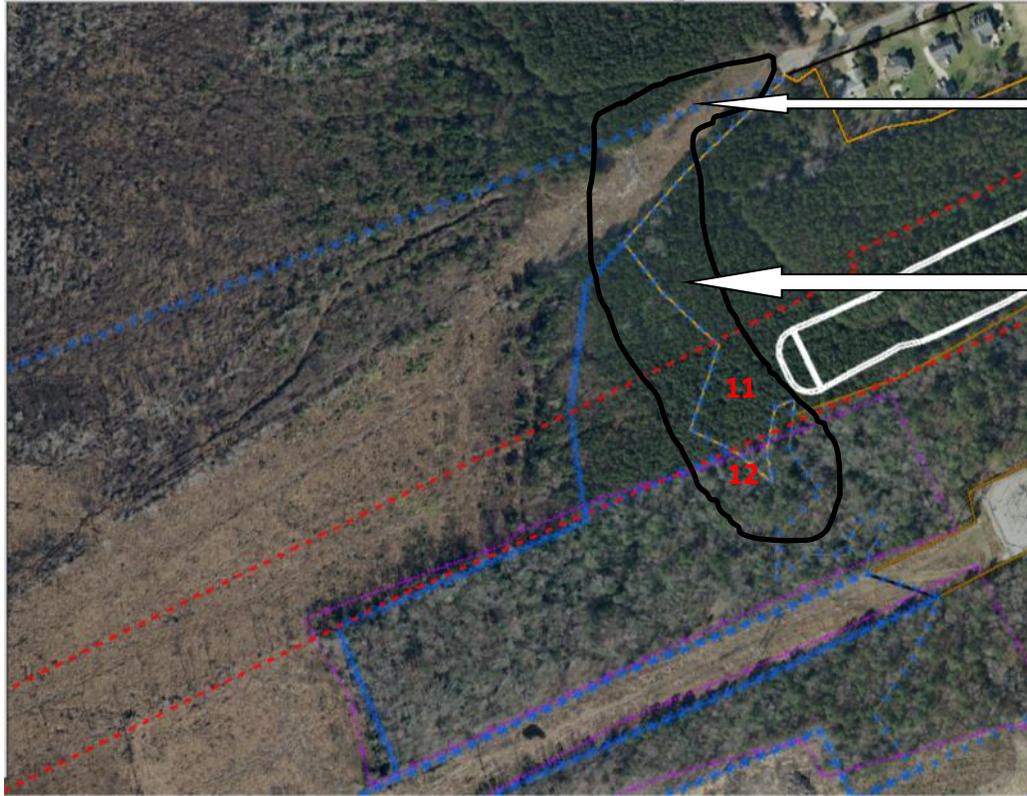
Site 5. East side of Maple Swamp (jurisdictional feature W013 in the 2011 NRTR).

Some discrepancy in the shape file; needs additional evaluation; wetland may be altered.

Portions of line checked and seemed fairly accurate; however, areas of pines are low relief and require many soil profiles. The purple polygons are Natural Heritage element occurrences of non-riverine swamp forest in Maple Swamp Natural Area. The polygons are still intact and have many large trees.

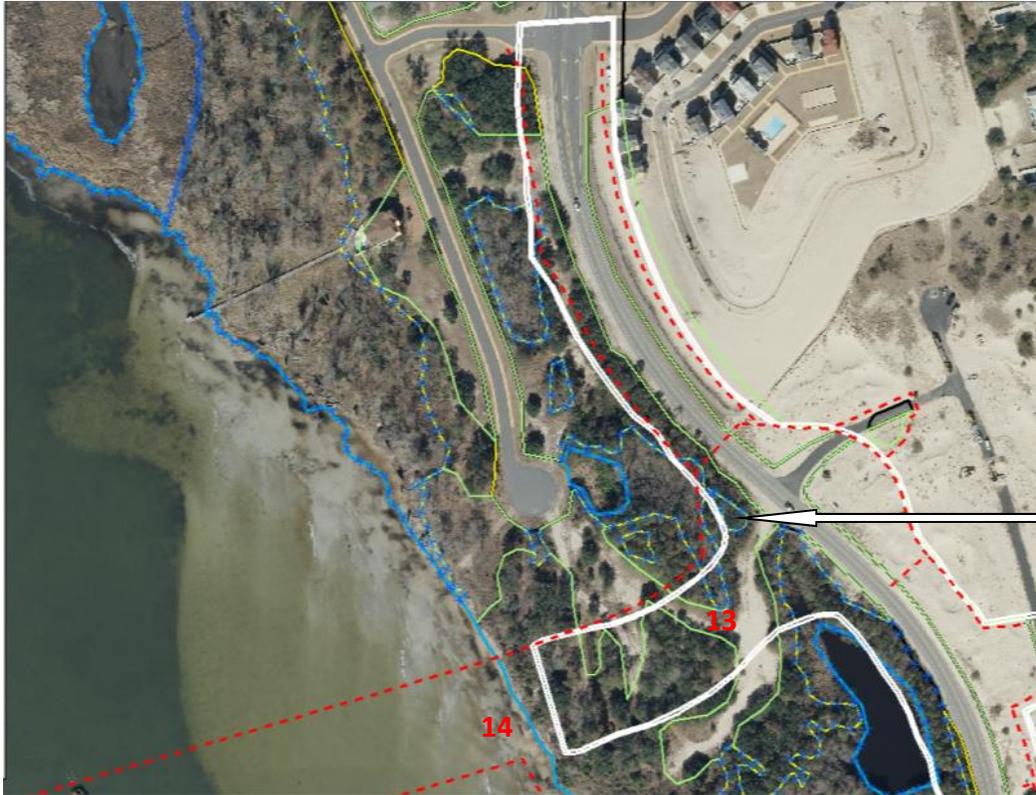
Site 6. Areas north of the Outer Banks bridge landing corridor. Most of the area in this image was visited during the field inspection.

There has been some shoreline erosion along the eastern shore of Currituck Sound.

Marginal wetland; small polygon

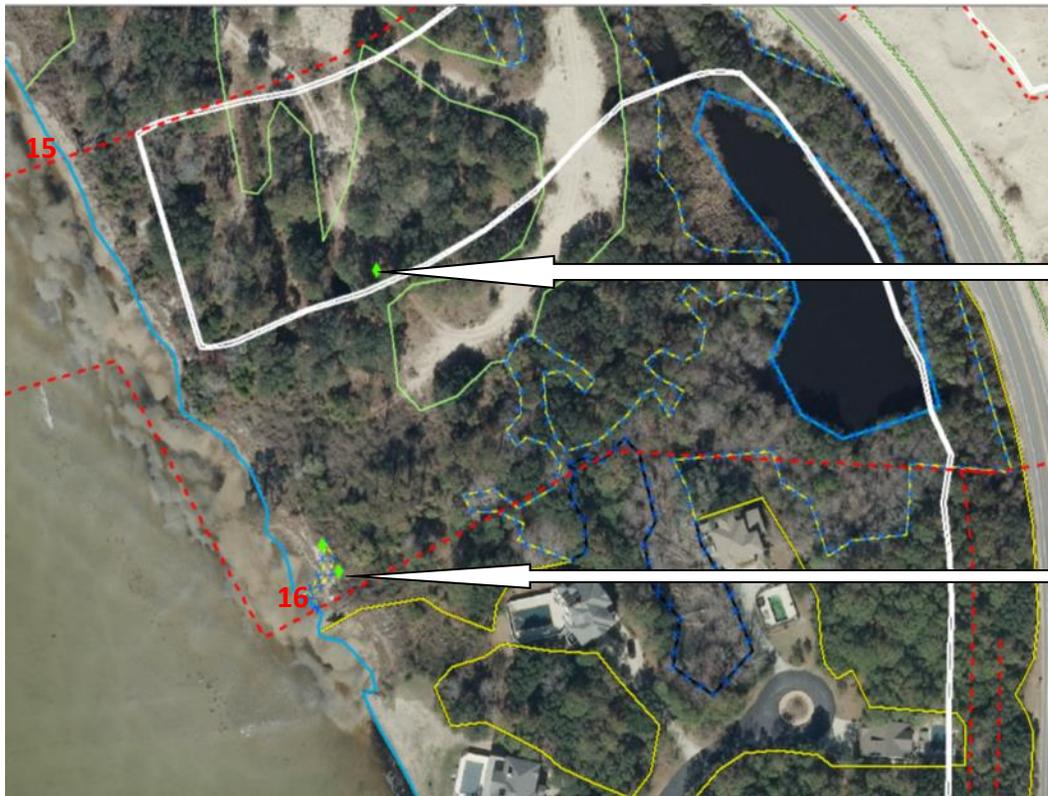
Site 7. Areas south of the Outer Banks bridge landing corridor. Most of the area in this image was visited during the field inspection.

Green diamond represents the location of an ~30'x30' pond dug out of upland. It does not appear to be a new pond. It is surrounded by wax myrtles and had water in it at the time of the visit.

The shoreline has eroded 45' east from previous mapping and is now located at the two green diamonds. The tiny wetland polygon (formerly W089) mapped here is now open waters of the Currituck Sound. There were a few stumps in the water where the polygon used to be.

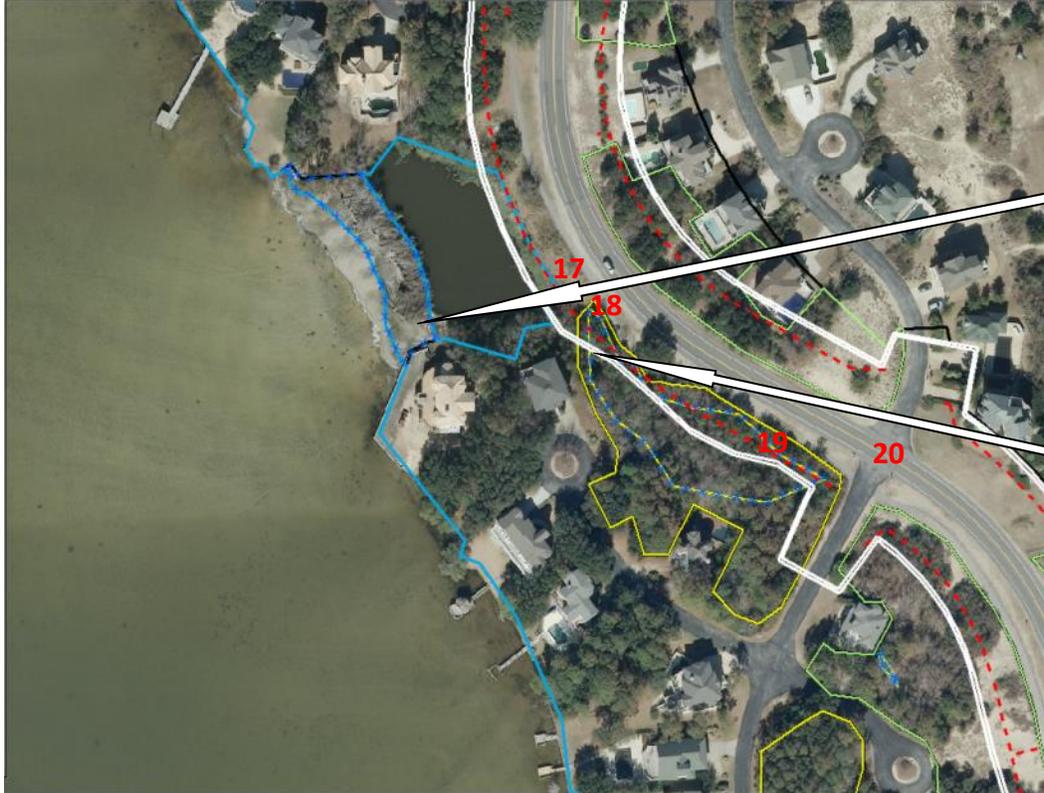
Site 8. Areas south of the Outer Banks bridge landing corridor near N Harbor View. Most of the area in this image was visited during the field inspection.

A breach has occurred here. This was mapped as pond P018 and should no longer be considered a pond but Currituck Sound waters. The wetland (W086A) between the pond and the sound has been reduced.

Wetland W086 drains into this water body and at times of high water, the sound waters could flow into the wetland. The small strip of mapped upland between the W086 wetland and this water may be wetland.

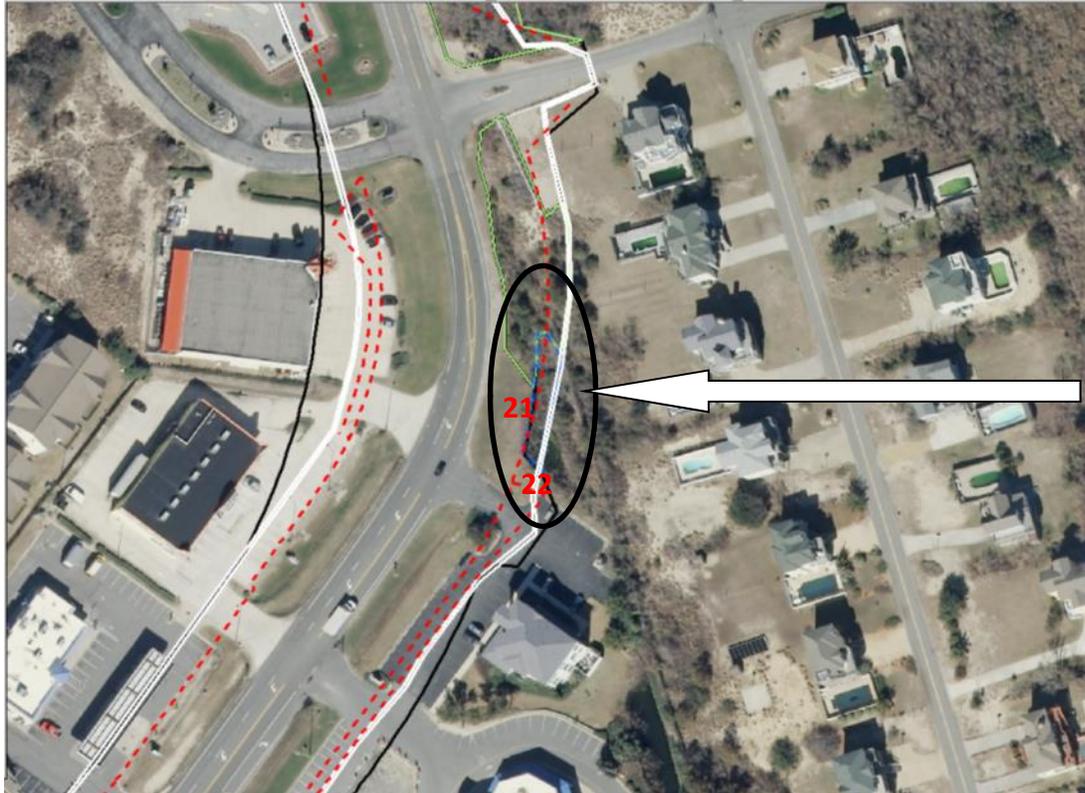
Site 9. Areas south of the Outer Banks bridge landing corridor across from Ace Hardware. Most of the area in this image was visited during the field inspection.

This wetland polygon (W076, 76a) is likely serving as a storm water wetland. There was water in it at the time of the visit. A partially buried corrugated plastic pipe helps to channel water from the parking area to the wetland. Northern boundary may be slightly different.

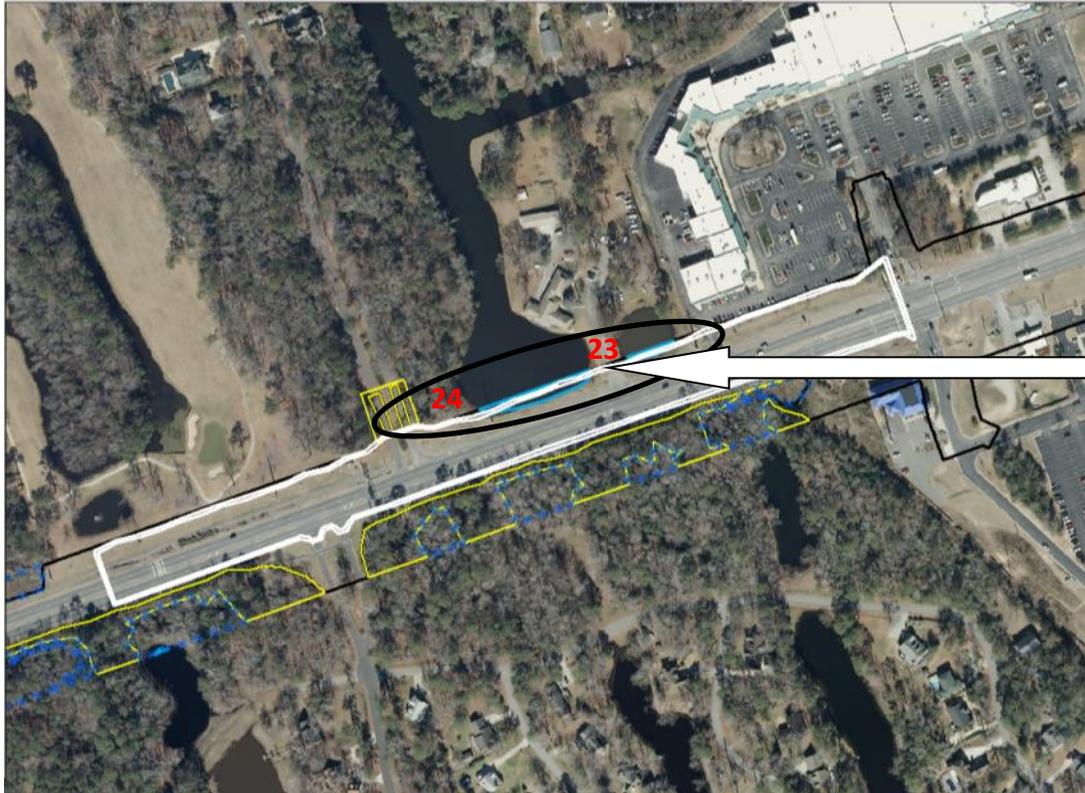
Site 10. US 158 Crossing of Kitty Hawk Woods in Dare County.

Small waterbody (P004) is still a pond with no apparent culverts to other waterbodies. The waters to the west were previously mapped as a pond (P003) but are connected via Little Jean Guite Creek to Currituck Sound.

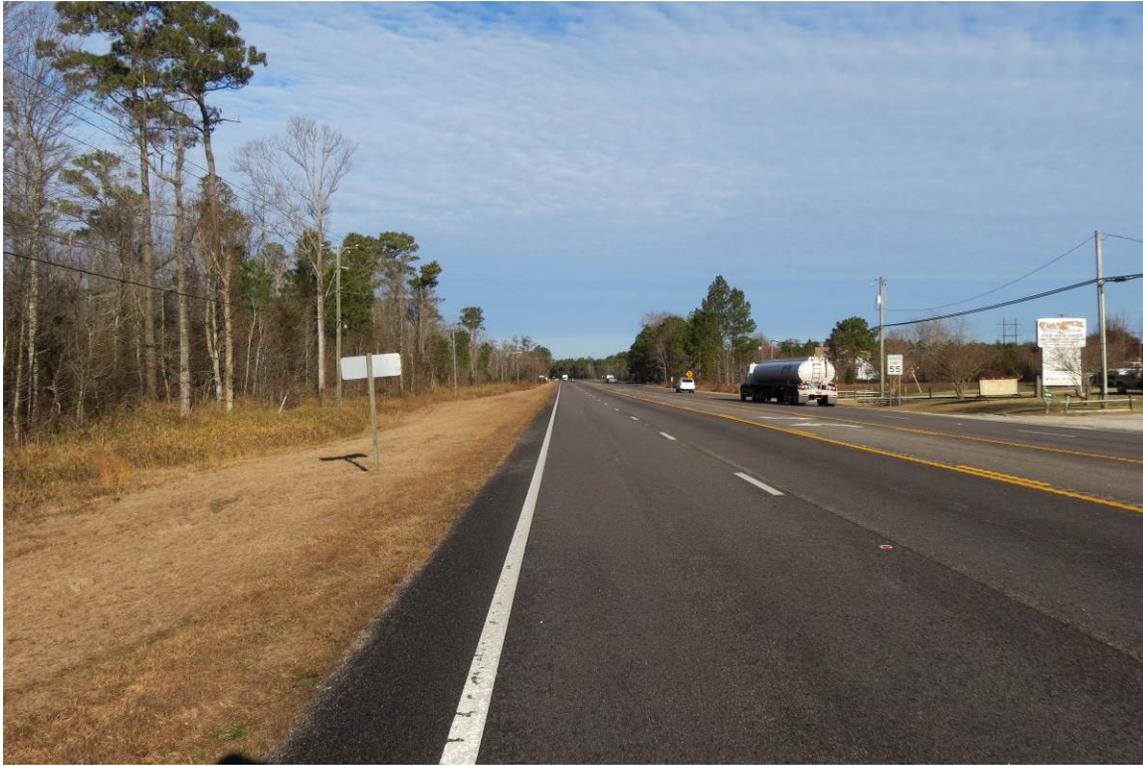
Photo #3 – Portion of W010 west of US 158 with more upland along road shoulder.

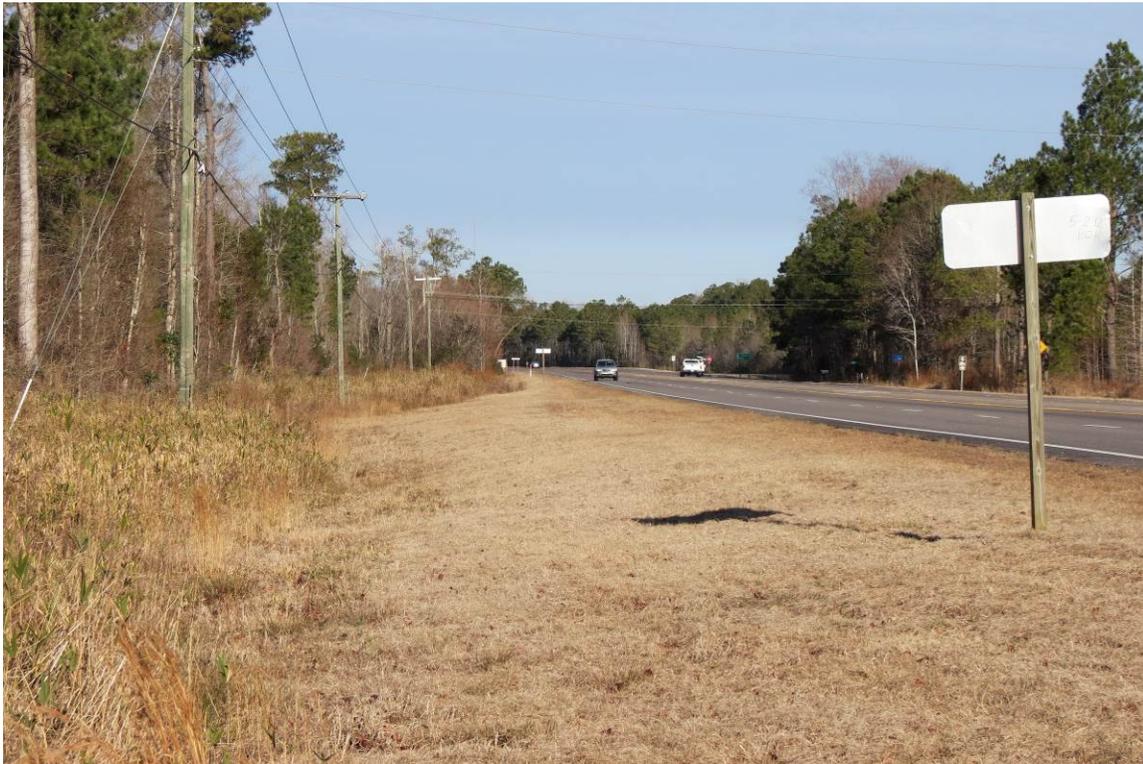
Photo #4 – View along road shoulder looking north along right-of-way at what was mapped as wetland W010 which may include some portions of upland.

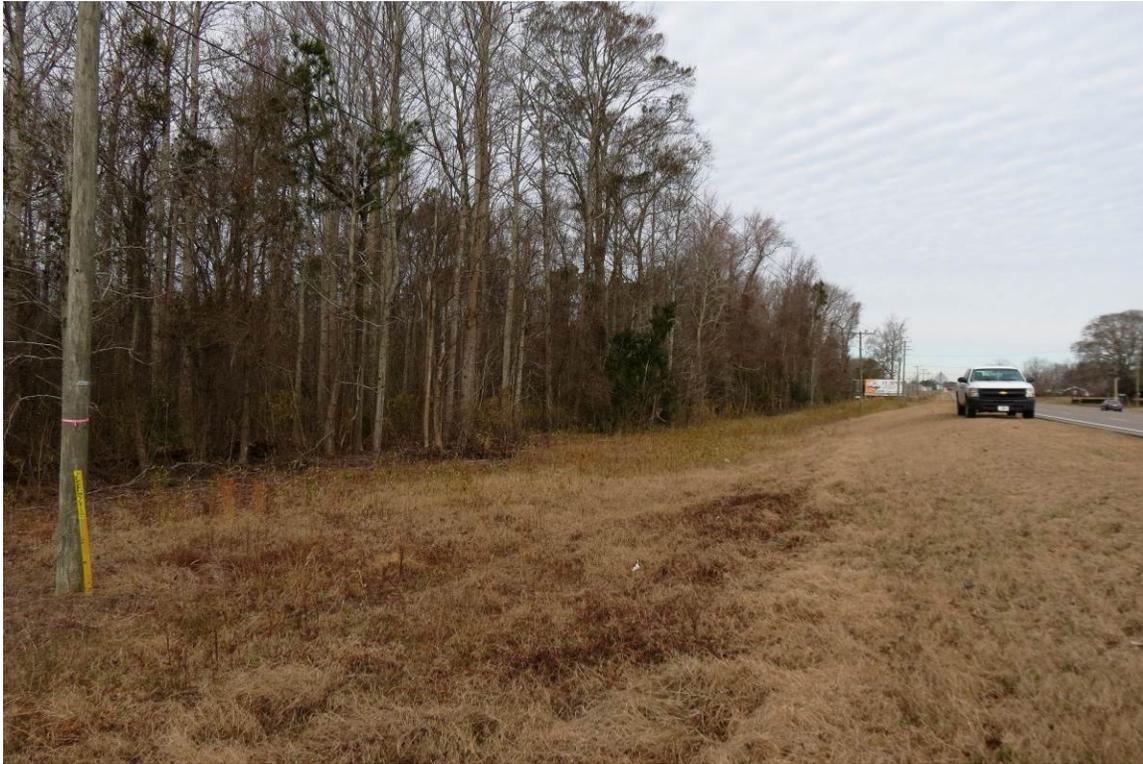
Photo # 7 – West side of US 158 south of Aydlett Road; portion of forest mapped as W010 that is upland.

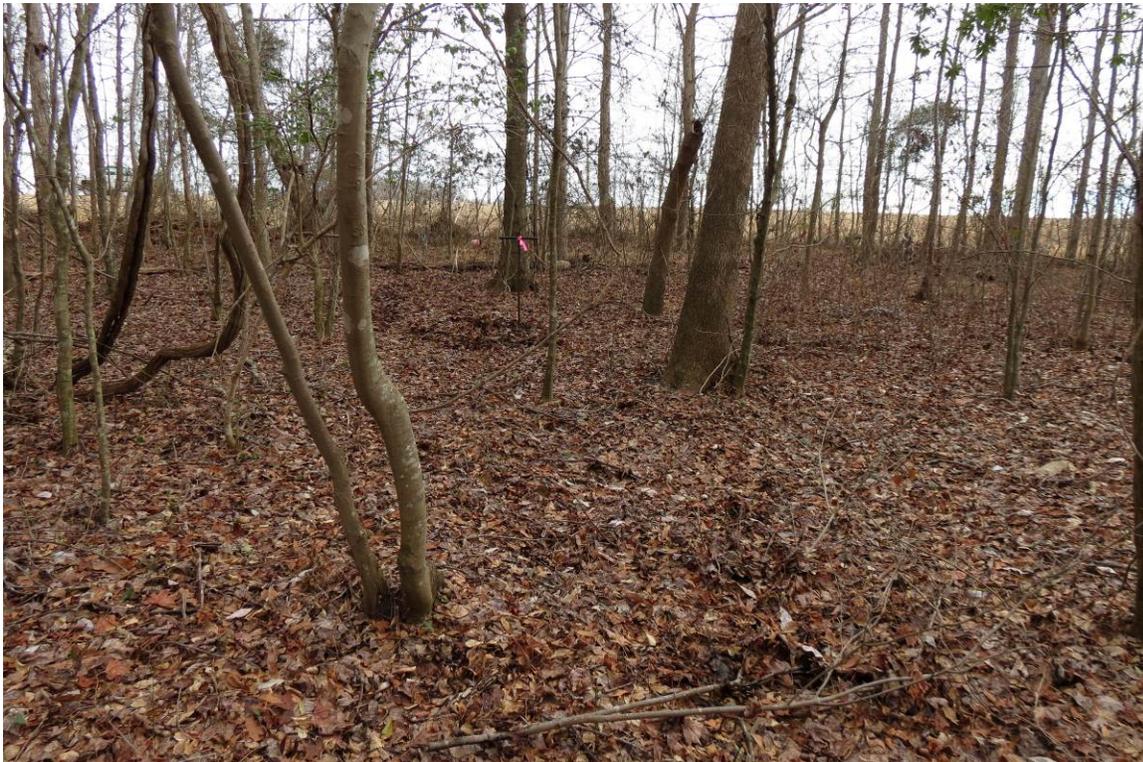
Photo # 8 – Portion of fringing upland hardwood forest west of US 158 within W010.

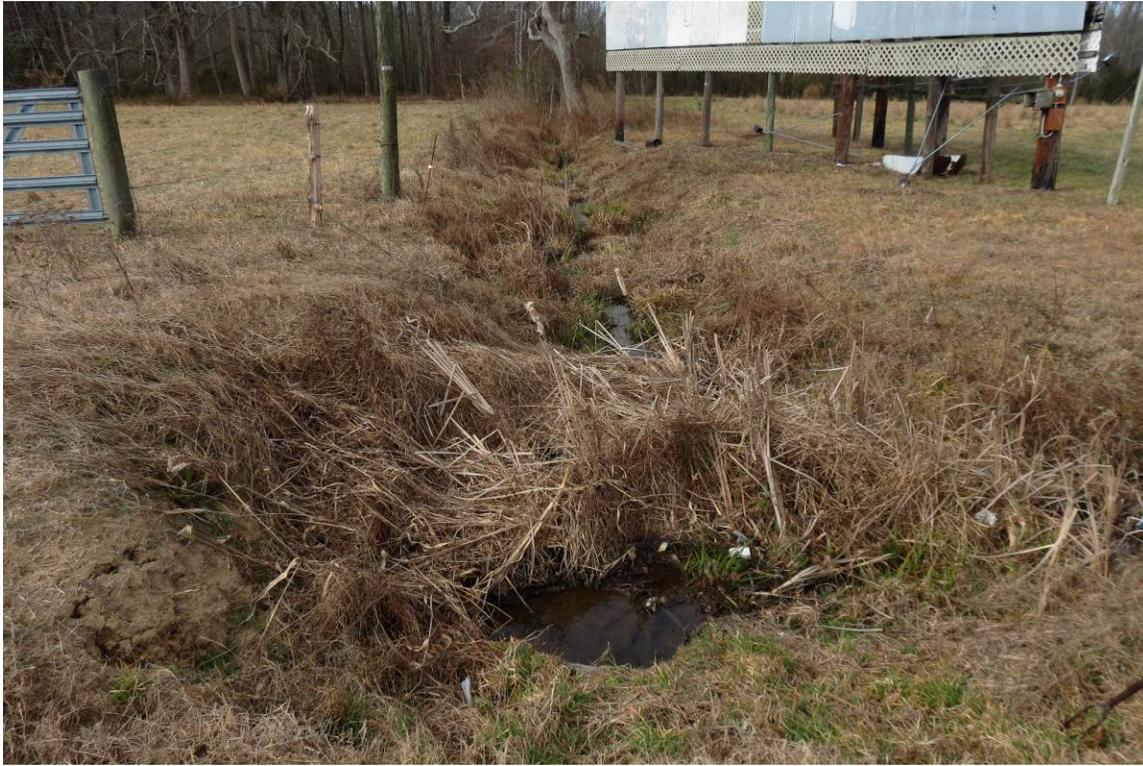
Photo # 5 – Ditch/drain west of US 158 that drains into W010.

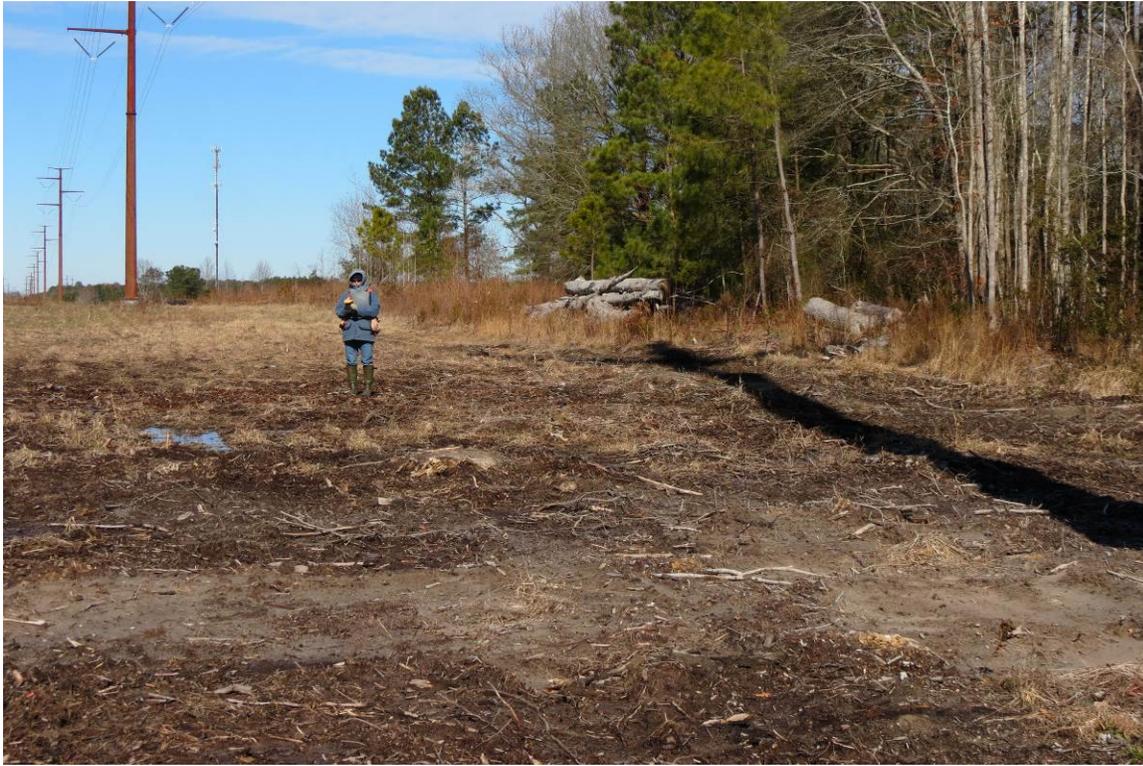
Photo # 9 – Biologist is standing at wetland boundary (former forest boundary) that has been cleared for power line expansion.

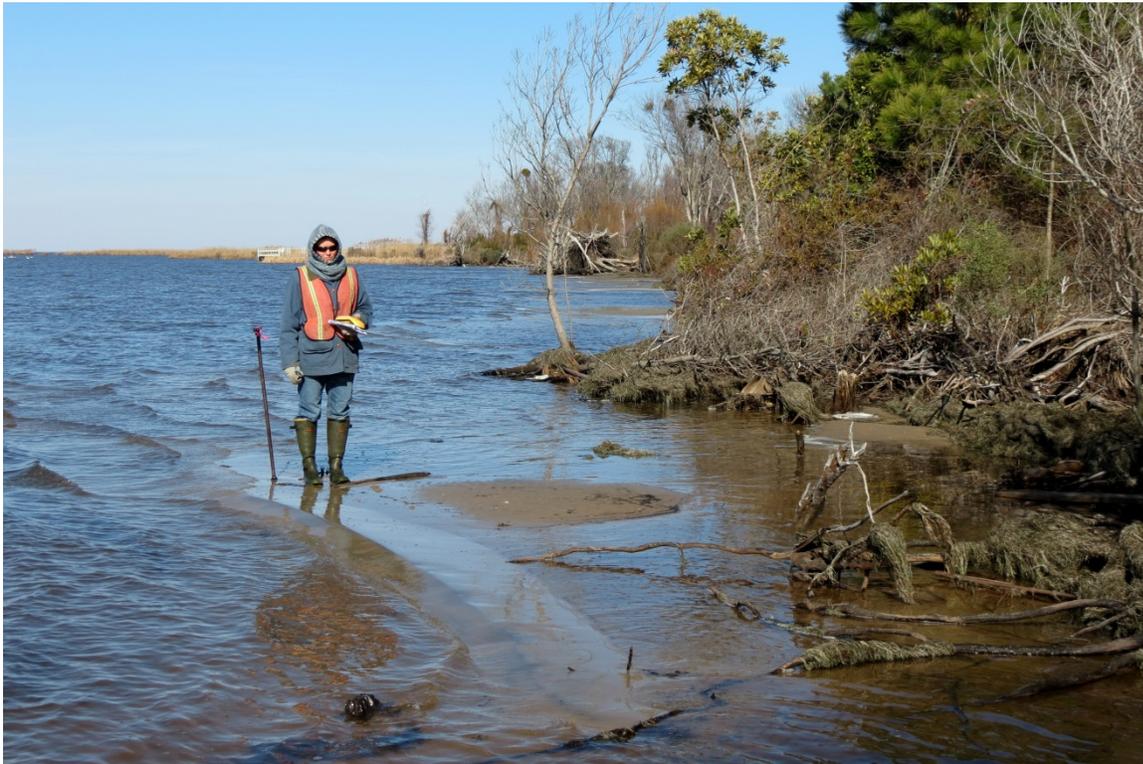
Photo # 14 – Biologist is standing along former shoreline, documenting eastward migration of shoreline edge.

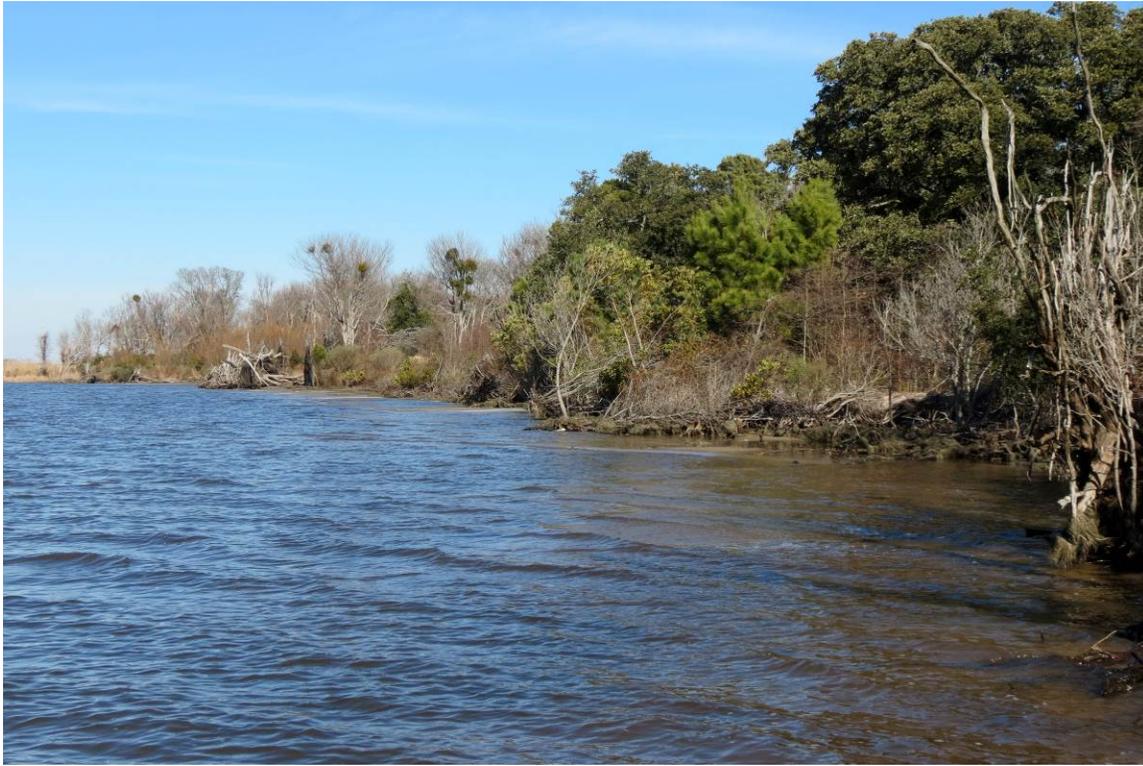
Photo # 15 – View to north along shoreline with scattered uprooted fallen trees.

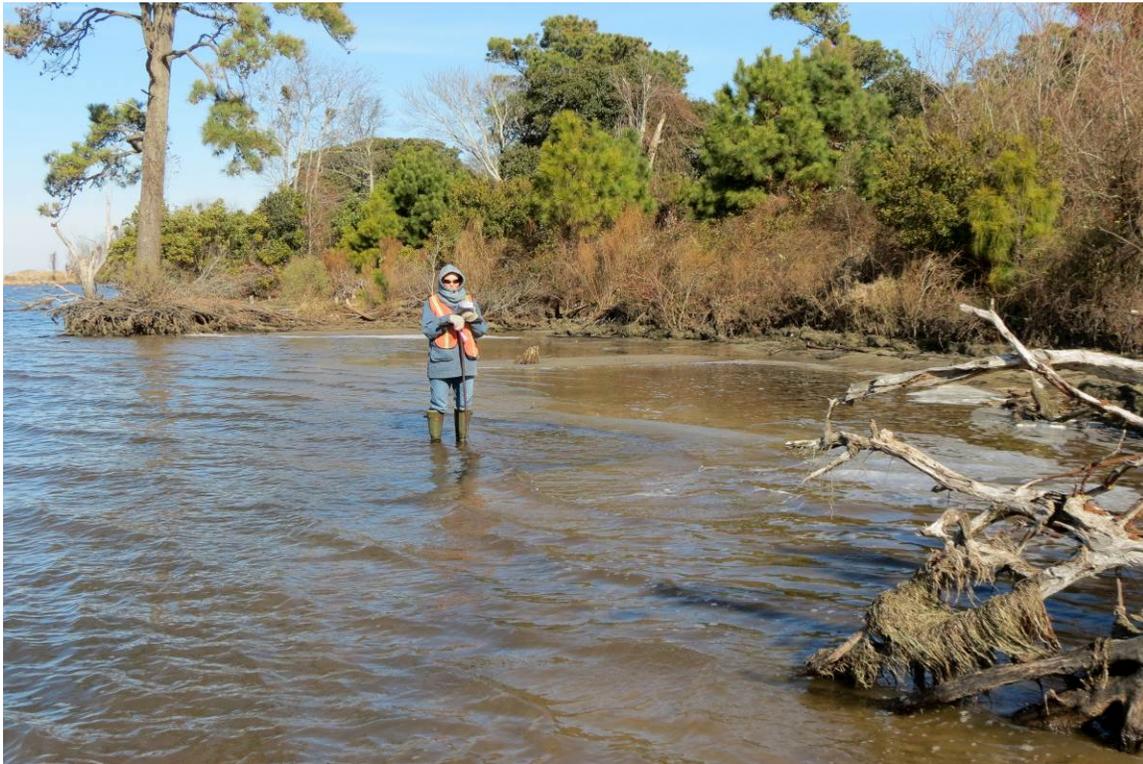
Photo # 16 – Biologist is standing at the western edge of former small wetland (W089) now in Currituck Sound.

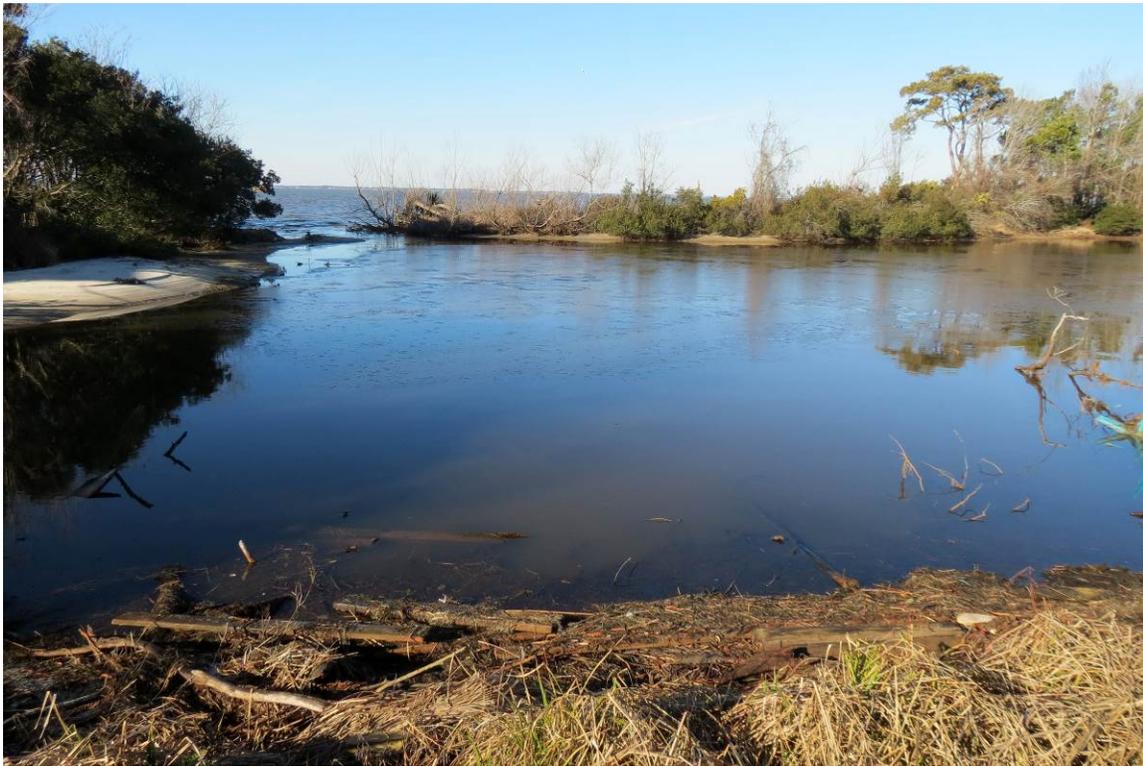
Photo # 17 – Former pond (P018) breached across wetland (W086a), now connected to Currituck Sound.

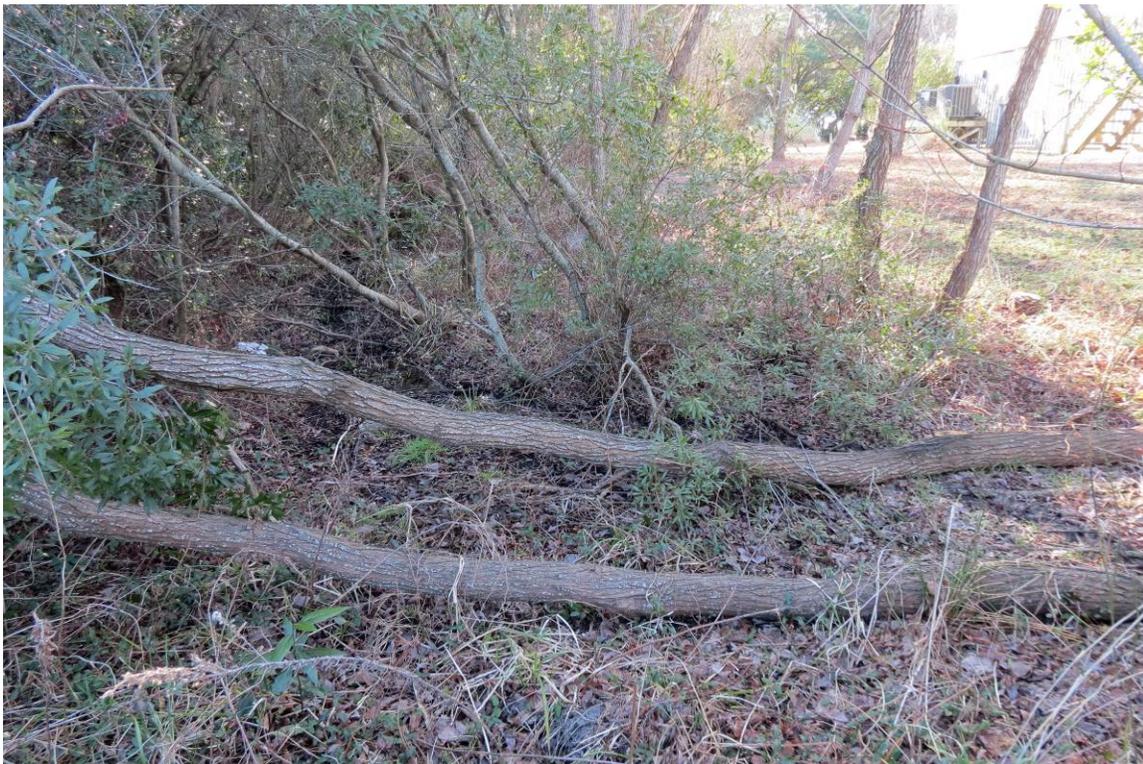
Photo # 18 – View of ditch/drain between former pond (P018) and wetland # W086.

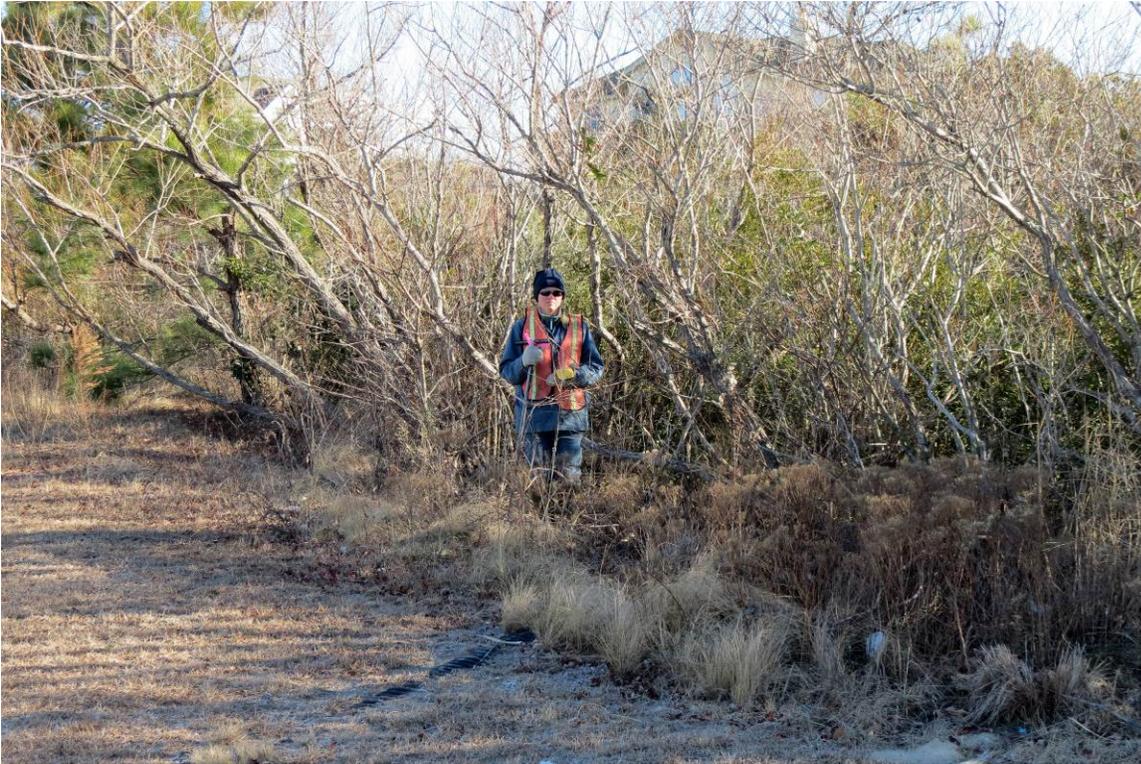
Photo # 21 – Biologist along mapped western boundary of wetland #W076 (appears accurate).

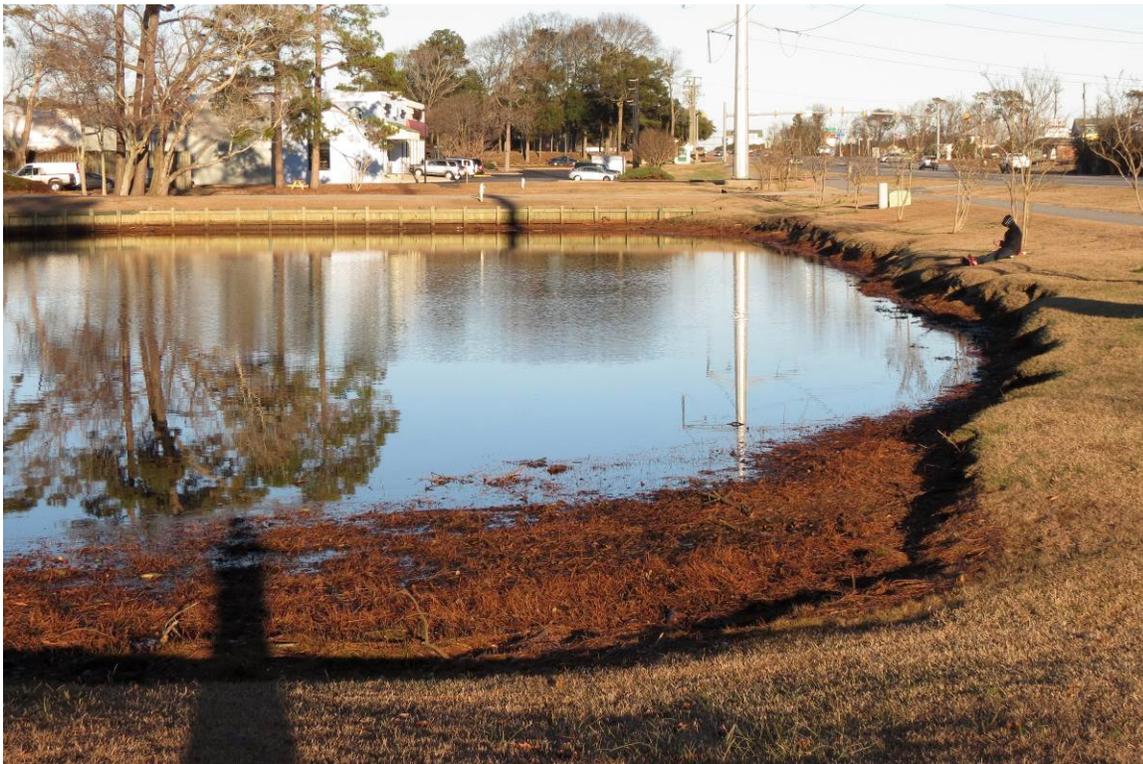
Photo # 24 – Open waters of Little Jean Guite Creek (mapped as pond P003) that is connected to the Currituck Sound.
