REPORT OF FINDINGS

TERRESTRIAL AND UNDERWATER ARCHAEOLOGICAL SURVEY, AND SITE AND ANOMALY EVALUATION FOR THE PREFERRED ALTERNATIVE OF THE MID-CURRITUCK BRIDGE PROJECT IN CURRITUCK AND DARE COUNTIES, NORTH CAROLINA

STIP No. R-2576

REVISED DRAFT REPORT ♦ NOVEMBER 2012

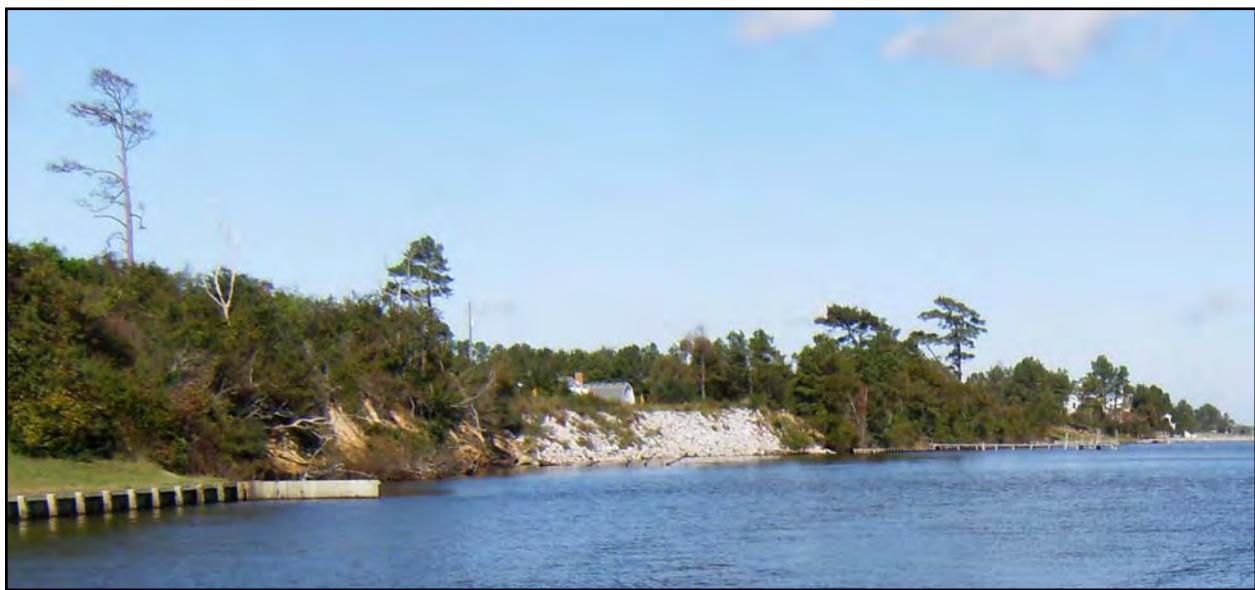
Figure 5.1. Looking northwest at the western terminus of the remote sensing survey area. Left of photograph along the seawall is the southern edge of the ROW. Northern edge of the ROW begins near riprap.

Figures 5.1 through 5.4 convey the environment and illustrates the working conditions of the survey area. Figures 5.1 through 5.3 illustrate that the western terminus of the bridge corridor ends predominantly at an eroding steep bluff adjacent and parallel to Narrow Shore Road (SR 1137). The southern edge of the ROW at this location is opposite a timber seawall that fronts the bluff at this location; the bluff here a well-manicured lawn. The northern edge of the ROW, highly eroded and nearly vertical, is adjacent to where the erosion is capped by limestone riprap.

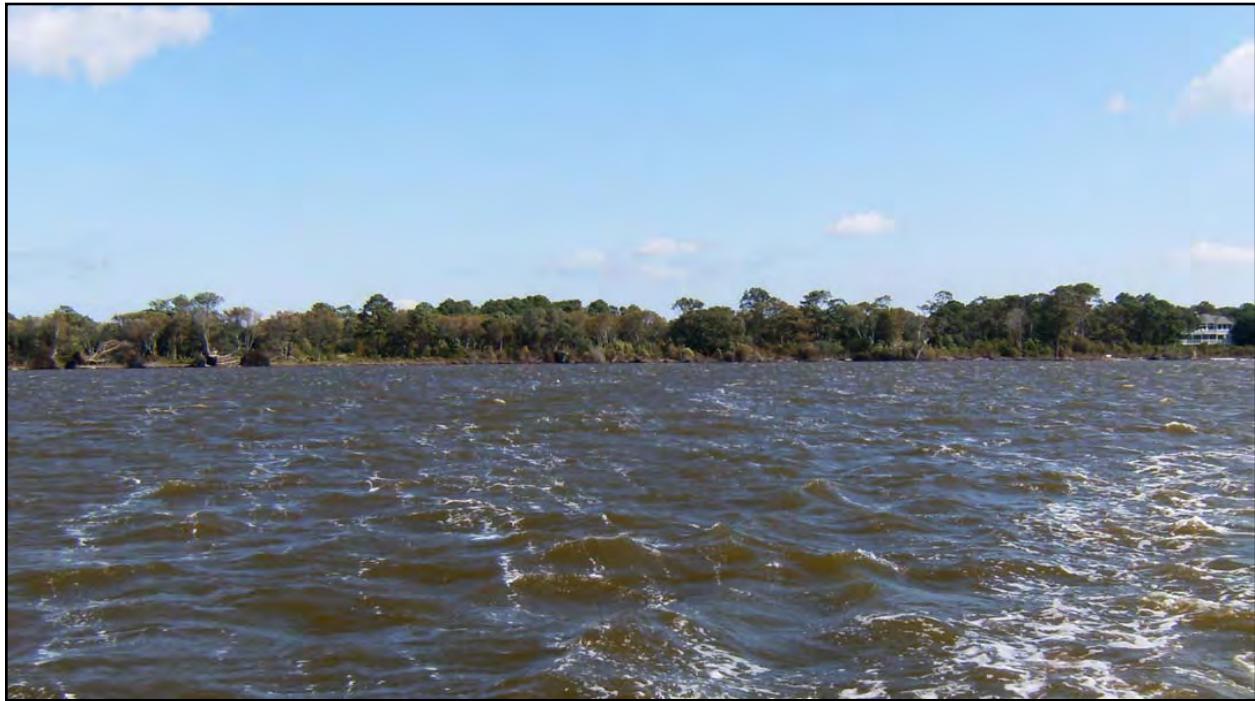
Figure 5.4. Photograph of the eastern terminus of the remote sensing survey area showing general location of the ROW for the bridge corridor. Note recent blow downs of large trees at left from Hurricane Irene.

The eastern end of both the bridge and survey corridor, as shown in Figures 5.4 and 5.5, end in a natural, forested shore. Damage to the trees in the form of blow-downs by Hurricane Irene indicate the shore was eroded during this storm.

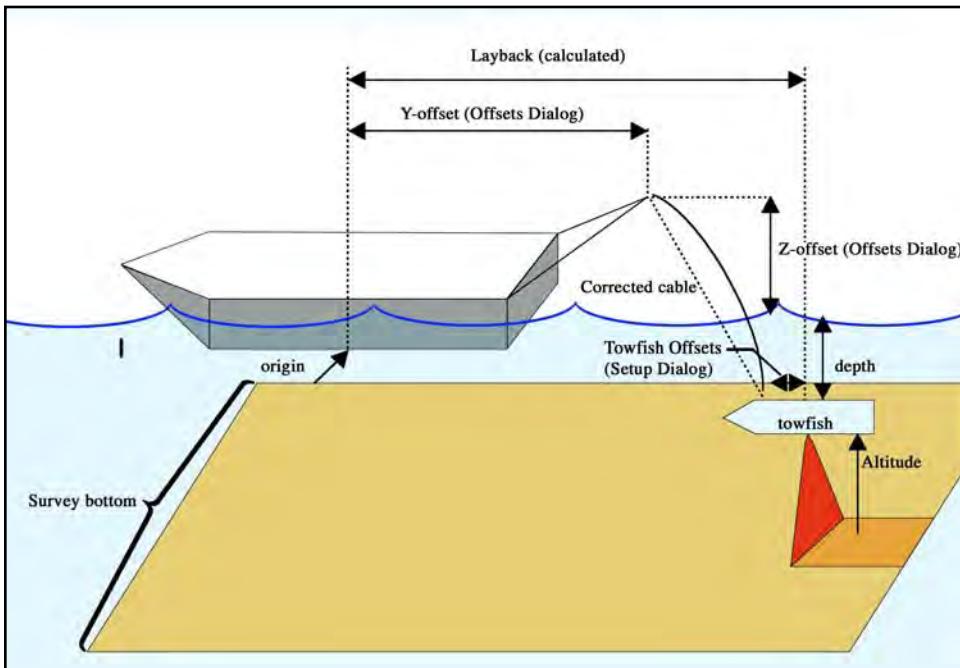
Figure 5.7. Equipment schematic illustrating layback (courtesy of Coastal Oceanographics, Inc.).

All positioning coordinates are based on the position of either of the two DGPS antennae. Layback for each of the remote sensing devices was noted and used in the target location determination (Figure 5.7). This layback information is critical for accurate positioning of targets in the data analysis phase and to relocate any targets for additional investigations.

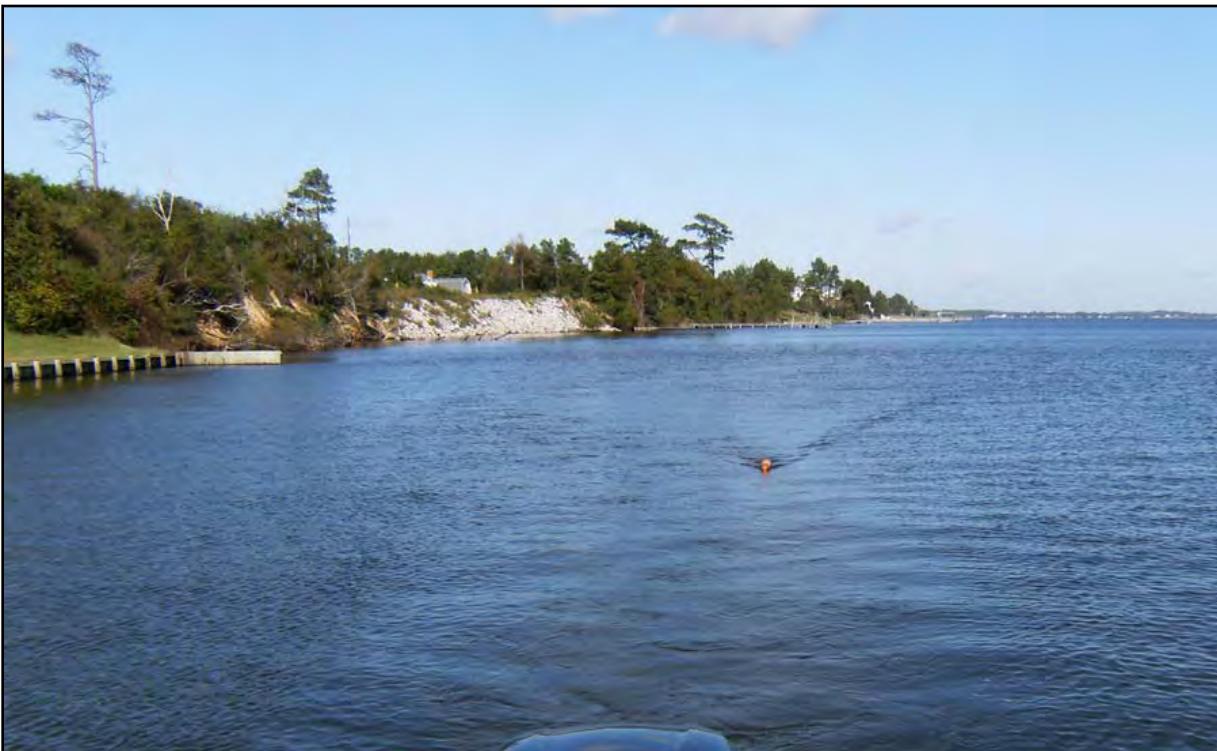
Figure 5.9. Floating of the magnetometer sensor during survey. Several unplanned lines were run parallel to the shore so as to survey as close to the shore as possible. Looking northwest at the western terminus of the bridge corridor.

Because of the shallow project area depths, the magnetometer towfish was activated with a float to allow it to be towed at approximately 1 ft. in the water column. With the shallow area depths, the towfish was generally between 6 to 10 ft. off the bottom depending on area of survey (Figure 5.9). Data was stored in the navigation computer and archived. Both instruments are capable of sub-second recordation for precise location control, but data was collected at 1-second intervals, providing a record of both the ambient field as well as the character and amplitude of the anomalies encountered. All survey electronics were powered by a 110-volt gasoline powered generator.

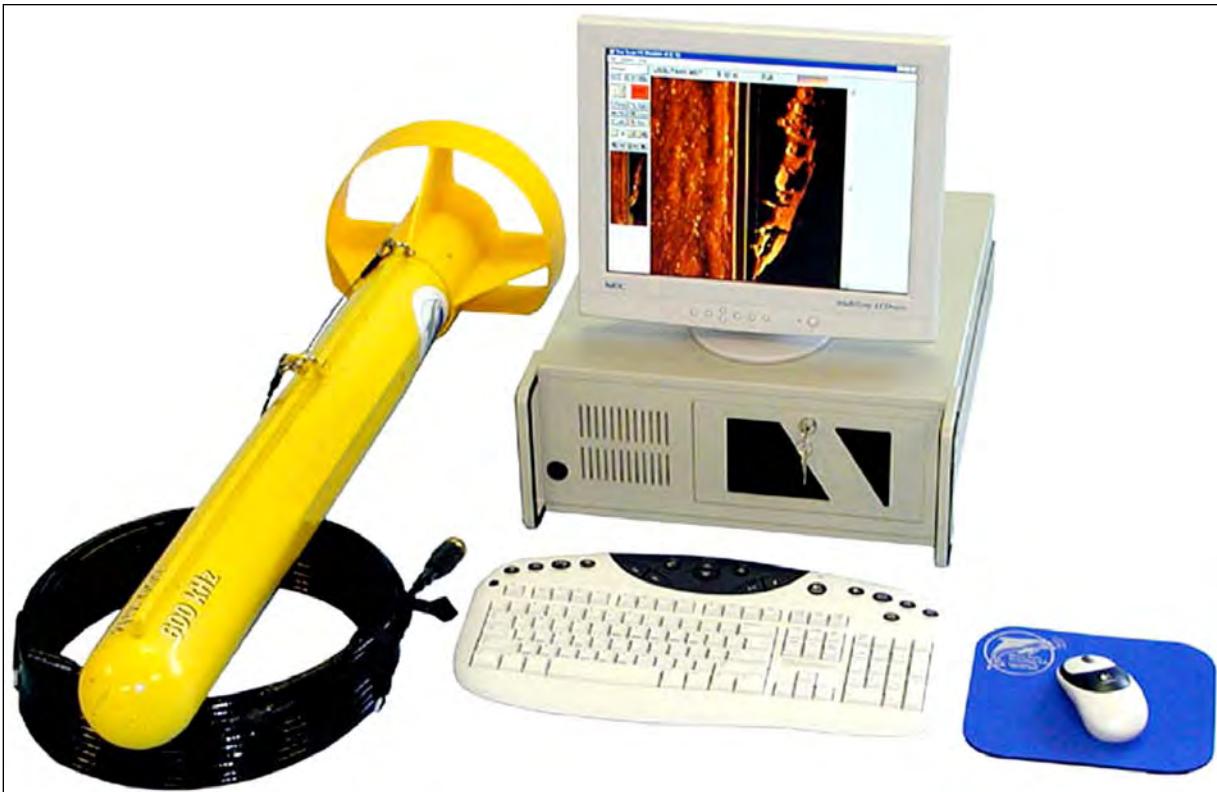
Figure 5.10. Marine Sonic Technology® Sea Scan sidescan sonar system.

The remote sensing instrument used to search for physical features on or above the ocean floor was a Marine Sonic Technology® (MST) Sea Scan sidescan sonar system (Figure 5.10). The sidescan sonar is an instrument that, through the transmission of dual fan-shaped pulses of sound and reception of reflected sound pulses, produces an acoustic image of the bottom. Under ideal circumstances, the sidescan sonar is capable of providing a near-photographic representation of the bottom on either side of the trackline of a survey vessel.

The Sea Scan PC has internal capability for removal of the water column from the instrument's video printout, as well as correction for slant range distortion. This sidescan sonar was utilized with the navigation system to provide manual positioning of fix or target points on the digital printout. Sidescan sonar data are useful in searching for the physical features indicative of submerged cultural resources. Specifically, the record is examined for features showing characteristics such as height above bottom, linearity, and structural form. Additionally, potential acoustic targets are checked for any locational match with the data derived from the magnetometer and the subbottom profiler.

The MST® Sea Scan PC sidescan sonar was linked to a towfish that employed a 600 kilohertz power setting and a variable side range of 20 meters-per-channel (131 ft.) on each of the survey lines. The 20-meters-per-channel setting was chosen to provide detail and 100% overlapping coverage with the 50-ft. line spacing to insure full coverage of the survey area. The power setting was selected in order to provide maximum possible detail on the record generated; 600 kilohertz was the preferred frequency.

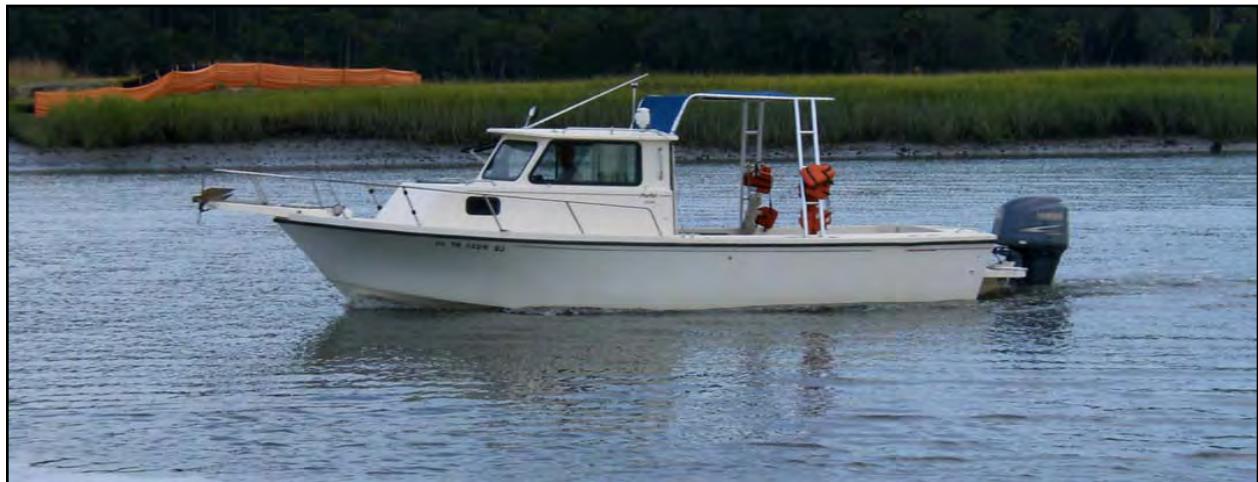
Figure 5.11. PCI's 25-ft. Parker employed for the remote sensing survey investigation.

The vessel employed during the remote sensing survey was a 25-ft. Parker, a modified V-hulled motor vessel powered by a 200 hp Yamaha 4-stroke engine. The vessel has a covered cabin and ample deck area for the placement and operation of the necessary remote sensing and diving equipment. The vessel conforms to all U.S. Coast Guard specifications, according to class, and it has a full compliment of safety equipment. The Parker carried appropriate emergency supplies, including: lifejackets, a spare parts kit, a tool kit, first-aid supplies, a flare gun, air horns, and paddles (Figure 5.11). The trailered survey vessel was launched and recovered each day of survey at the Poplar Branch boat ramp.

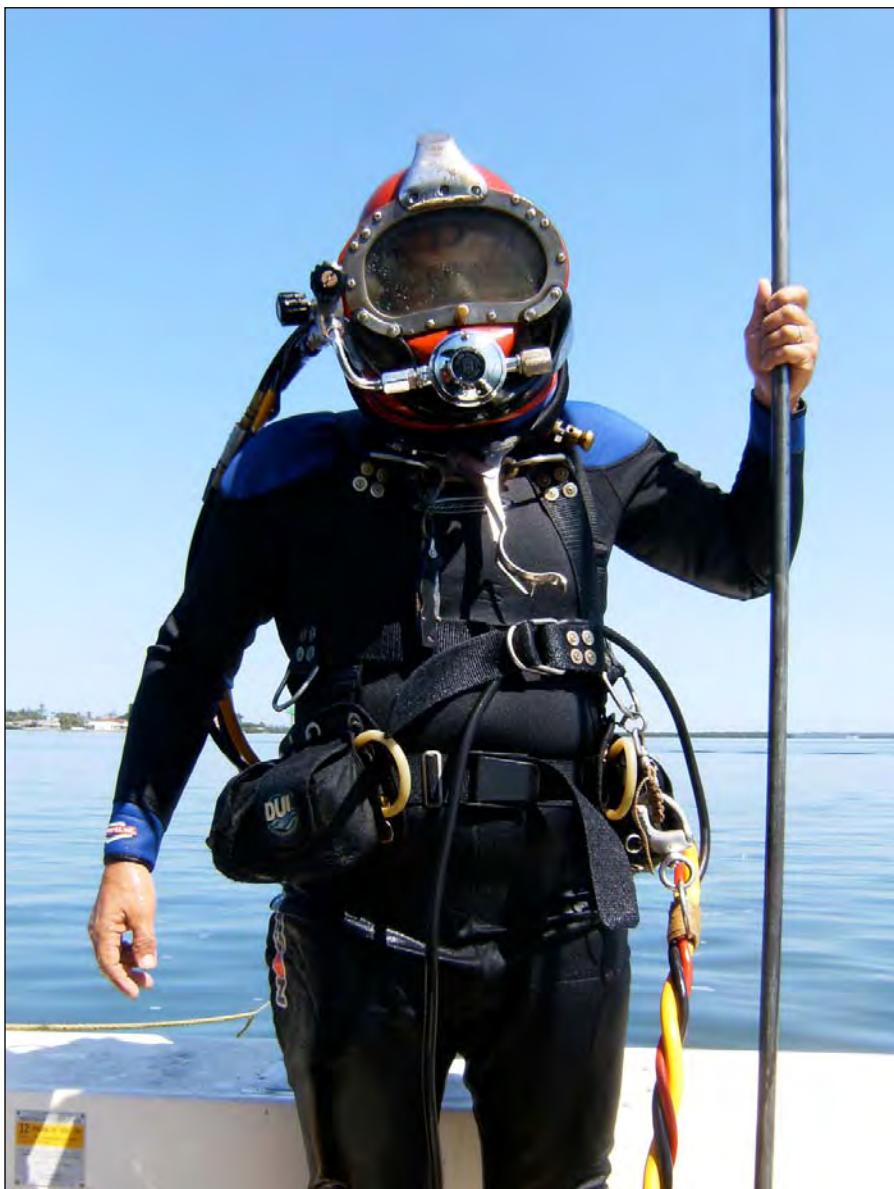
Figure 5.19. Surface Supplied Air-equipped diver (Jim Duff) preparing to enter the water with 10-ft. hydro-probe.

The second phase of the anomaly identification and assessment included an on-site diver investigation of the targets. Surface Supplied Air (SSA) was chosen as the most efficient and safe method of conducting investigations within the project area. Divers employed a Kirby-Morgan Superlite-17 dive helmet connected to a surface-supplied air source, radio communications cable, safety tether, and pneumo hose (Figure 5.19). On the surface various individuals and pieces of equipment ensured safe diving operations. A dive tender was required to aid the diver in donning and doffing equipment and to tend the diver while submerged and moving about the sea floor. The radio communications operator kept in constant contact with the diver and relayed messages between the diver and the surface support team. A standby diver was required on site in the event of an emergency situation that would require aid to the primary diver. Finally, a dive supervisor was present on site at all times to coordinate the activity of the diver and surface support team to achieve the project goals.

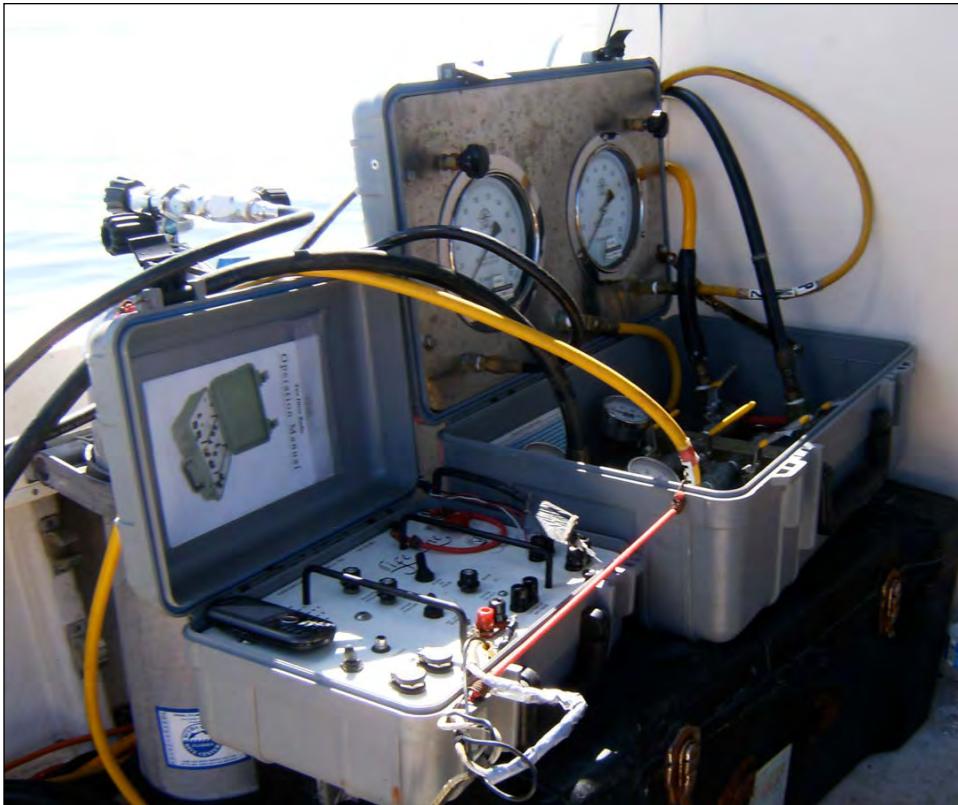
Figure 5.20. Dive station. Diver-to-Surface radio is box in the front, dive manifold with pneumo gauges is to the back right, and cascade system of tanks can be seen behind radio and manifold.

Air for SSA diving was provided by a cascade system of three 80-cubic-foot (cf) SCUBA bottles, opened to supply air one at a time. Pressure gauges and check valves were included in the air supply system. Two levels of redundant backup air supply were used, including an aluminum 80-cf SCUBA cylinder linked to the SSA cascade system and a 50-cf aluminum SCUBA cylinder worn by the diver and connected to the dive helmet. The dive supervisor acted as timekeeper and radio operator, monitoring the air supply system during each dive to ensure that air pressure was correctly maintained and adequate reserve air was always available (Figure 5.20).

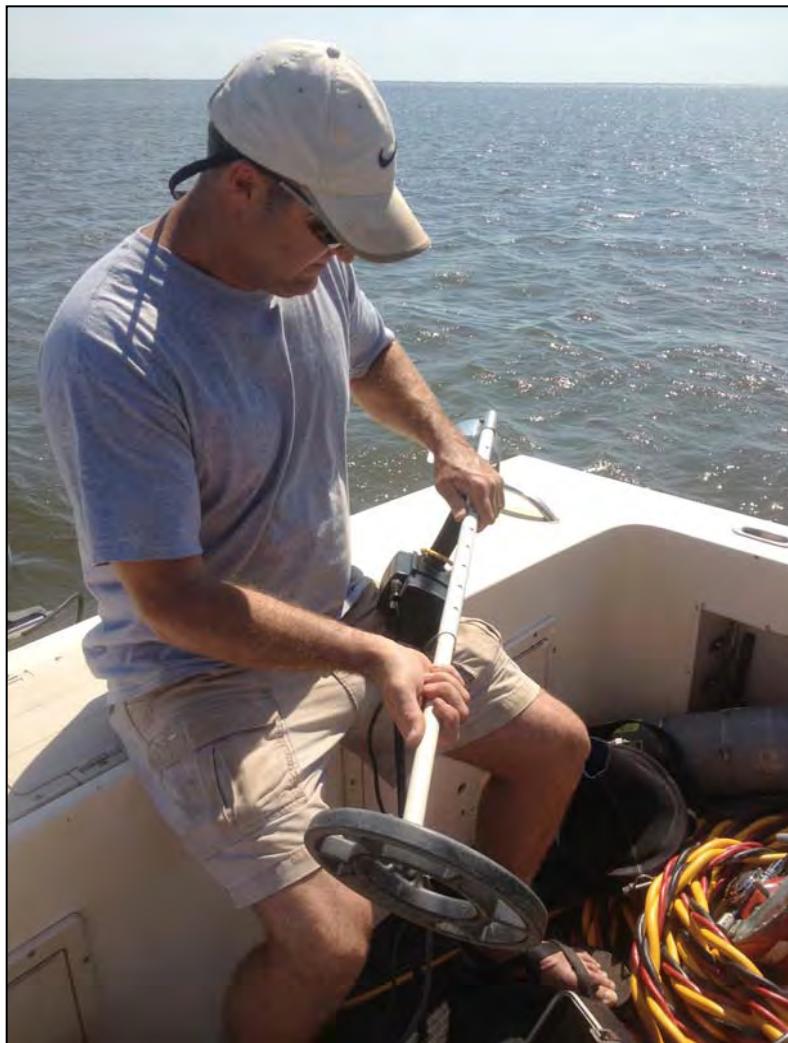
Figure 5.21. Metal detector employed for the initial investigation of the magnetic anomalies.

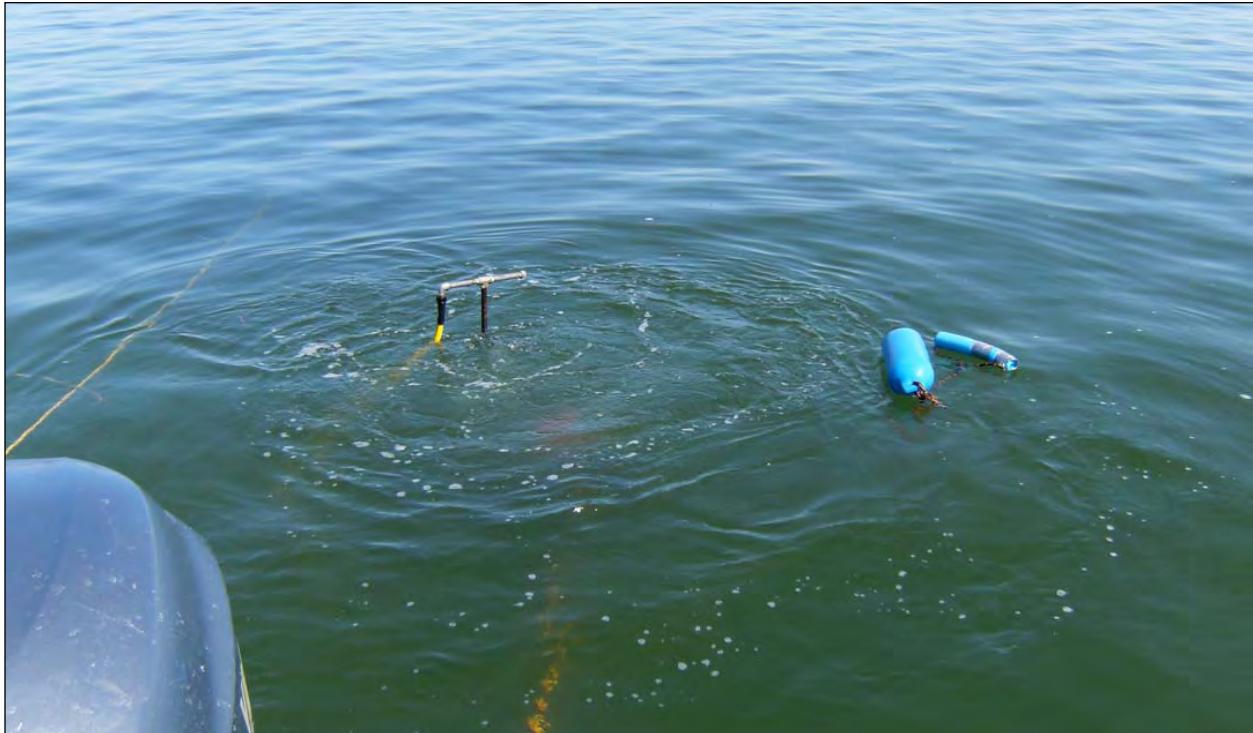
Figure 5.23. Probing was conducted at magnetic targets with a 10-ft.-long hydro-probe. Approximately 9 ft. deep at this target, the T-top of the probe with attached garden hose is visible, as is the diver's umbilical (lower center) which leads to his red dive helmet just visible below the surface adjacent to the probe.

Probing of anomalies or features is an effective means of determining the spatial extent and burial depth of a given target located beneath the sea floor. The hydro-probe apparatus consists of a water pump, lengths of garden hose, and the probe that is $\frac{1}{2}$ -in. galvanized pipe. The hose was connected to the $\frac{1}{2}$ -in. diameter steel probe by a cam-lock. The hydro-probe used for this investigation was 10 ft. in length and powered by a 5-hp Honda water pump. The basic function of the hydro-probe is to aid in determining the presence or absence of buried cultural material, and, if present, spatial extent of the material, types of overburden (i.e., sand, mud, shell), the type of cultural material, and depth of overburden. This is accomplished by forcing water through the 10-ft. pipe attached to the water pump's effluent hose. The force of the water ejected from the pipe end effectively allows the probe to be inserted through sediments of varying density (e.g., sands, silts, shell hash) and depth, thereby contacting the feature if present and/or sediment layers (Figure 5.23).

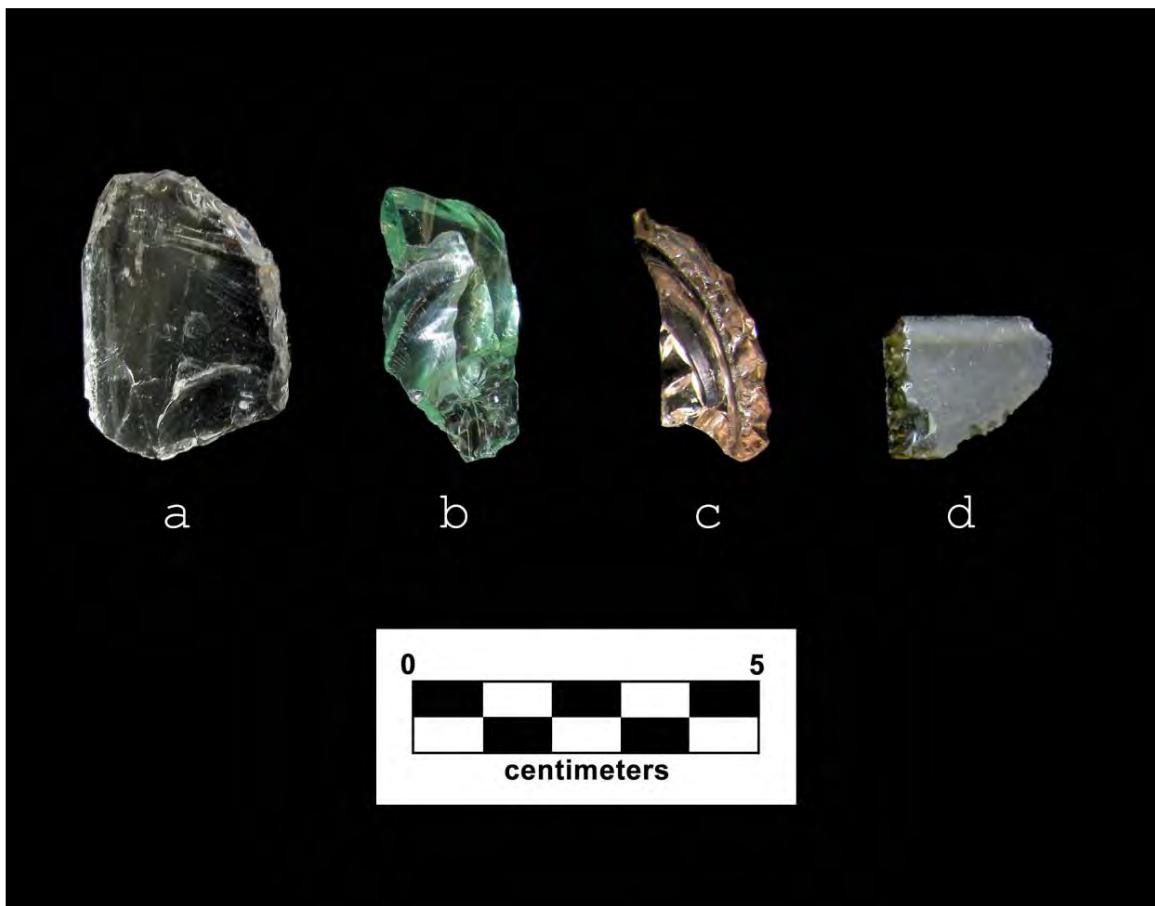
Figure 6.3. Worked container glass from 31CK220**: a) clear; b) aqua; c) pink; and d) olive green.

Olive glass was often knapped and made into scrapers by Creek Indians from the seventeenth century on and also by early nineteenth century non-Indian inhabitants of the region. Therefore, obviously reworked olive glass will frequently be evidence of Indian occupation during the historic period but can also be associated with non-Indian peoples as well. Evidence of glass working, such as debitage or actual tools is not a definitive indicator of Indian habitation but is often found in such contexts. Several specimens of worked container glass of various colors were recovered (Figure 6.3).

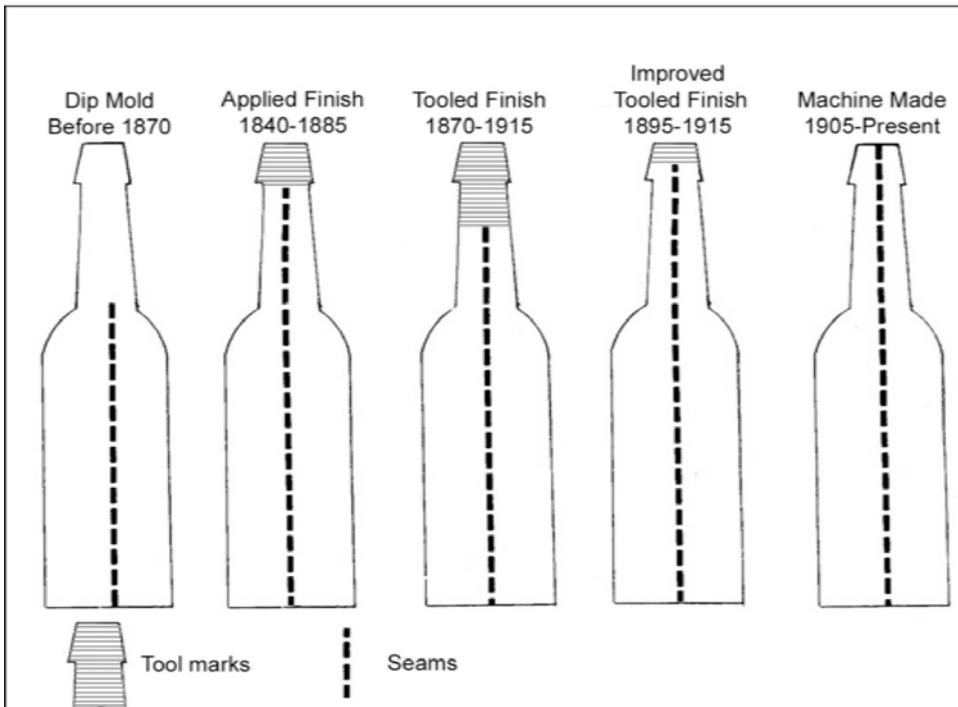
Figure 6.12. Glass bottle seams chronology (drawn by Charles Redwine based on images from Polak [1994] and data from U.S. Department of the Interior, Bureau of Land Management 2010).

Bottle seams are important chronological markers as well. Prior to the twentieth century, bottles were either free blown or blown into molds (Polak 1994). Bottles that were free blown are characterized by their lack of seams and symmetry. When initially blown, the vessels have a globular shape due to surface tension and can be reshaped using tools or centrifugal force (Toulouse 1969). Bottle makers began blowing glass into molds in large quantities in the early 1800s. Types used were tapered dip molds, turn-molds, hinged bottom molds, two-piece molds, three-piece dip bottom molds, and three-part (or more) molds. Some of these are often difficult, if not impossible, to discern without having a complete bottle. The method of manufacture determines the length and placement of the seams (Figure 6.12).

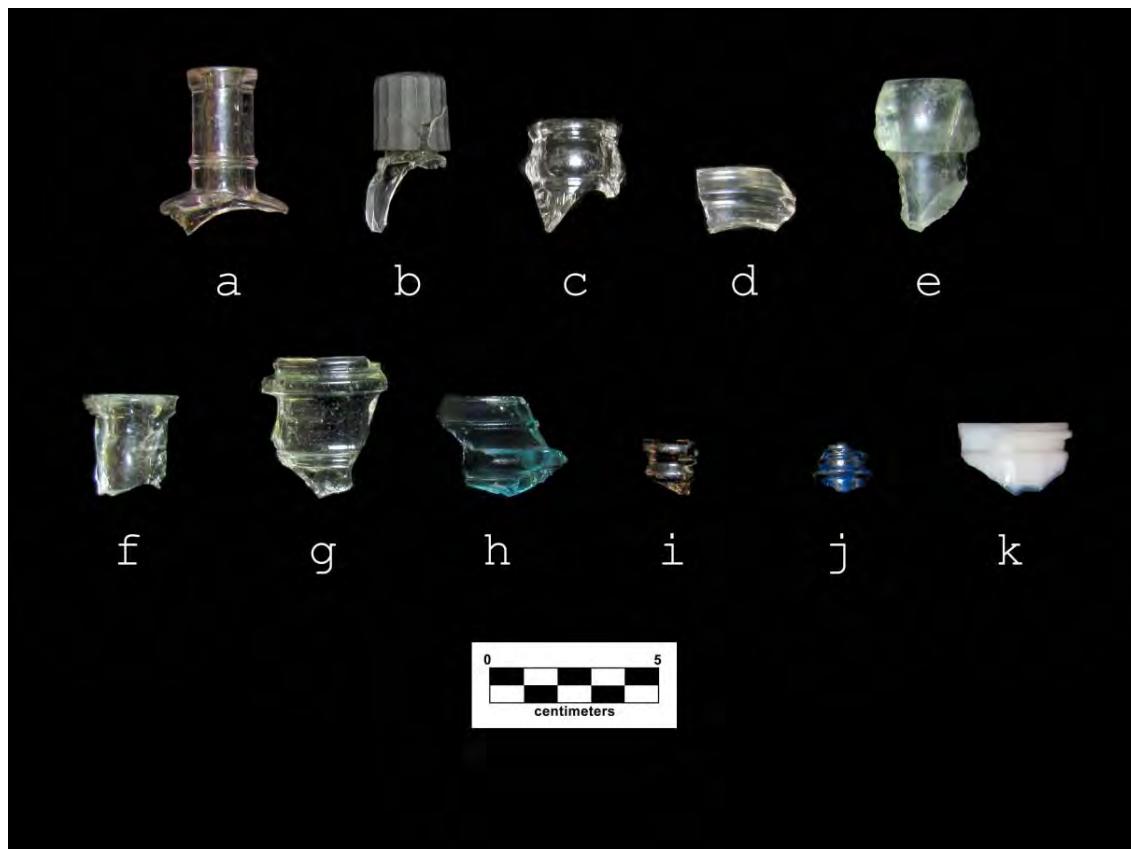
Figure 6.14. Bottle finishes: a) tooled patent (31CK220**); b) external thread (31CK218**); c) crown (31CK225**); d) capseat (31CK218**); e) tooled blob (31CK220**); f) tooled prescription (31CK224/31CK224**); g) smooth rim cannning jar (31CK219**); h) external thread (31CK219**); i) double ring (31CK220**); j) external thread (31CK218**); and k) external thread (31CK218**).

There were no applied finishes recovered. Tooled finishes were found in various styles, including patent (Figure 6.14a), prescription (Figure 6.14f), and blob (Figure 6.14e). Some machine-made finishes were found, such as patent, small mouth external thread (Figure 6.14j), and capseat (Figure 6.14d), all pointing to a twentieth century date. Other finishes recovered

included large mouth interrupted external thread (Figure 6.14k), large mouth external thread (Figure 6.14h), bead, double ring (Figure 6.14i), and crown (Figure 6.14c).

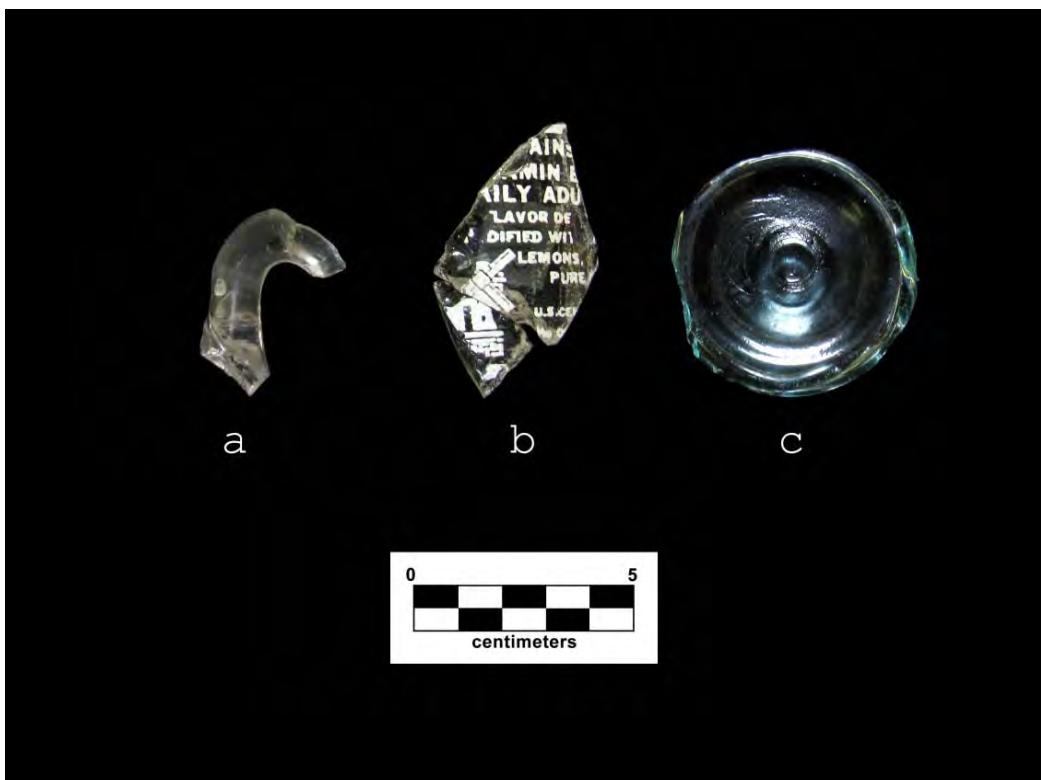
Figure 6.15. Other glass: a) clear handle fragment(31CK218**); b) clear "Mil-Kay" with painted label (31CK220**); and c) aqua base with indeterminate pontil (31CK219**).

Types of bottle bases found are not as numerous as the various finishes. PCI's survey revealed an indeterminate pontil scar (Figure 6.15c). One discernible manufacturer's mark was that of the Hazel-Atlas Glass Company, which was formed in 1902 as a result of the merger of the Hazel Glass Company (started 1887) and the Atlas Glass Company (started 1896). The manufacturer's mark was reportedly first used in 1923 until 1964. Two pieces of clear container glass featured a "Mil-Kay" bottle company painted label, which dates to ca. 1940 (Figure 6.15b).

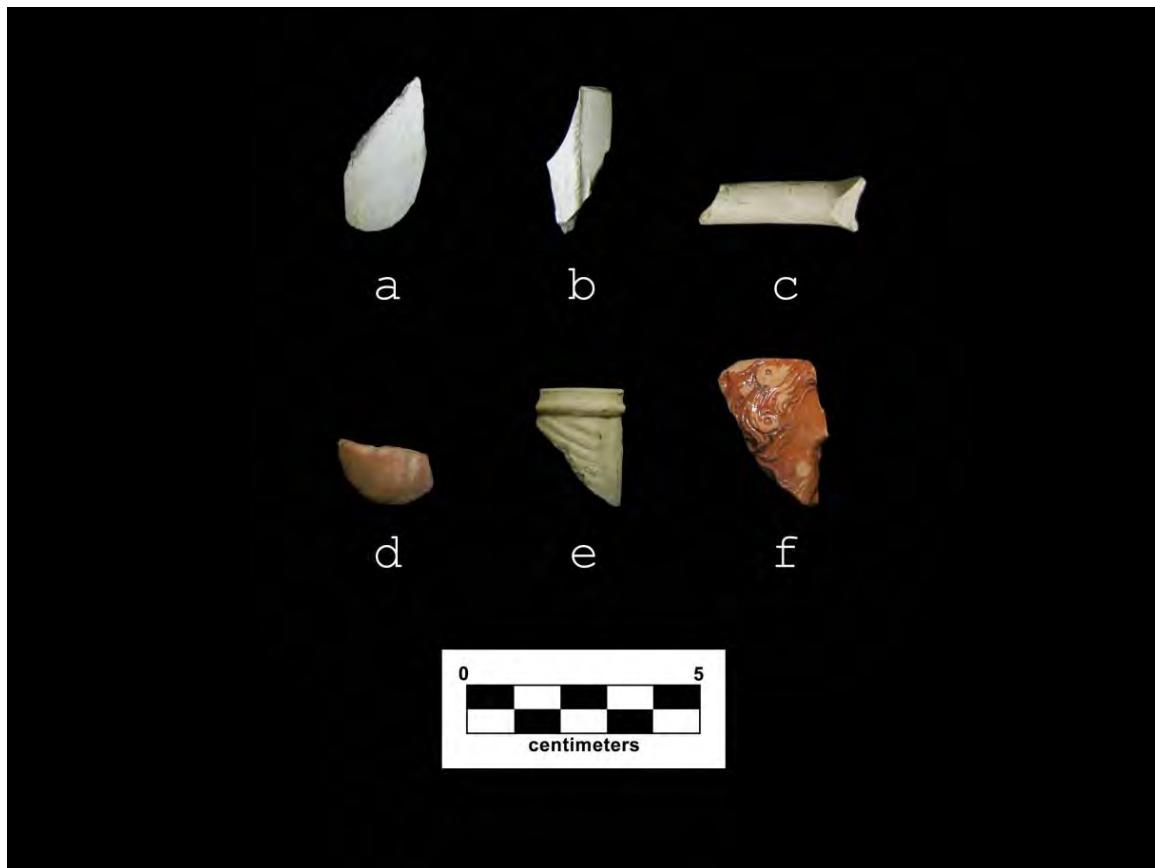
Figure 6.17. Smoking pipe bowls and stem fragments recovered: a) kaolin pipe bowl fragment (31CK220**); b) kaolin pipe bowl fragment (31CK220**); c) kaolin pipe stem fragment (31CK221**); d) unglazed earthenware pipe bowl fragment (31CK220**); e) unglazed stoneware pipe bowl fragment (31CK218**); and f) earthenware anthropomorphic pipe bowl fragment (31CK220**).

The artifacts in this group are associated with tobacco use and typically include fragments of smoking pipes made of earthenware, stoneware, or kaolin. Several kaolin pipe fragments were recovered and included a kaolin smoking pipe bowl fragment (Figure 6.17a), four relief molded kaolin smoking pipe bowl fragments (Figure 6.17b), and three kaolin smoking pipe stem fragments with hole diameters measuring 5/64 inches (Figure 6.17c). There was also one relief molded unglazed stoneware smoking pipe bowl fragment (Figure 6.17e). One unglazed earthenware smoking pipe bowl fragment (Figure 6.17d), as well as one red-brown glazed earthenware anthropomorphic smoking pipe bowl fragment (Figure 6.17f) were recovered.

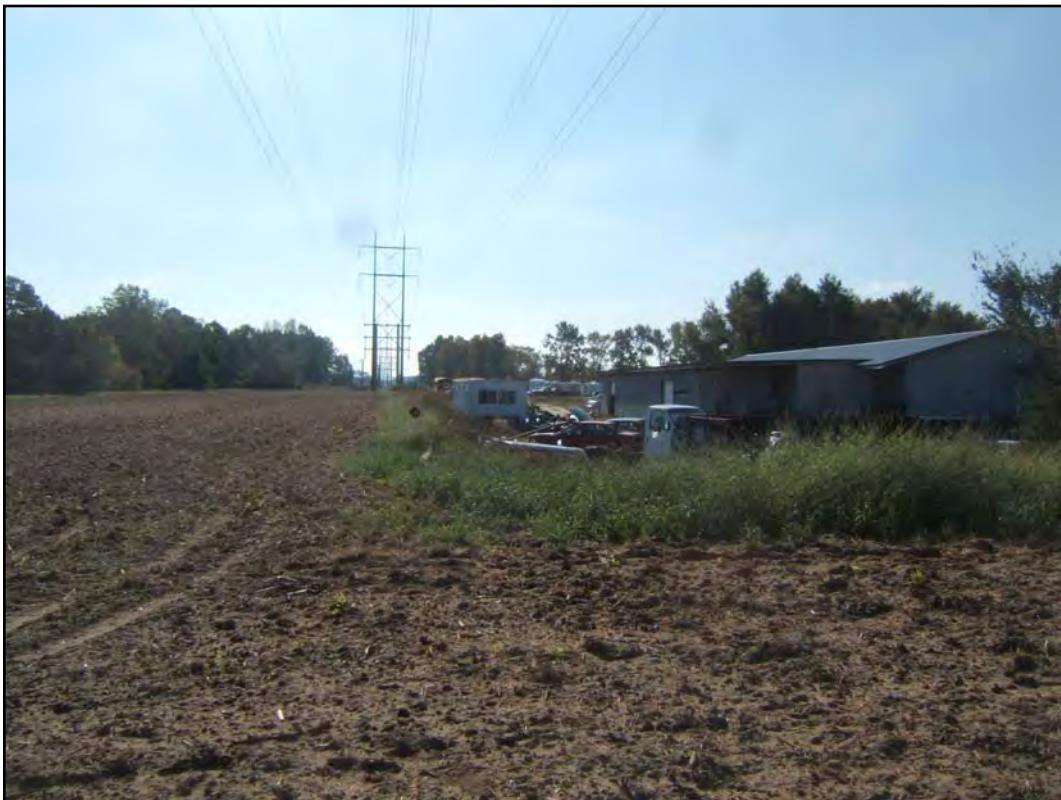
Figure 7.3. Photograph showing disturbance to Site 31CK36/31CK36, facing south.**

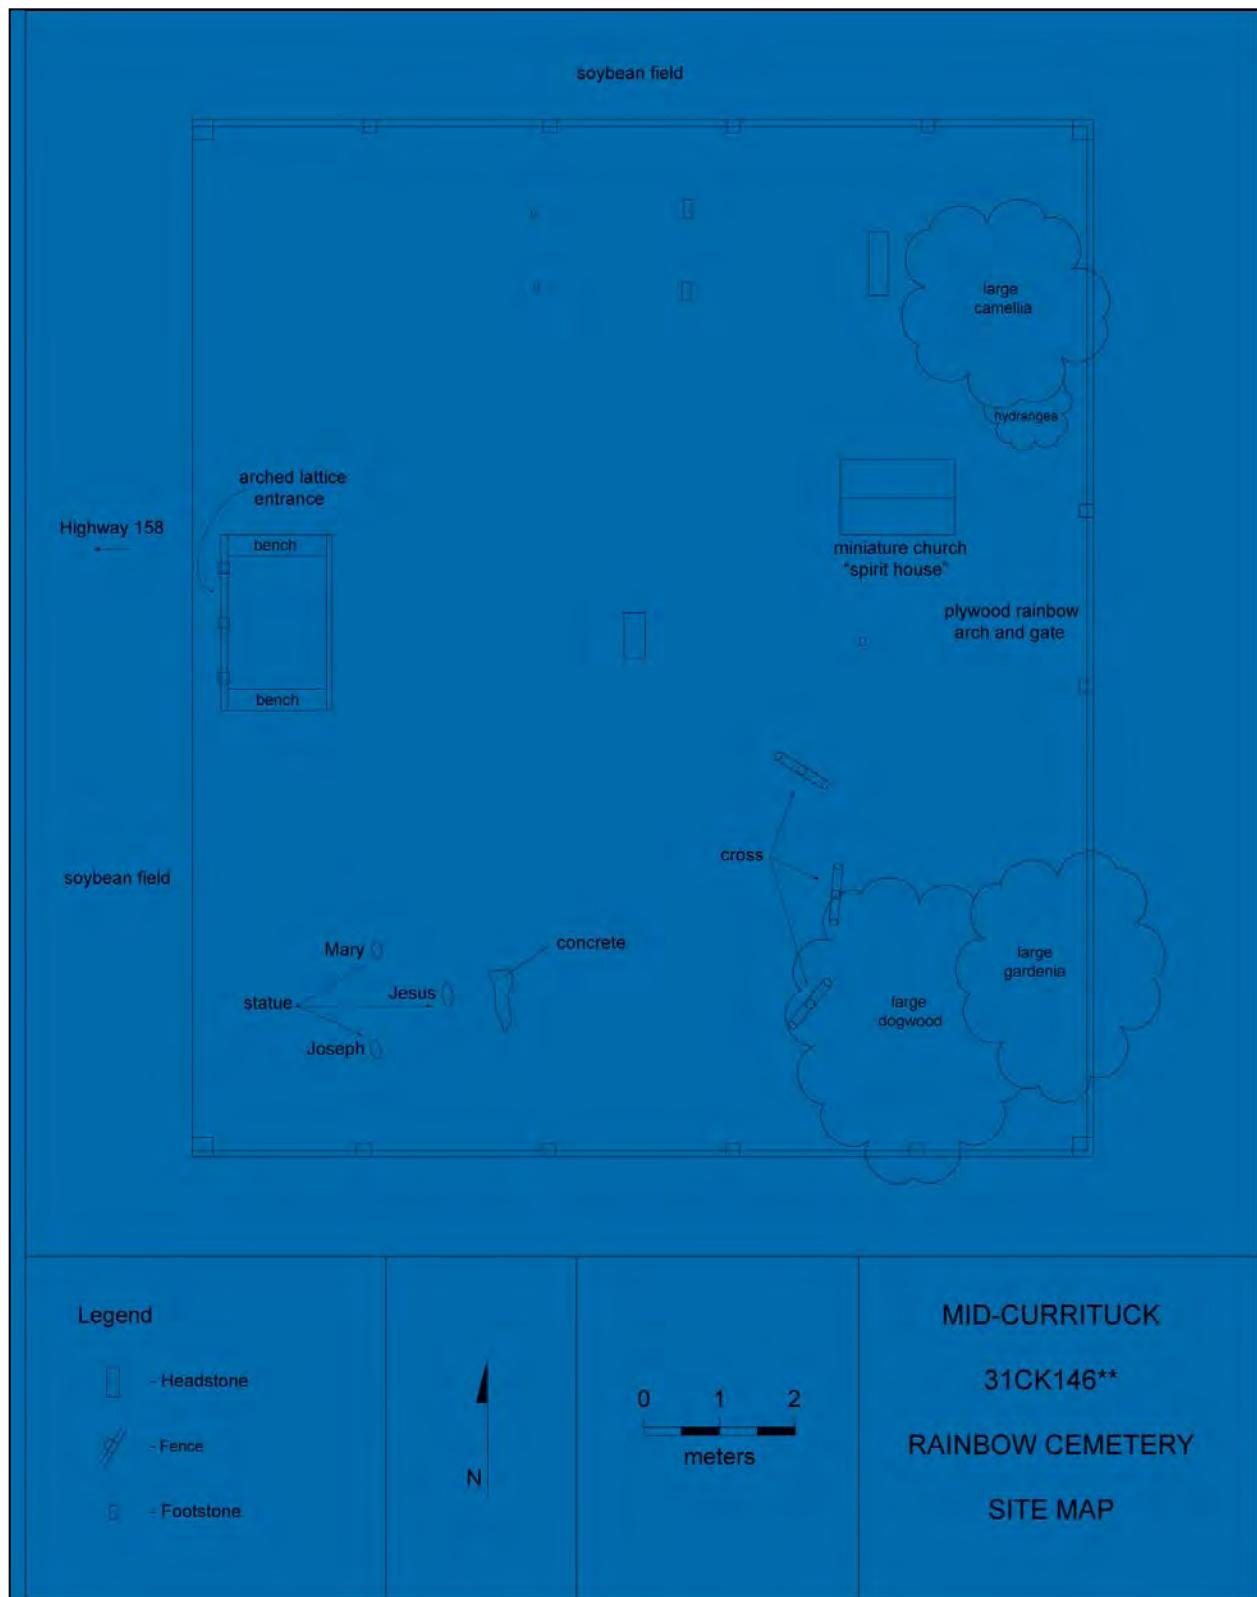
Figure 7.10. Site map for Site 31CK146**.

in a soybean field. There is a fenced enclosure surrounding the graves that measures approximately 14 m north-south by 12 m east-west (Figure 7.10). Presently there are four headstones visible at this location with internment dates ranging between 1906 and 2001. The oldest is the grave of Captain William M. Burton who was Dempsey Burton's grandson. The remaining graves consist of two individuals with the last name of Parker and one with the last name of Sneed.

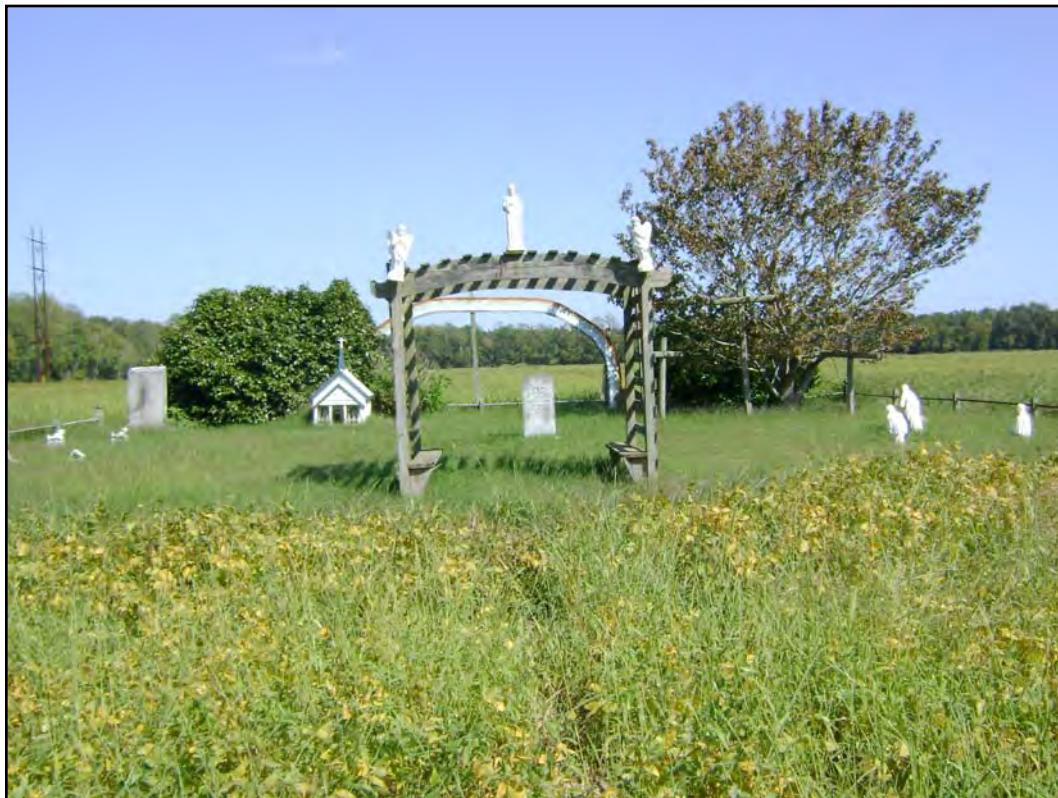
Figure 7.11. Photograph of Site 31CK146** Dempsey Burton Cemetery, facing east.

What is notable about this cemetery is the elaborate way in which it has been decorated (Figure 7.11). There is a gateway along the eastern perimeter that has a plywood arch built over it that has been painted like a rainbow. An accompanying plywood pot of gold is situated at the southern end of the rainbow. Just a few meters west of this gate there is what appears to be a "spirit house." It unclear if this small dollhouse-like structure is covering a grave, but it takes the form of a church measuring 145 cm east-west by 1 m north-south. It has a gabled roof, lapped siding, and its windows have had pieces of various colored broken glass arranged in the opening to give the appearance of stained glass (Figure 7.12). There is a functioning door on the west side of the structure and at the time this site was visited, it was being utilized by a large groundhog as a façade hiding the entrance to his burrow within the spirit house.

Three large wooden crosses constructed out of pressure-treated landscape timbers stand to the south of the spirit house. The western side of the cemetery fence has collapsed but the original entrance is marked by a lattice archway that incorporates two bench seats. To the south of this there are plaster statues between 60 and 80 cm tall that depict Jesus, Mary, and Joseph (Figure 7.13). These figures stand before a piece of concrete that shows evidence of having had additional concrete plastered to its surface. The exact meaning of this is perhaps known only to the artist. The embellishments to this cemetery have been so energetically applied as to elevate them to the level of folk art.

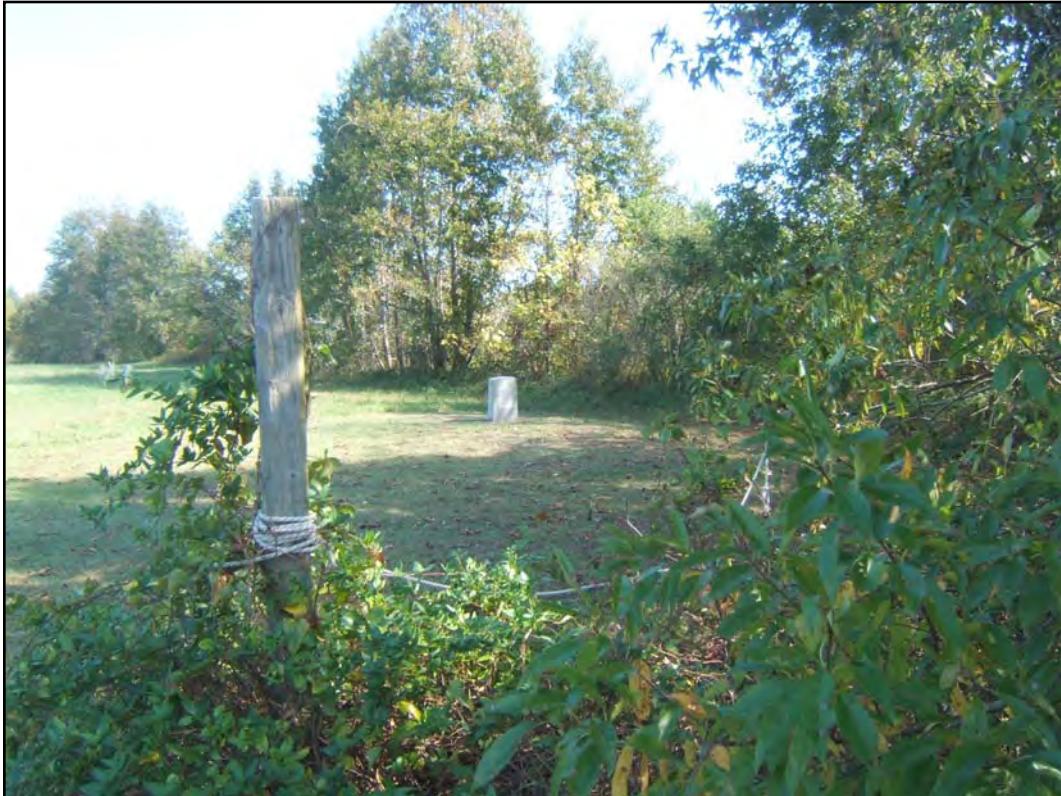
Figure 7.15. Photograph of Site 31CK174**, facing east-southeast.

These graves exist about 20 m east of Water Lily Road at its intersection with the modern corridor of U.S. 158 (Figure 7.14). The area is planted in grass and is bound by drainage ditches to the south and west (Figure 7.15). A local informant reported that the Ryckwald home had stood to the northeast of these graves (personal communication, Ned Markert 2011). There is a slight crown to the landform in that area that looks like a likely location for the home, but it is outside of the project area.

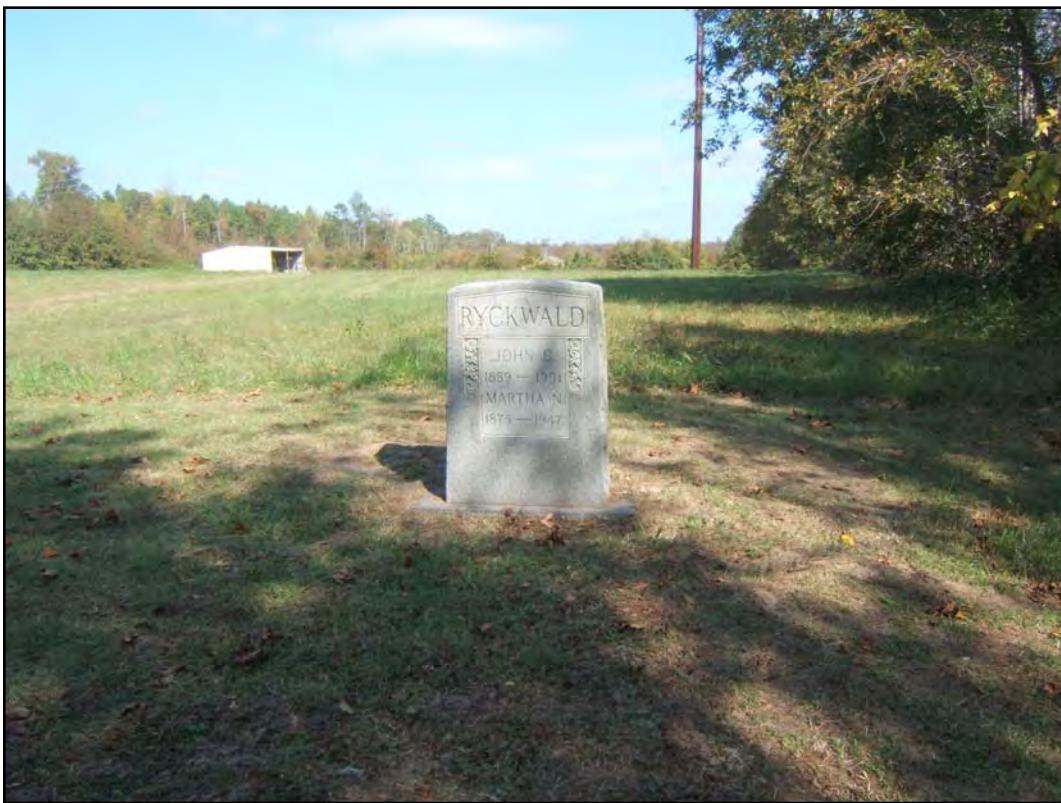
Figure 7.16. Photograph of headstone at Site 31CK174**, facing east.

Two graves are present here that mark the final resting place of John G. Ryckwald (1889 to 1951) and Martha N. Ryckwald (1875 to 1947). They are marked with a single headstone (Figure 7.16).
