REPORT OF FINDINGS

TERRESTRIAL AND UNDERWATER ARCHAEOLOGICAL SURVEY, AND SITE AND ANOMALY EVALUATION FOR THE PREFERRED ALTERNATIVE OF THE MID-CURRITUCK BRIDGE PROJECT IN CURRITUCK AND DARE COUNTIES, NORTH CAROLINA

STIP No. R-2576

REVISED DRAFT REPORT ♦ NOVEMBER 2012

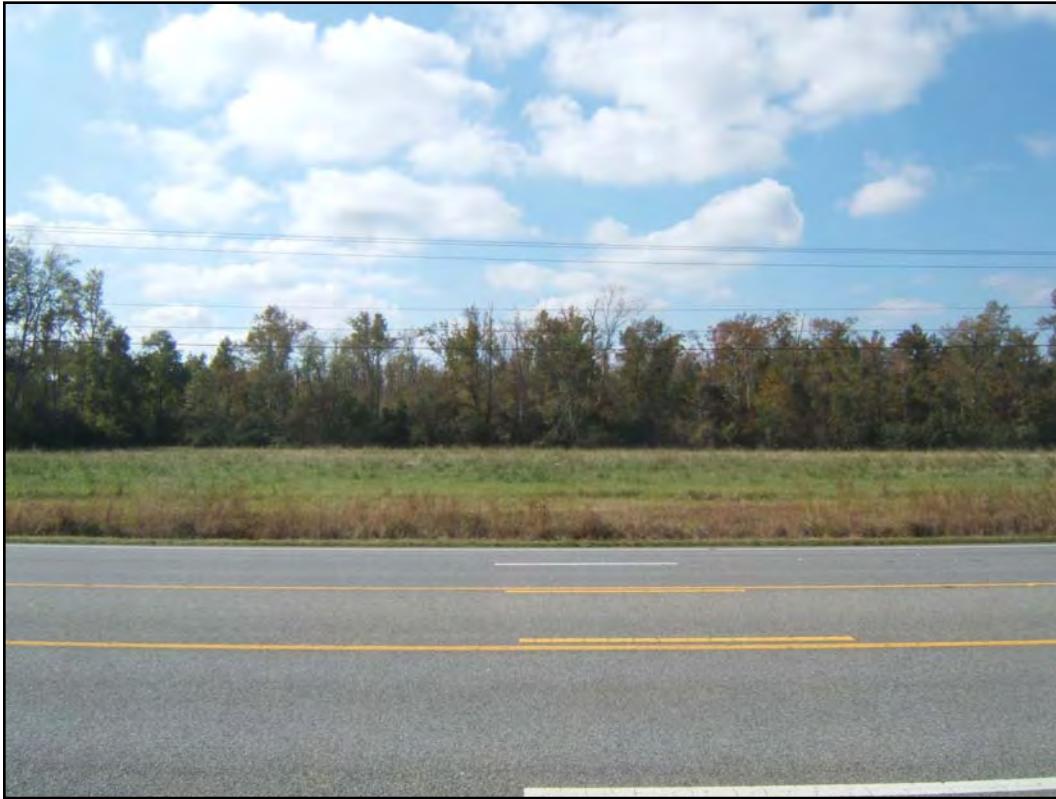
Figure 7.17. Photograph of Site 31CK216**, facing west.

Site 31CK216** was recorded in 2007 by the landowner. This occurrence is an isolated find that consisted of a bayonet and scabbard found on the ground surface. The site is located approximately 40 m west of U.S. 158 on a low rise in a flood plain that is part of the Pasquotank River drainage (Figure 7.17). The bayonet is twentieth century in origin and it was conjectured by the recorder that it was possibly a World War I weapon.

The coordinates for this site were visited during this survey and the area was found to be low and wet. The 25th shovel test dug on Transect 38 was on the same landform only 8 m north-northeast of this location and it filled with water at a depth of 20 cmbs. This area is low and marshy and unremarkable.

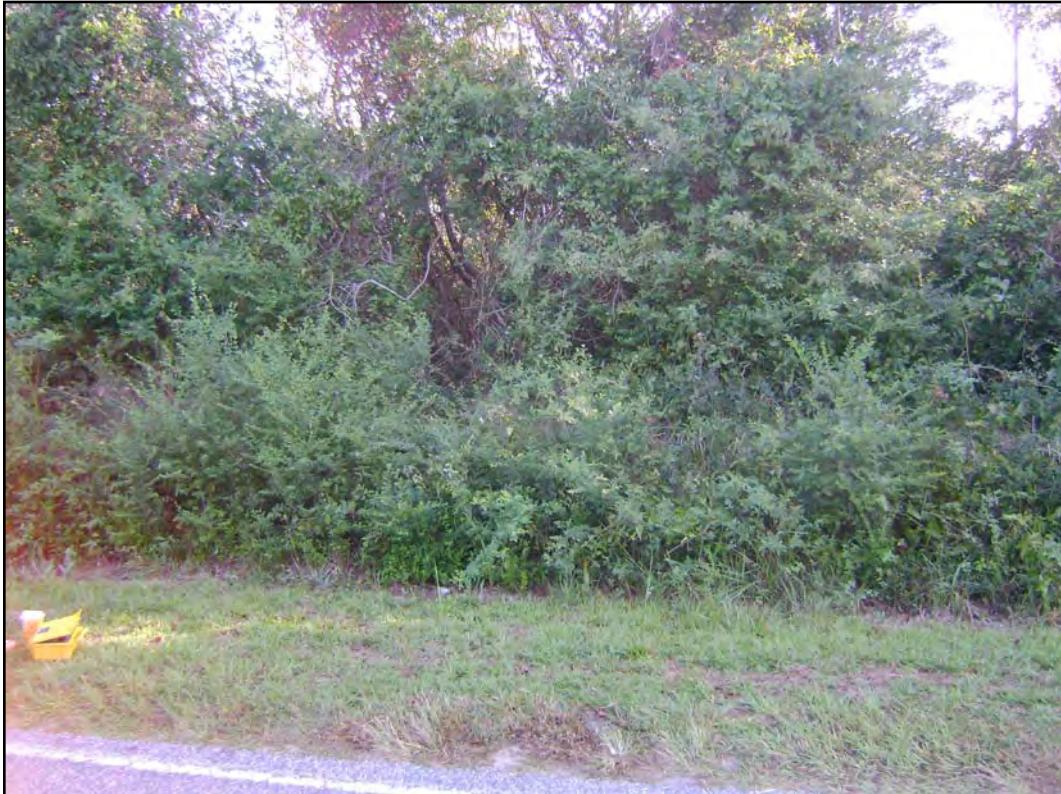
Figure 7.47. Photograph of Site 31CK229**, facing west.

This site is a late nineteenth to twentieth century artifact scatter with an associated house ruin and cemetery. The cemetery contains two marked graves and is located about 8 m west of Narrow Shore Road; the house itself is about 45 m west of this location. Only one of the graves has an epitaph, marking the final resting place of Mary E. Saunders who died in 1915 (Figure 7.46). Immediately around the graves the vegetation has been cleared, but the rest of the area is thickly forested with sweet gum, privet, sassafras, and a few cedars (Figure 7.47). The understory is choked with wisteria, wild roses, and green briar.

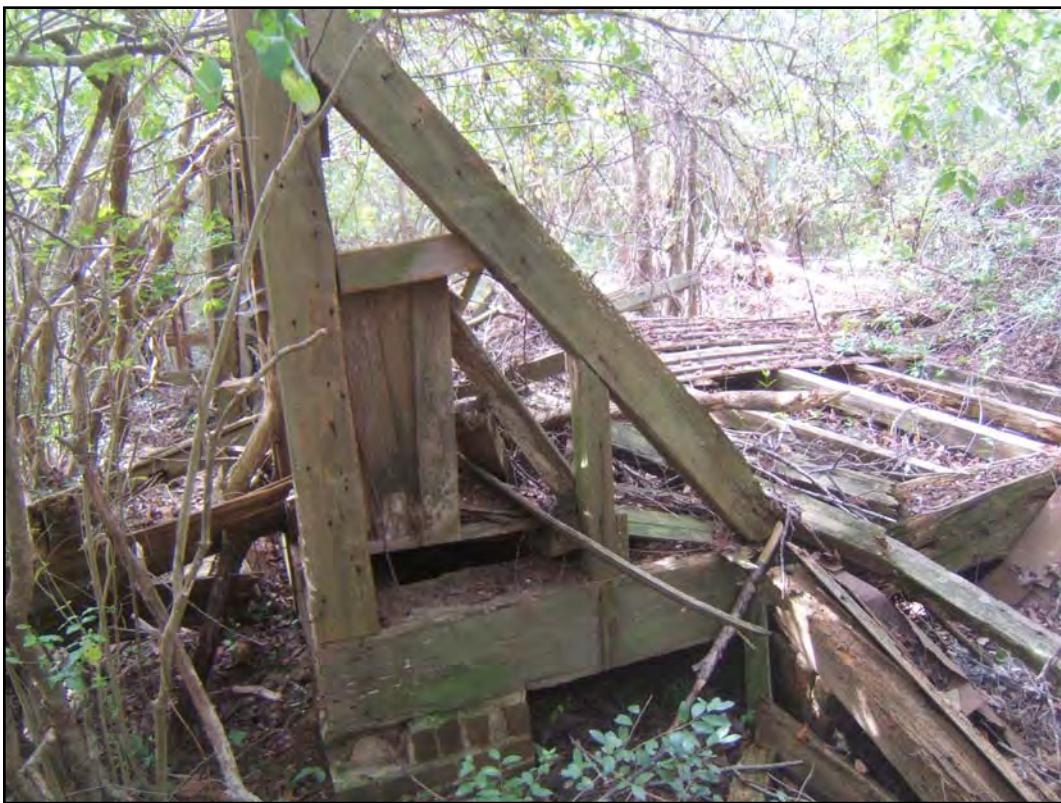
Figure 7.48. Photograph of house ruin at Site 31CK229**, facing southwest.

While it is in an advanced state of decay, portions of the house are still standing (Figure 7.48). The main living area of the house measured 20-x-30 ft. with the long axis running very close to north-south (355 degrees). There is a porch across the front of the house (east side) and a 12-x-12 ft. porch or room centered off the back. A 12-x-12 ft. detached kitchen sits 10 ft. behind this back room and there is some evidence that this gap had been spanned with a covered walkway. Approximately 15 ft. south of the kitchen is a ceramic-lined well 2 ft. in diameter (Figure 7.49). Wire nails dominate what is observable on the structure with one exception. At the southeast corner of the house there is still a section of the wall standing. These timbers have been assembled using a mortise and tenon technique and fastened with 3/4 inch wooden pegs and cut nails (Figure 7.50). The rafters which lie on top of the decomposing structure exhibit saw marks indicating they were milled, but the house sits on a 10-x-10 inch sill which shows some evidence of having at least been trued with an adze (Figure 7.51). The foundation piers were all constructed out of hand-made bricks, although one showed obvious signs of having been repaired with end-augured brick.

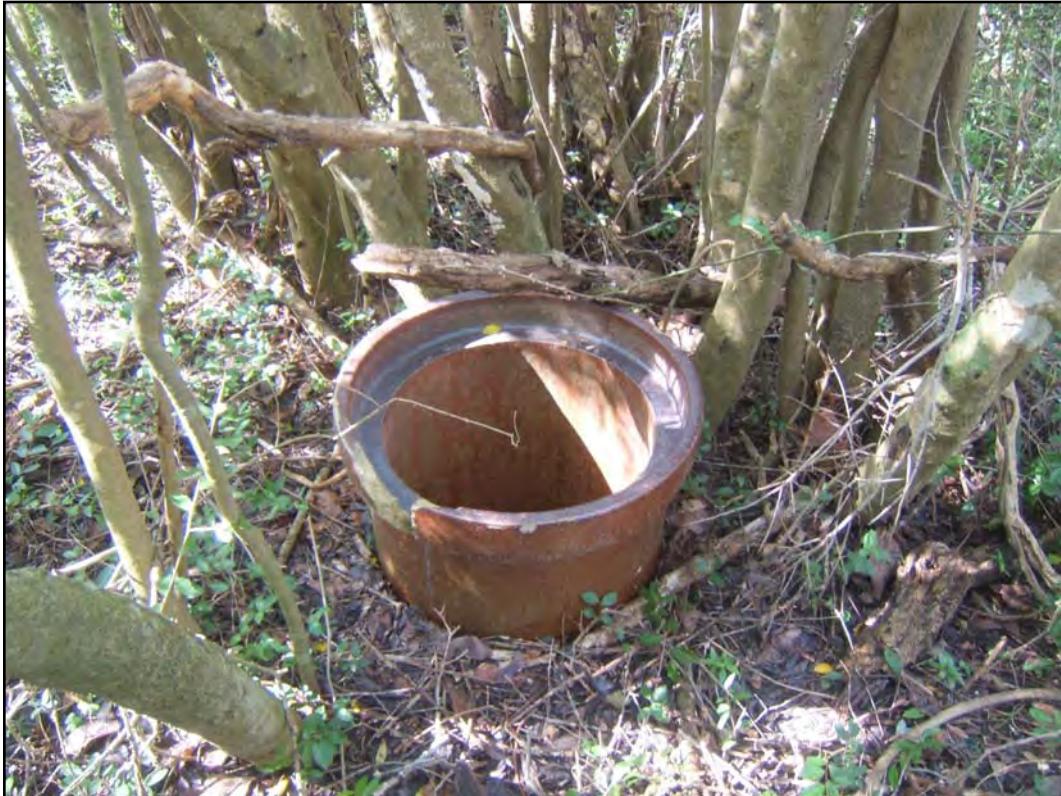
Figure 7.49. Photograph of ceramic-lined well at Site 31CK229**, facing southwest.

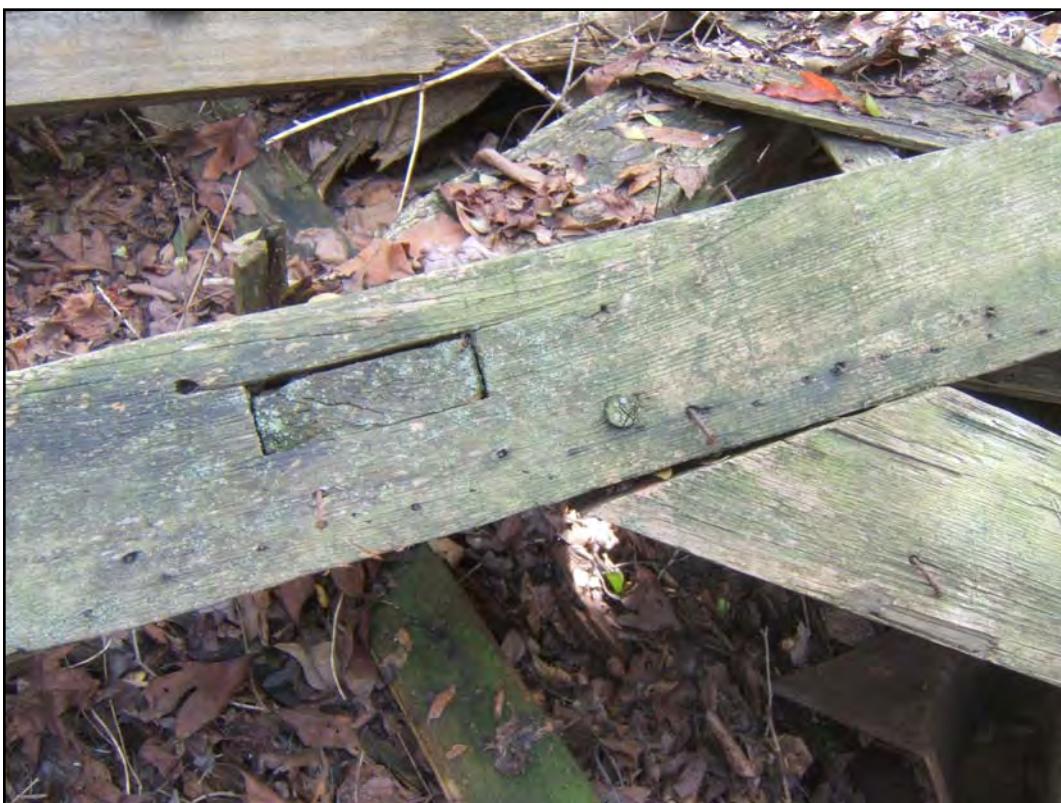
Figure 7.50. Photograph showing mortise and tenon joint and wooden pegs at Site 31CK229**, facing southeast.

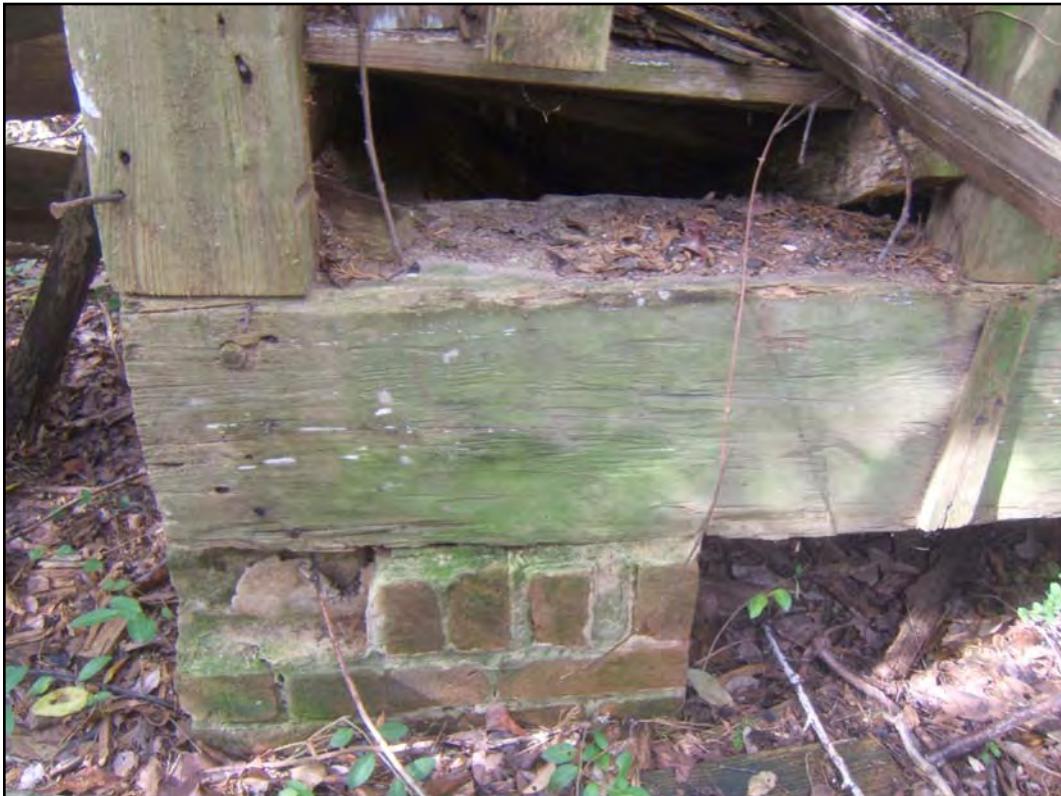
Figure 7.51. Photograph of adze marks and wooden pegs at Site 31CK229**, facing west.

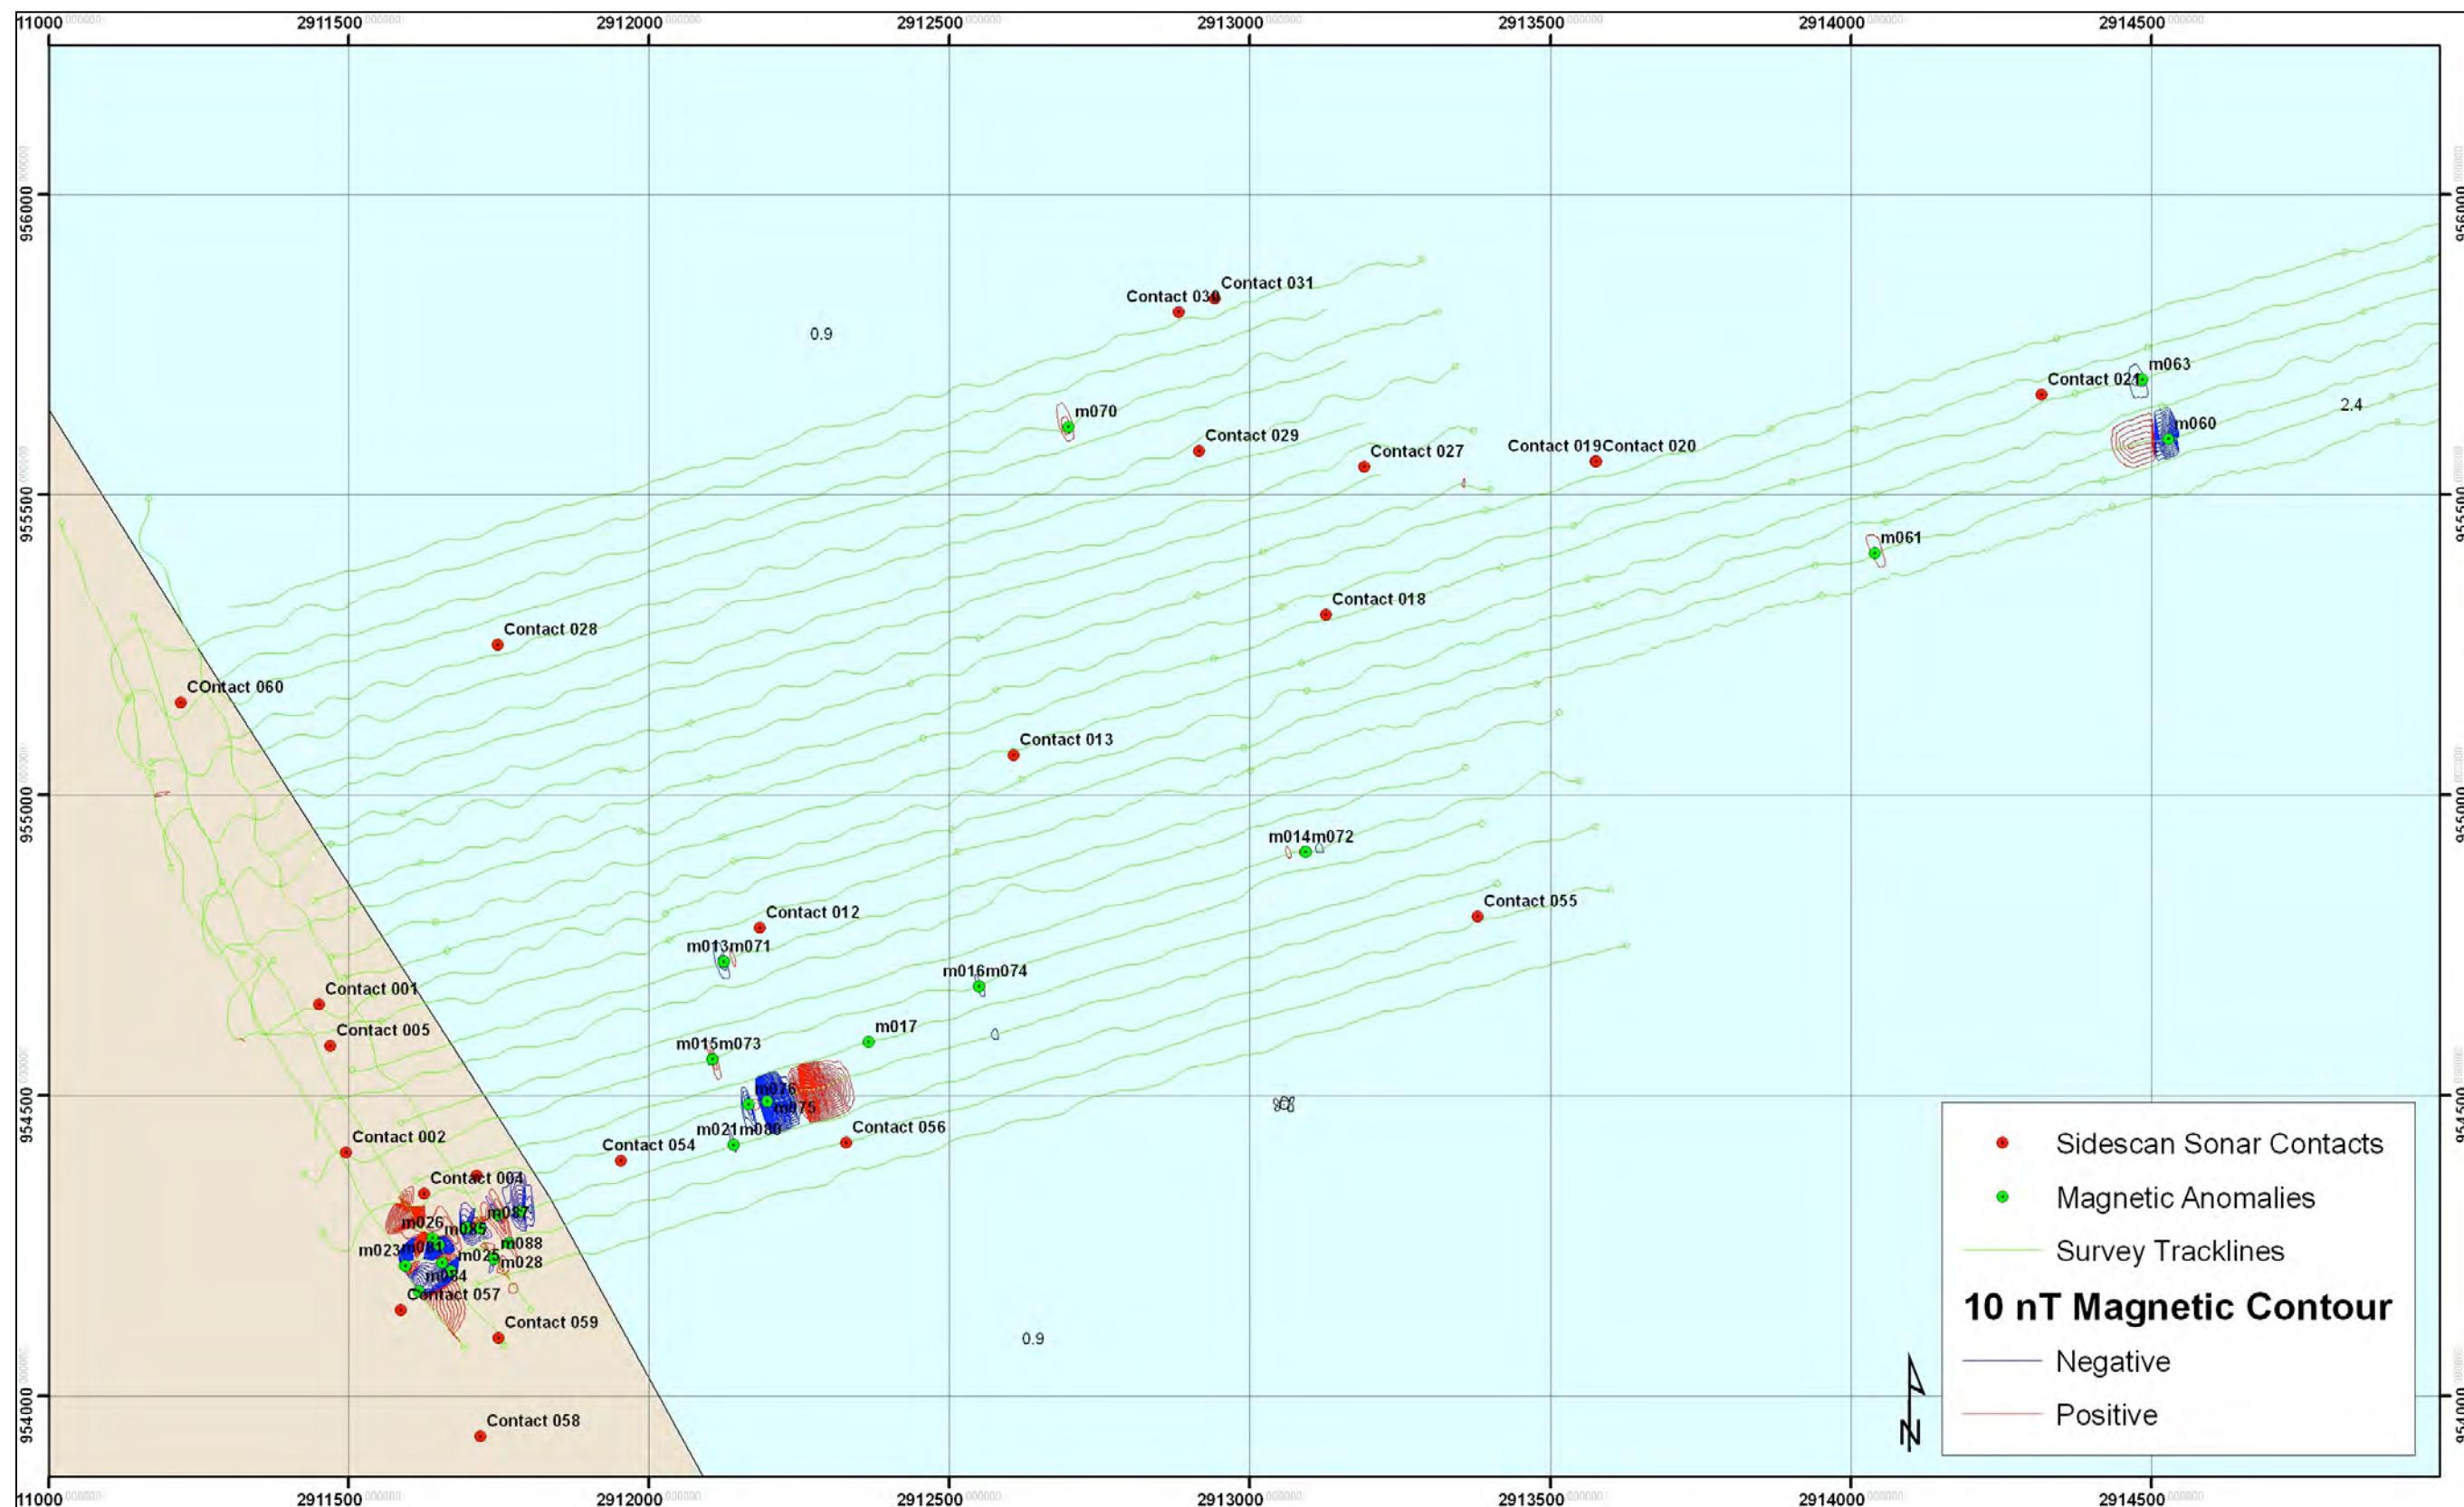
Figure 8.2. Magnetic Contour Map 1 showing coverage of the western side of the bridge corridor. Note both magnetic anomalies and sidescan sonar targets are shown. Large magnetic cluster at bottom left is a dock well outside of the ROW. Survey grid is in feet.

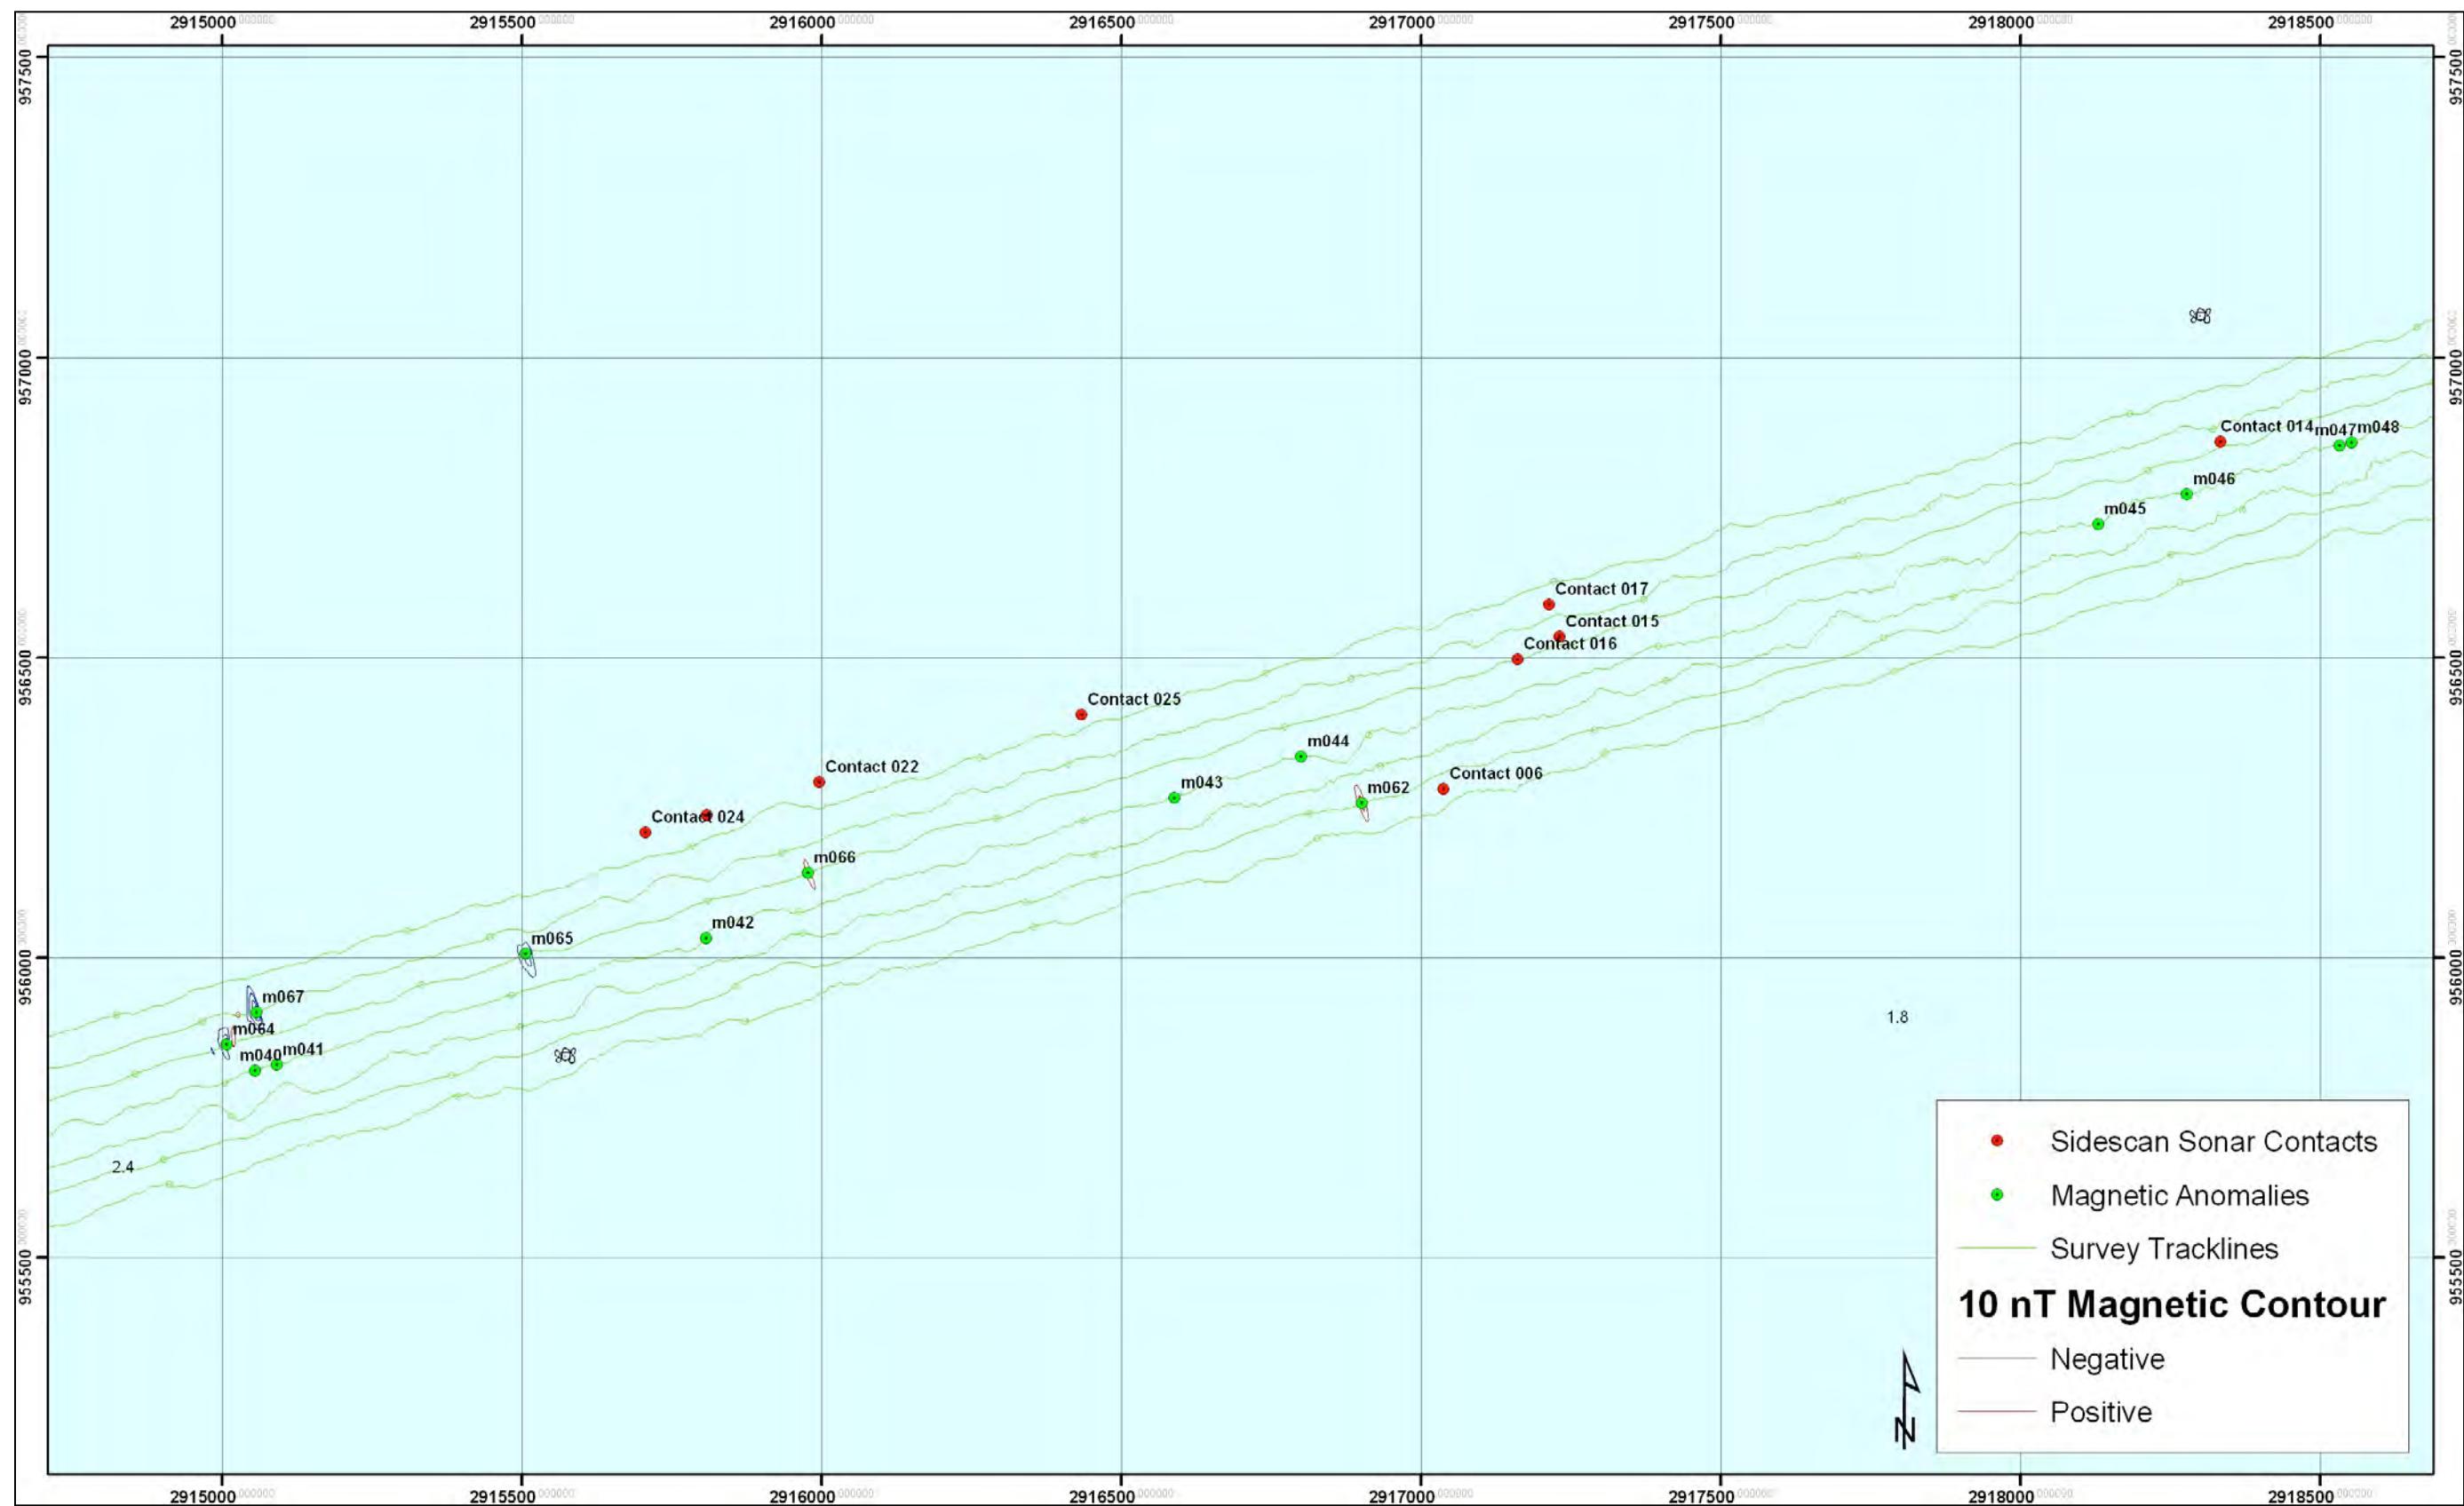
Figure 8.3. Magnetic Contour Map 2. Note both magnetic anomalies and sidescan sonar targets are shown. Survey grid is in feet.

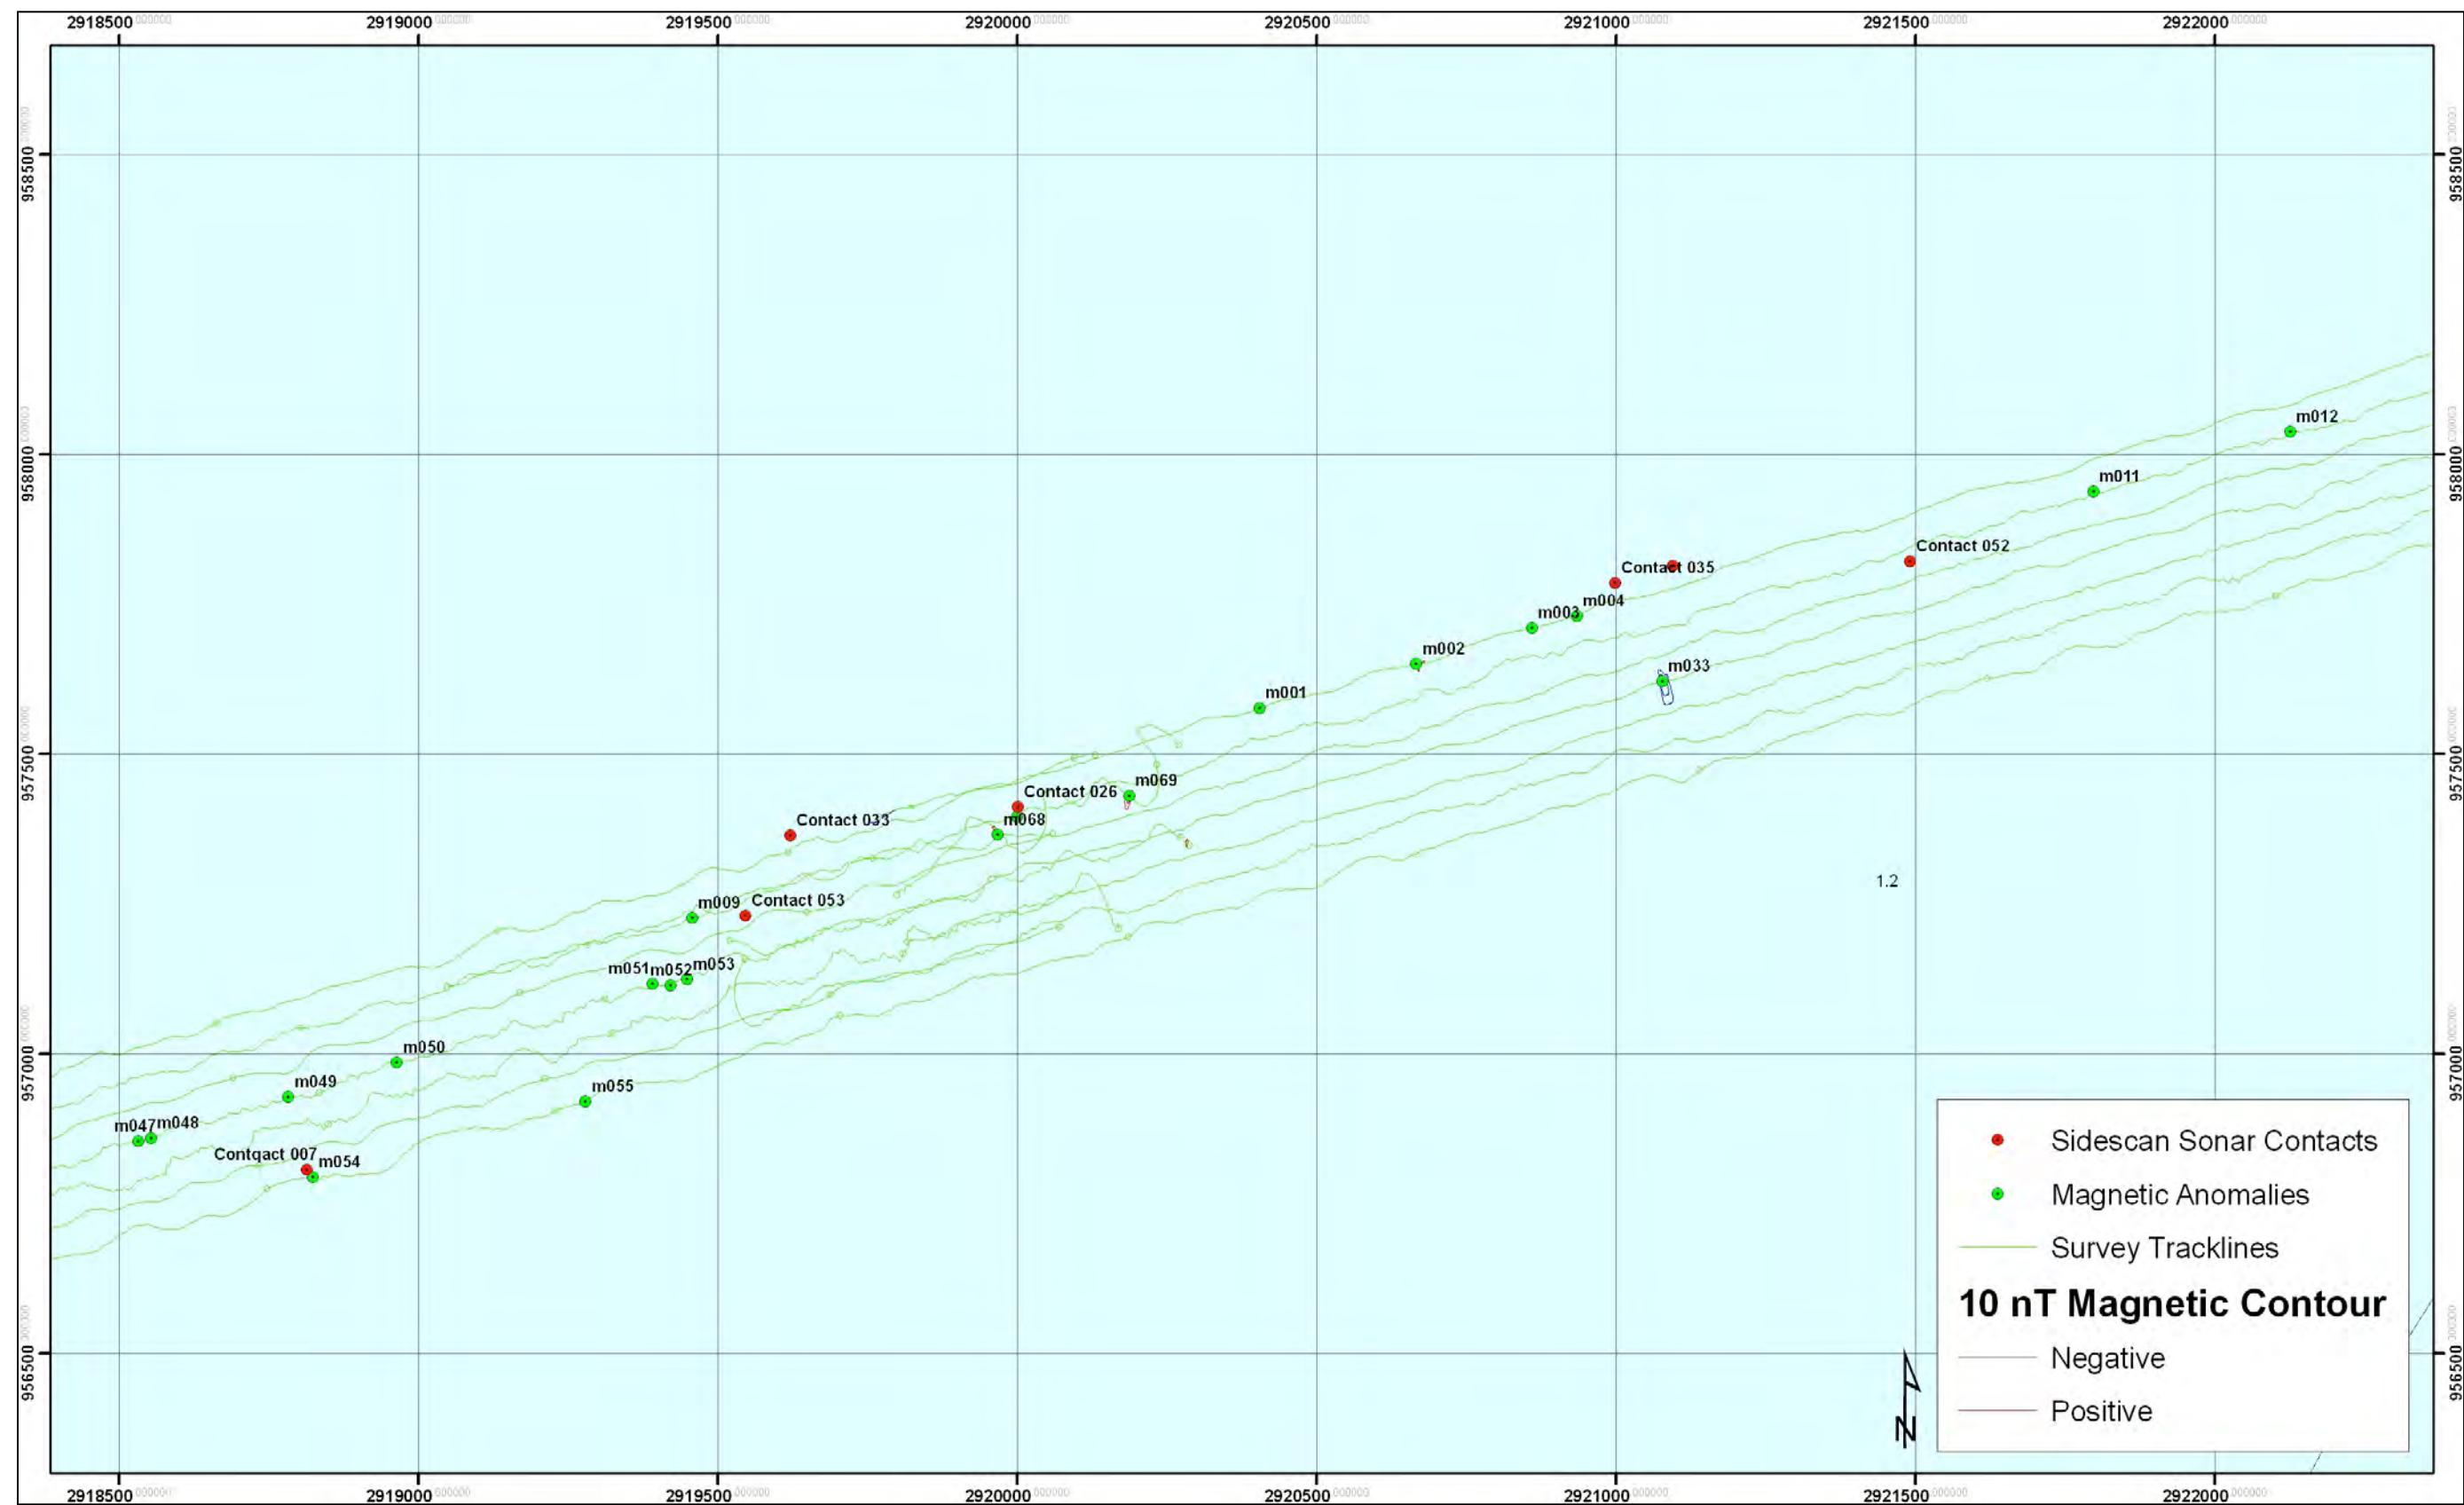
Figure 8.4. Magnetic Contour Map 3. Note both magnetic anomalies and sidescan sonar targets are shown. Survey grid is in feet.

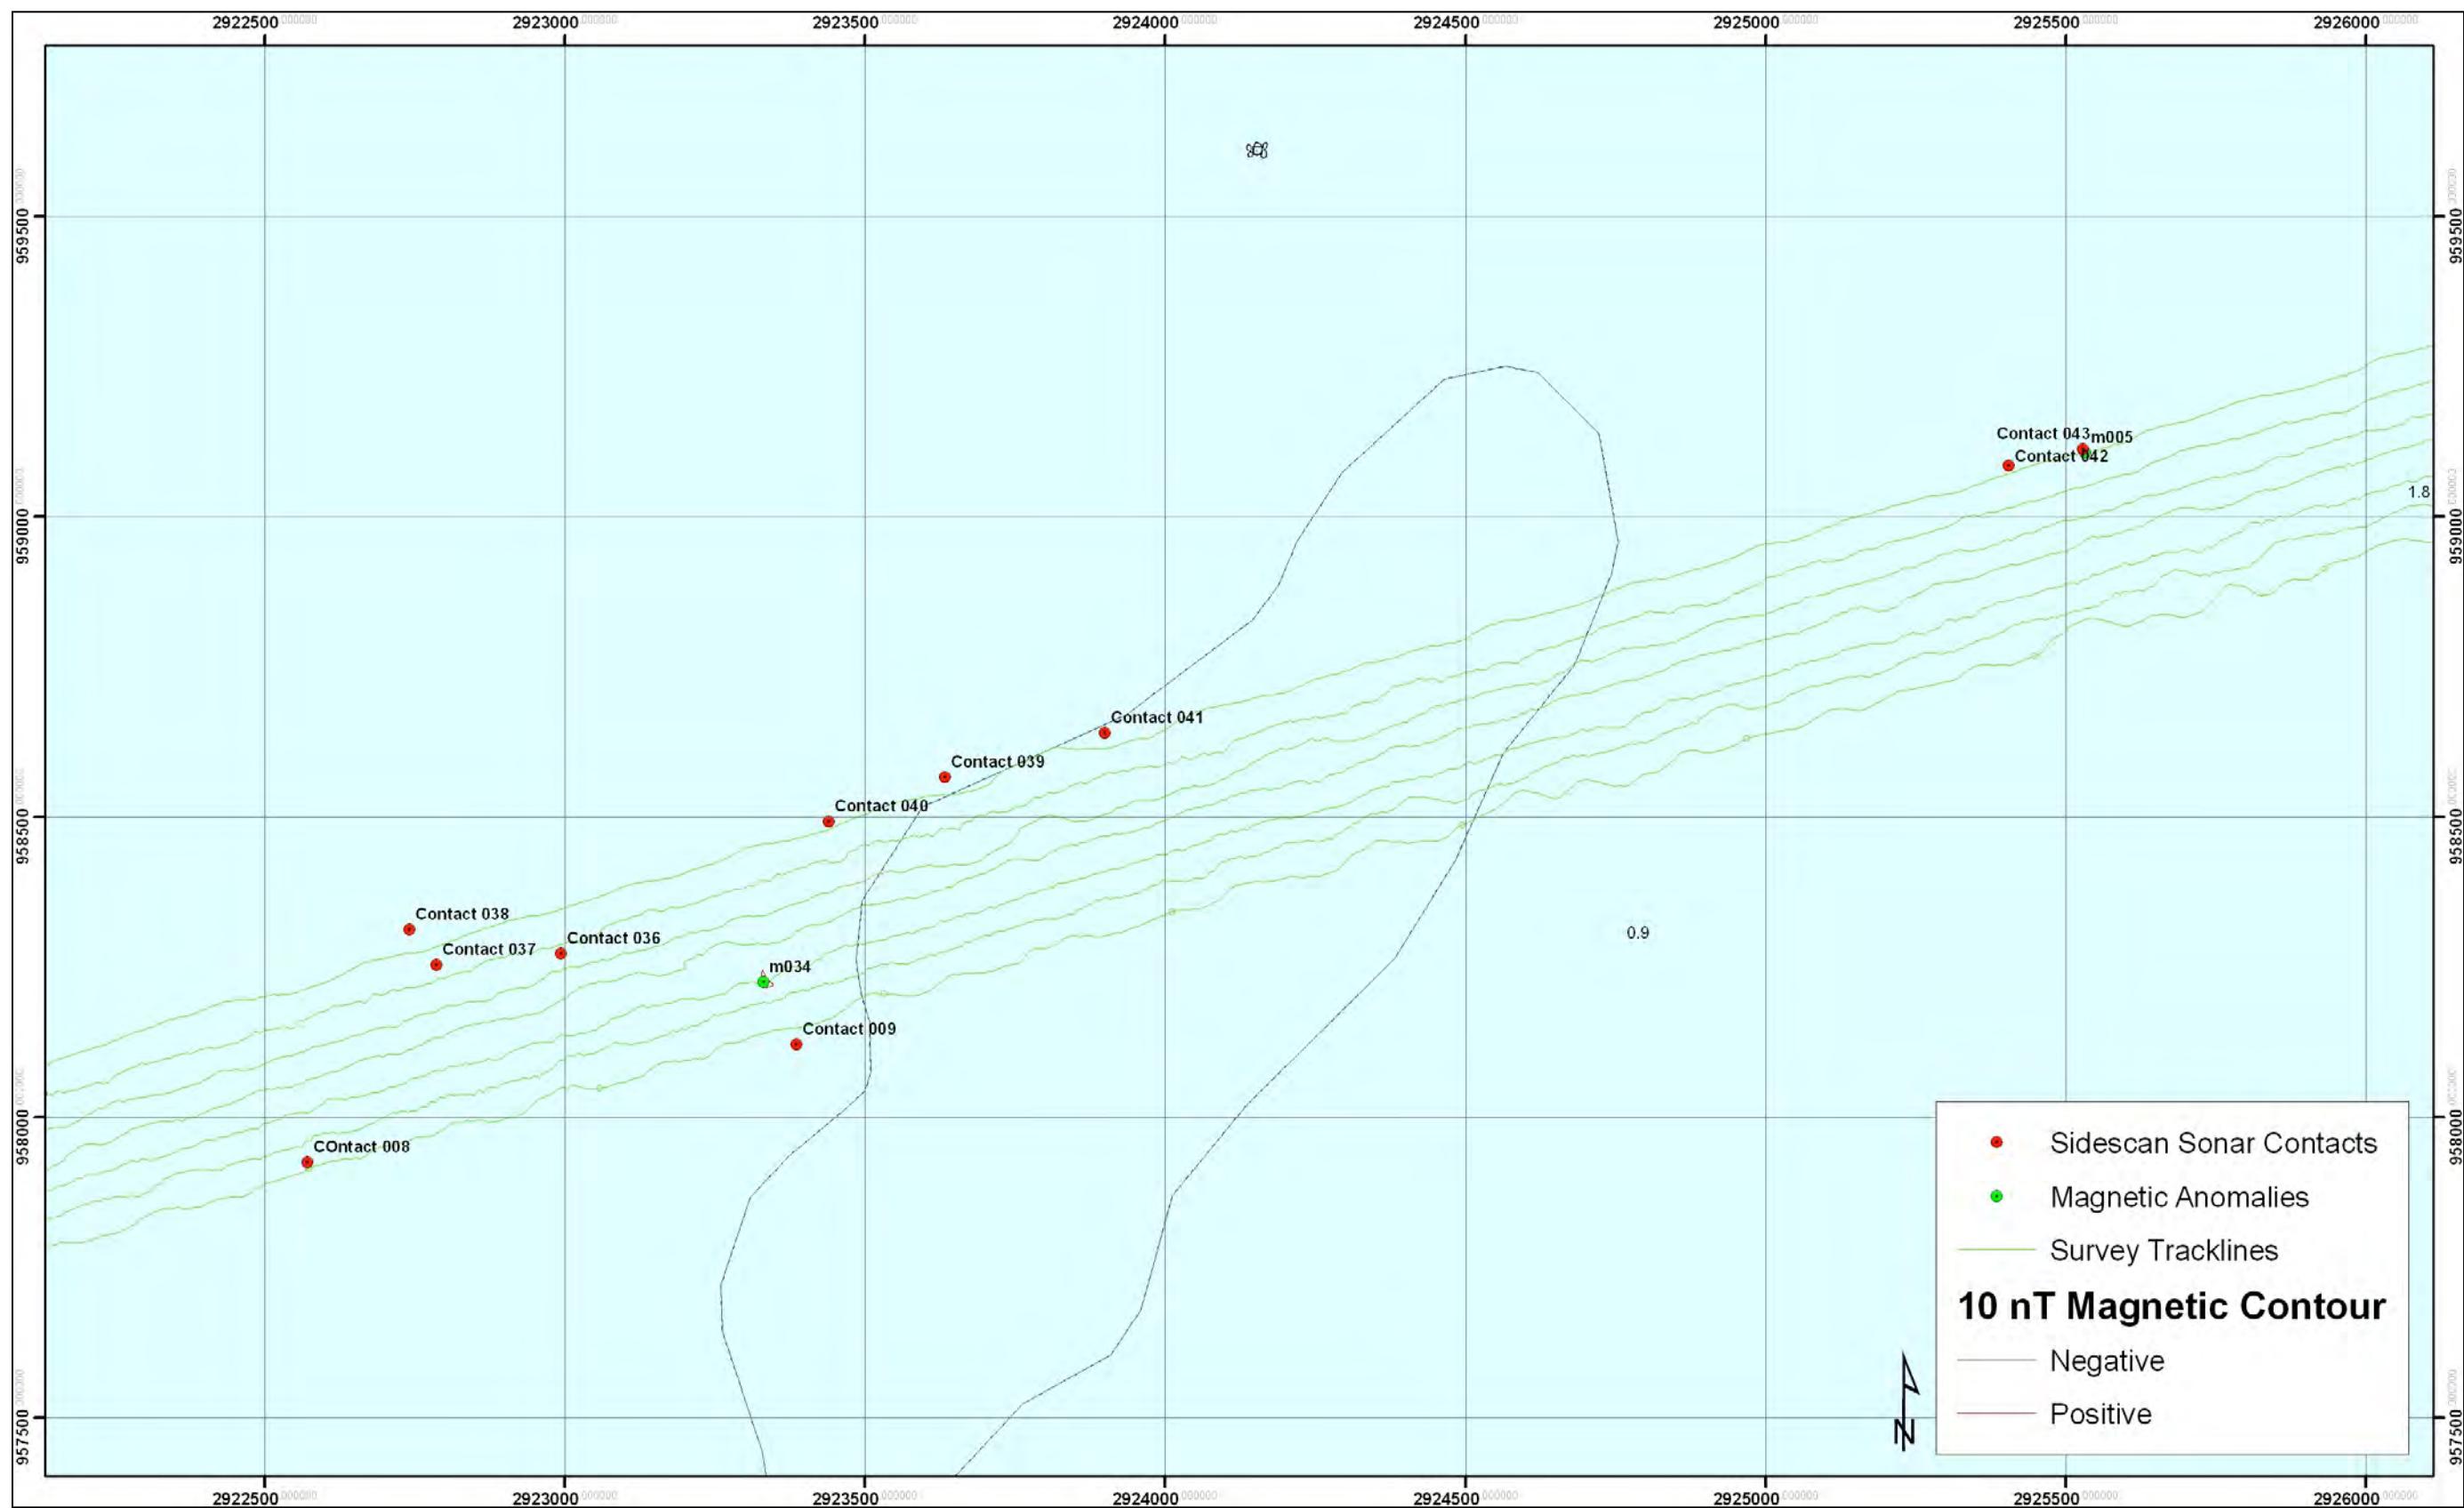
Figure 8.5. Magnetic Contour Map 4. Note both magnetic anomalies and sidescan sonar targets are shown. Survey grid is in feet
