REPORT OF FINDINGS

TERRESTRIAL AND UNDERWATER ARCHAEOLOGICAL SURVEY, AND SITE AND ANOMALY EVALUATION FOR THE PREFERRED ALTERNATIVE OF THE MID-CURRITUCK BRIDGE PROJECT IN CURRITUCK AND DARE COUNTIES, NORTH CAROLINA

STIP No. R-2576

REVISED DRAFT REPORT ♦ NOVEMBER 2012

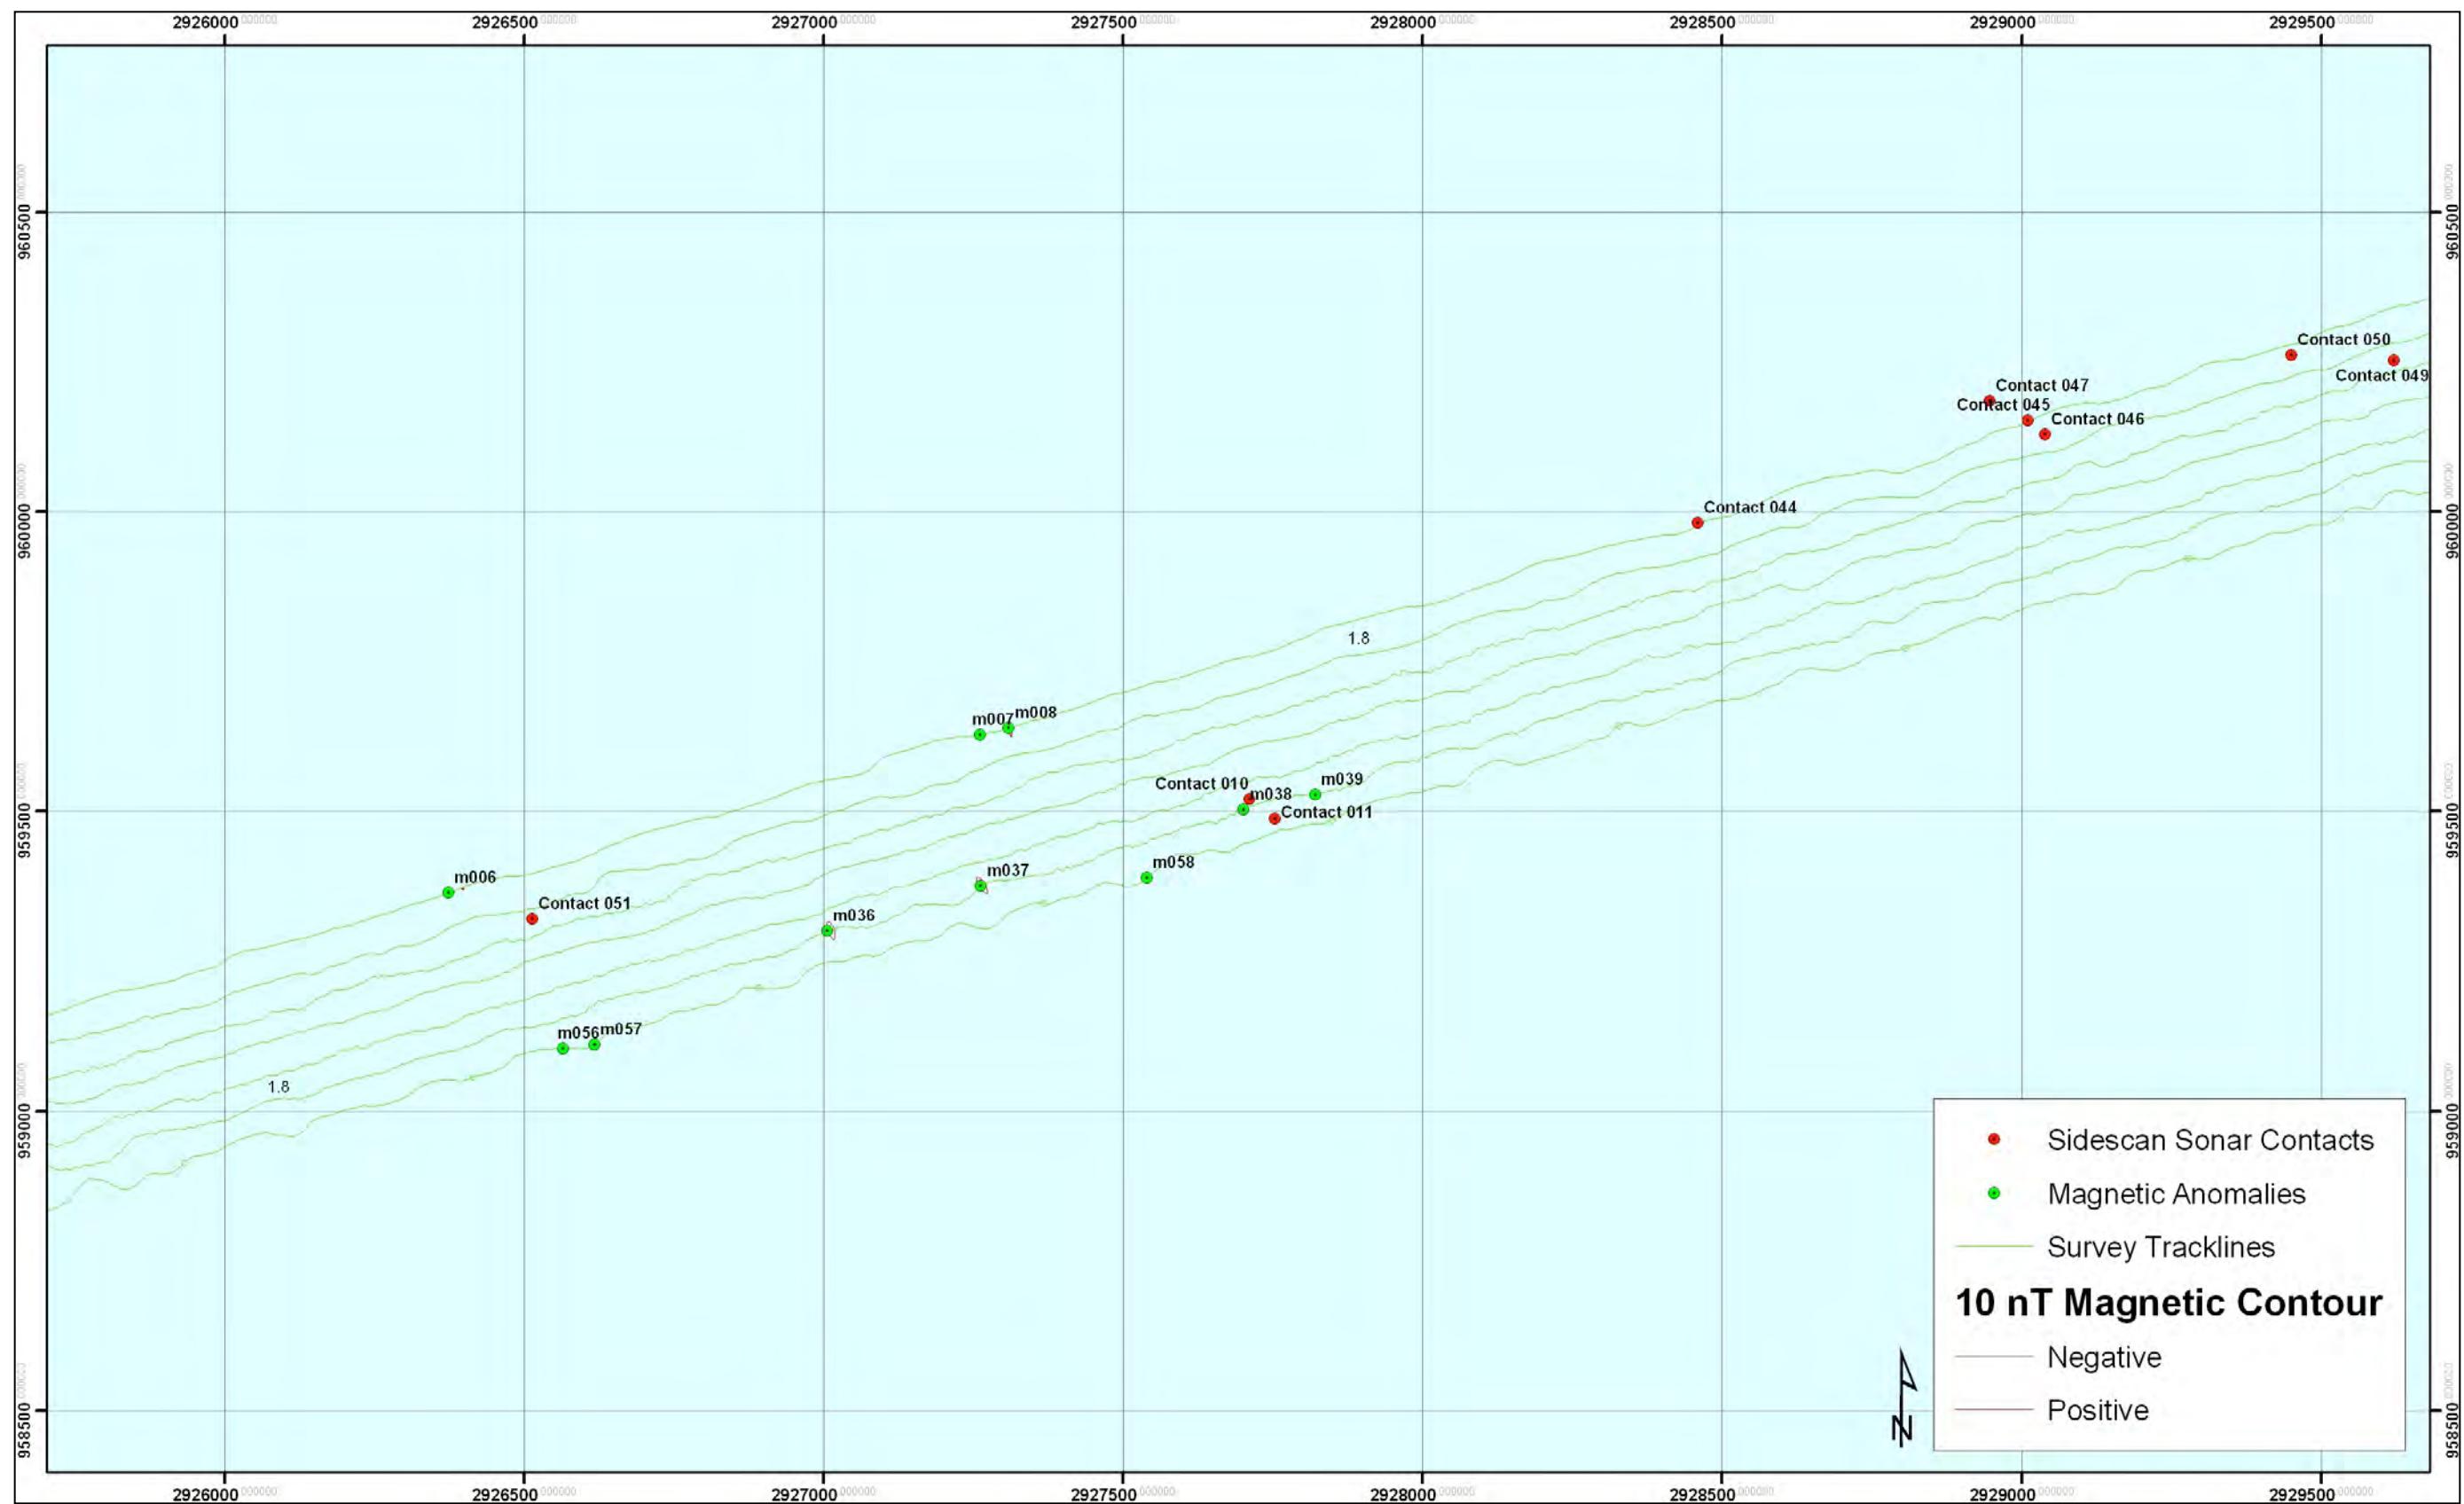
Figure 8.6. Magnetic Contour Map 5. Note both magnetic anomalies and sidescan sonar targets are shown. Survey grid is in feet.

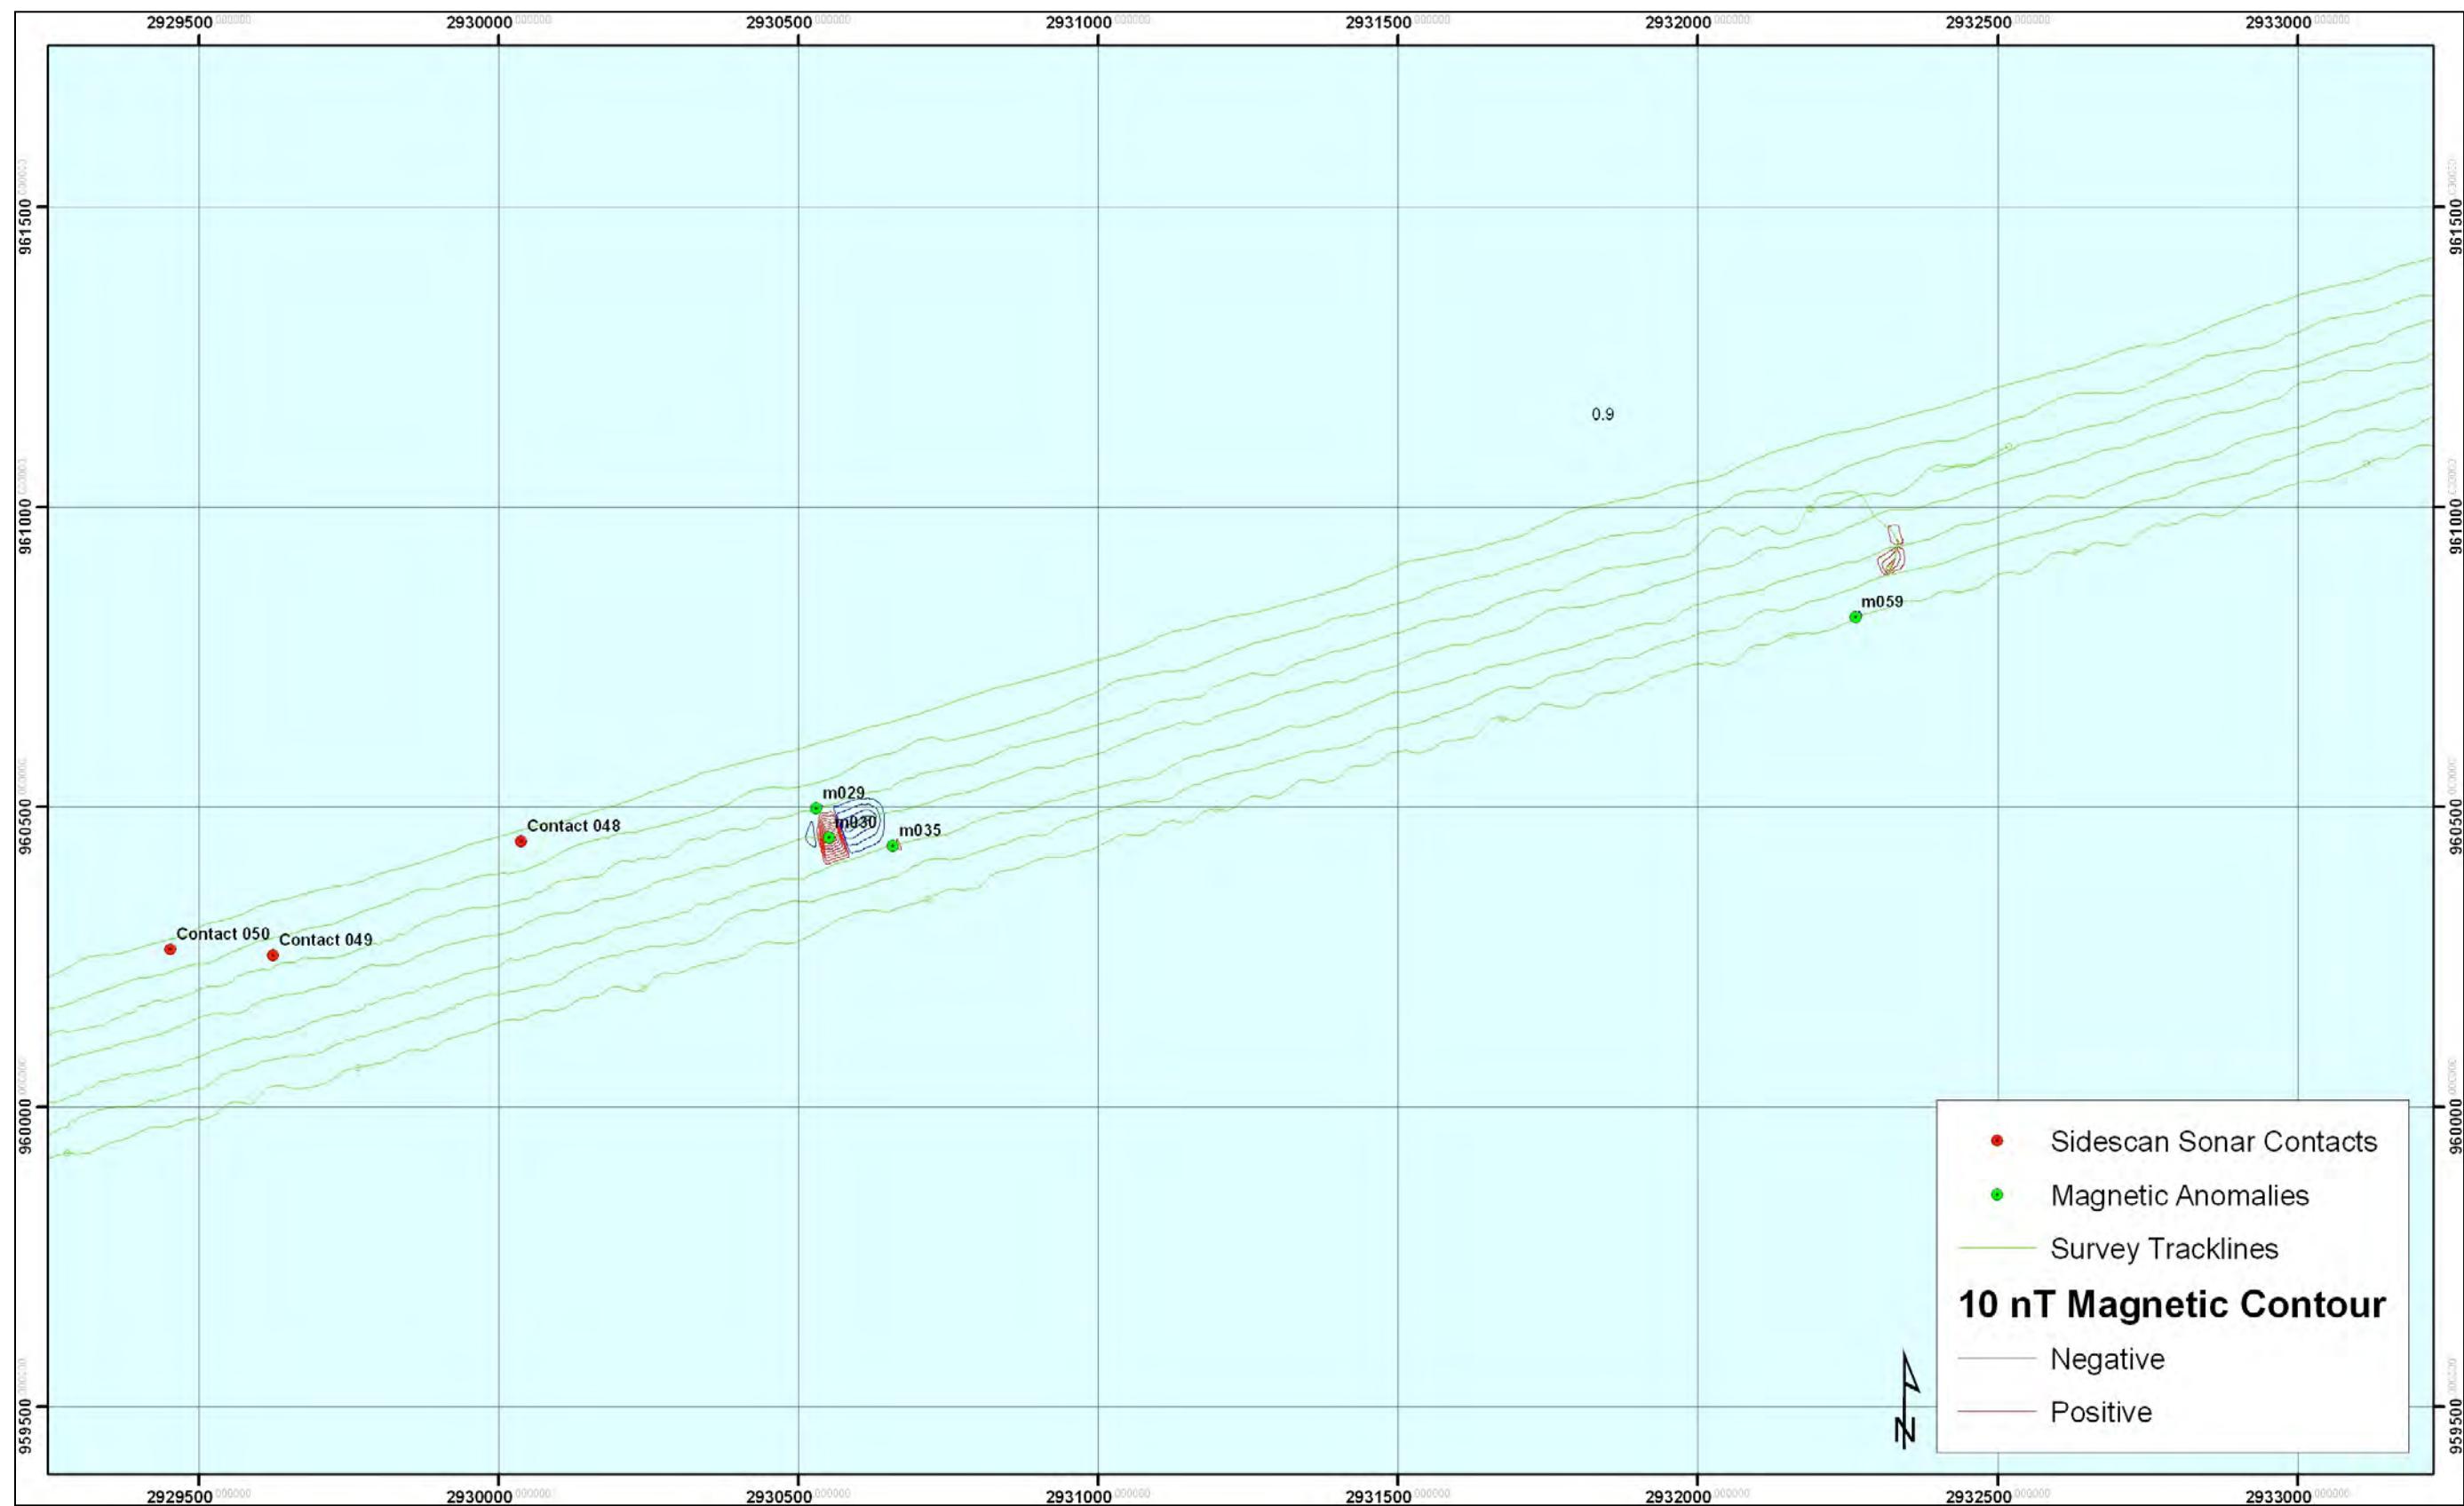
Figure 8.7. Magnetic Contour Map 6. Note both magnetic anomalies and sidescan sonar targets are shown. Survey grid is in feet.

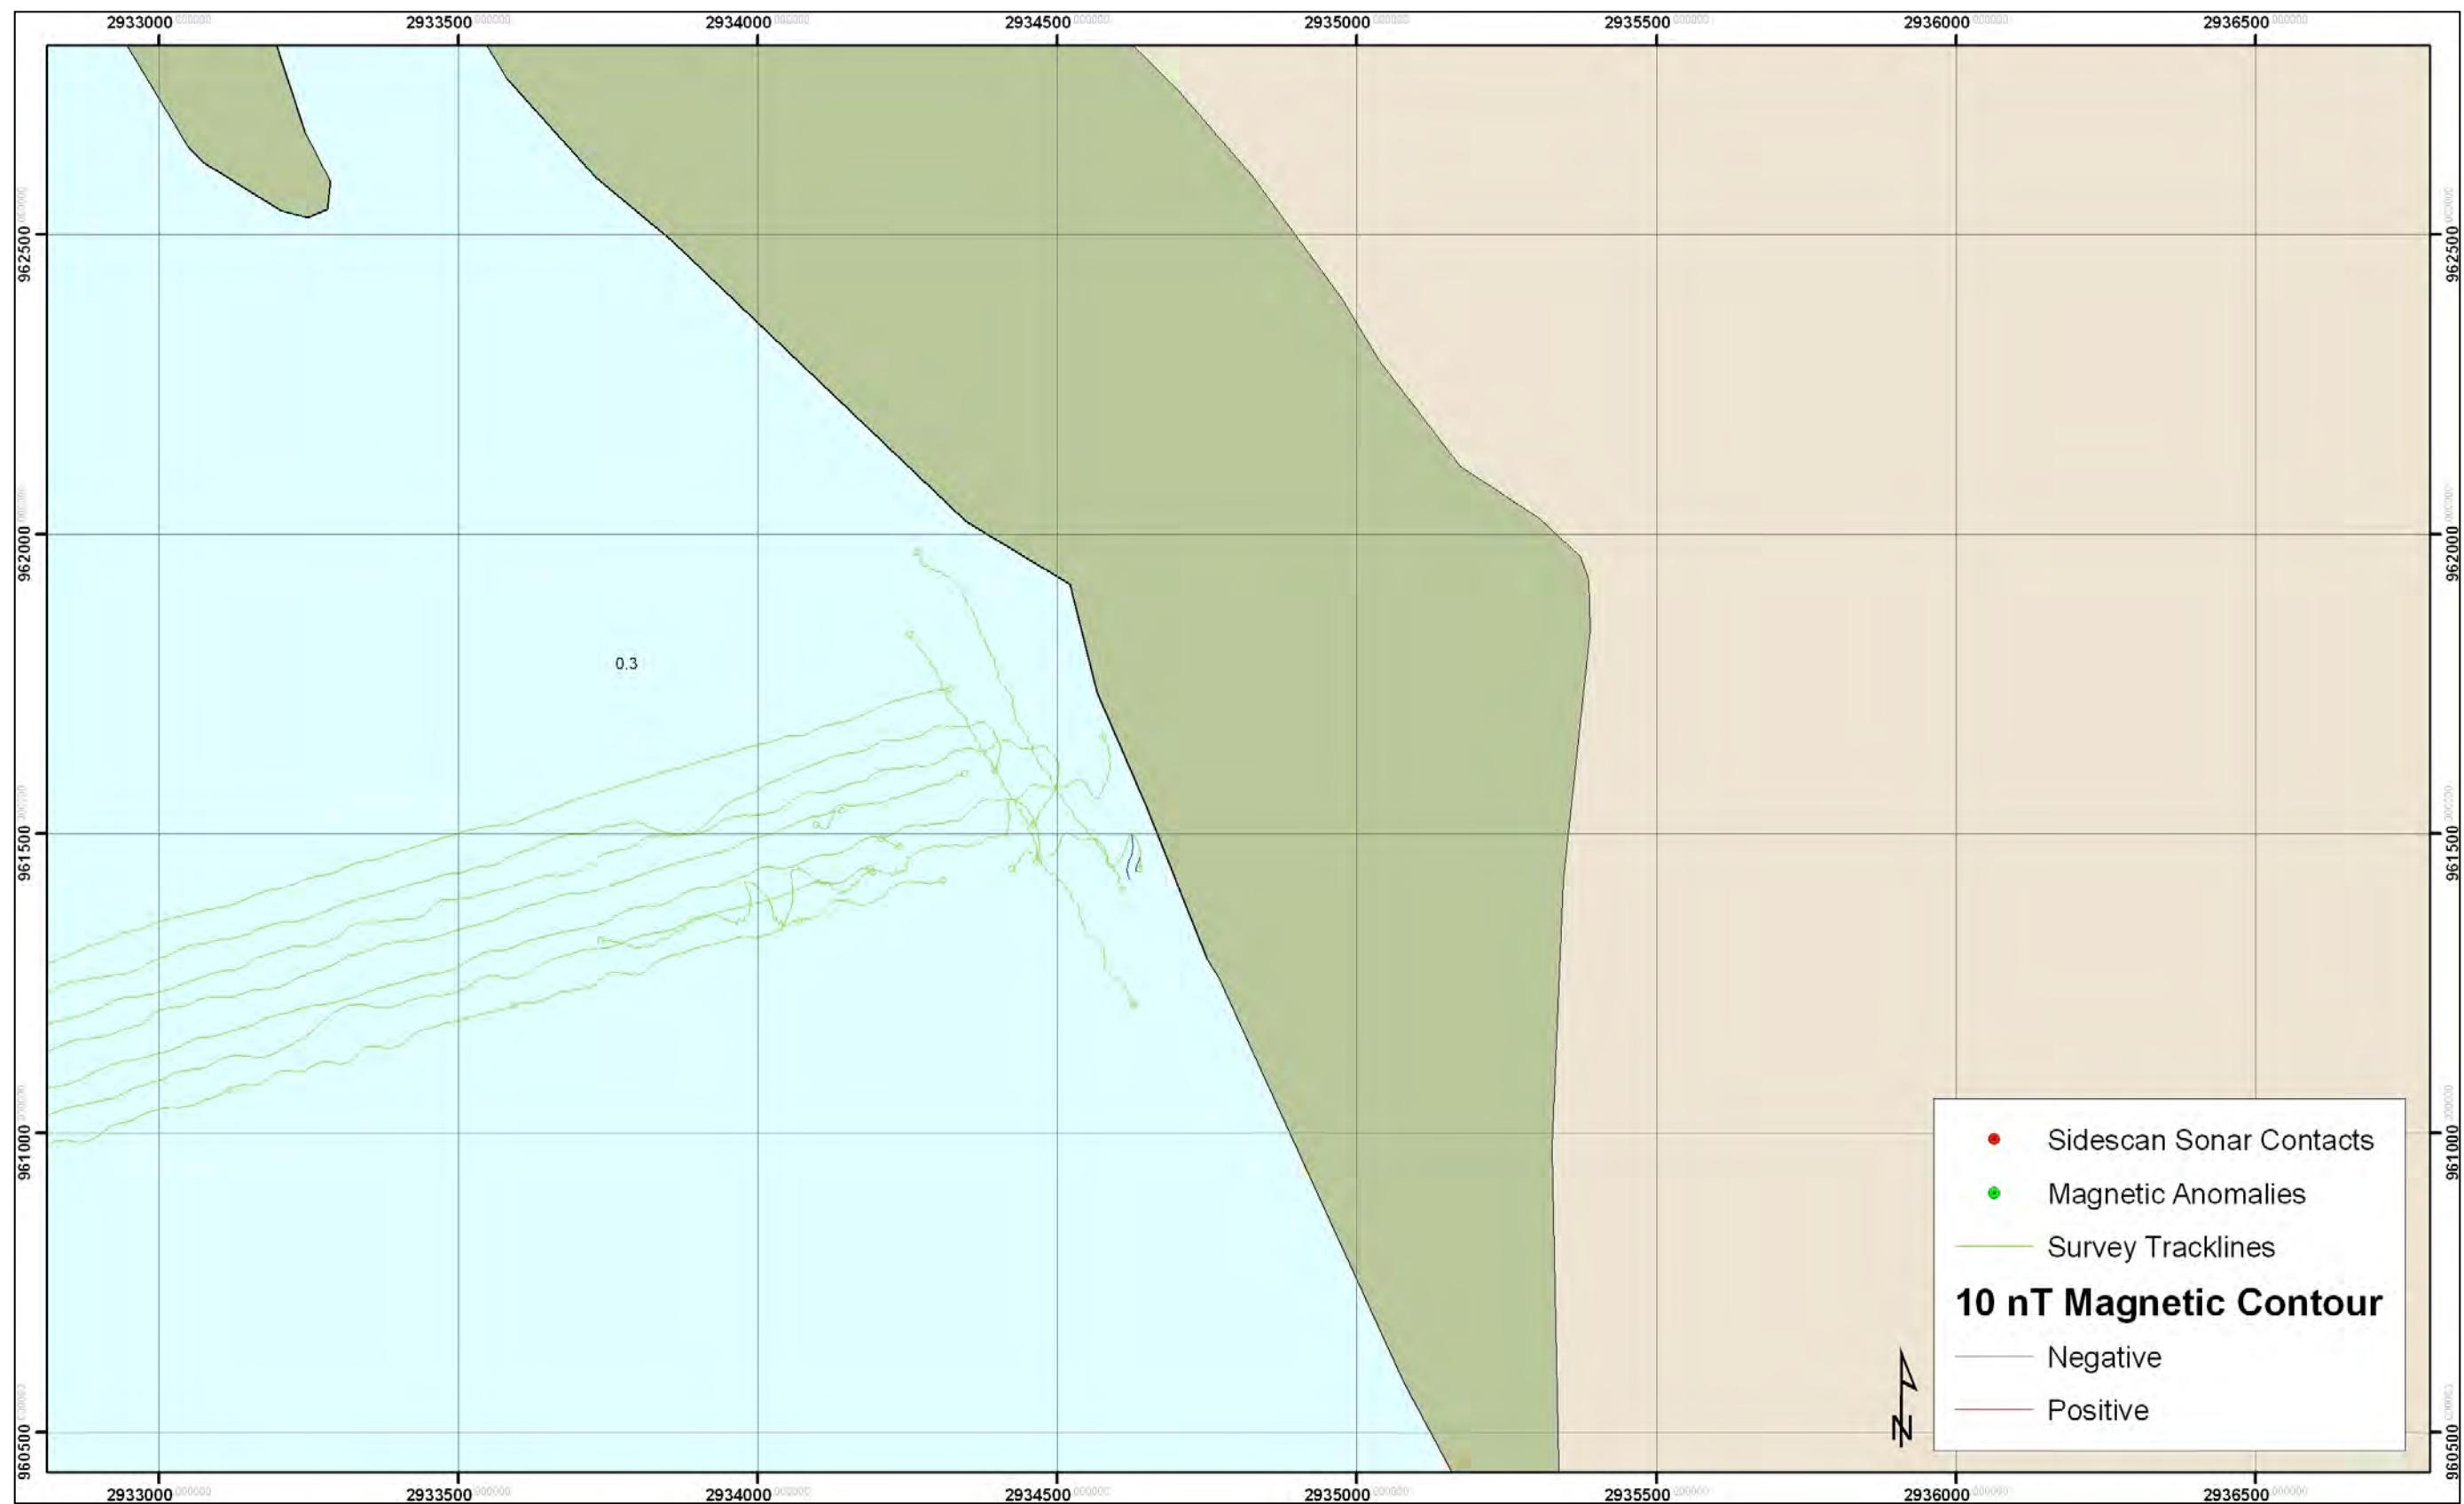
Figure 8.8. Magnetic Contour Map 7. Note both magnetic anomalies and sidescan sonar targets are shown. Survey grid is in feet.

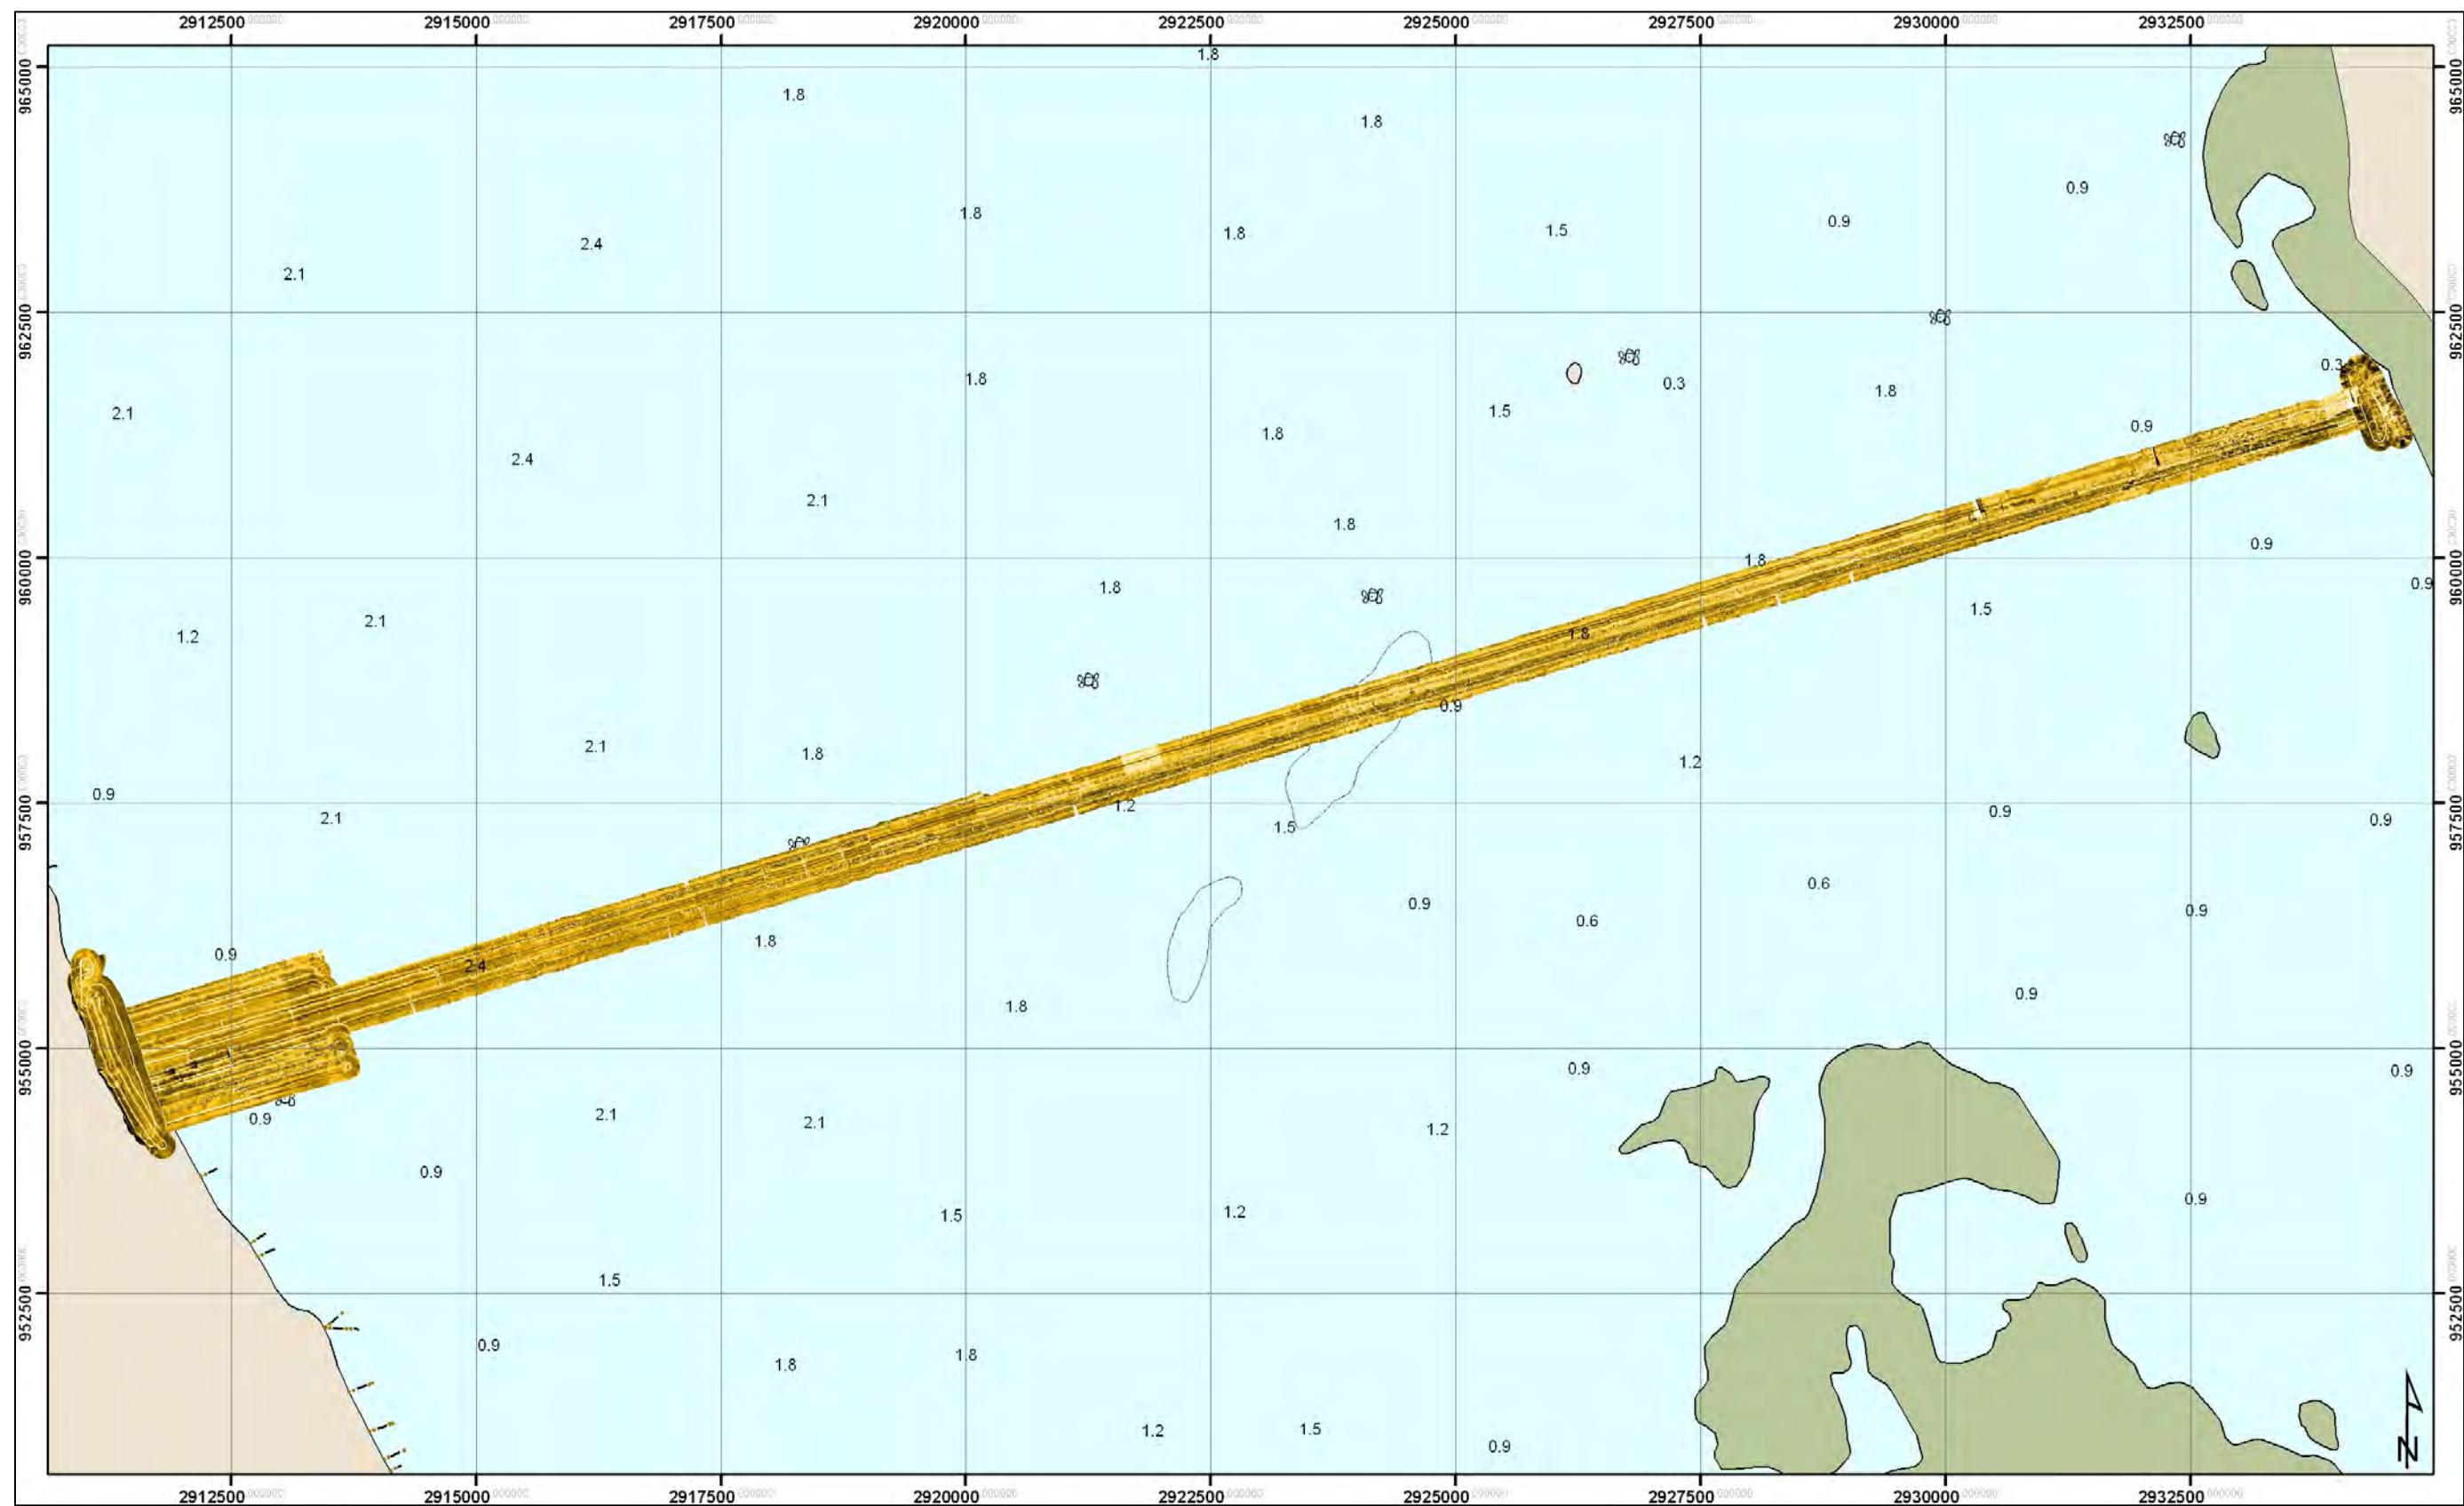
Figure 8.9. Sidescan sonar mosaic showing total coverage of survey area.

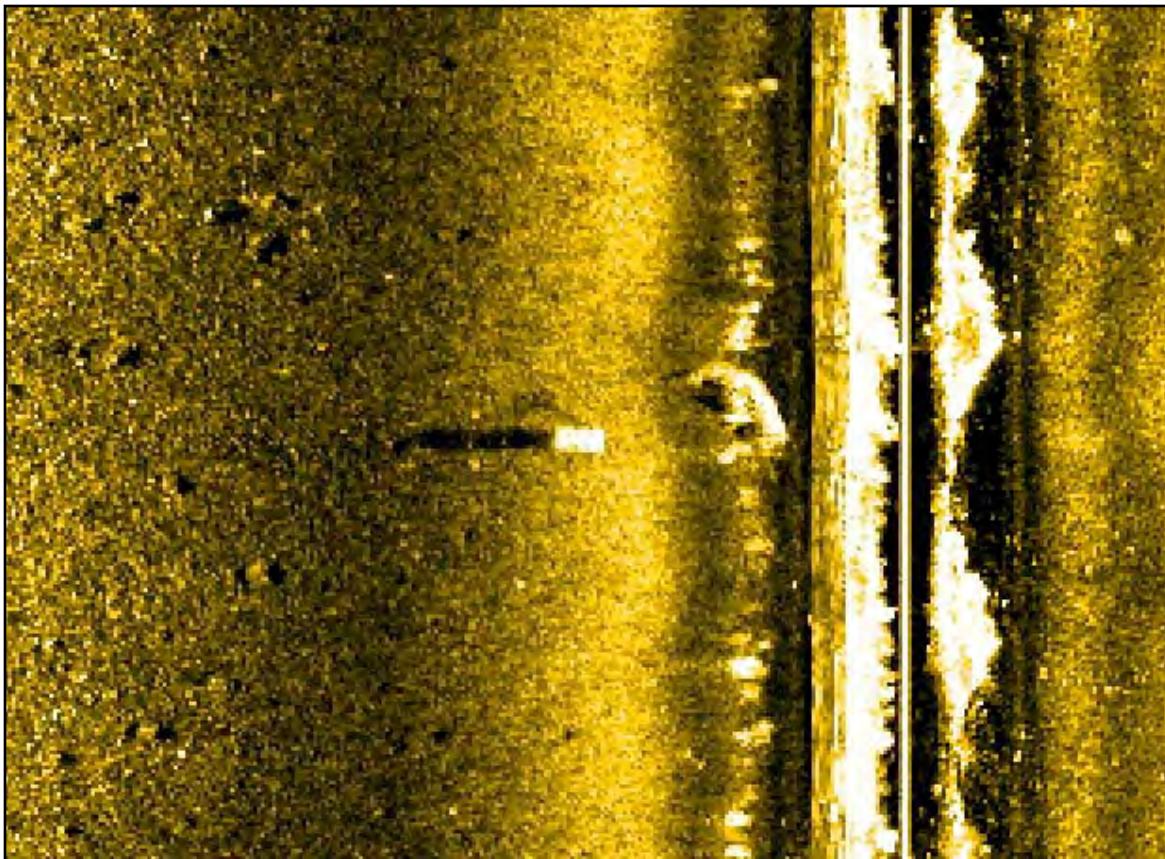
Figure 8.10. Sidescan Sonar target C-43, a crab trap that is associated with Anomaly M-5. Images for all acoustic targets are found in Appendix C.

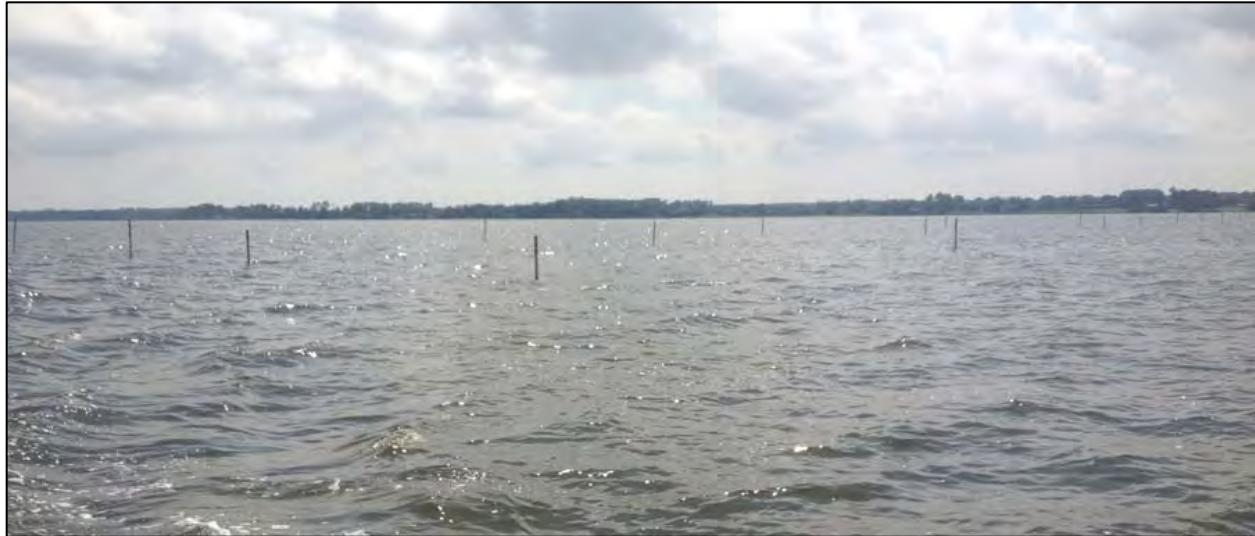
Figure 8.13. View of the powerline corridor marked with PVC pipe; view to the southwest.

All targets were investigated employing the above refinement survey methodology. During the refinement survey it was found that several of the anomalies were located within a buried power cable corridor that runs partially through the bridge corridor on the western side. The presence of the cable corridor was known during the original survey, and the data was reviewed real-time and during data analysis to determine if linear anomalies representing cables were present. While some anomalies were recorded within the cable area, the linear signatures of the cables/powerlines were not readily visible within the 2011 data. They were very apparent during the 2012 refinement survey and the cables are the obviously sources for some of the anomalies (Figure 8.11). During the current refinement survey, the exact location of the cables had been recently both buoyed and demarcated with PVC piping within the larger (i.e., wider) cable area seen on maps, with buoys placed on the western end and PVC pipes marking the cable east of the buoys (Figures 8.12 through 8.14). An unnamed local interviewed at the nearby dock stated that the powerline had just recently been marked.

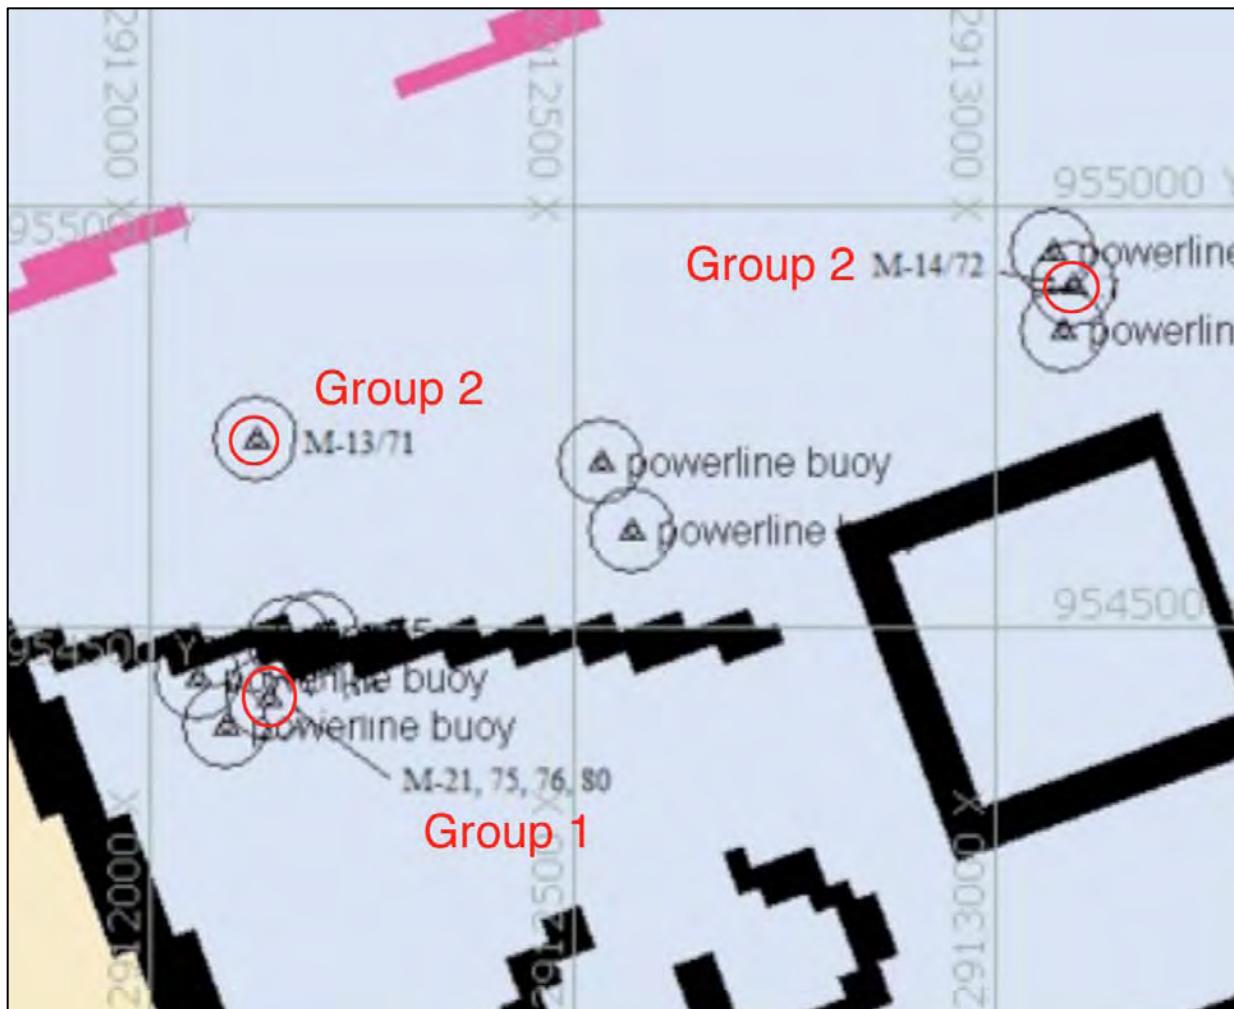
Figure 8.15. Location of Group 1 and Group 2 within the buoyed and PVC-marked powerline corridor location (note that Anomalies M13/71 are a portion of Group 2, and are not within the marked corridor).

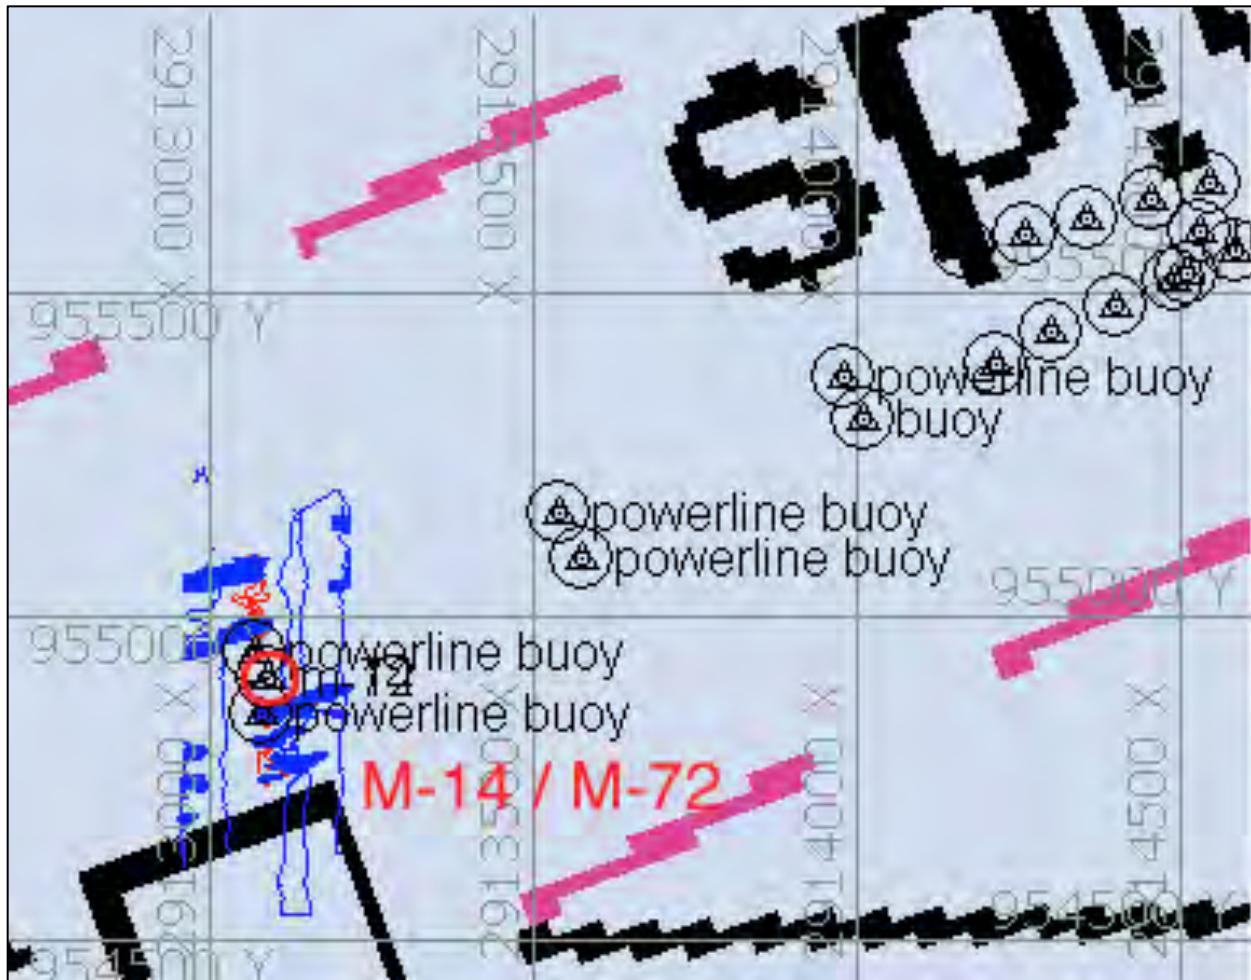
Figure 8.16. Refinement survey showing location of Anomalies M-14/M-72 of Group 2 in relation to the linear anomalies that represent the powerline locations and alignment within the buoyed cable corridor.

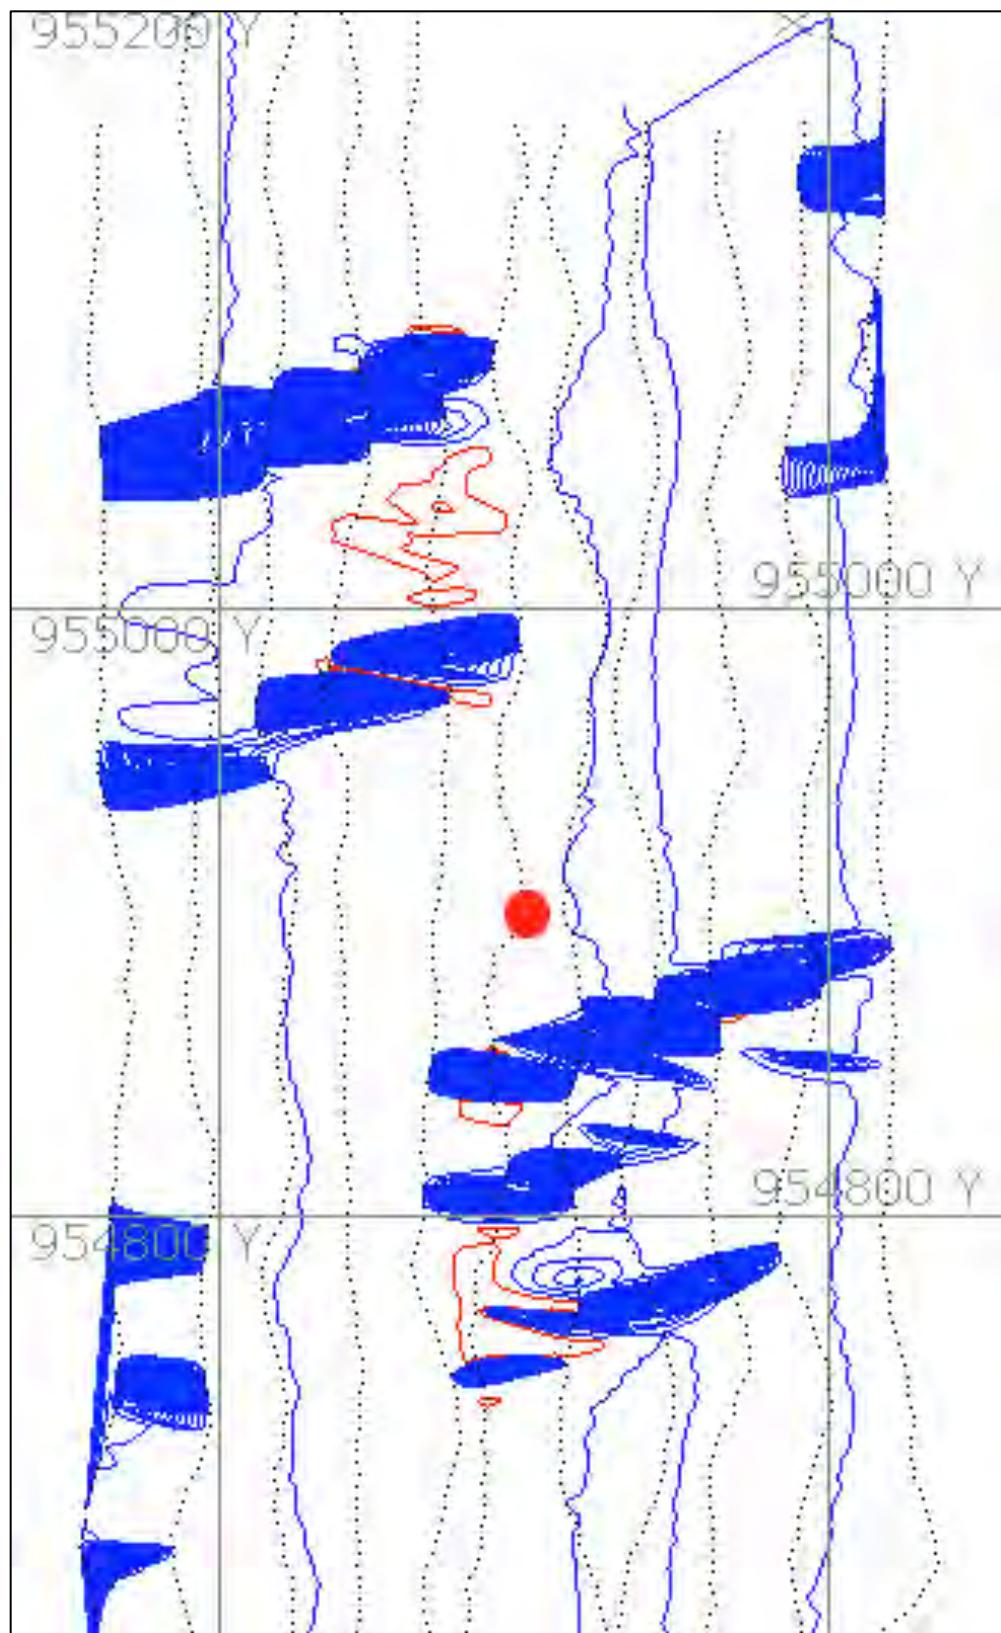
Figure 8.17. Magnetic contour refinement map showing location of M-14/M-72 coordinates (red dot) in relation to the linear anomalies that represent the powerline locations. It appears that there are five cables present; three to the south and two to the north, with the anomaly directly in between.

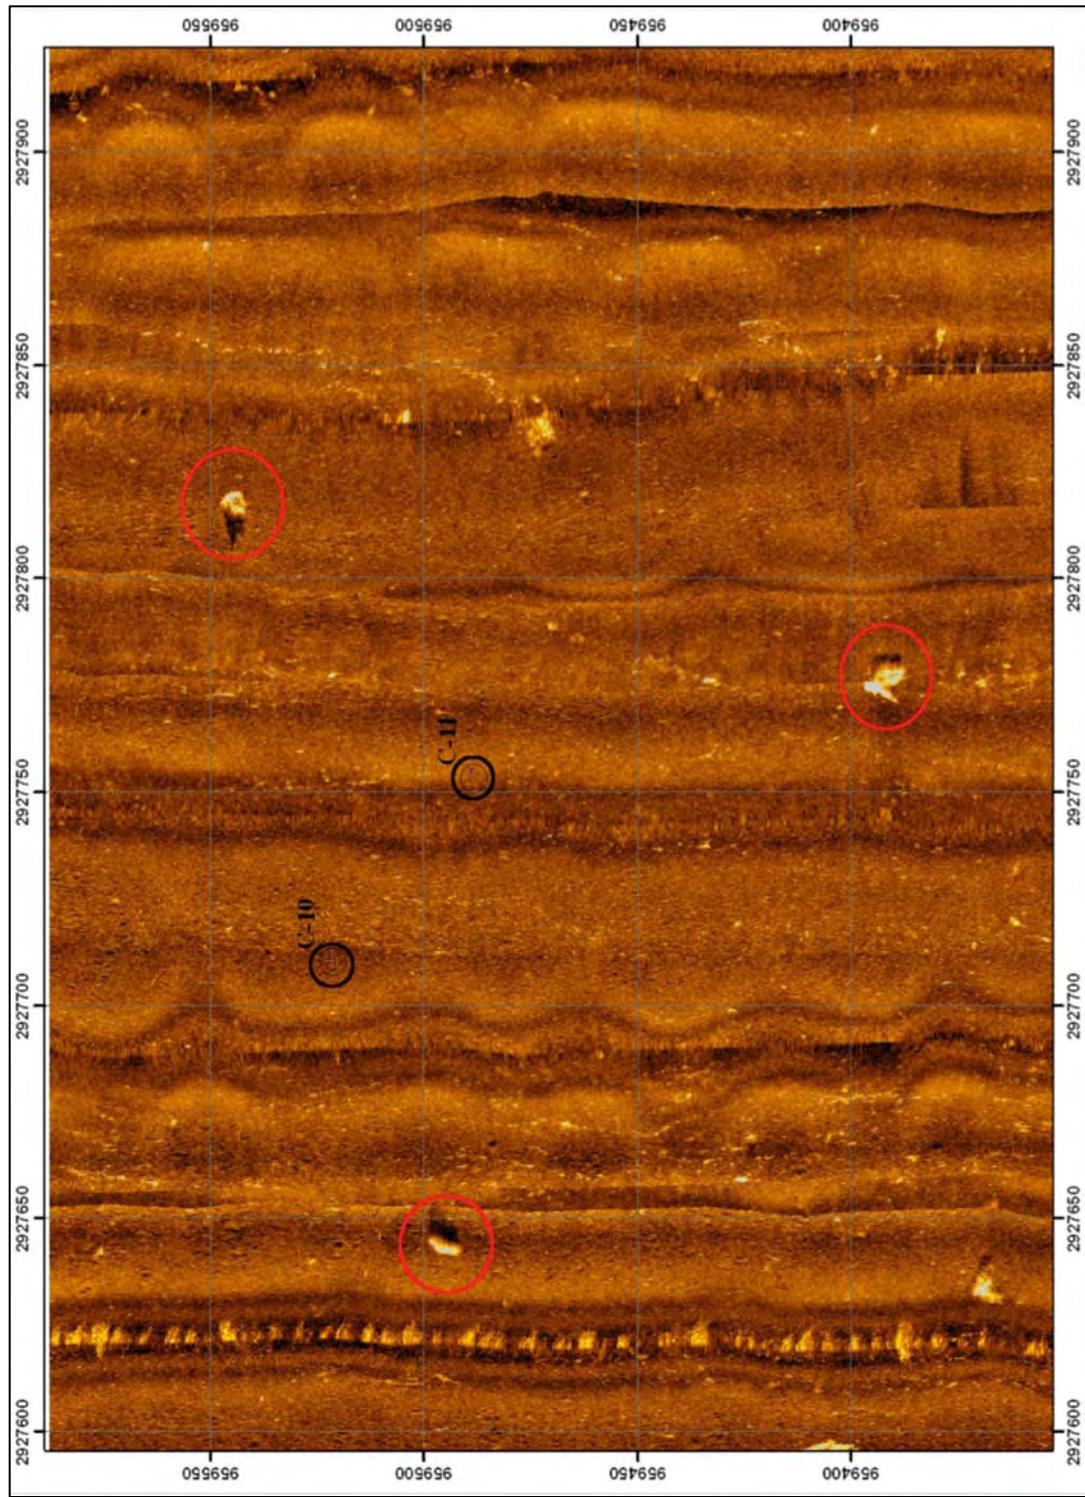
Figure 8.22. Original location of Sonar Contacts C-10 and C-11 (circled in black) overlain on the 2012 Group 4 sonar mosaic. The mosaic shows additional sonar contacts that were not present during the 2011 survey: one is over 100 ft. to the south of C-11, has an associated anomaly, and likely represents a crab pot; and one northeast of C-11 that is approximately 100 ft. and has an associated anomaly, again associated with a crab pot. The changing sonar contact and anomaly locations are all attributable to the crab fishing industry that witnesses constant movement of traps throughout the area.
