Freshwater Mussel Survey Report

Monroe Connector/Bypass (STIP No R-3329/R-2559)

Mecklenburg and Union Counties, North Carolina

July 13, 2009

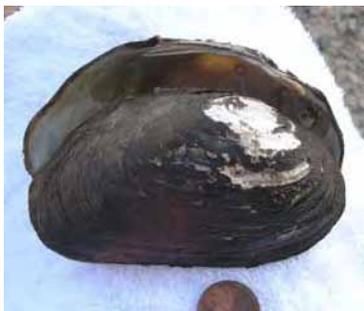
2.1. Species Characteristics

The Carolina heelsplitter is characterized as having an ovate, trapezoid-shaped, unsculptured shell. The outer surface of the shell ranges from greenish brown to dark brown in color, with younger specimens often having faint greenish brown or black rays.

The shell's nacre is often pearly white to bluish white, grading to orange in the area of the umbo (Keferl 1991). The hinge teeth are well developed and heavy and the beak sculpture is double looped (Keferl and Shelly 1988). Morphologically, the shell of the Carolina heelsplitter is very similar to the shell of the green floater (Clarke 1985), with the exception of a much larger size and thickness in the Carolina heelsplitter (Keferl and Shelly 1988).

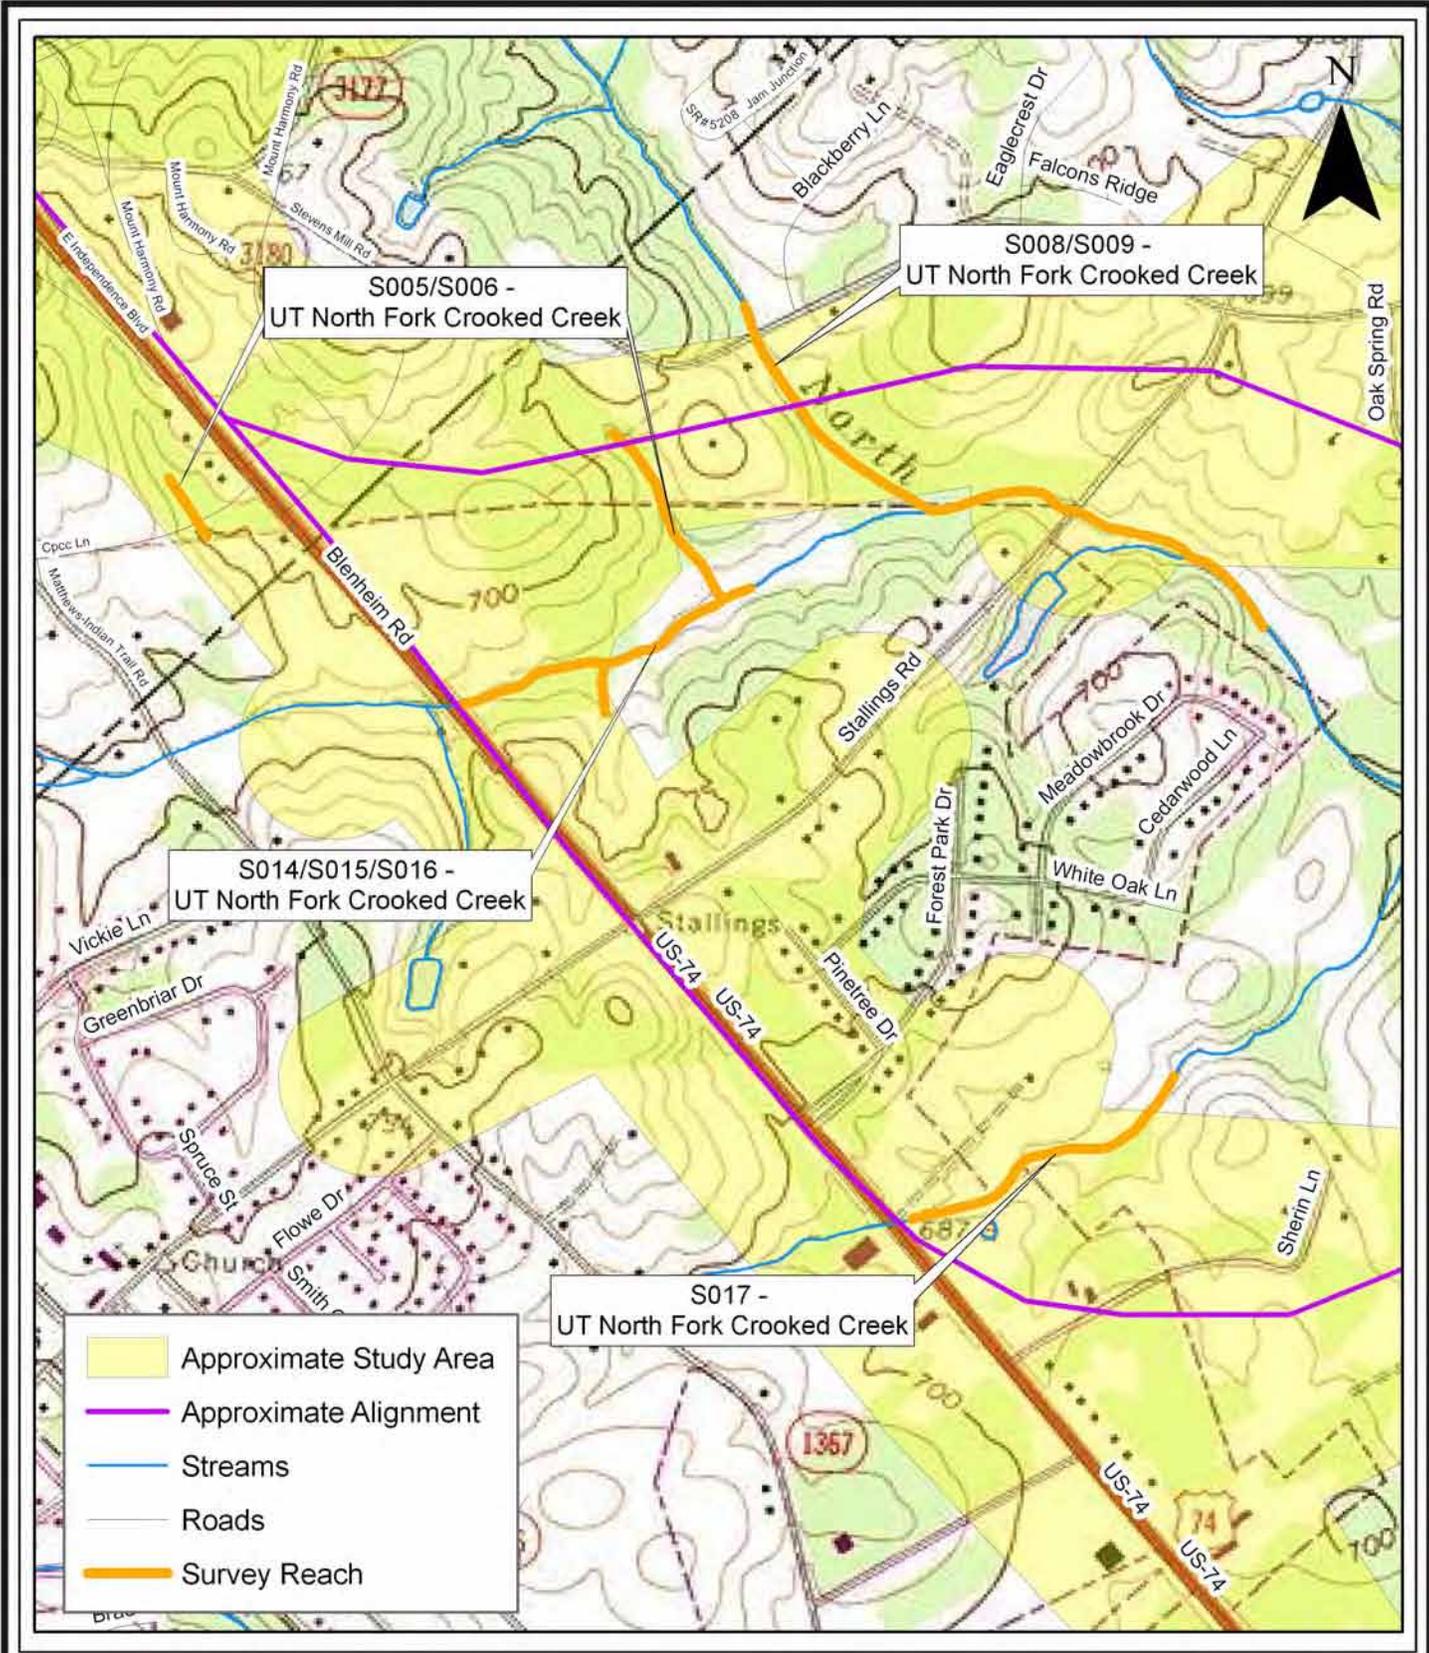
Sheet
1

This stream system was evaluated downstream of the corridor study area in the vicinity of the Tank Town Road crossing (SR 3453) in order to determine if potential habitat was present upstream (Sheet 1). The very small stream was approximately 1 meter wide with little flow and mostly pool habitat. There was a significant amount of scour and erosion. Substrate was dominated by silt, and sand, with some areas of cobble also present. The surrounding area consisted of a narrow to moderate natural buffer, residential areas, road, and utility corridor. A habitat evaluation was performed for 0.5 person-hours during which it was determined that the stream did not contain appropriate habitat to warrant a full survey due to small size and degraded condition.

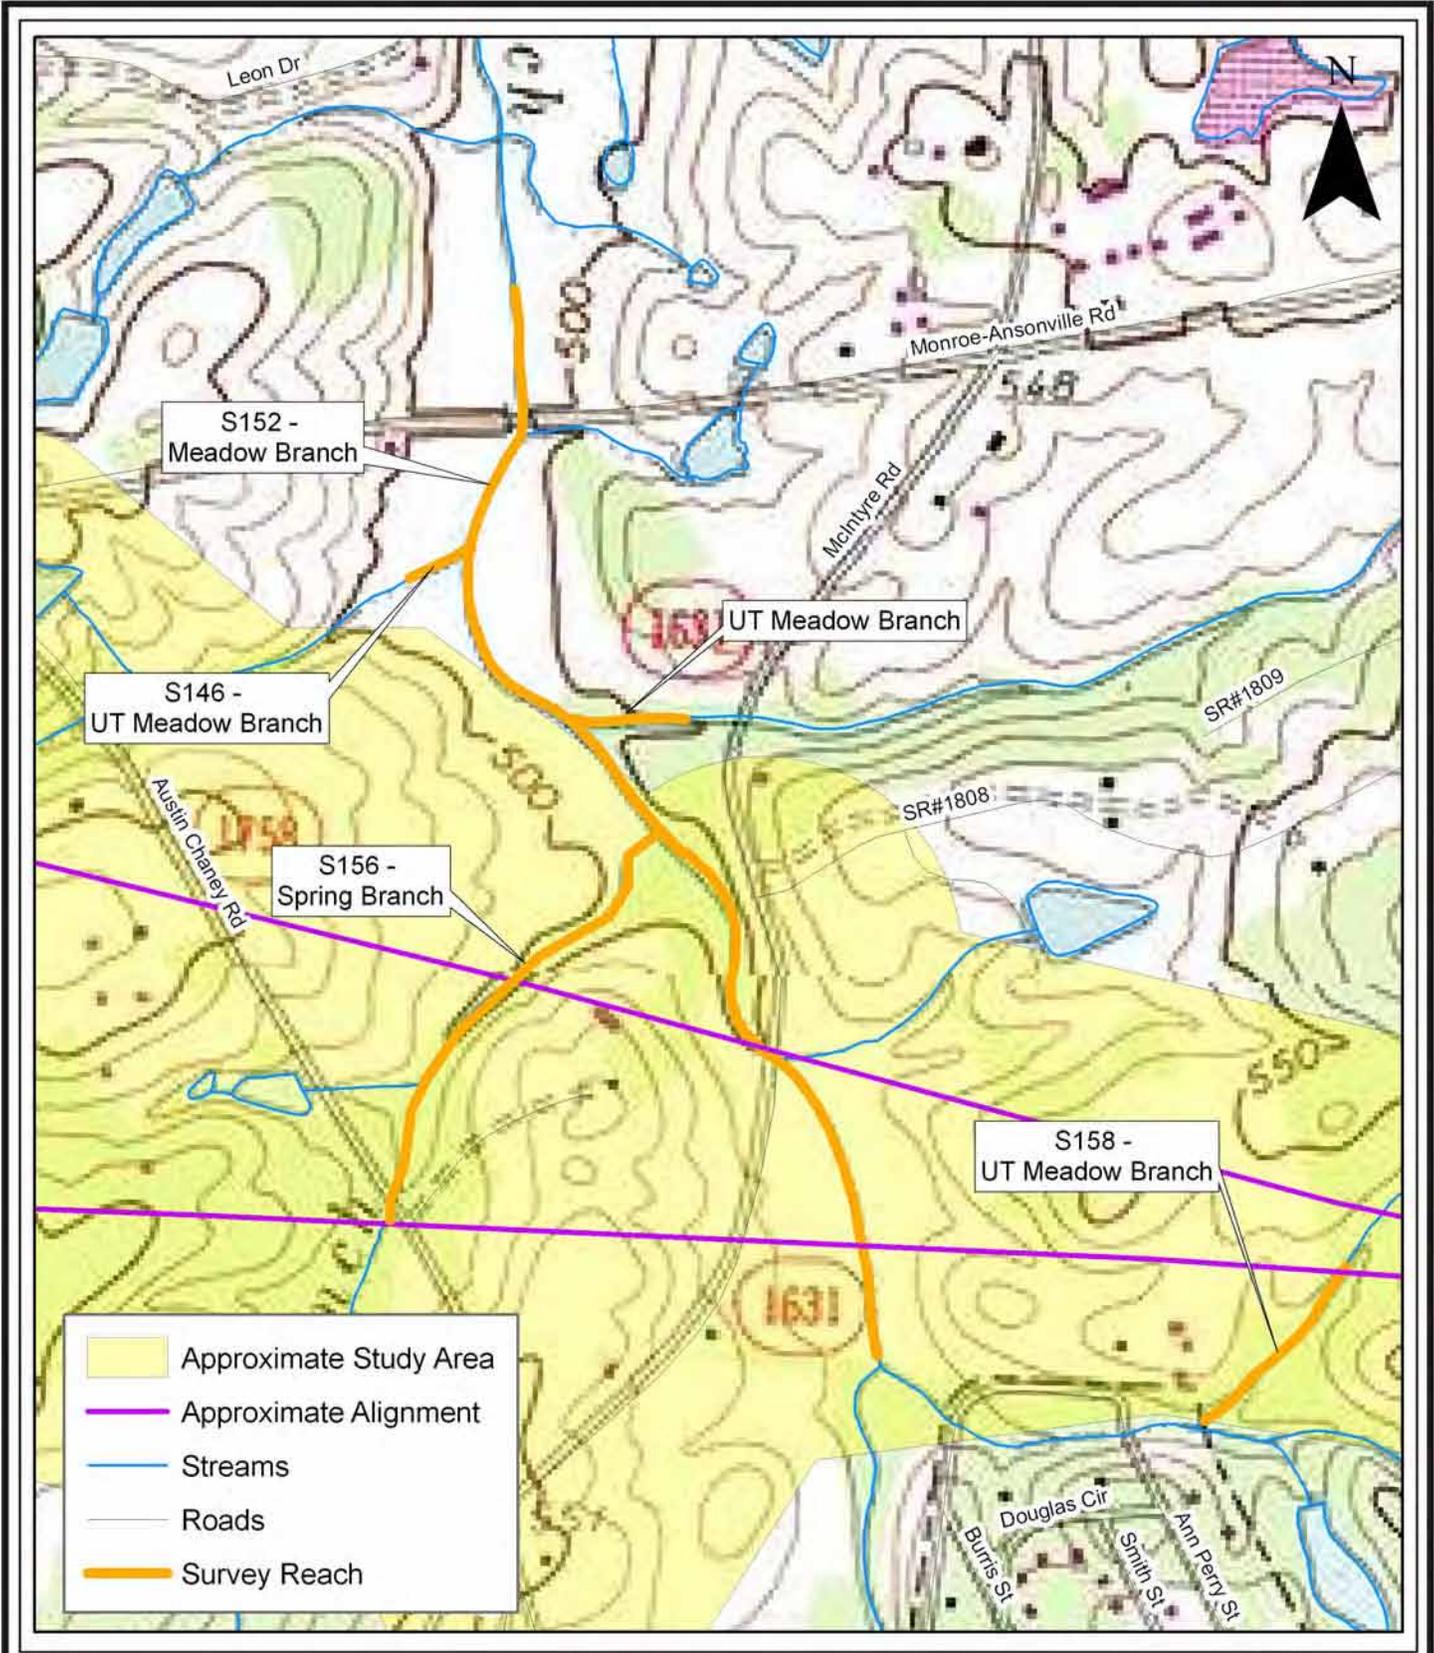
Sheet
12

This small and heavily incised stream was accessed at its confluence with the main stem of Richardson Creek (Sheet 12). The stream ranged from 1-2 meters wide with unstable 2-3 meter high banks. Substrate was dominated by hard packed clay, gravel, cobble, sand, and silt. A narrow to moderately wide natural buffer was present along most of the reach to surrounding rural land uses. A habitat evaluation was performed for 0.5 person-hours during which it was determined that the stream too small and degraded to warrant a full survey.
