Coastal Monitoring Program

NC 12 Transportation Management Plan

TIP Project B-2500

2019 UPDATE REPORT

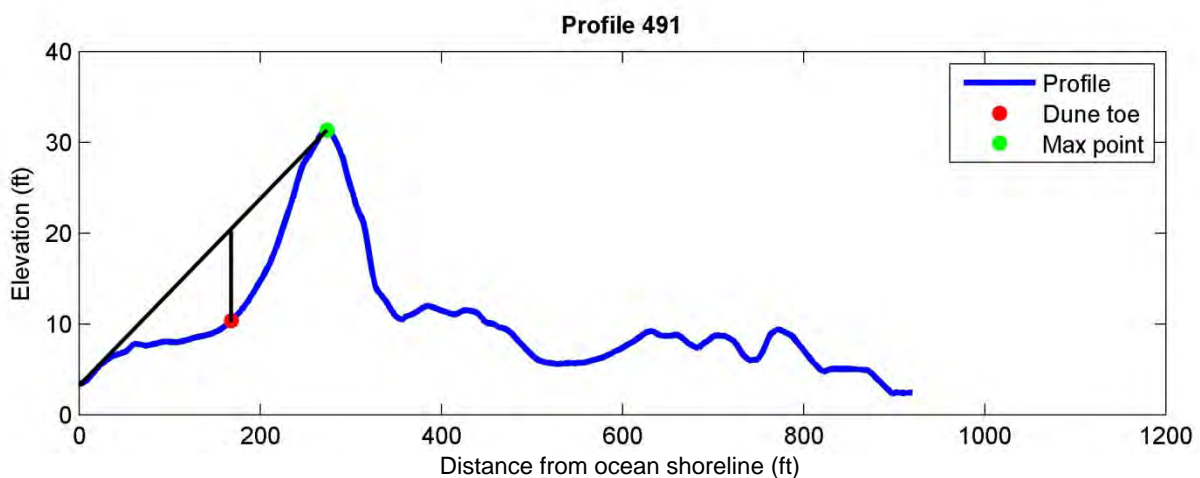
To identify the dune toe, a partially automated algorithm was used. For initial dune toe identification, a straight line between the maximum profile elevation and the shoreline was drawn, and the maximum difference between this line and the profile elevation was identified as the toe (see Figure 2). However, in some cases the automatically extracted toe was either not suitable, or no significant dune was present on the profile. This led to the development of an inspection method where the user views the profile at each transect, and can either accept or replace the estimated dune toe, or identify a profile as having no visible dune feature. For profiles identified as “no dune,” the dune toe elevation and position were not reported.

Figure 2. Schematic of dune toe identification methodology. Ocean shoreline is at horizontal position zero.

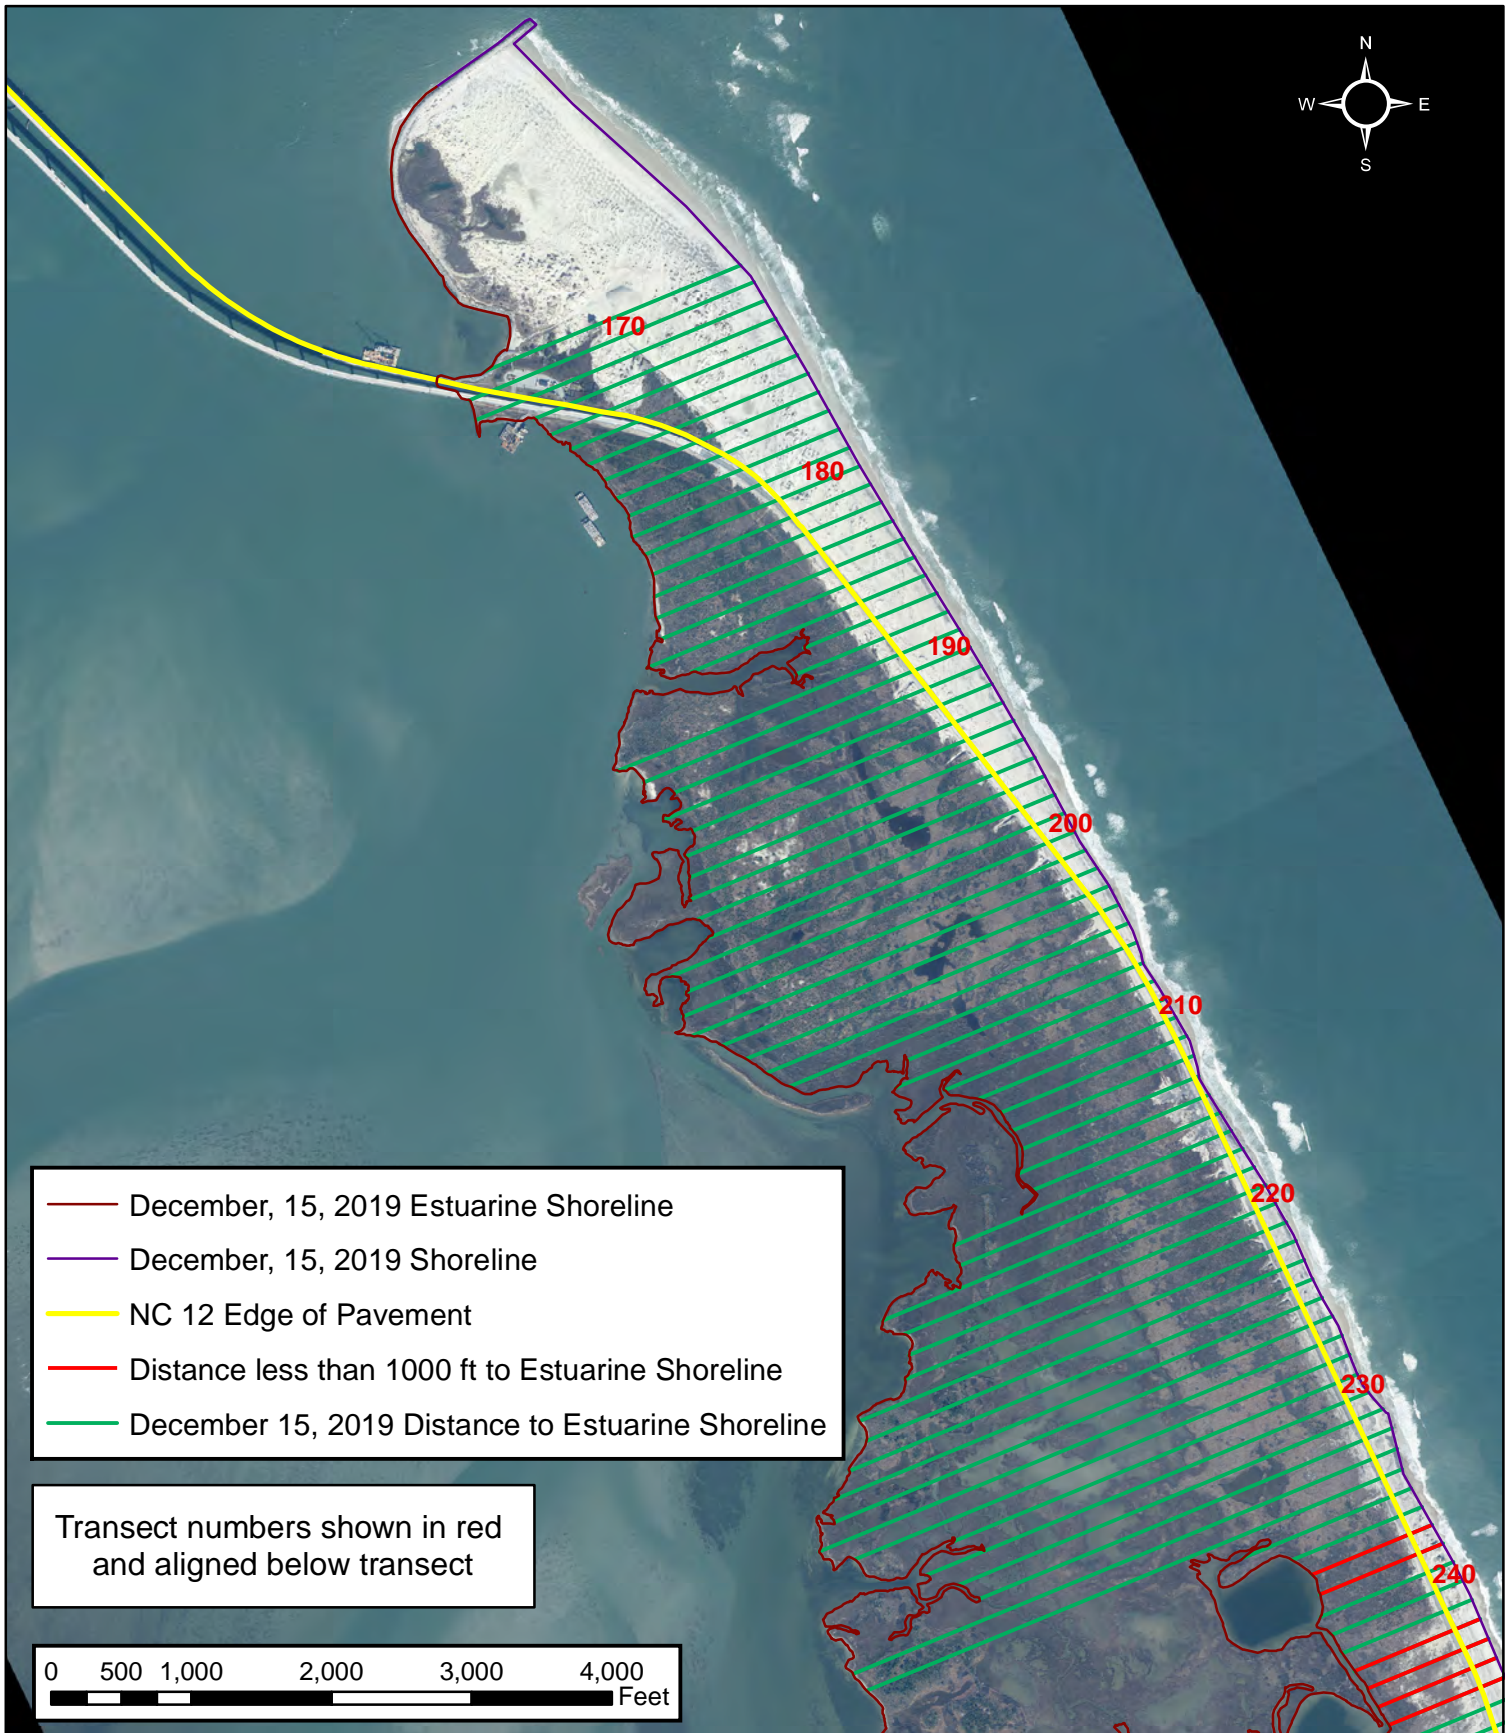
Figure 6

(View 1 of 6)

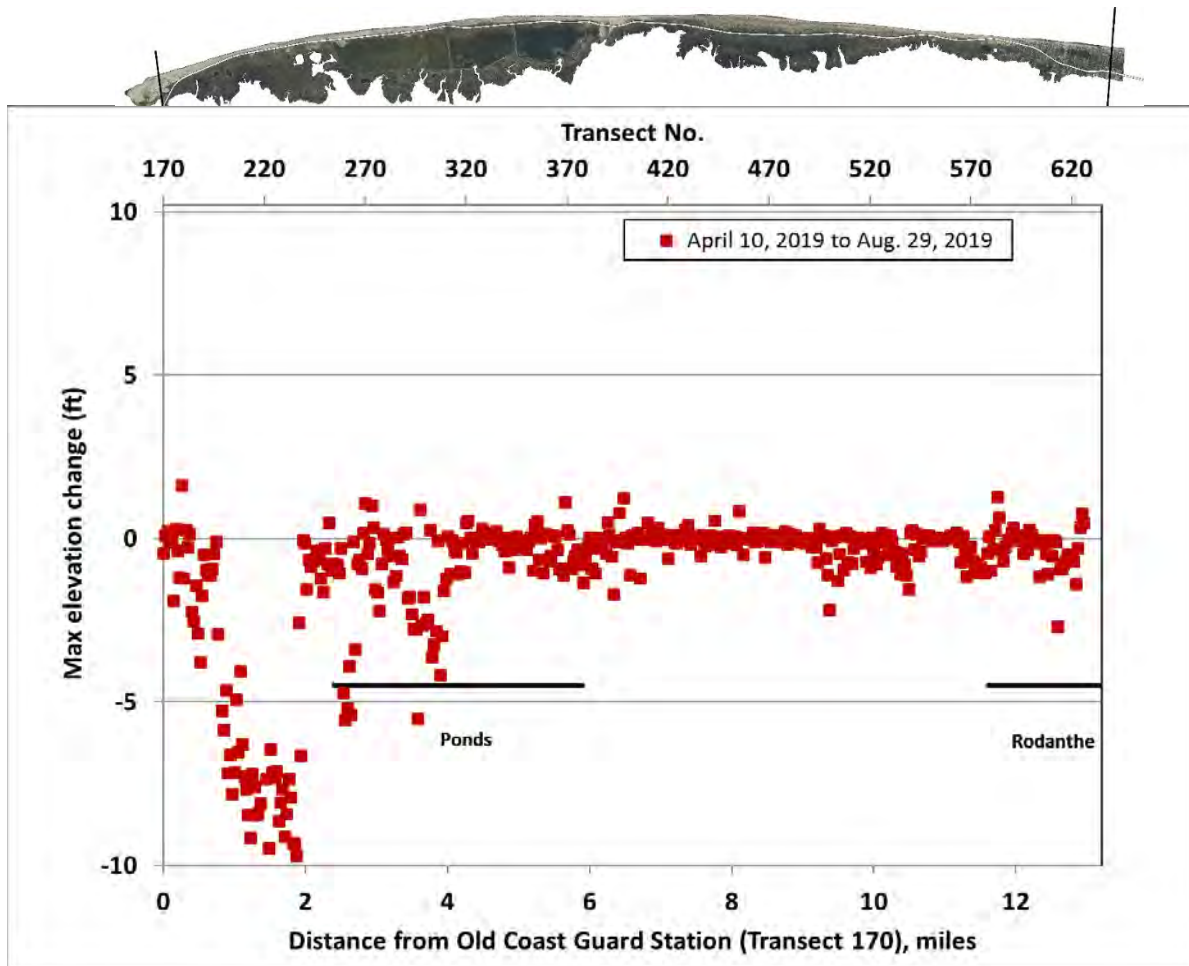
Changes occurring between April 10 and August 29 are shown in Figure 13. The average change was 1.2 ft. The largest increase was approximately 1.6 ft near mile 0.26 (Transect 179), and the largest decrease just under 11 ft near mile 1.4 (Transect 220). The largest changes during this time period were decreases within the highly active Canal Zone and are attributed primarily to wind transport, because no severe storms were reported during this time period.

Figure 13. Maximum elevation change from April 10, 2019 to August 29, 2019 at each transect, displayed from north to south along the study area. Note that transects are spaced 150 ft apart.

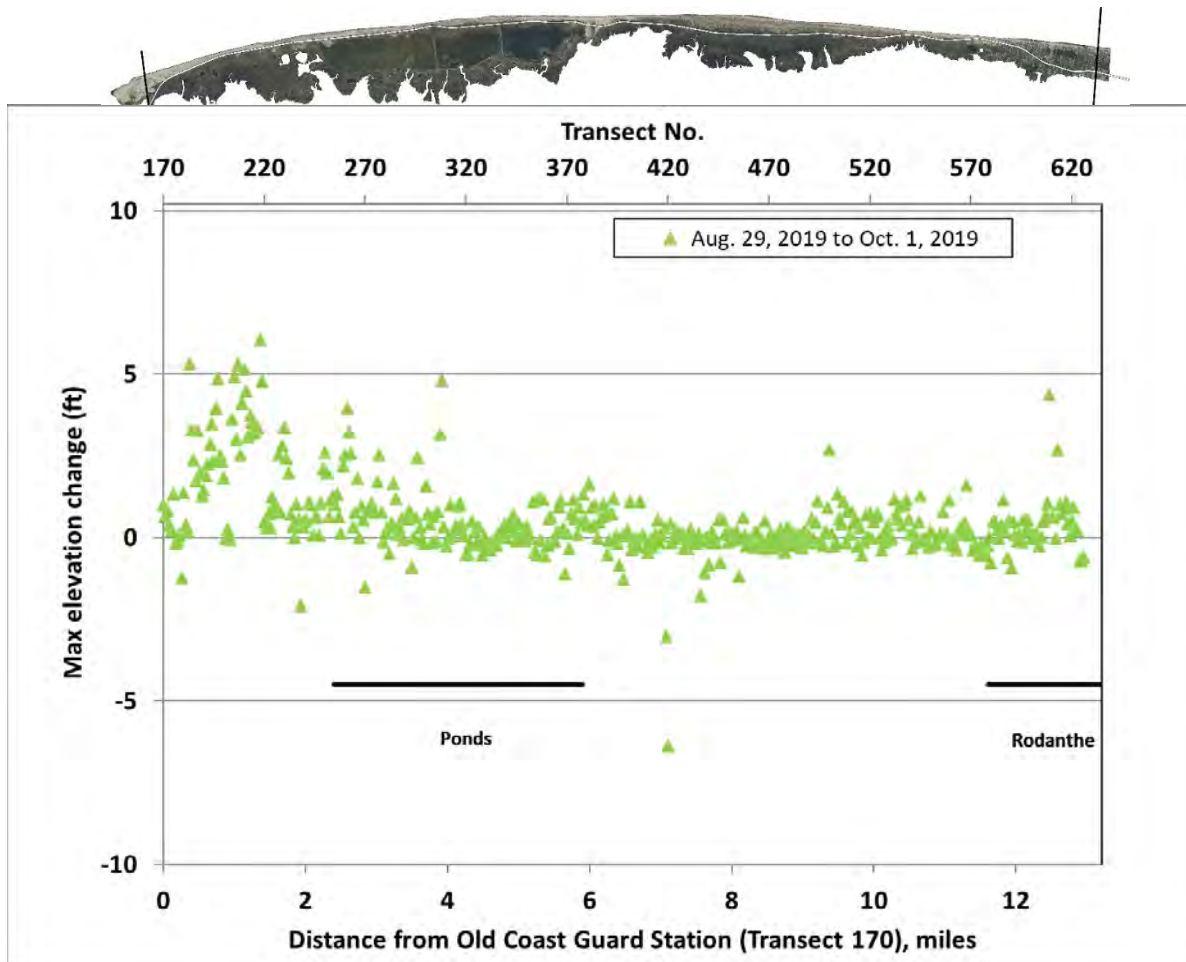
Changes in maximum elevation from August 29 to October 1, 2019 are shown in Figure 14. Average change during this time period was 0.8 ft. The largest increase was 6 ft at Transect 218 (approximately mile 1.4), and the largest decrease was 6.4 ft at approximately mile 7.1 (Transect 420). The combination of wind-blown and water-borne transport and human intervention on the degraded dune field on Pea Island contributes to the high degree of variability observed over the study year, which for 2019 was primarily observed in the Canal Zone where high rates of sand transport and earth moving operations are frequent.

Figure 14. Maximum elevation change from August 29, 2019 to October 1, 2019 at each transect, displayed from north to south along the study area. Note that transects are spaced 150 ft apart.

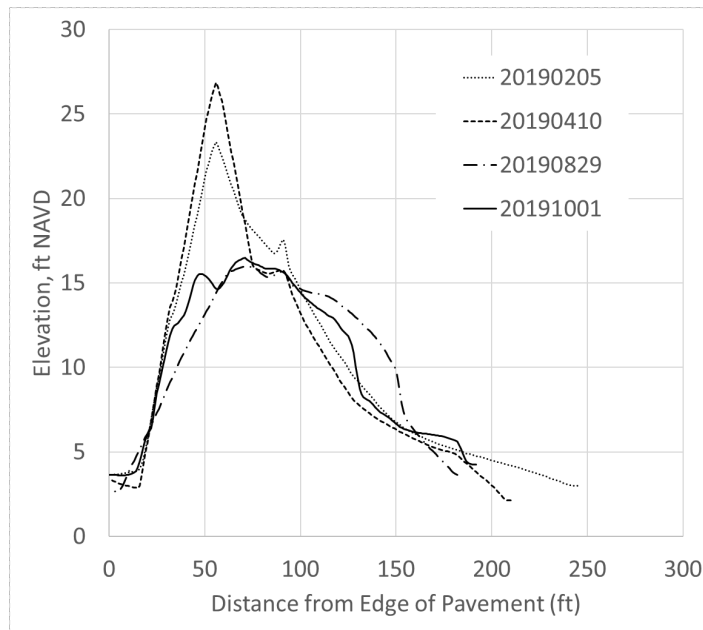
Figure 15. Left, typical Canal Zone Profile at Transect 220, where an increase was shown from February to April, due to dune rebuilding following two nor'easters in March, followed by a decrease of over 10 ft from April to August primarily due to wind effects, since no severe storms were reported during this time period. The maximum elevation increased slightly from August to October. This variability is typical of the Canal Zone, which is very active with frequent wind transport as well as wave/water impacts and frequent earth moving operations. Right panel shows aerial imagery for each of the four dates.

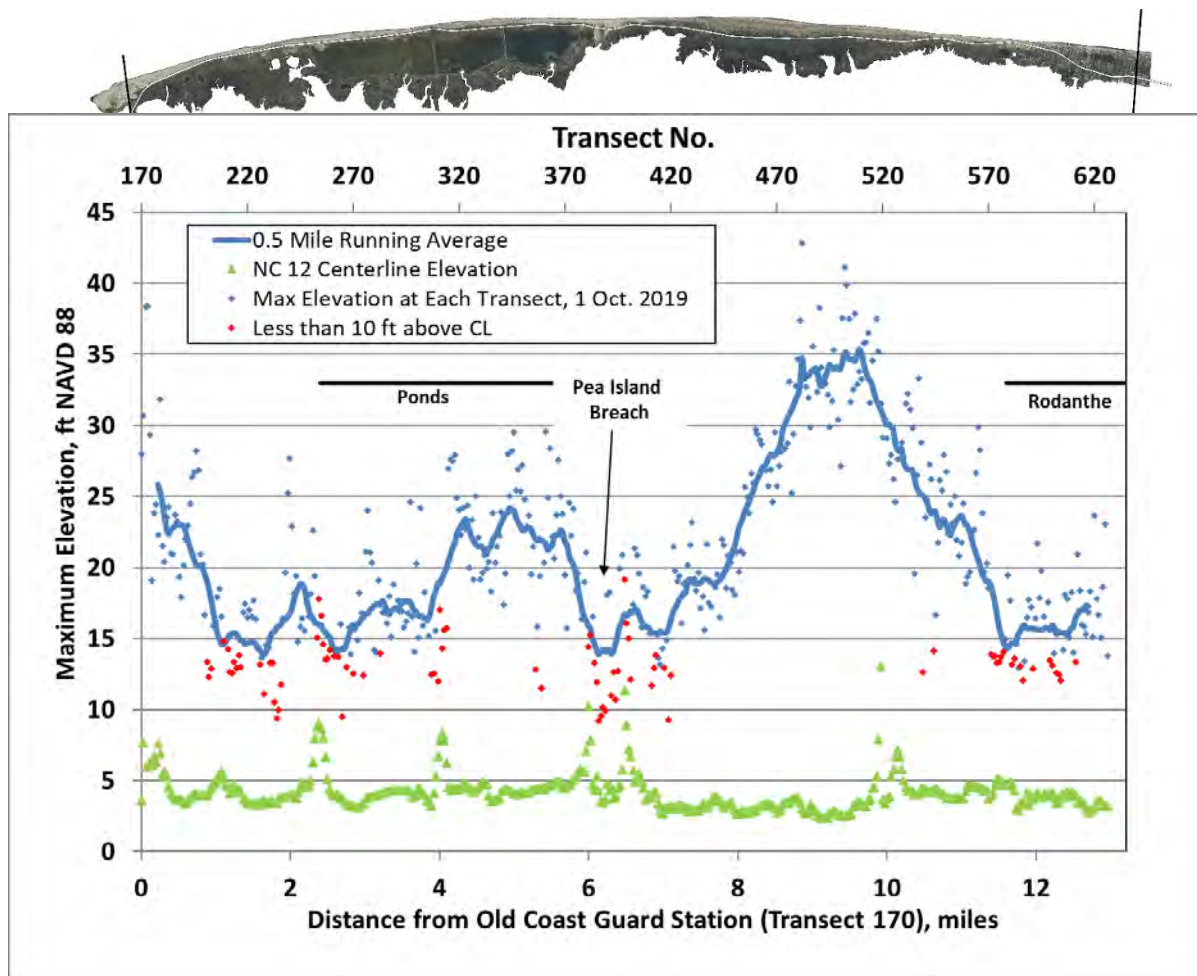
northern six miles of the study area, the average elevation of the dunes ranges from approximately 15 to 25 ft. Just south of the ponds the dunes were removed by the Pea Island Breach and are gradually recovering. From miles 7 to 10, most dunes were greater than 20 ft in elevation; moving south from this area toward Rodanthe, the dune field is substantially degraded. In many parts of this stretch a narrow artificial dune was previously constructed over sandbags; these dunes were augmented by a beach nourishment project in August-September 2014, although the area has since returned to pre-project or further eroded conditions. As described in the methodology section, the maximum elevation was compared to the elevation of the road at each transect. The trends are similar to those described in previous reports.

Figure 16. Maximum elevation at each transect, displayed from north to south along the study area for the October 1, 2019 topographic data set. Blue points are > 10 ft above the CL elevation, red points are ≤ 10 ft above the CL elevation. Note that transects are spaced 150 ft apart. To assist in visualizing the alongshore spatial variation in dune crest height, a 0.5 mile running average of the height is also shown (blue line). Elevations at the centerline of NC 12 are plotted in green for comparison.

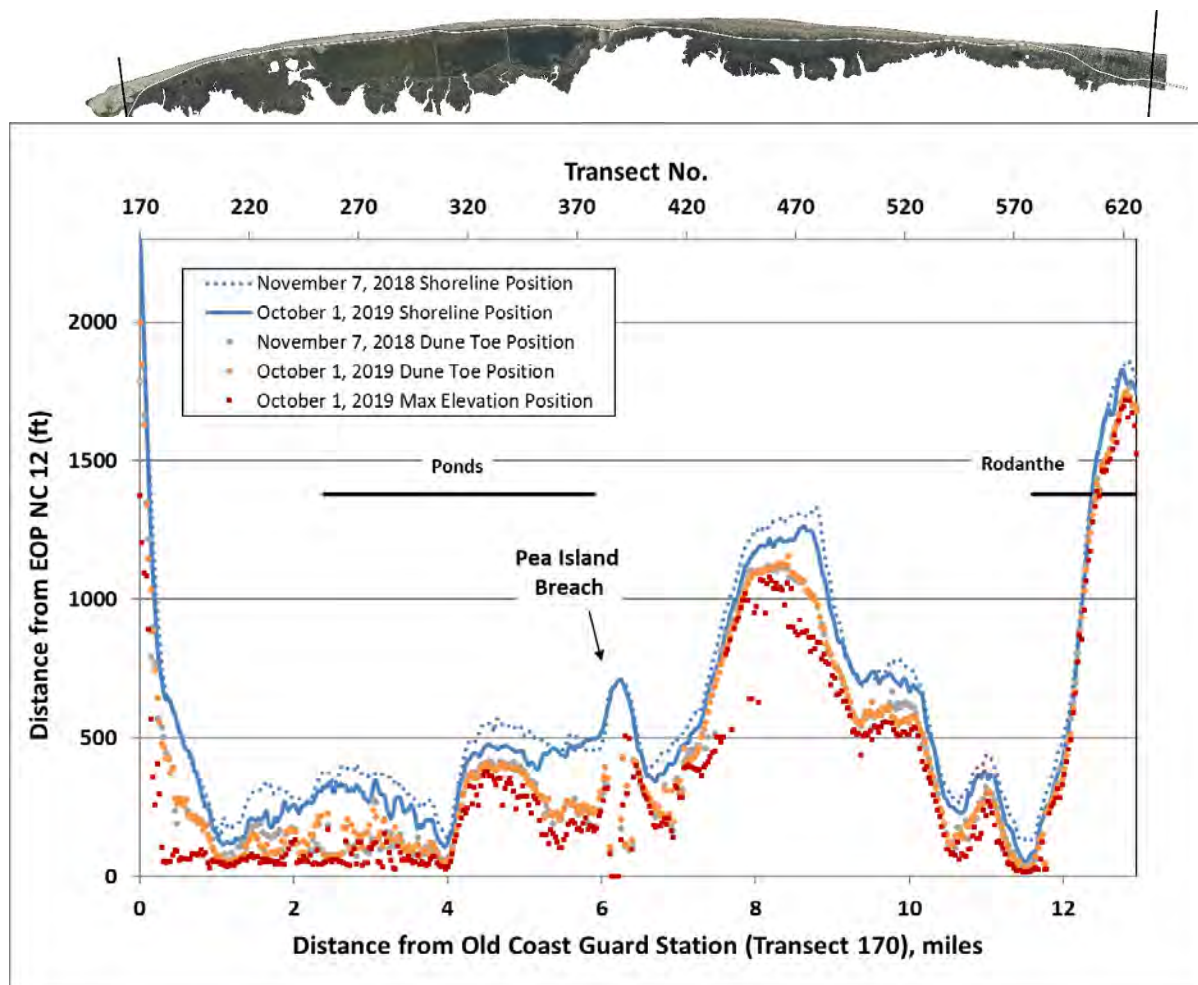
Dune toe position and elevation for the October 1, 2019 topographic data were evaluated. Figure 17 shows the horizontal dune toe position relative to the NC 12 edge of pavement as well as the shoreline and maximum dune elevation position as of October 1, 2019. The position of the shoreline and maximum elevation as of November 7, 2018 are presented as well, for reference. The position of the dune toe is similar to that in 2019, as were the general patterns across the study area. Dunes along miles 1 through 4 and south of mile 11 have been reconstructed multiple times. It is noted that NCDOT is restricted in where and how high the dunes could be constructed due to the location of the current NC 12 highway easement within the PINWR. NCDOT was required to stay within its existing easement unless otherwise authorized. This is why the dunes in these areas are so close to the roadway.

Figure 17. Dune toe, shoreline, and maximum elevation positions as of October 1, 2019, measured as distance from the NC 12 edge of pavement, compared with dune toe and shoreline positions as of November 7, 2018.

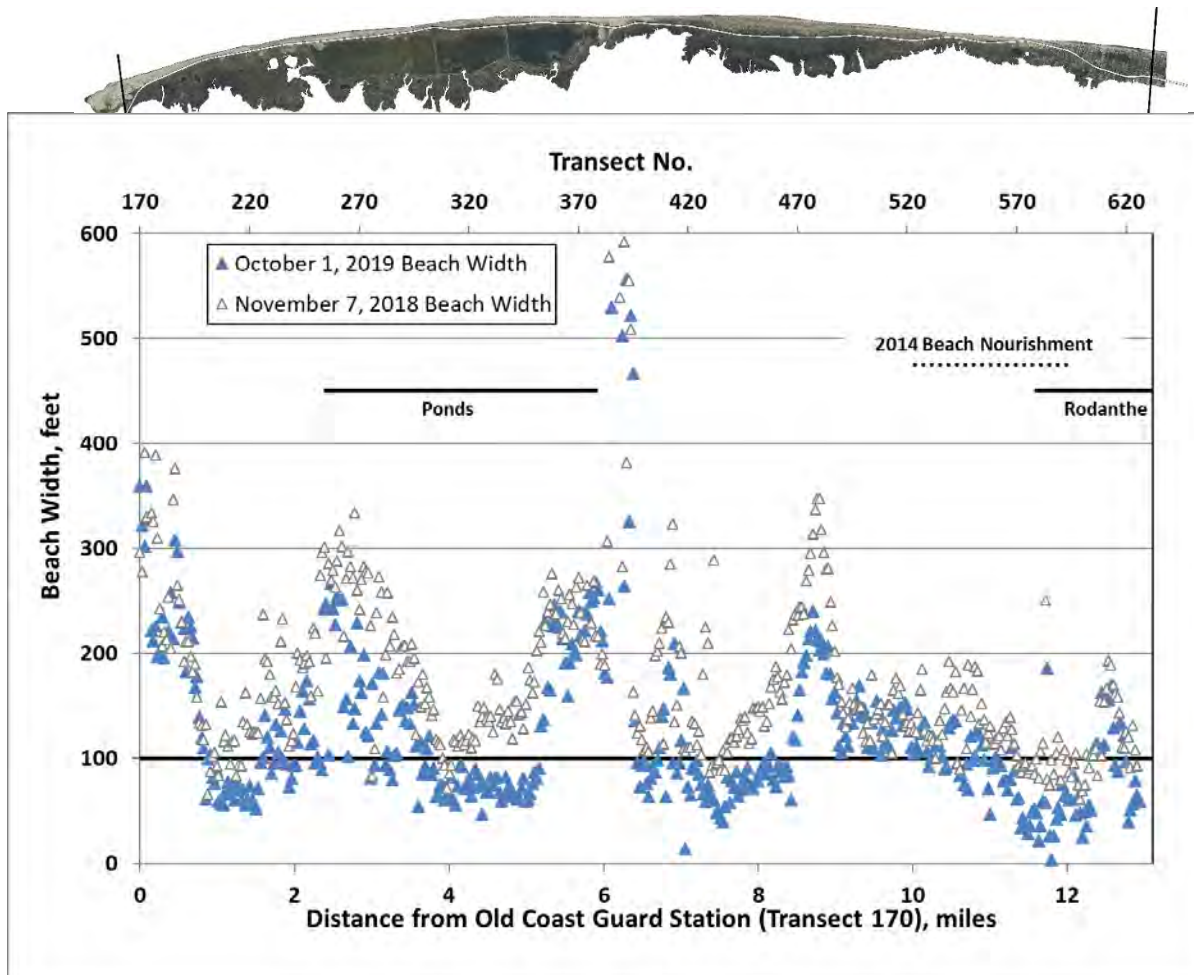
At this point in time, five years after placement, the beach width in the area of the Rodanthe beach nourishment project is narrower than pre-project conditions. This was expected as the project was designed to mitigate erosion for three years (see the 2014 Report for further details on the project).

Figure 19. Beach width as of October 1, 2019 (blue), compared with beach width on November 7, 2018 (gray).

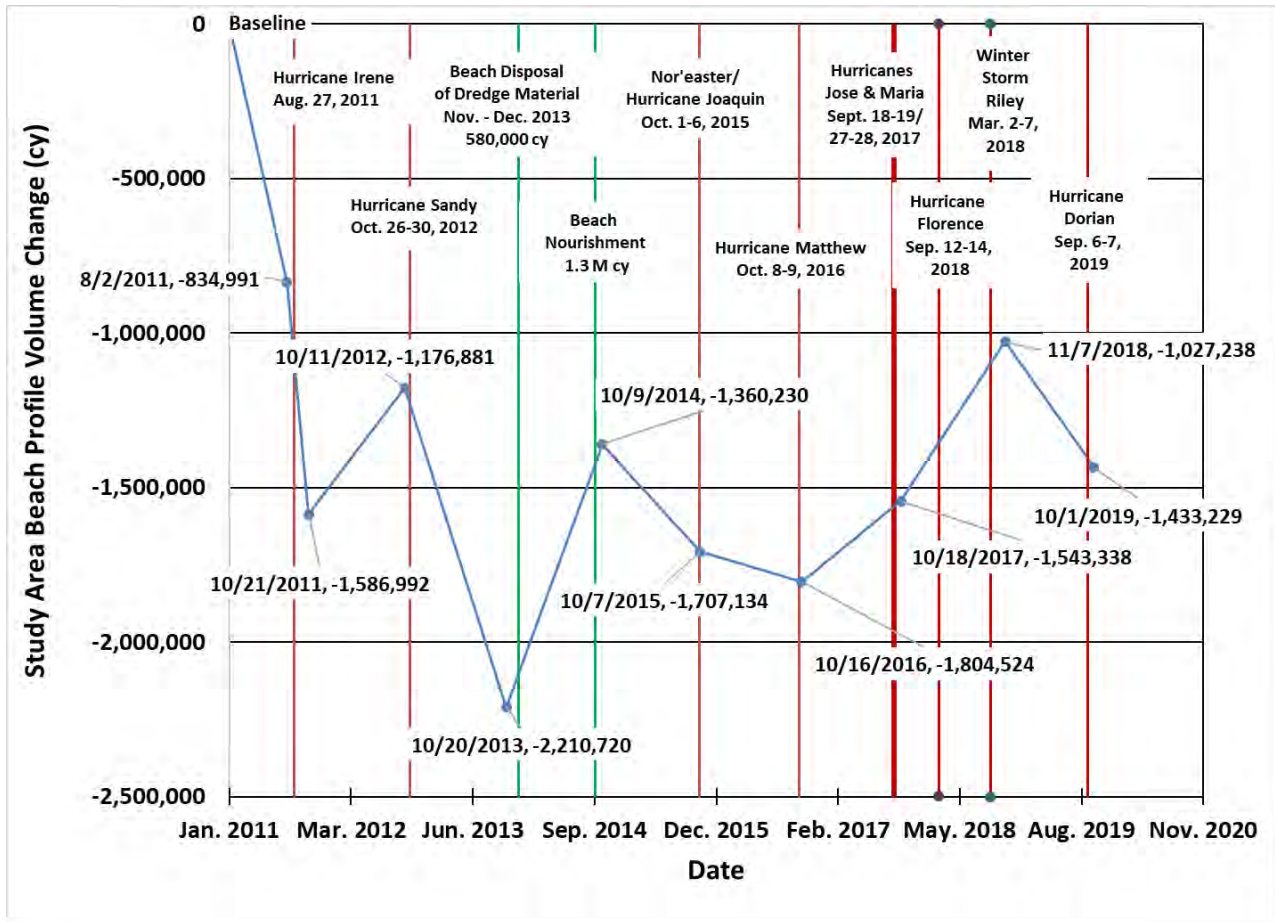
To compare volumetric conditions across the entire study area since the inception of the coastal monitoring program, a comparison of total sub-aerial volume change between the edge of pavement and the shoreline is shown in Figure 22. Dates of sand placement (2013 dredge material disposal near Oregon Inlet and the 2014 beach nourishment project) and significant storms are also indicated. The total volume was calculated by multiplying each of the profile volumes by 150 ft (the distance between the profiles) and summing the total across transects 170 to 626. Significant events affecting the volumes are highlighted by vertical red lines (Hurricane Irene, Hurricane Sandy, the October 2015 “Joaquín-easter” event, Hurricane Matthew in October 2016, Hurricanes Jose and Maria in September 2017, Winter Storm Riley and Hurricane Florence in 2018, and Hurricane Dorian in 2019). As of October 2019 there was an estimated approximately 1.4 million cubic yards less volume between the road and the shoreline than there was under baseline conditions (January 2011). Note that the net volume change over the entire study area due to the shift in EOP was an increase of 4,195 cy.

Figure 22. Total beach volume change (EOP to shoreline) across the study area, with respect to baseline conditions.

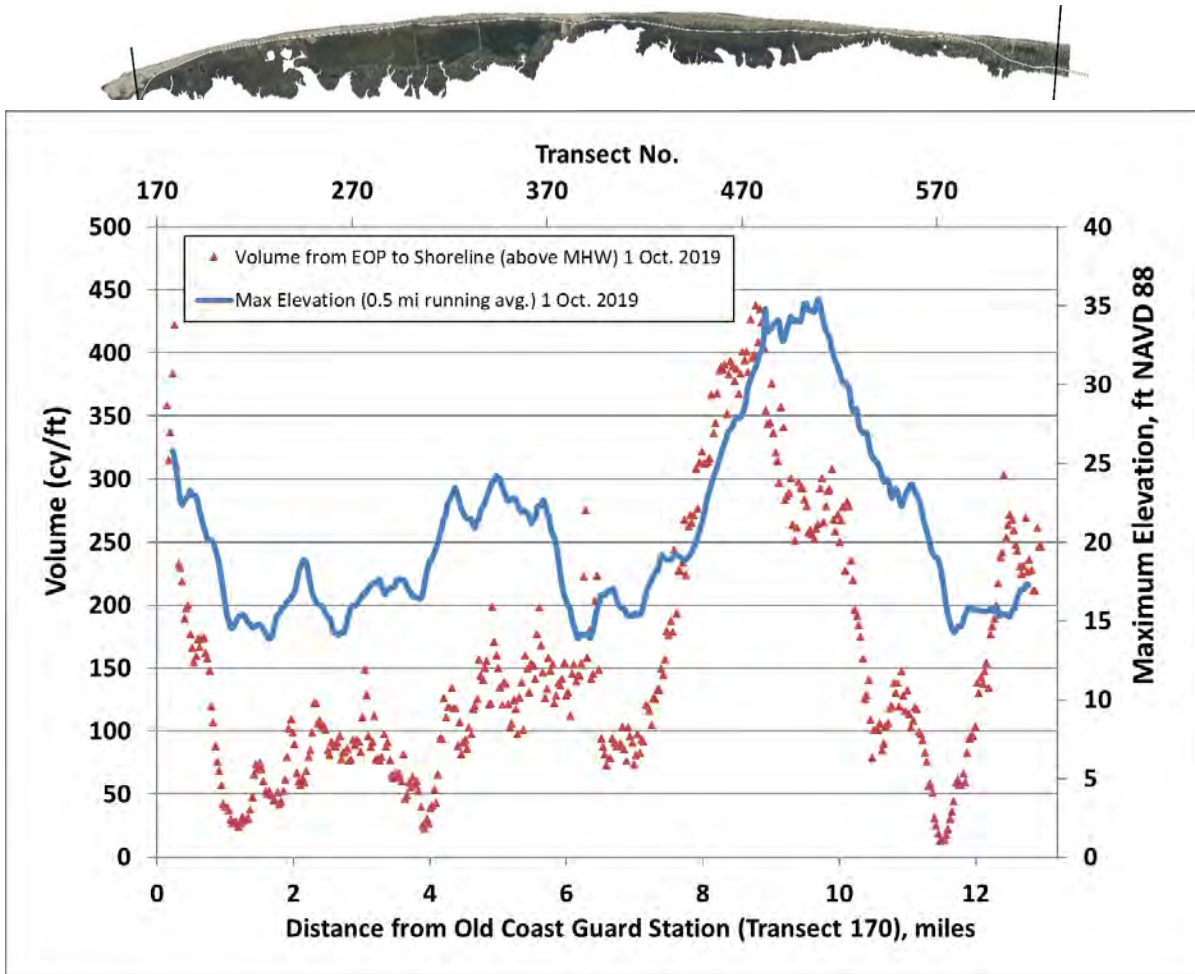
To assess conditions as of the last available topographic data of 2019, the computed volumes for October 1, 2019 are presented in Figure 23 with the running average of dune height included for comparison. The minimum measured value was approximately 13 cy/ft at Transect 574 at mile 11.5 north of Rodanthe. The average volume from the edge of pavement to the shoreline in October 2019 was approximately 165 cy/ft (in 2018 it was 171 cy/ft). Low values along the Canal Zone and freshwater ponds sections reflect the smaller dunes as well as the proximity of the road to the shoreline. From miles 7 to 10 the larger volumes correspond with higher dunes and the position of NC 12, which is set back further from the shoreline. In general, the spatial variation in profile volumes are similar to those observed in previous reports.

Figure 23. Computed volume as of October 1, 2019, from the NC 12 edge of pavement (EOP) to the shoreline above the MHW elevation displayed from north to south along the study area. The volume follows a trend similar to the running average of the maximum dune crest height, also shown.

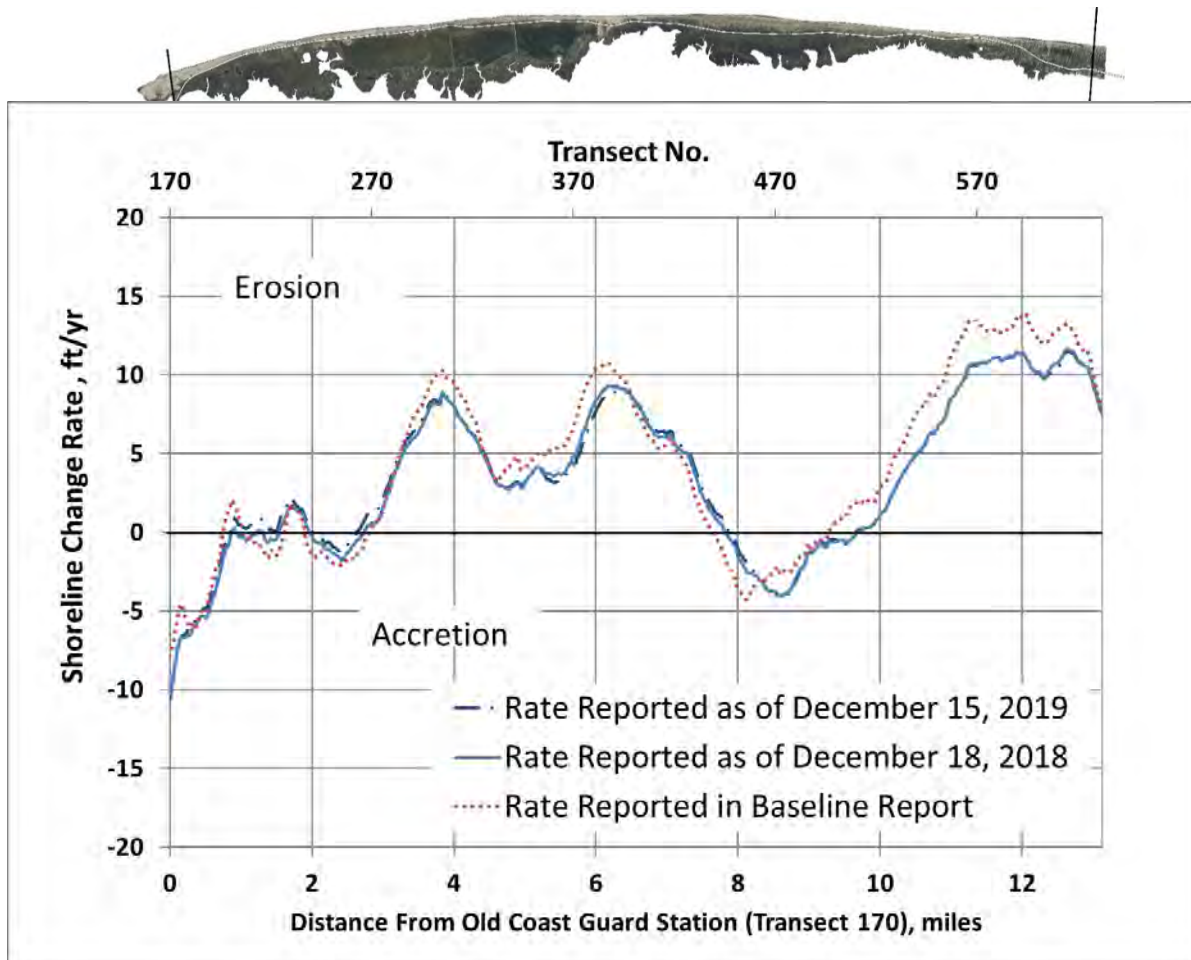
With the recent shoreline position data from 2019 added, the linear regression long-term shoreline change rates for the study area changed very little from the 2018 update conditions, as shown in Figure 28. Note that in this figure, “positive” shoreline change rates indicate erosion. Since the Baseline Report (conditions as of January 2011), similar rates of accretion have been present over the first mile with relatively low erosion (less than 2 ft/year) or slight accretion observed from miles 1 to 3. Over the remainder of the study area, trends have remained similar since the Baseline Report, with an average slight decrease in the rates of erosion in most areas.

Figure 28. Updated erosion rates through December 15, 2019, compared with 2018 update conditions (as of December 18, 2018) and baseline report conditions.

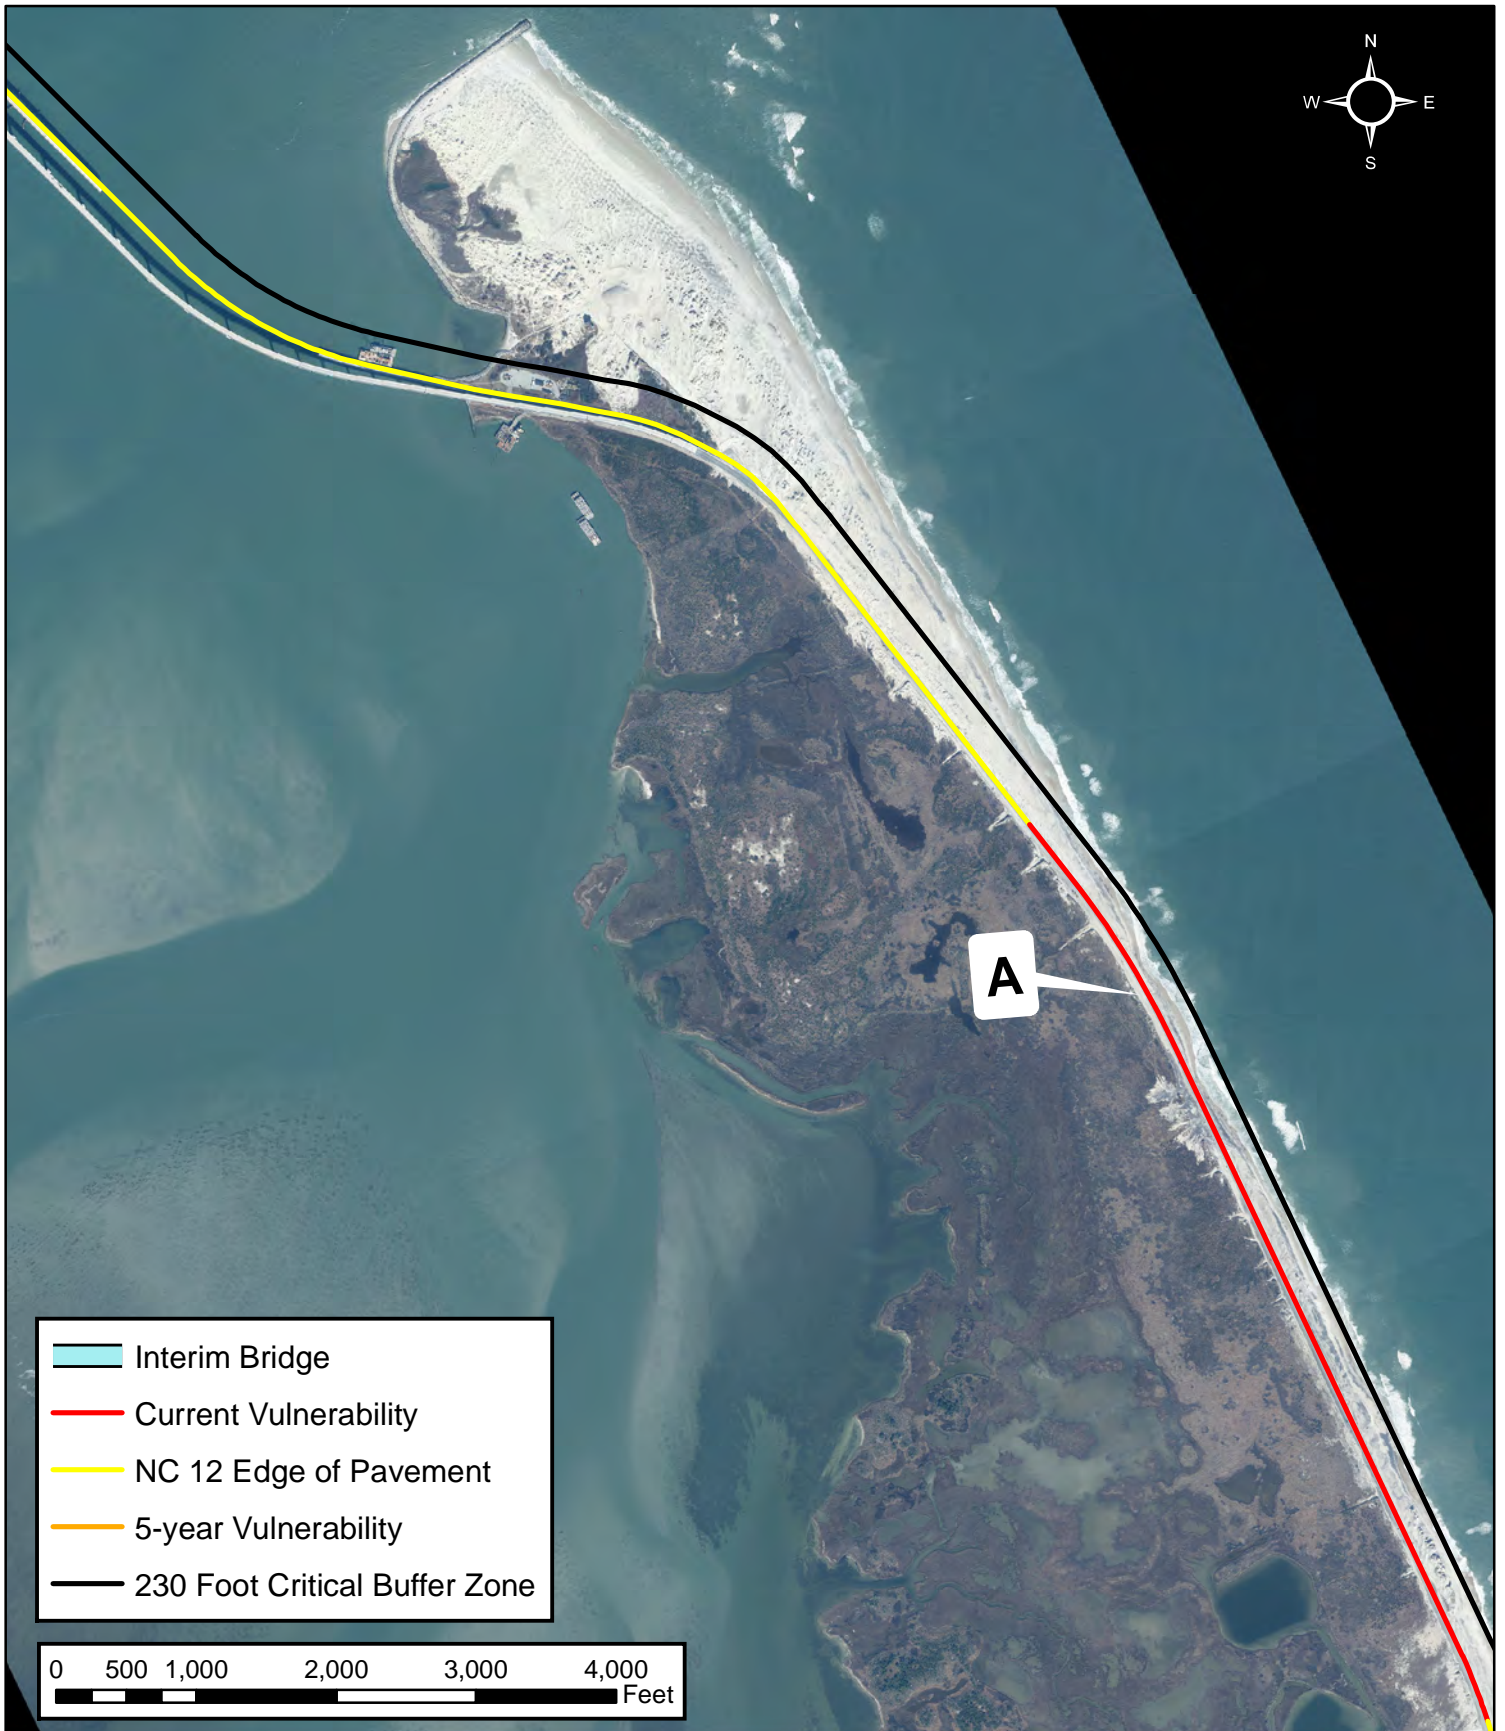
(View 1 of 6)

Figure 29 to Figure 34 illustrate the location of the 230-foot buffer offset from the NC 12 edge of pavement at the conclusion of the 2019 study year (photography dated December 15, 2019). The lengths of NC 12 where the shoreline falls within this buffer or would be expected to fall within the buffer within 5 years, using the linear regression predicted average position, are highlighted on these maps. The average predicted position is used for the 5-year forecast to provide an indication of the areas most likely to be immediately impacted. It is noted that if the 5-year forecast from the present report (2023) is compared to 2020 forecast maps from early reports, vulnerable areas are substantially longer in the prior 2020 forecast maps than those shown on the current (2019) and 5-year (2024) vulnerability maps. This is due to the inclusion of the prediction interval bands (i.e., the “worst-case” high-erosion shoreline position) on the previous 2020 maps. This essentially shows the uncertainty associated with the shoreline prediction, which makes the potentially vulnerable section larger.

Map Location (refer to Figure 29-Figure 34)	Designation in 2018 Report	Vulnerability Timeframe	Length (ft)	Approximate Transect Span	Location Description
A	A, B	Current	7,214	200-248	Canal Zone
B	C,D	Current	5,393	280-316	Adjacent to PINWR Visitors Center (Freshwater Ponds)
C	E	5-year	630	540-544	Narrow area north of Rodanthe
D	E	Current	419	545-547	
E	E	5-Year	136	547-548	
F	F	5-Year	253	562-565	Just north of refuge boundary into Rodanthe (S-Curves)
G	G	Current	3,089	565-585	
H	H	5-year	290	585-587	
TOTAL Current			16,116		
TOTAL 5-Year			1,310		
OVERALL TOTAL			17,425

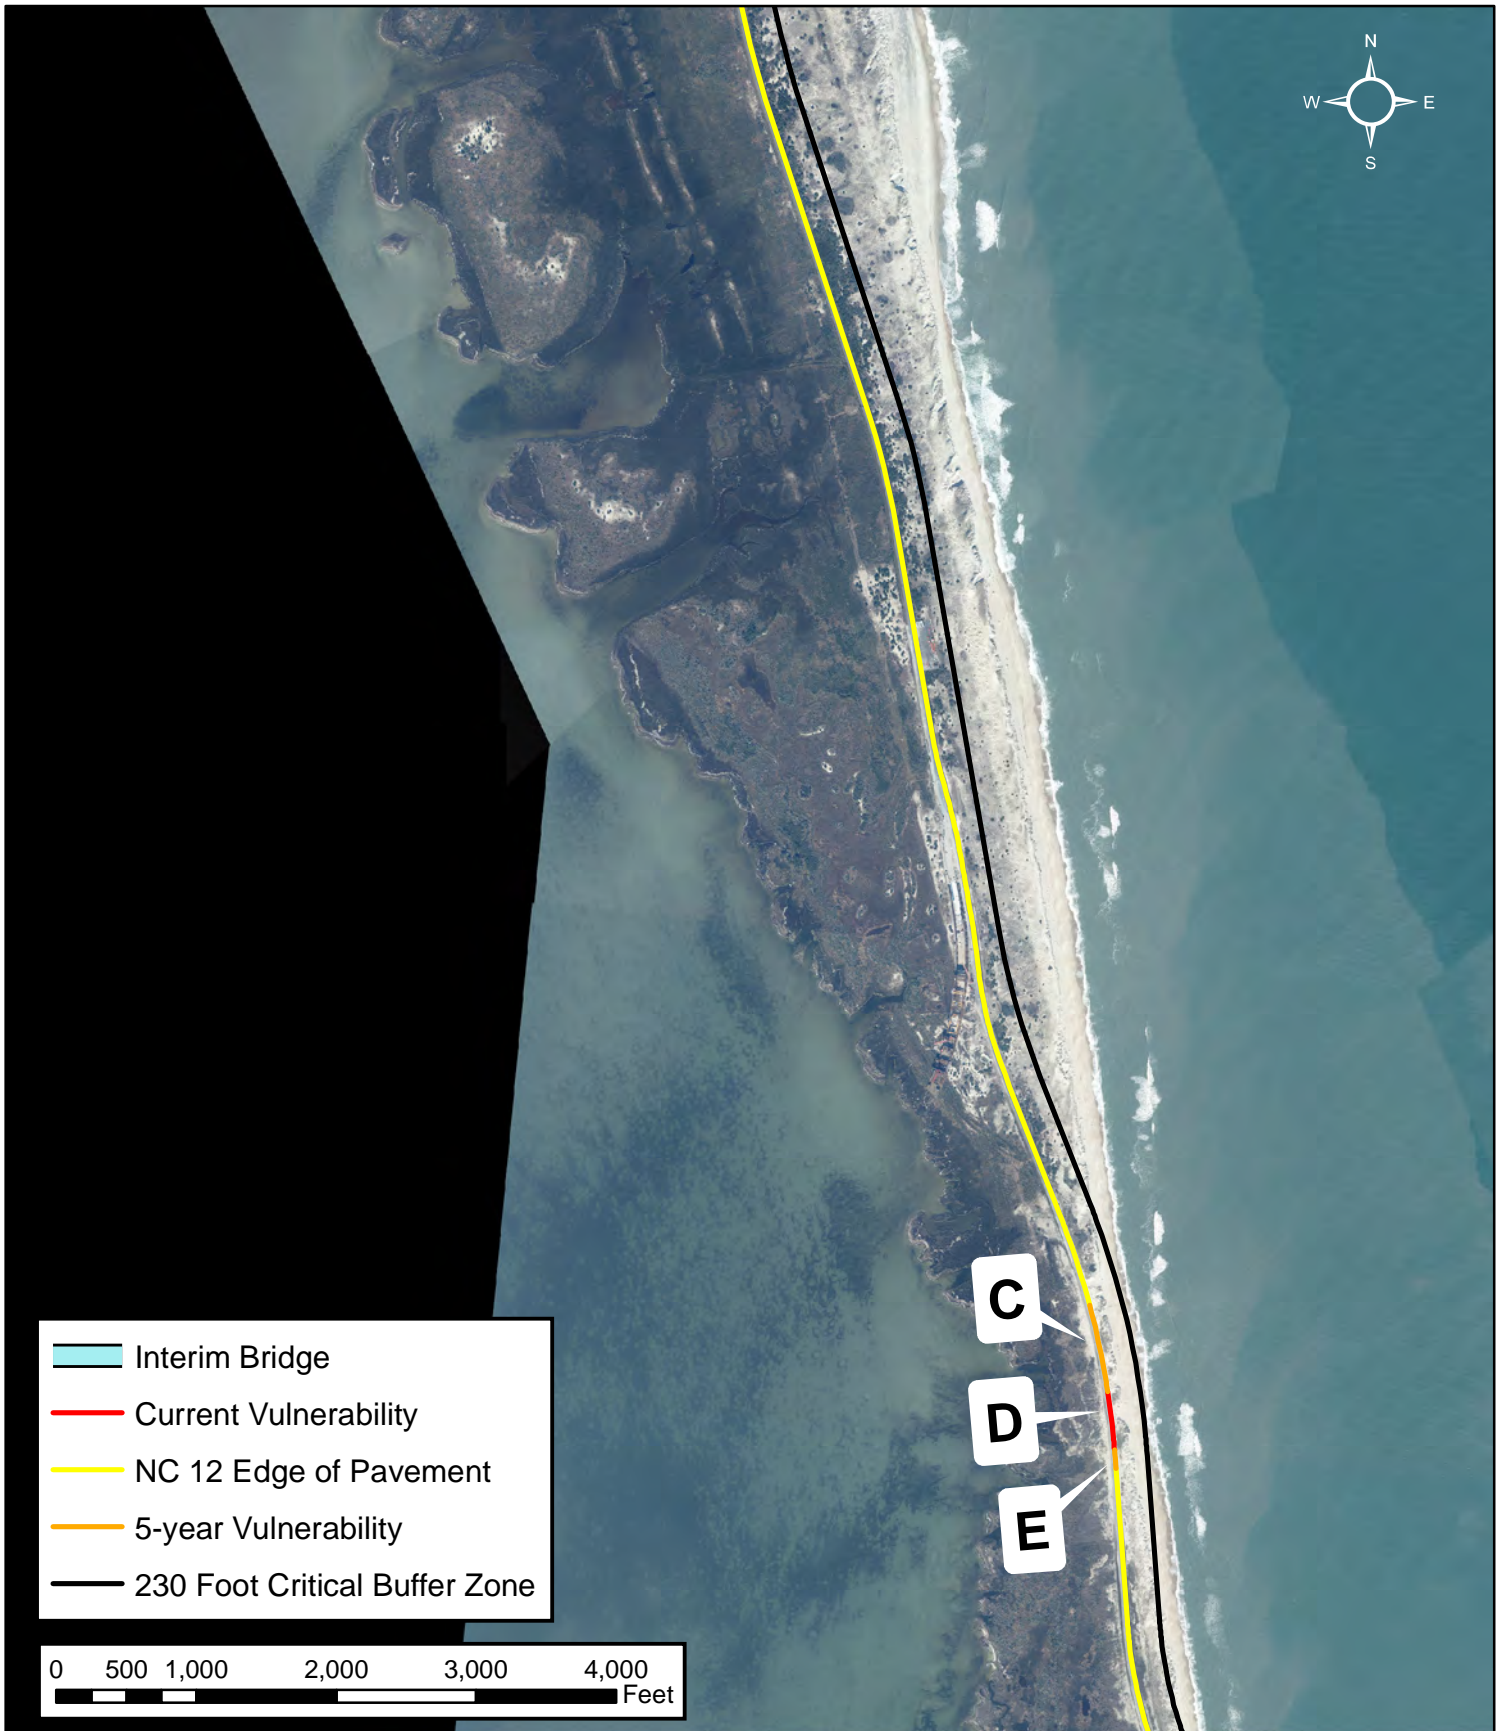
Figure 33

(View 5 of 6)

Current and 5-Year NC 12 Vulnerability
