Coastal Monitoring Program

NC 12 Transportation Management Plan

TIP Project B-2500

2019 UPDATE REPORT

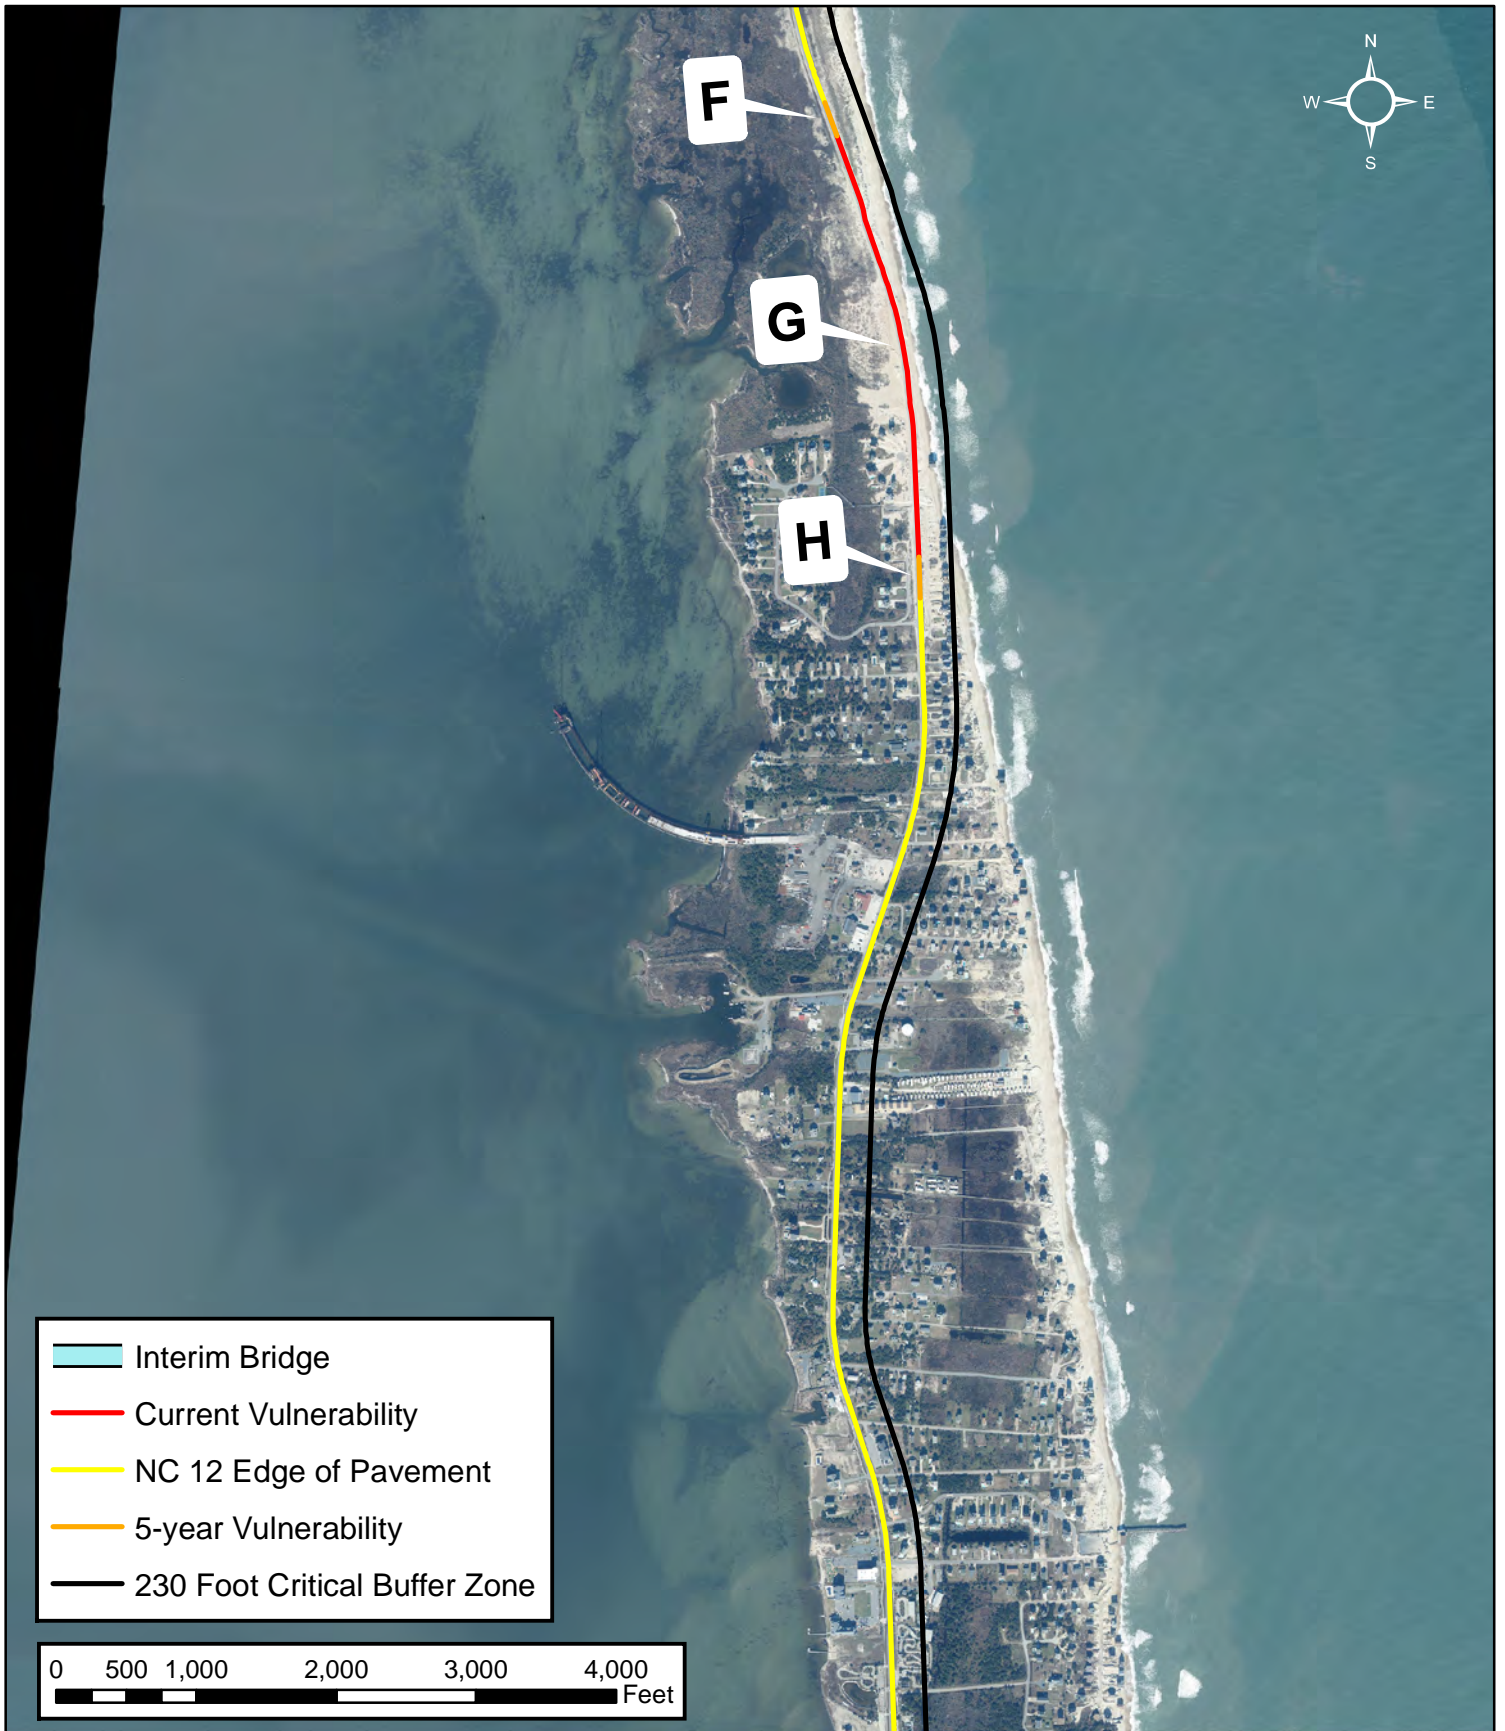
(View 6 of 6)

Figure 29 to Figure 34 illustrate the location of the 230-foot buffer offset from the NC 12 edge of pavement at the conclusion of the 2019 study year (photography dated December 15, 2019). The lengths of NC 12 where the shoreline falls within this buffer or would be expected to fall within the buffer within 5 years, using the linear regression predicted average position, are highlighted on these maps. The average predicted position is used for the 5-year forecast to provide an indication of the areas most likely to be immediately impacted. It is noted that if the 5-year forecast from the present report (2023) is compared to 2020 forecast maps from early reports, vulnerable areas are substantially longer in the prior 2020 forecast maps than those shown on the current (2019) and 5-year (2024) vulnerability maps. This is due to the inclusion of the prediction interval bands (i.e., the “worst-case” high-erosion shoreline position) on the previous 2020 maps. This essentially shows the uncertainty associated with the shoreline prediction, which makes the potentially vulnerable section larger.

Map Location (refer to Figure 29-Figure 34)	Designation in 2018 Report	Vulnerability Timeframe	Length (ft)	Approximate Transect Span	Location Description
A	A, B	Current	7,214	200-248	Canal Zone
B	C,D	Current	5,393	280-316	Adjacent to PINWR Visitors Center (Freshwater Ponds)
C	E	5-year	630	540-544	Narrow area north of Rodanthe
D	E	Current	419	545-547	
E	E	5-Year	136	547-548	
F	F	5-Year	253	562-565	Just north of refuge boundary into Rodanthe (S-Curves)
G	G	Current	3,089	565-585	
H	H	5-year	290	585-587	
TOTAL Current			16,116		
TOTAL 5-Year			1,310		
OVERALL TOTAL			17,425

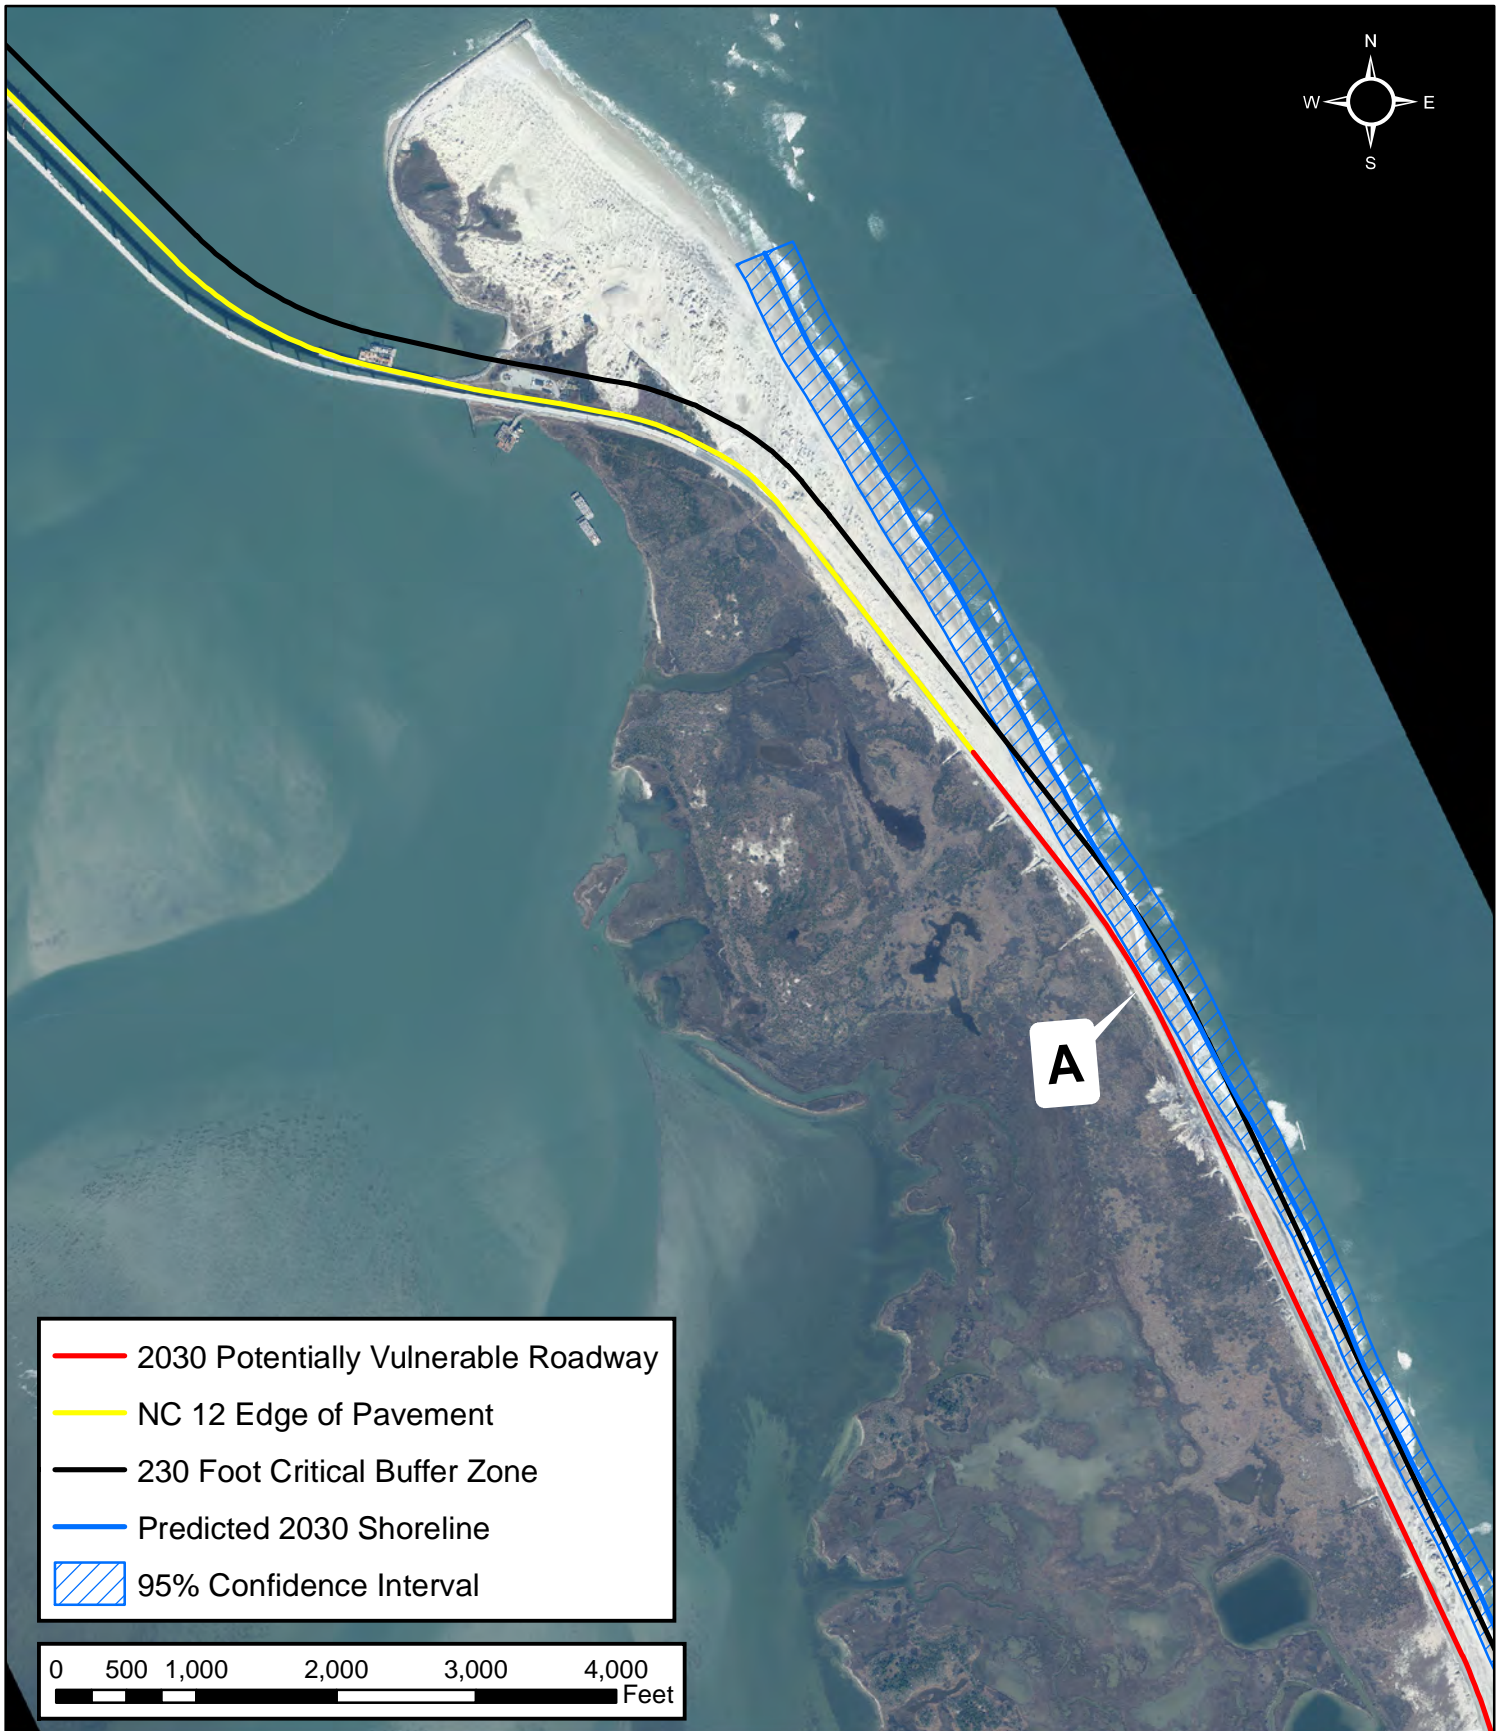
Figure 35

(View 1 of 6)

Map Location (refer to Figure 35-Figure 40)	Designation in 2018 Report	Length (ft)	Approximate Transect Span	Location Description
A	A	8,170	196-250	Canal Zone
B	B	5,827	280-319	North of, Adjacent to, and South of Pea Island Visitors Center (Freshwater Ponds)
C	C	3,761	355-380	Adjacent to South Pond and just north of Pea Island Breach
Interim Bridge	C	506	380-383	Small section at the north side of the Interim Bridge span
D	--	210	403-404	Small section south of the Interim Bridge
E	D	8,936	535-594	Narrow area north of Rodanthe, past refuge boundary into Rodanthe (S-Curves)
TOTAL		27,410

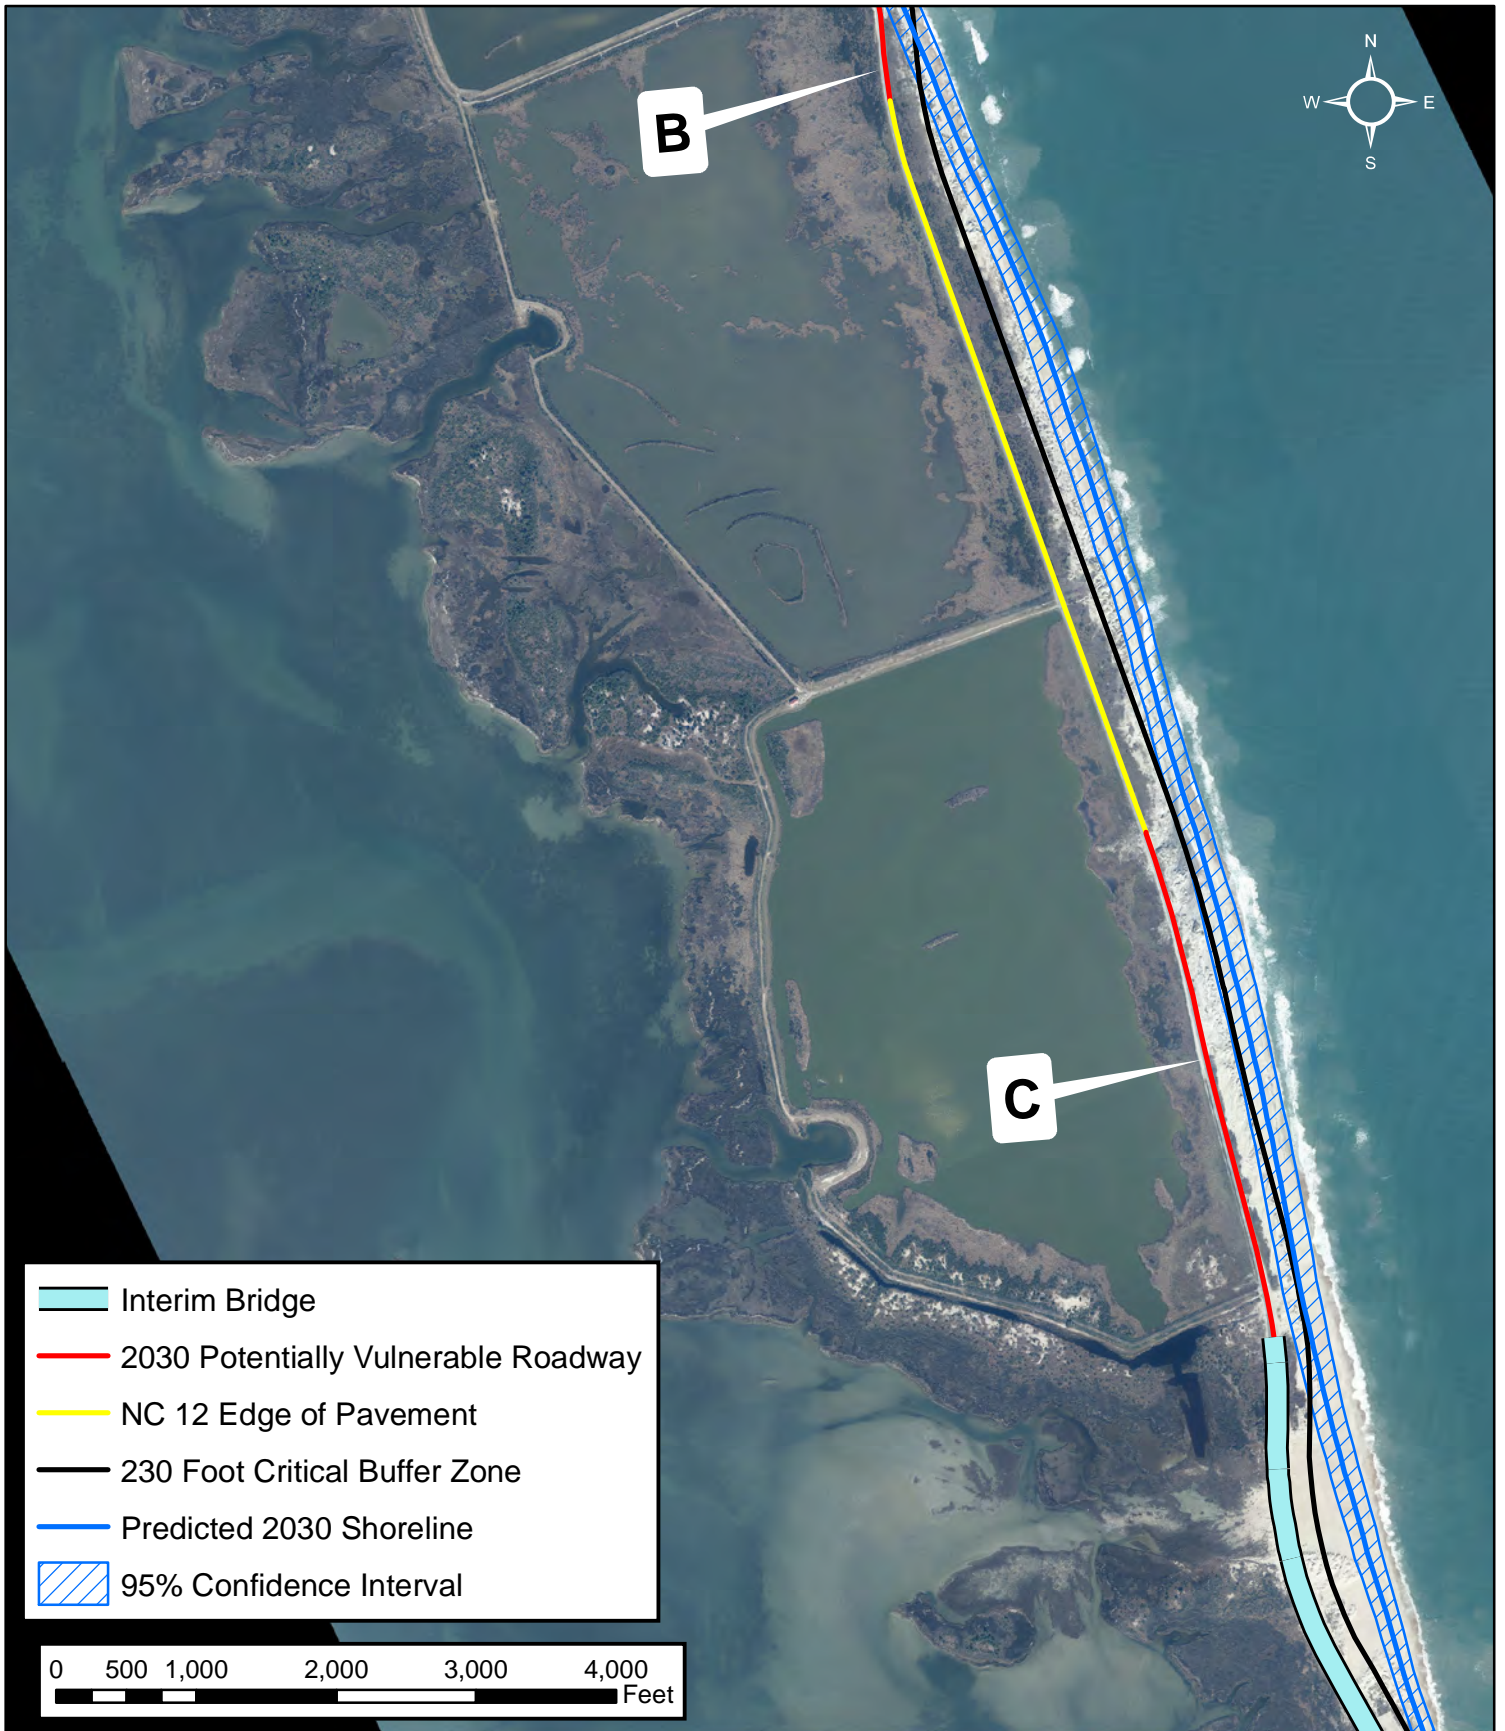
Figure 37

(View 3 of 6)

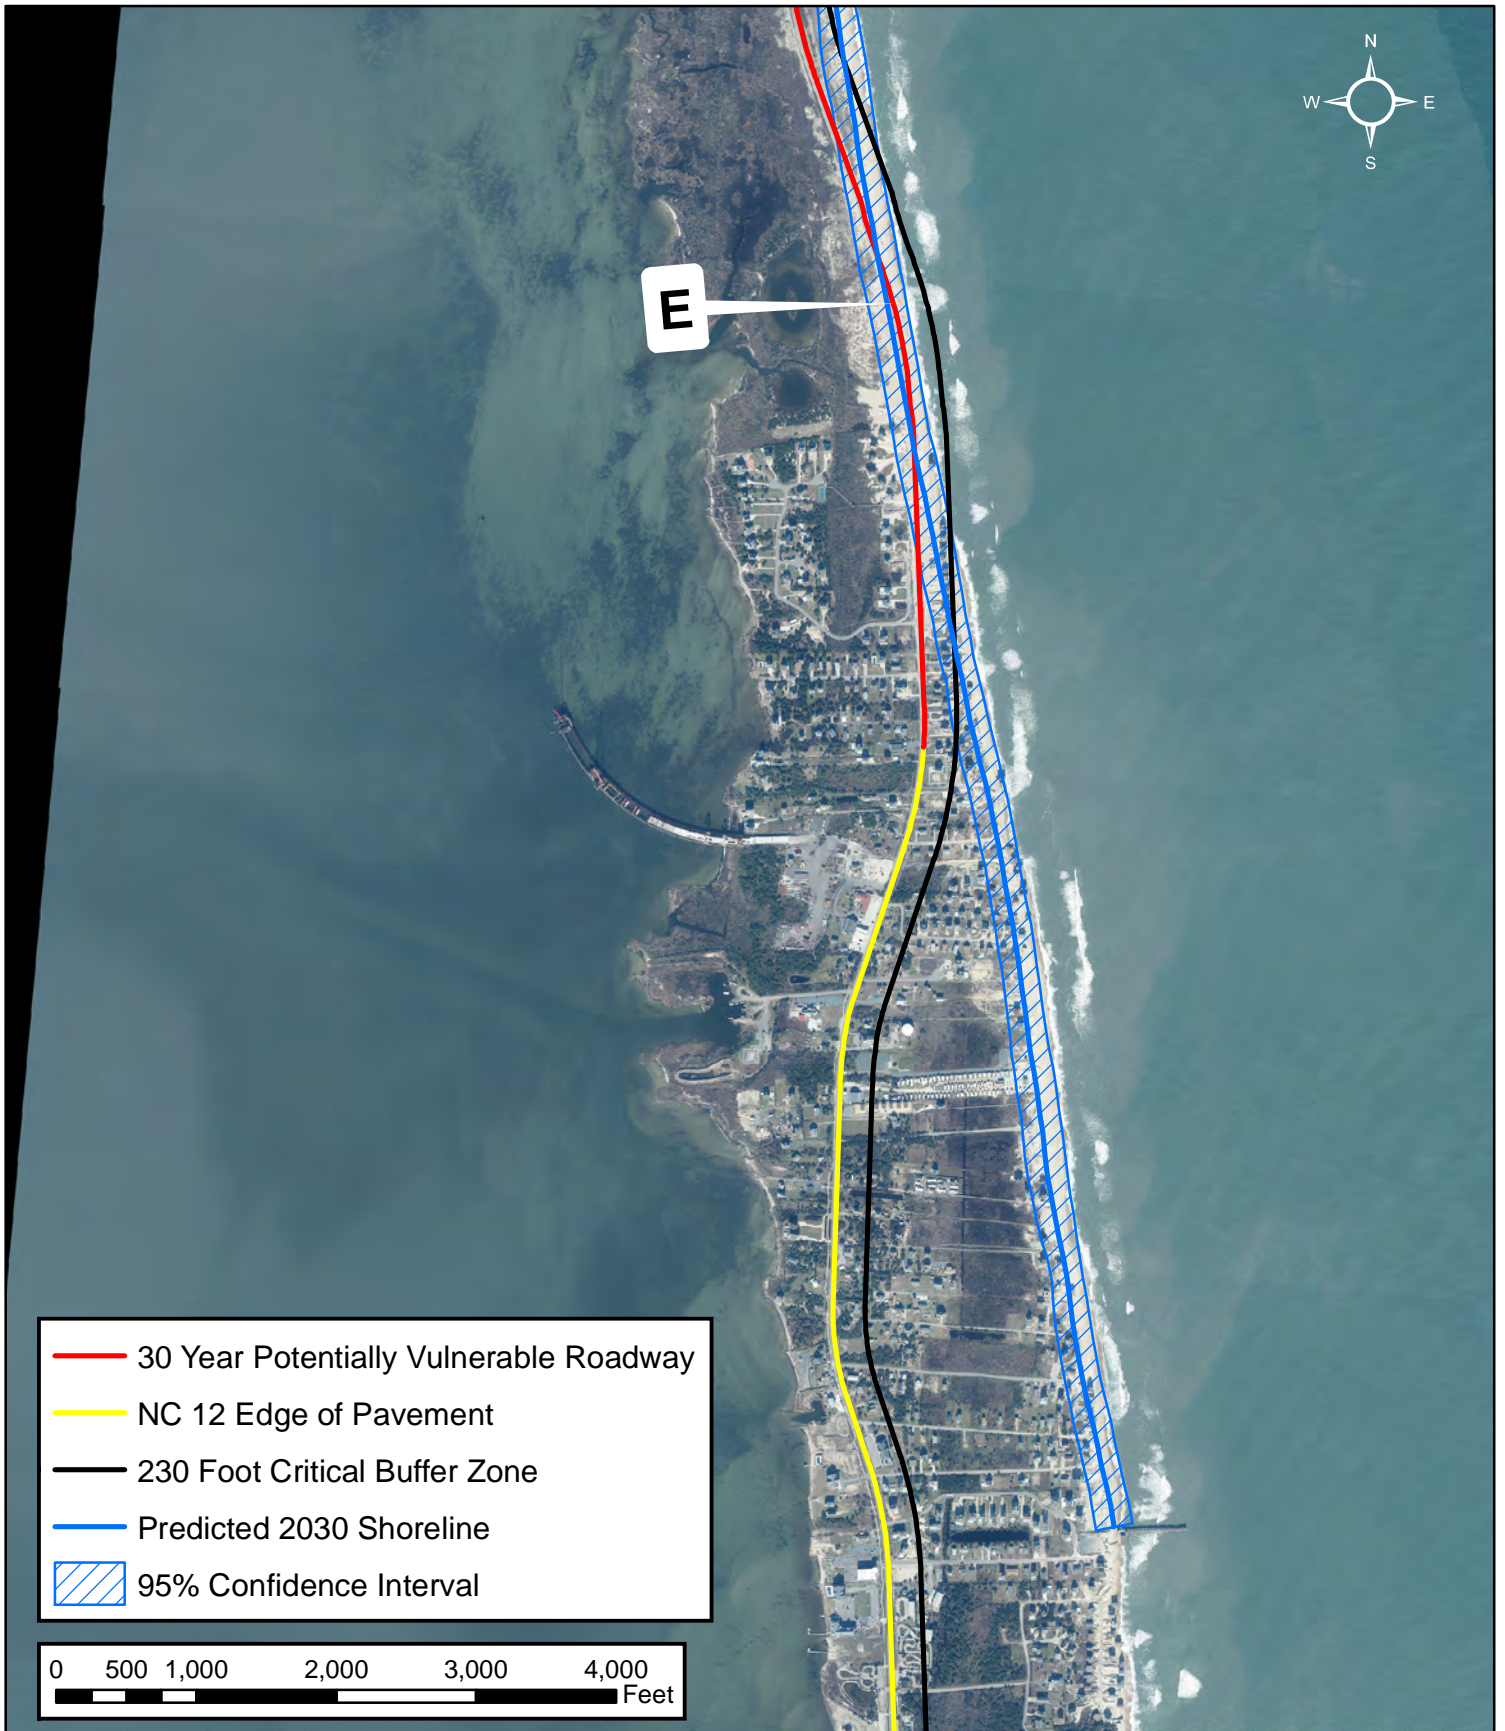
Figure 40

(View 6 of 6)

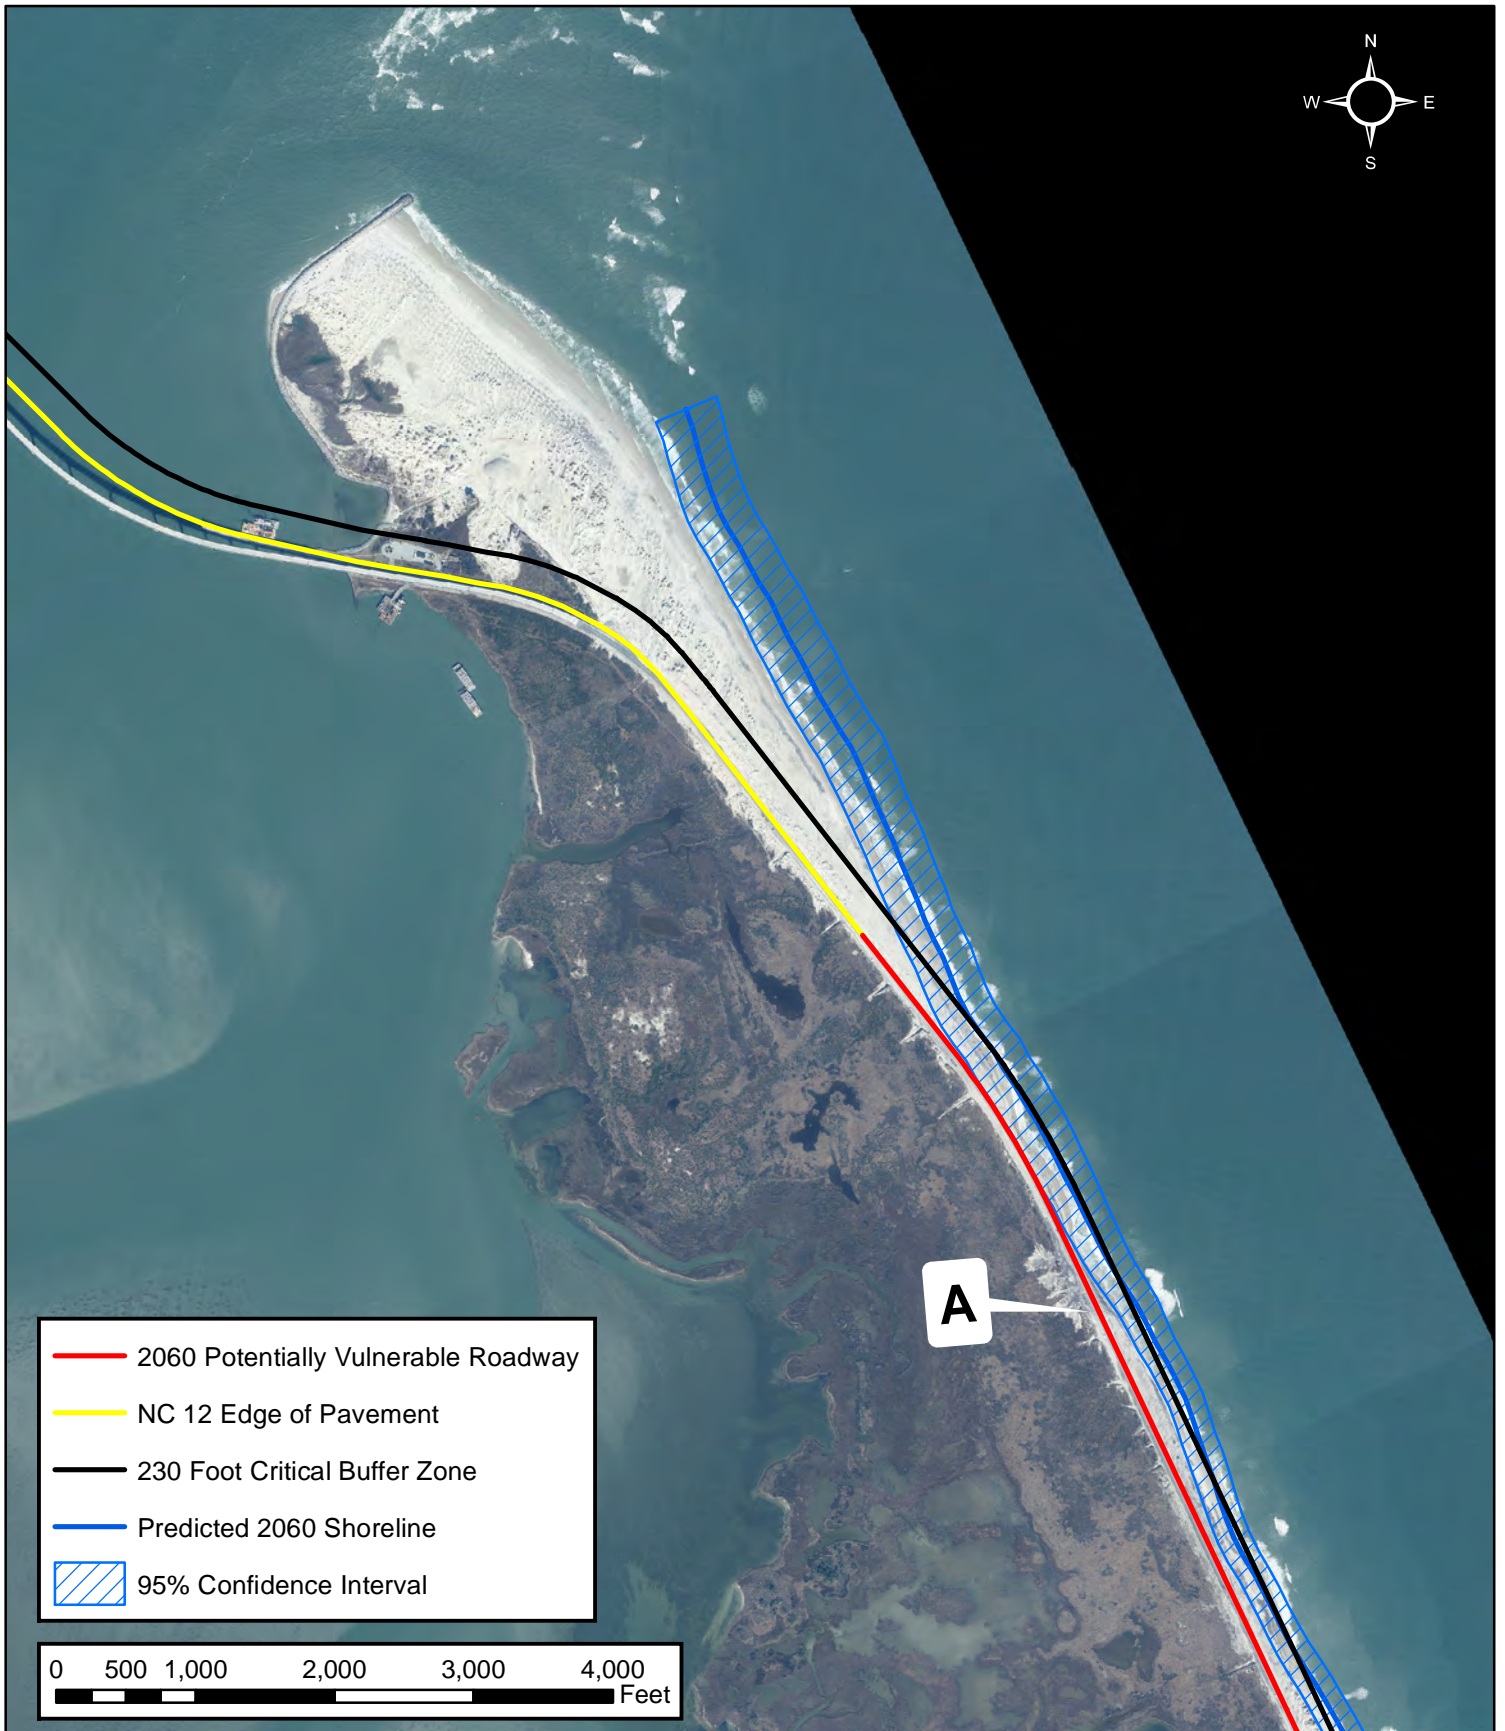
Figure 42

(View 1 of 6)

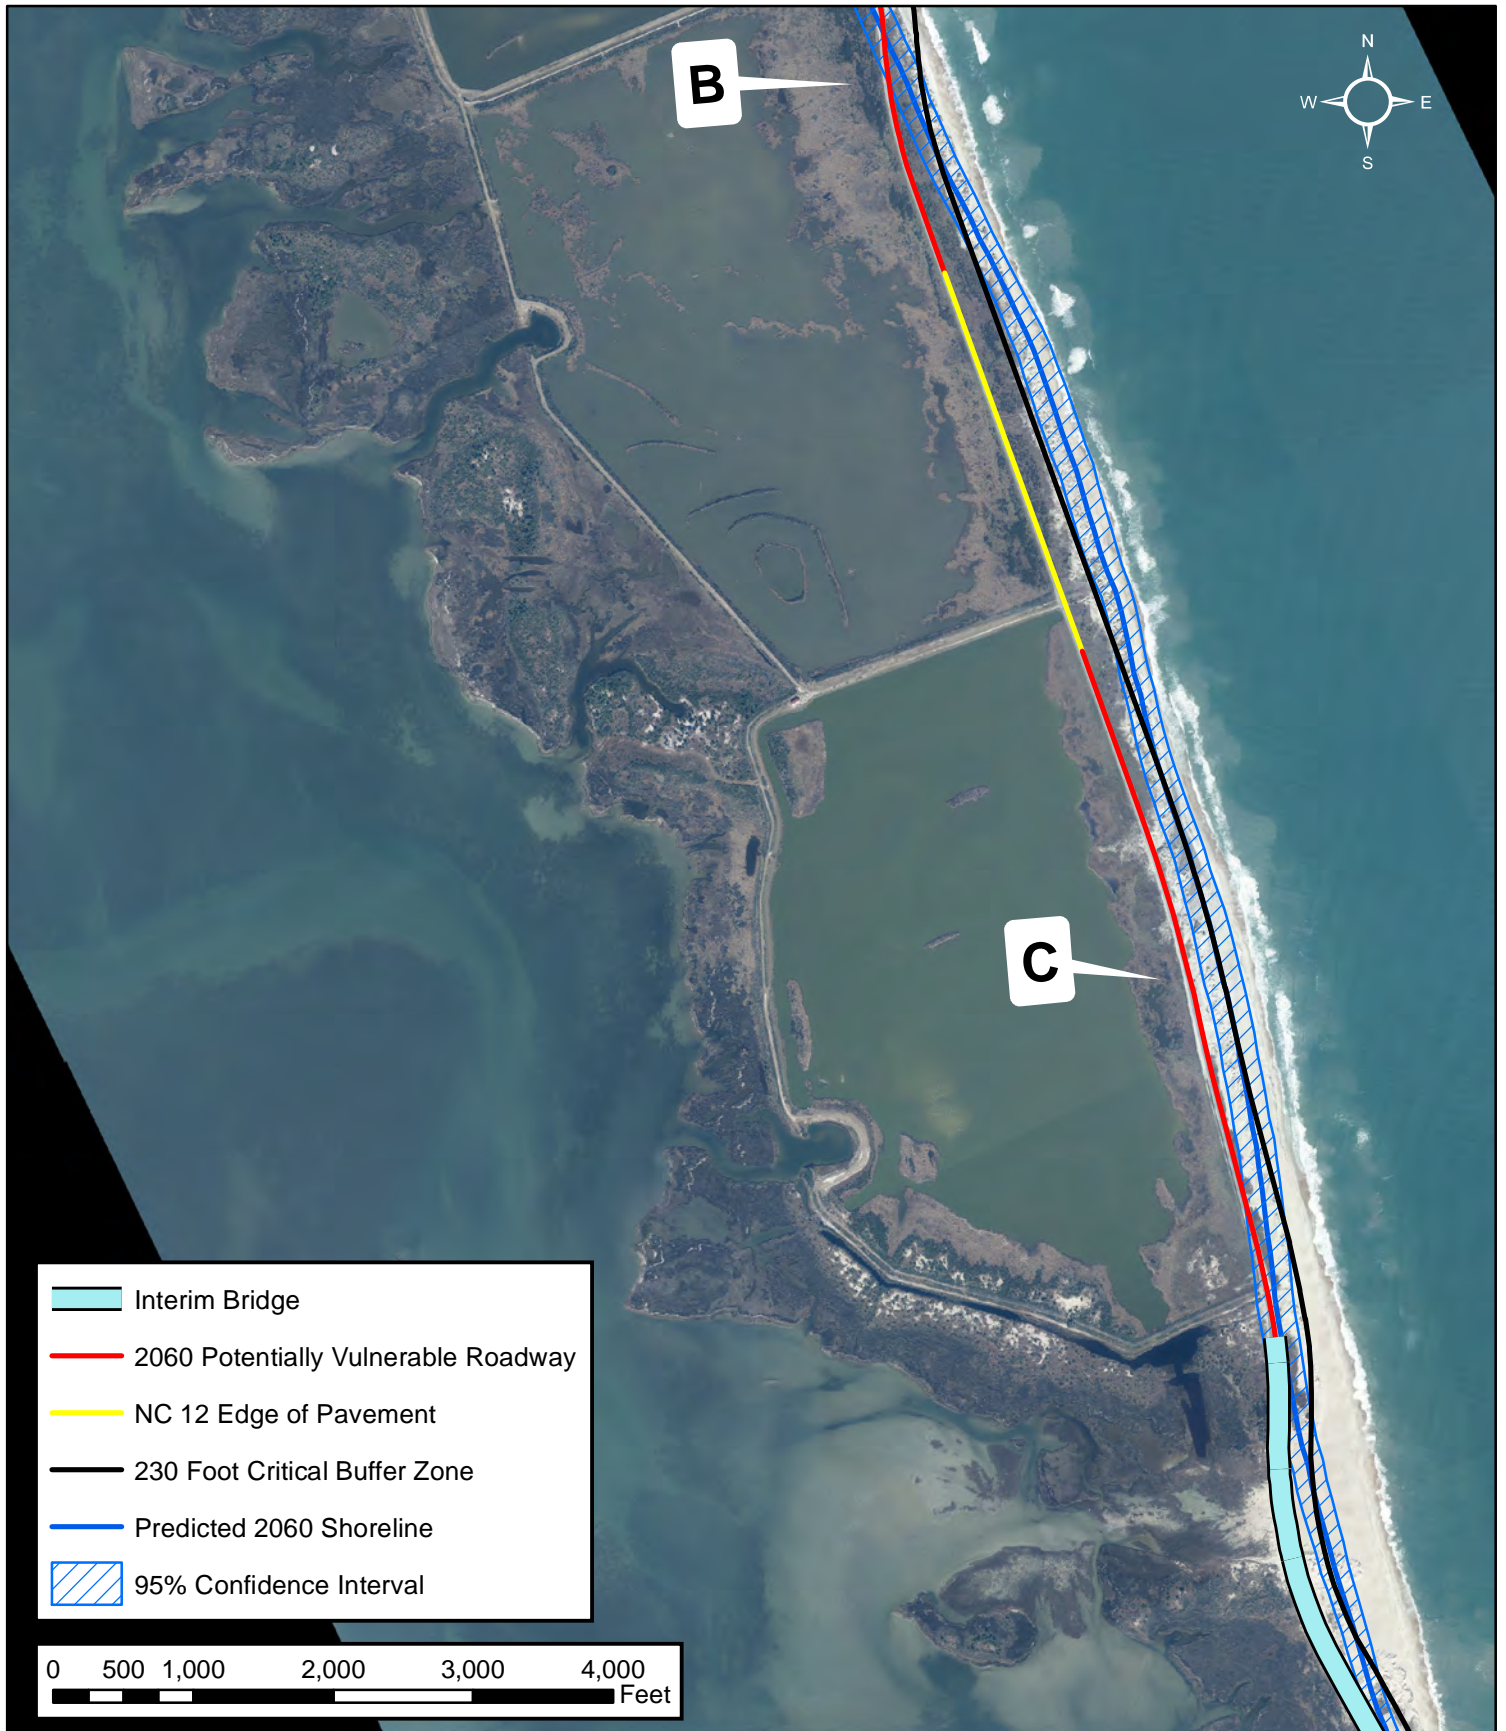
Figure 44

(View 3 of 6)

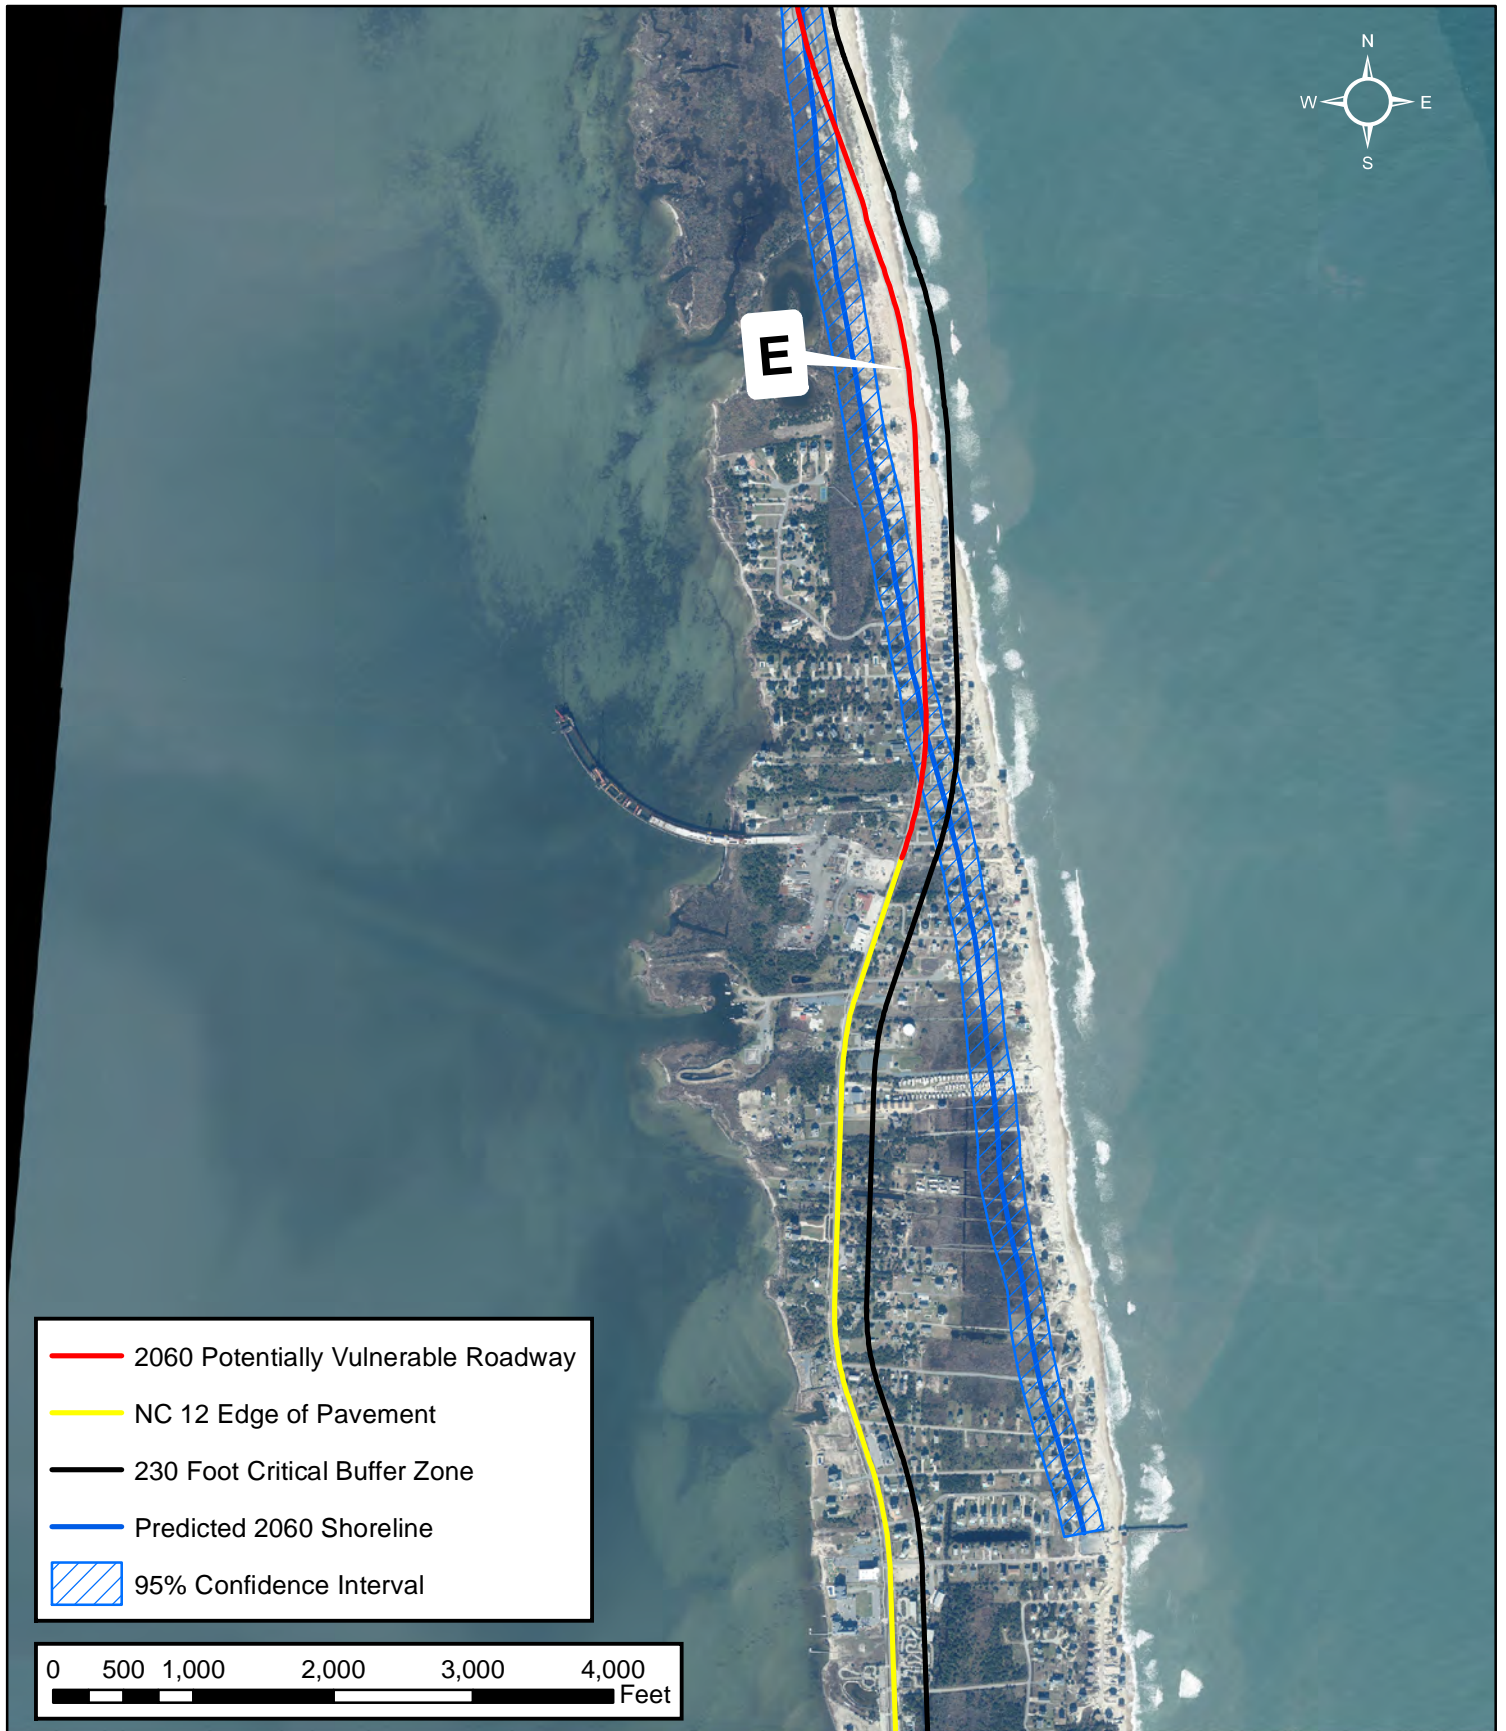
Figure 47

(View 6 of 6)

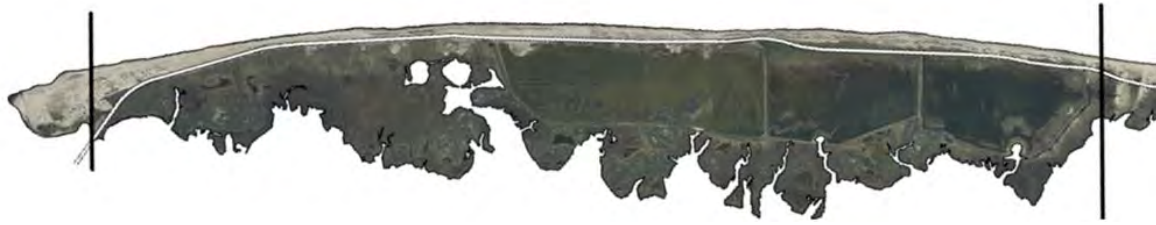
Figure 50. Annual Historical Erosion Rate: October 3, 1968 to October 9, 1988.

Figure 50 shows the annual historical erosion rate based upon linear regression of shoreline position at each transect from October 1968 to October 1988. Transect 170 corresponds to mile zero reported in Figure 50, and Transect 381 corresponds to mile 6 (see Figure 1 for transect locations). In general, the historical erosion rate along this portion of Pea Island was relatively high, with a mean value of about 12.7 ft/yr. The portion of the shoreline within the first mile of the old Coast Guard Station (closest to the inlet) was clearly the area of highest erosion, as one would expect near the inlet. In this area, the erosion rate has a maximum value of 36 ft/yr, and decreases to about 12 ft/yr approximately 1 mile south of the old Coast Guard Station. Rates increase to over 20 ft/year at the northernmost pond (mile 2.6), with lower rates further south.

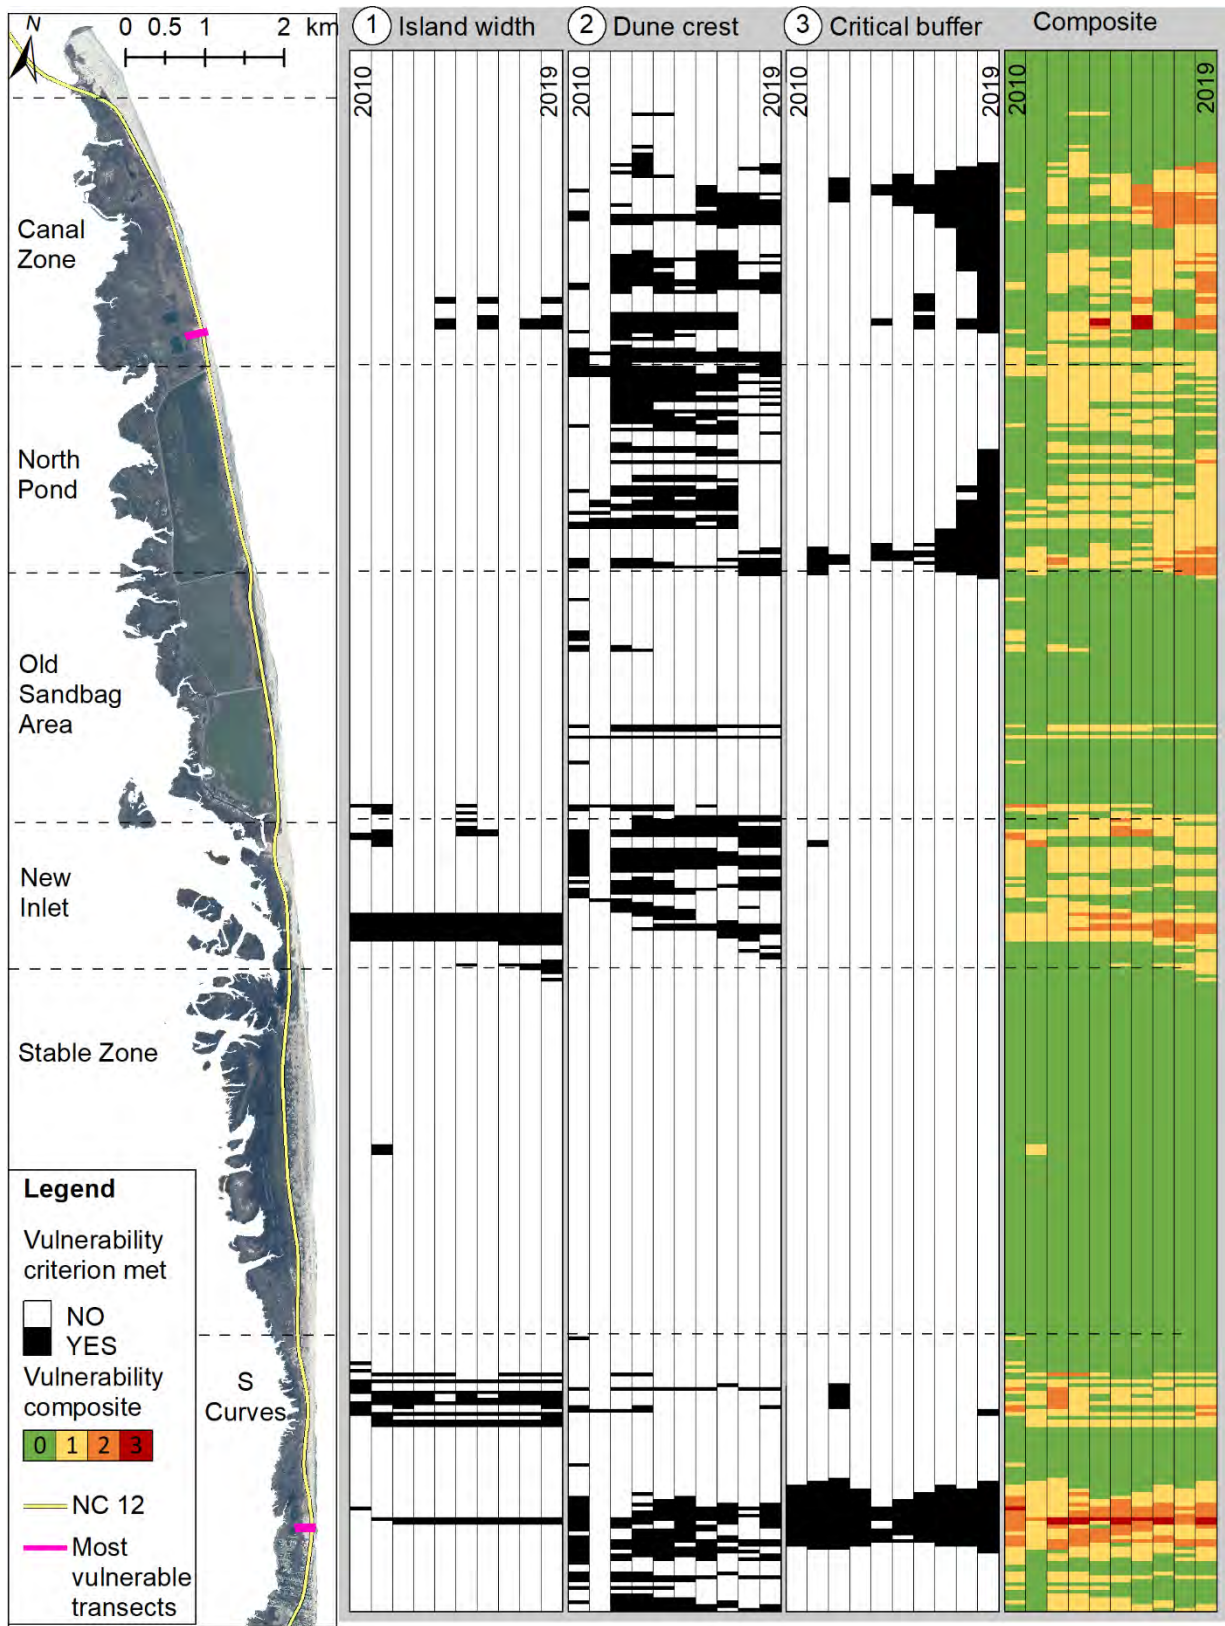
Figure 59. Comparison of vulnerability from the baseline report to the 2019 report. Vulnerabilities reported at the end of each study year.

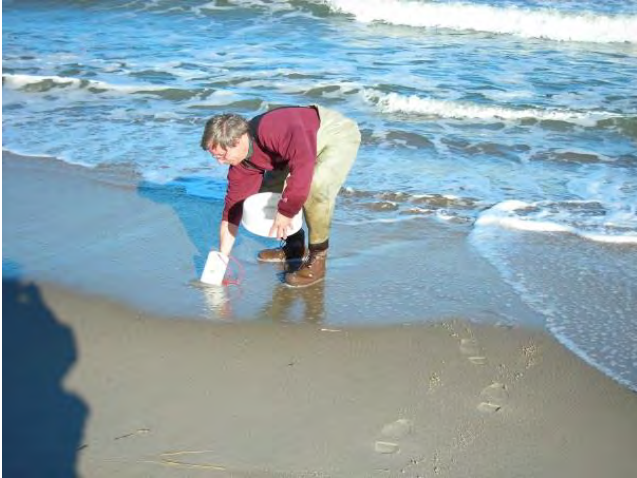
Collecting benthos sample in swash zone

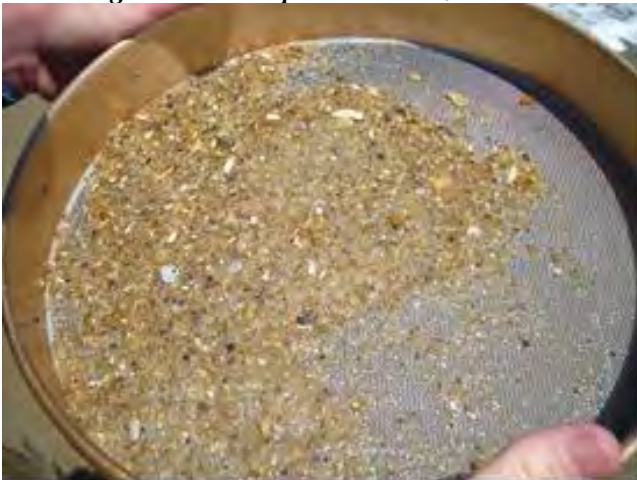
Sand sample in sieve

Samples were delivered to the NCDOT Soil Laboratory for sieve analysis in accordance with 1995 Standard Specifications. The following sieve sizes were used for analysis. #4 (4.75mm), #10 (2mm), #18 (1mm), #25 (0.75mm), #35 (0.5mm), #60 (0.25mm), #100 (0.15mm), and #140 (0.106mm). The samples were dried, split evenly and approximately *spacing* 200 grams was weighed for sieve analysis. Samples were washed over the # 200 sieve until the wash water ran clear, transferred to a sample container and placed in an oven to dry at a temperature of 230 degrees Fahrenheit. Dried samples were then poured into the nest of required sieves and shaken for a short period of time. The retained material on each individual sieve was weighed and recorded.

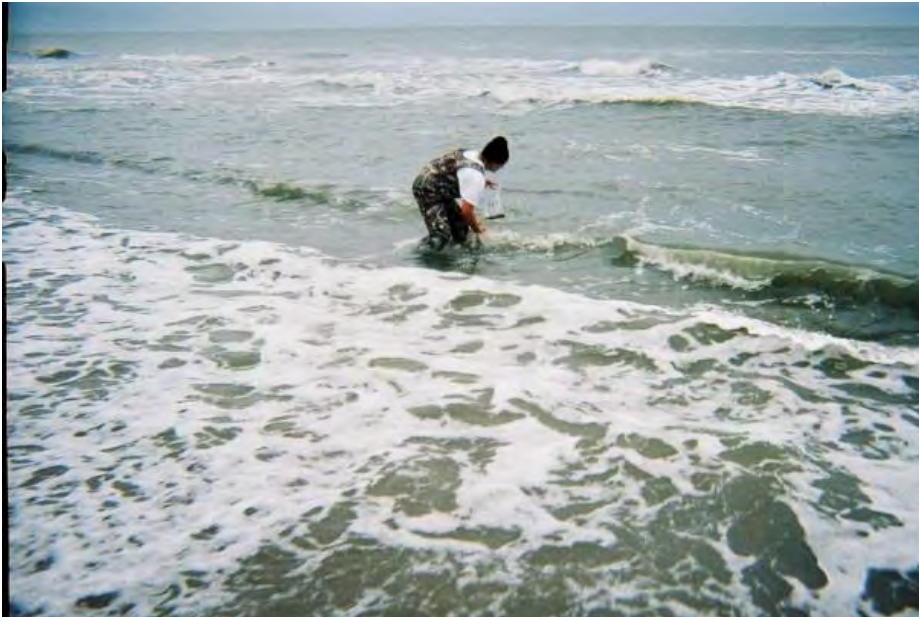
Collecting sand sample for grain size analysis

Sand samples consisting of an amount equivalent to about ¼ cup of material were placed in sealable polyethylene bags for lab analysis. Samples were submitted to the NCDOT Materials and Test Unit Soils laboratory for sieve analysis and to the North Carolina Geologic Survey for heavy mineral analysis.
