Coastal Monitoring Program

NC 12 Transportation Management Plan

TIP Project B-2500

2019 UPDATE REPORT

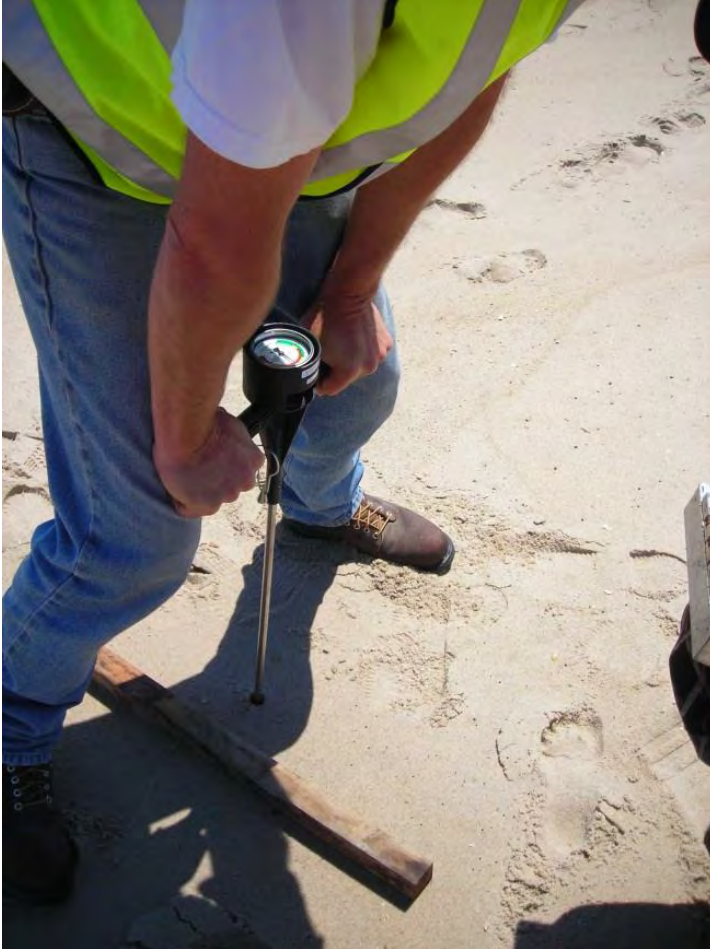
Measuring compaction

Compaction measurements were collected just above the upper-swash zone from the surface to 12-inches deep with a DICKEY-john® Soil Compaction Tester. Compaction measurements were recorded every three inches. According to United States Army Corp of Engineers personnel, this equipment (DICKEY-john® Soil Compaction Tester) is commonly used for compaction testing in similar studies. There is no ASTM method associated with the soil compaction tester. Slope measurements were made using a Brunton™ compass placed on a 12-inch board. The 12-inch board was oriented perpendicular to the water's edge.

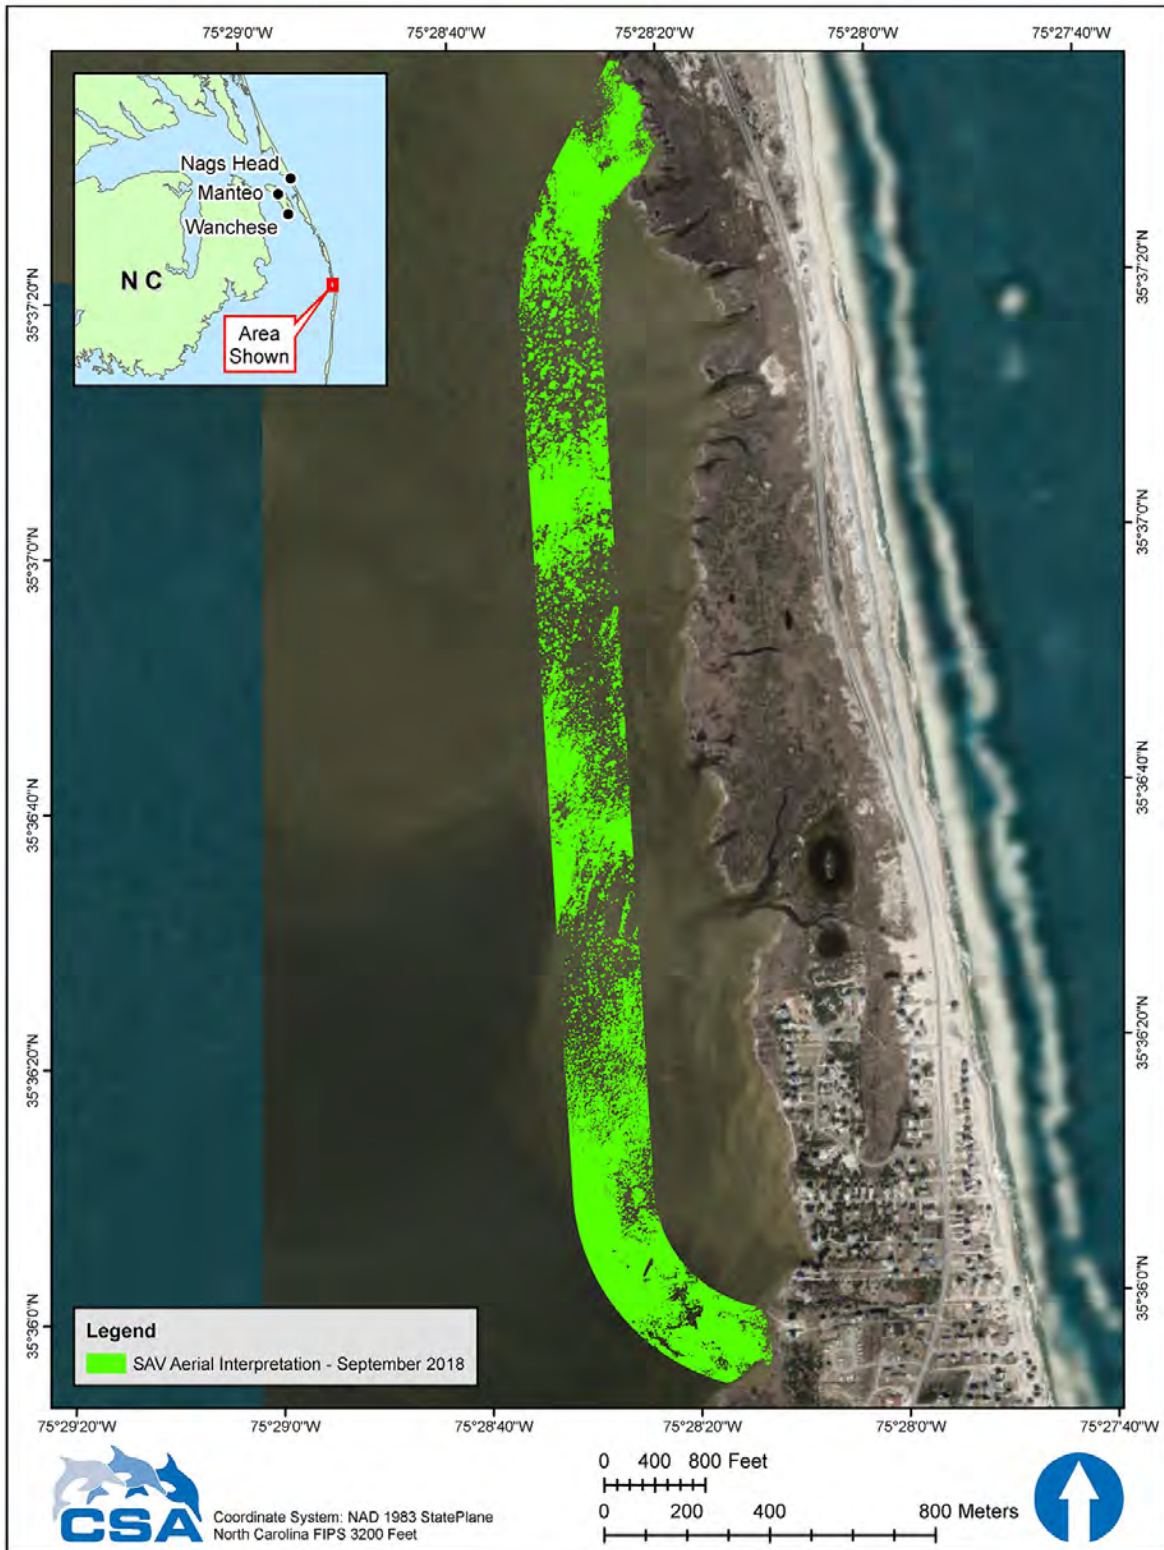
Figure 3. GIS-based interpretation of submerged aquatic vegetation (SAV) cover within the study area (bridge alignment, shading and reference strata) for the September 2018 survey.

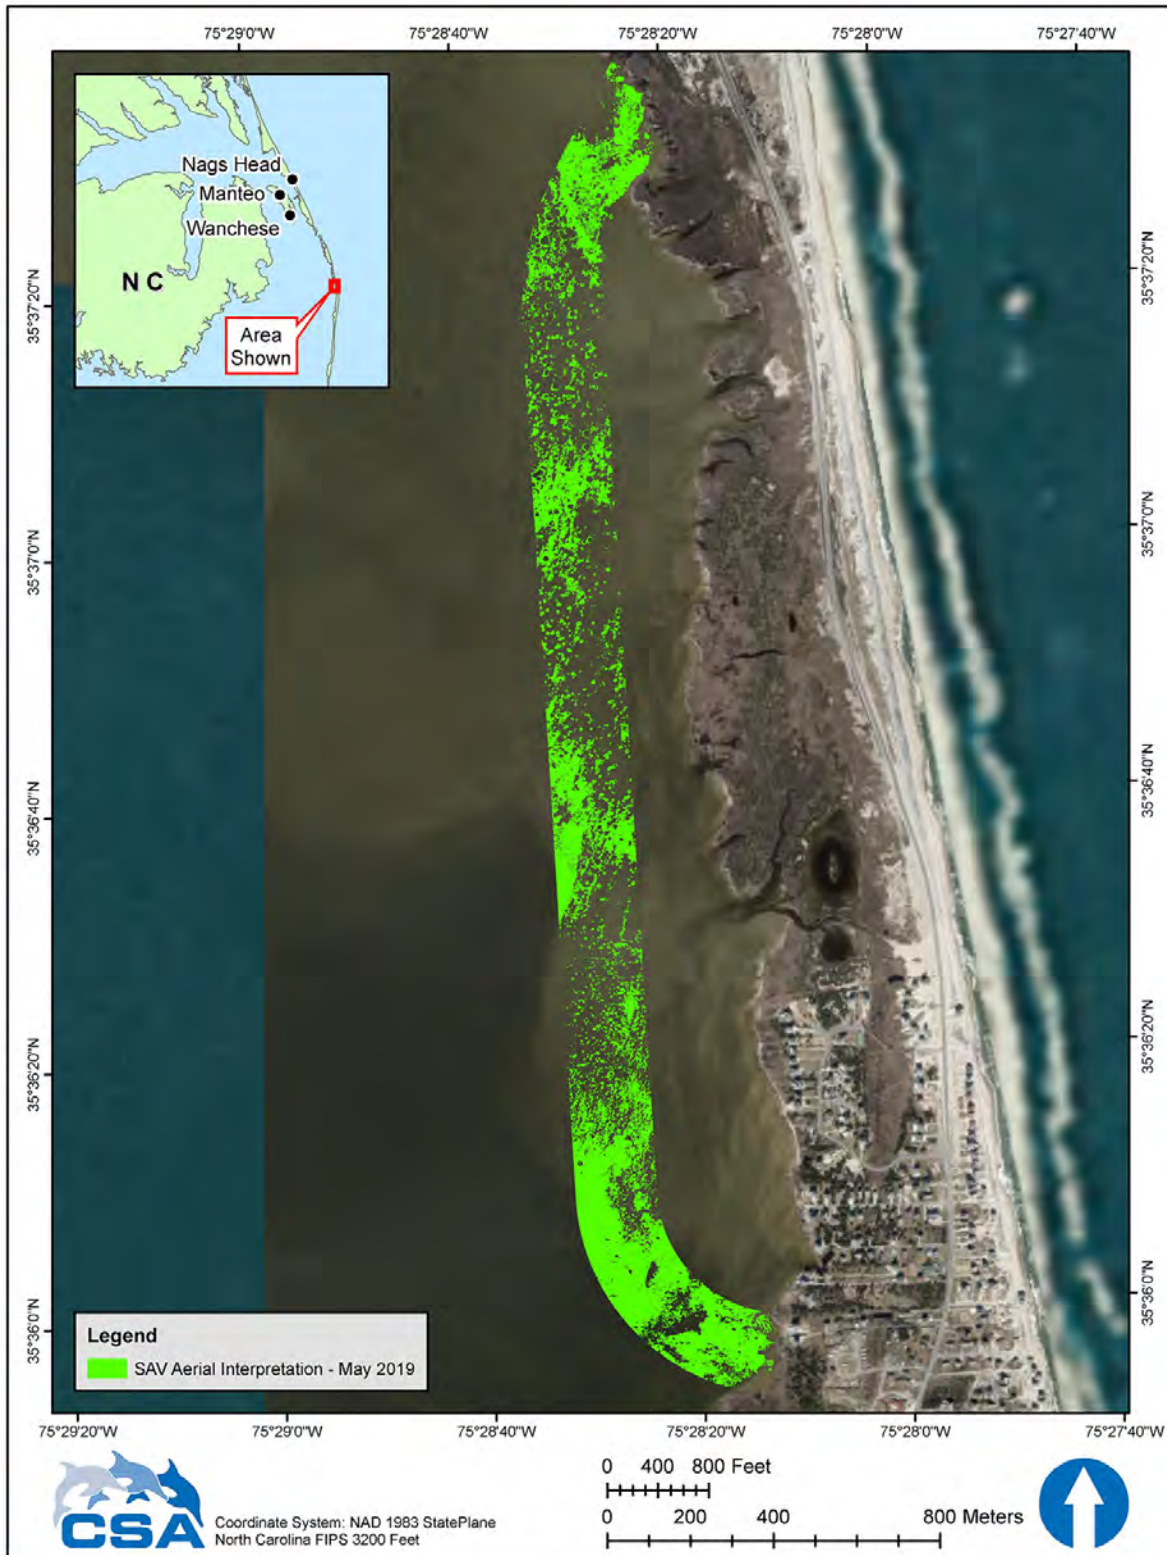
Figure 4. GIS-based interpretation of submerged aquatic vegetation (SAV) cover within the study area (bridge alignment, shading and reference strata) for the May 2019 survey.

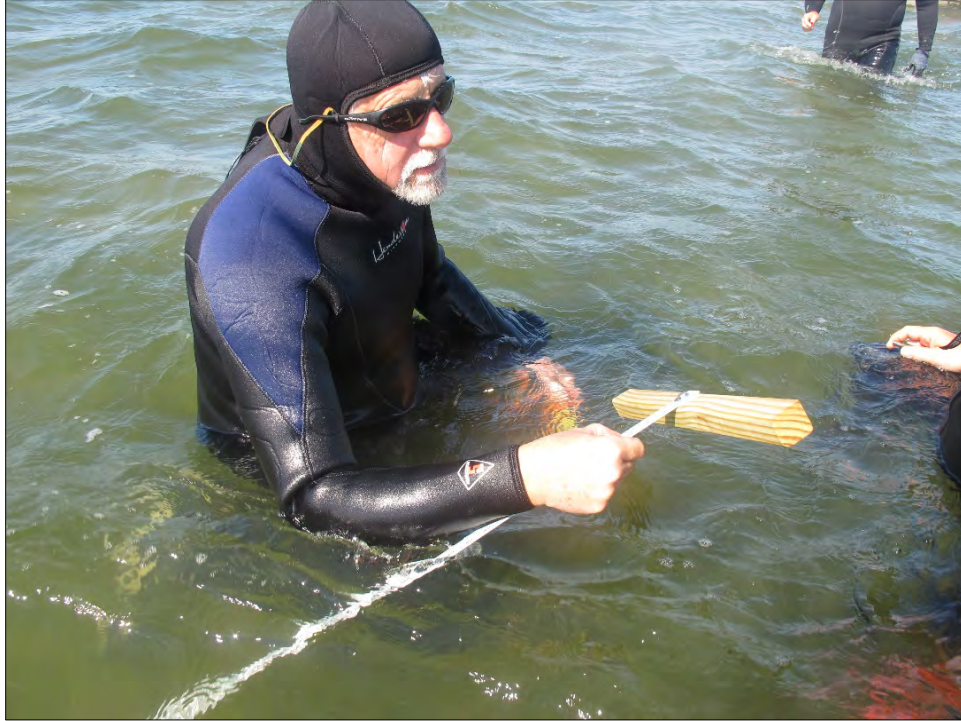
Photo 2. Inverted “T” shape ruler used to measure rod height above or below the substrate at the Bonner Bridge Seagrass Mitigation Site.

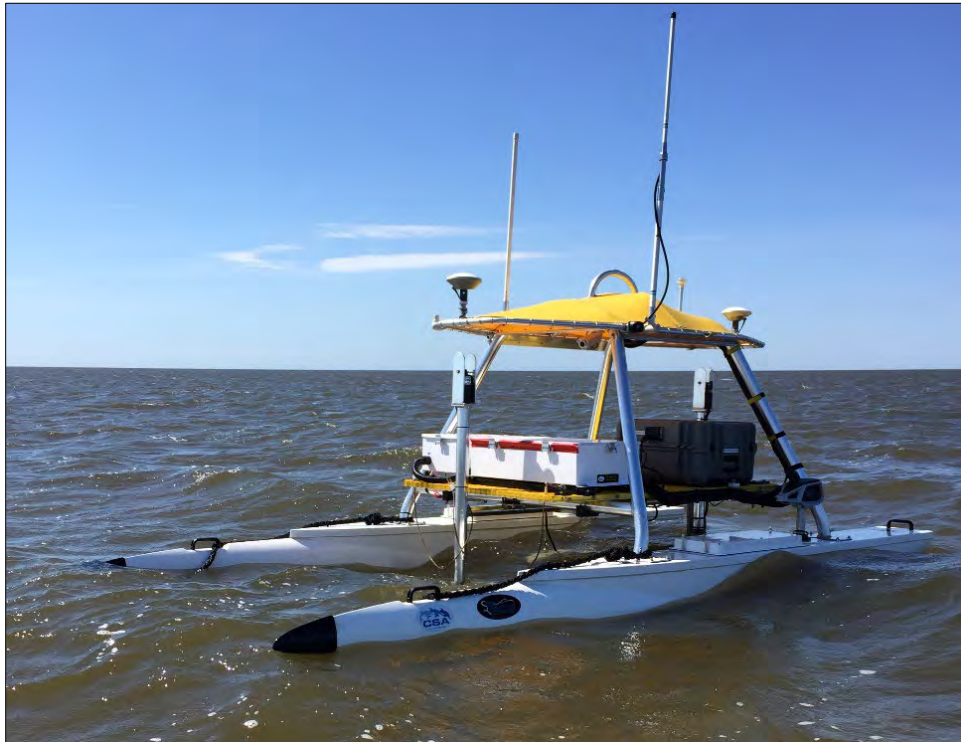
Photo 3. Unmanned surface vehicle (USV) collecting bathymetry data across the Bonner Bridge Seagrass Mitigation Site.

USV Digital Elevation Model: A second method was employed to evaluate the entire area forecast to be affected by the wavebreak. In June 2016, CSA used a USV to develop a sediment digital elevation model to document changes in shoal elevation associated with the wavebreak installation. The USV (**Photo 3**) was pre-programmed to run a pre-selected geographic grid at 50-m (164-ft) spacing which encompassed the entire site. Bathymetry data was collected using dual frequency, single beam sonar at a rate of 220 to 224 kHz. A Trimble RTK system (RTK) was mounted on the USV to integrate real time navigation while the USV ran the pre-programmed grid lines (speed of approximately 9 kph [5.7 mph]). The RTK had a horizontal and vertical accuracy of 2 cm (± 0.787 in) and real-time tidal corrections were applied to accurately determine water levels across the site. This survey will be repeated at the end of the five-year monitoring period in 2021.

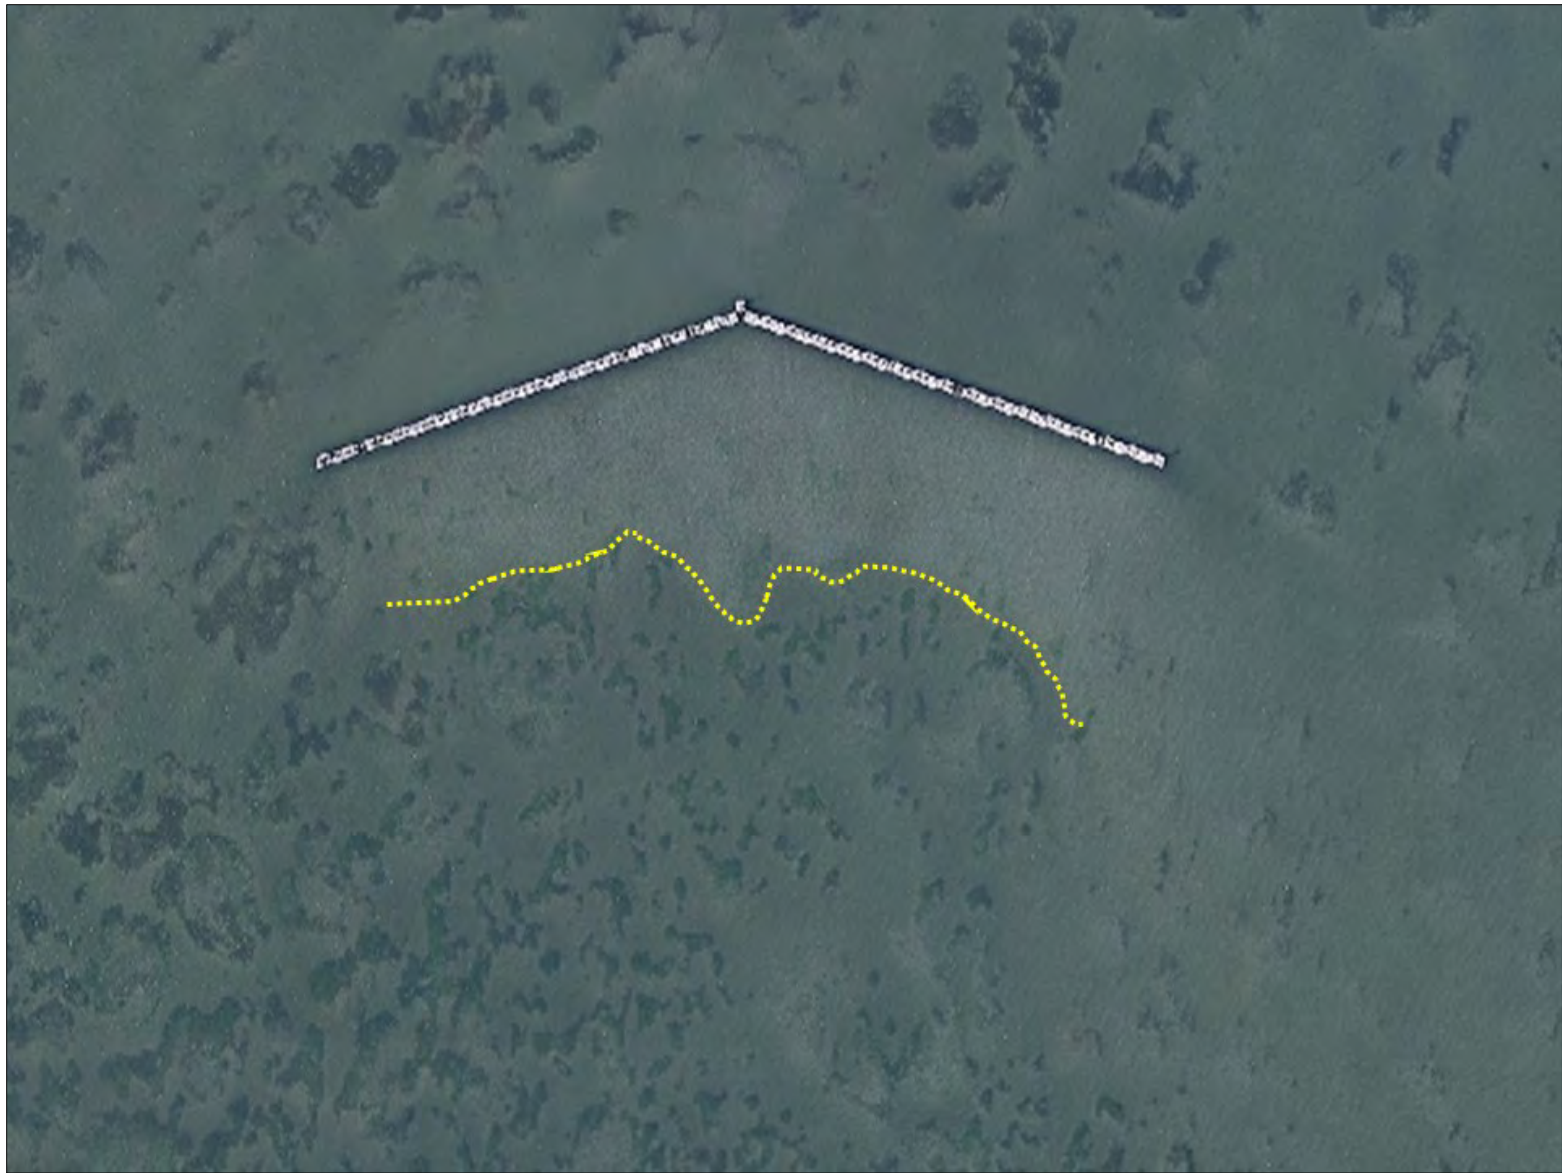
Figure 3. Sand apron south of wall visually outlined. 18 April 2018.

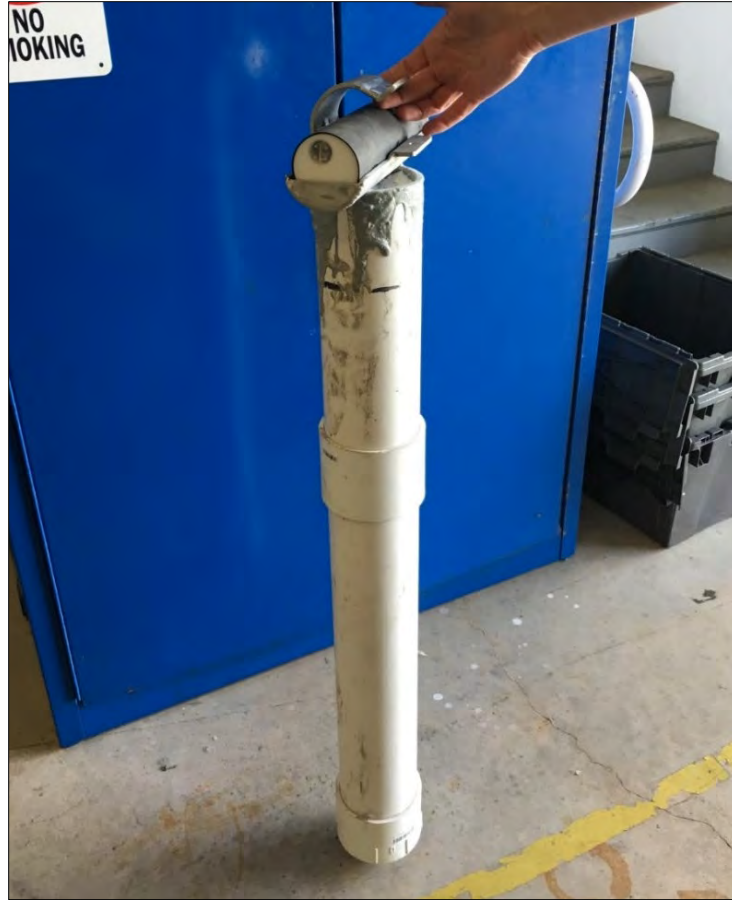
Photo 4. Photograph of one of the two wave sensor brackets cemented into its base, prior to installation at the Bonner Bridge Seagrass Mitigation Site. The hinged bracket is shown being lifted; a disposable padlock is installed through the hinged piece to keep the sensor secure.

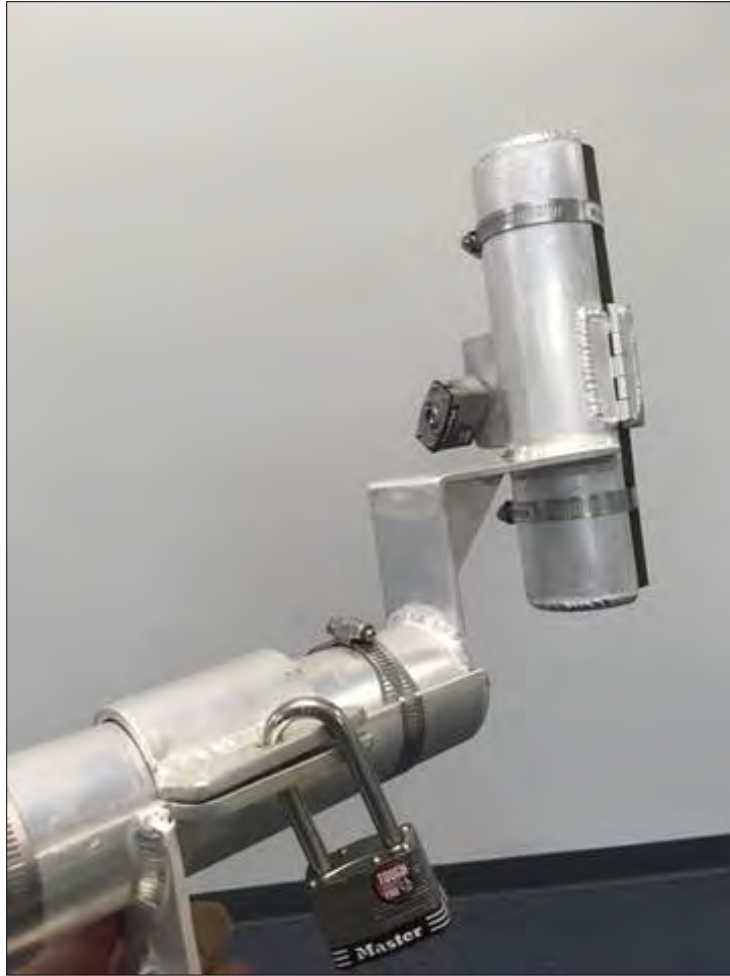
Photo 5. Re-engineered wave sensor bracket installed in January 2018 to hold the sensor vertical and further away from the sand surface.

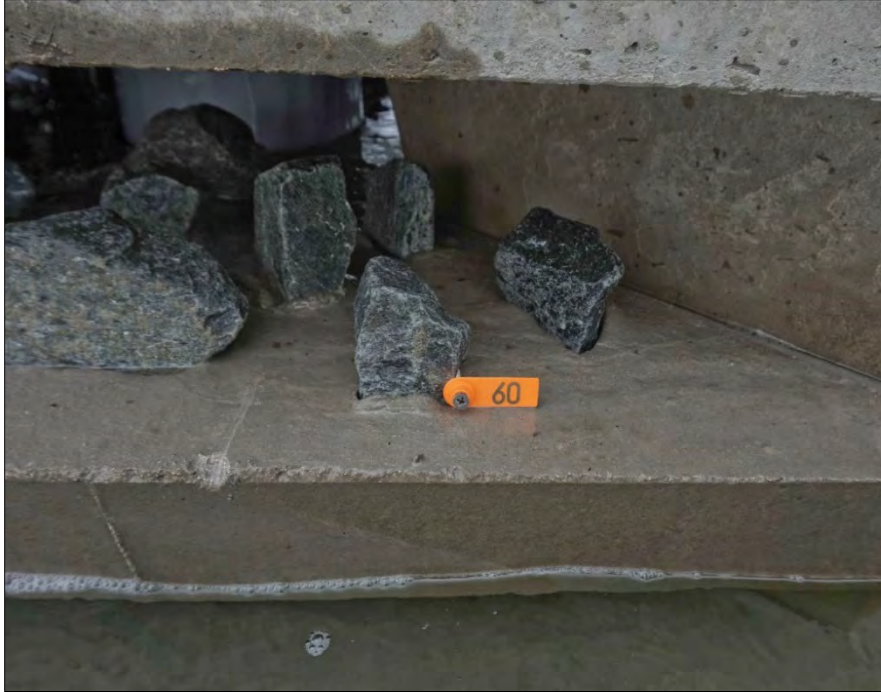
Photo 6. Example of numbered tag installed at every monitoring station on the wavebreak at the Bonner Bridge Seagrass Mitigation Site.

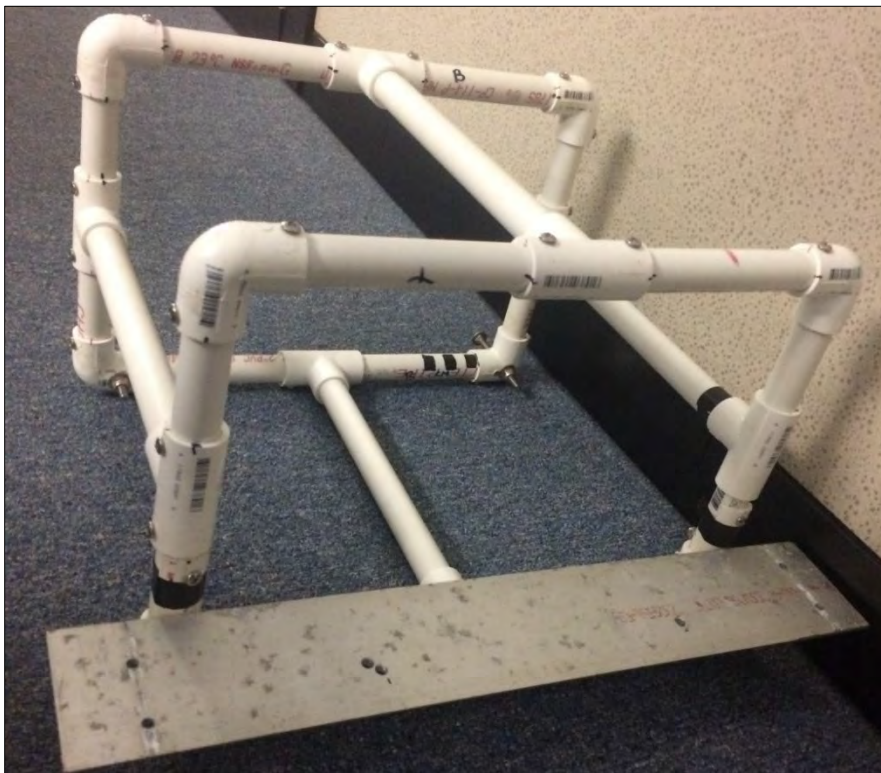
Photo 7. PVC camera mount framer used to photograph every monitoring station on the wavebreak at the Bonner Bridge Seagrass Mitigation Site.

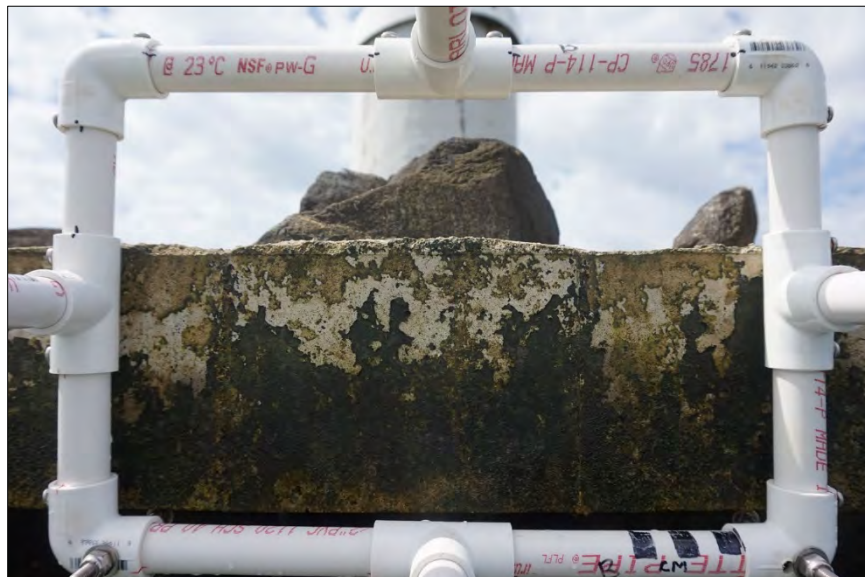
Photo 15. Representative photo of rock substrate for a high elevation monitoring station (Station 27) showing wet rock on the structure at the Bonner Bridge Seagrass Mitigation Site during the 2019 survey.

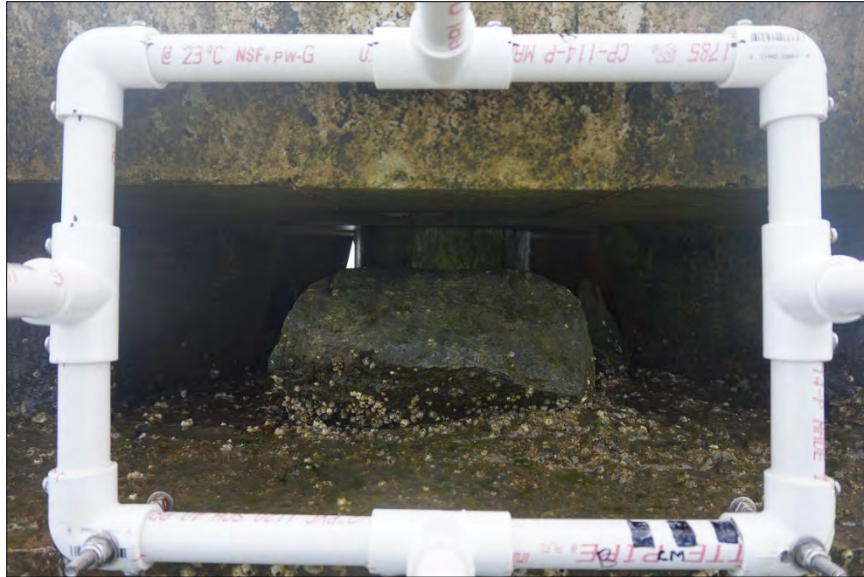
Photo 16. Representative photo of concrete substrate for a middle elevation monitoring station (Station 7) showing wet concrete, algae, and barnacle growth on the structure at the Bonner Bridge Seagrass Mitigation Site during the May 2019 survey.

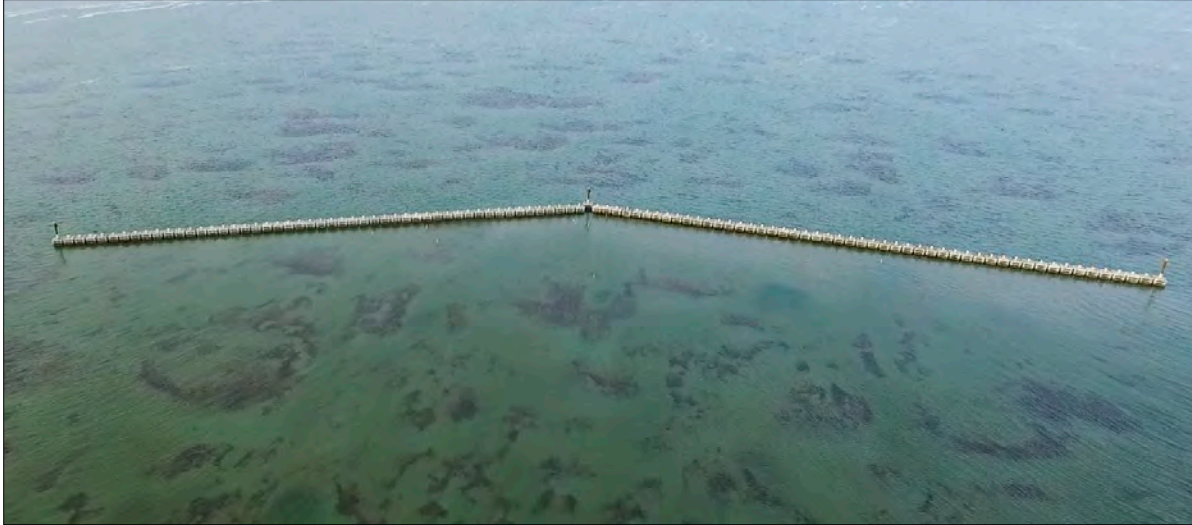
Photo 18. North-oriented view of the wavebreak installed in January 2017 at the Bonner Bridge Seagrass Mitigation Site. The total structure length is 500 ft (152 m).

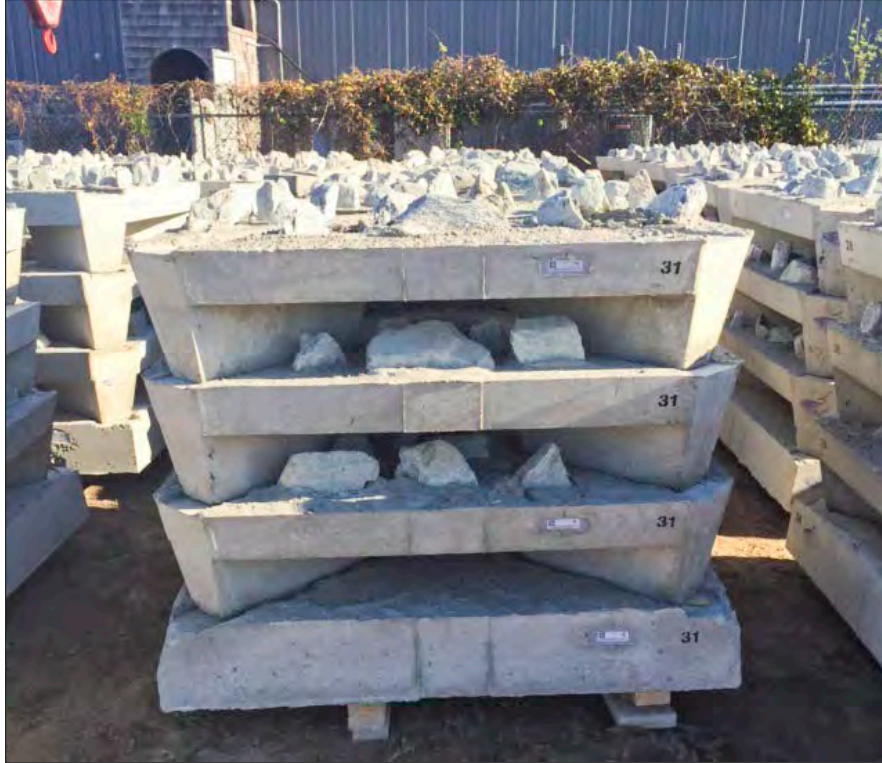
Photo I-2. One Reefmaker unit consisting of one base unit on the bottom and three wave attenuator units containing granite rock. One hundred and one of these units were installed at the Bonner Bridge Seagrass Mitigation Site. For scale, the width of the units is 4.8 ft (1.46 m).

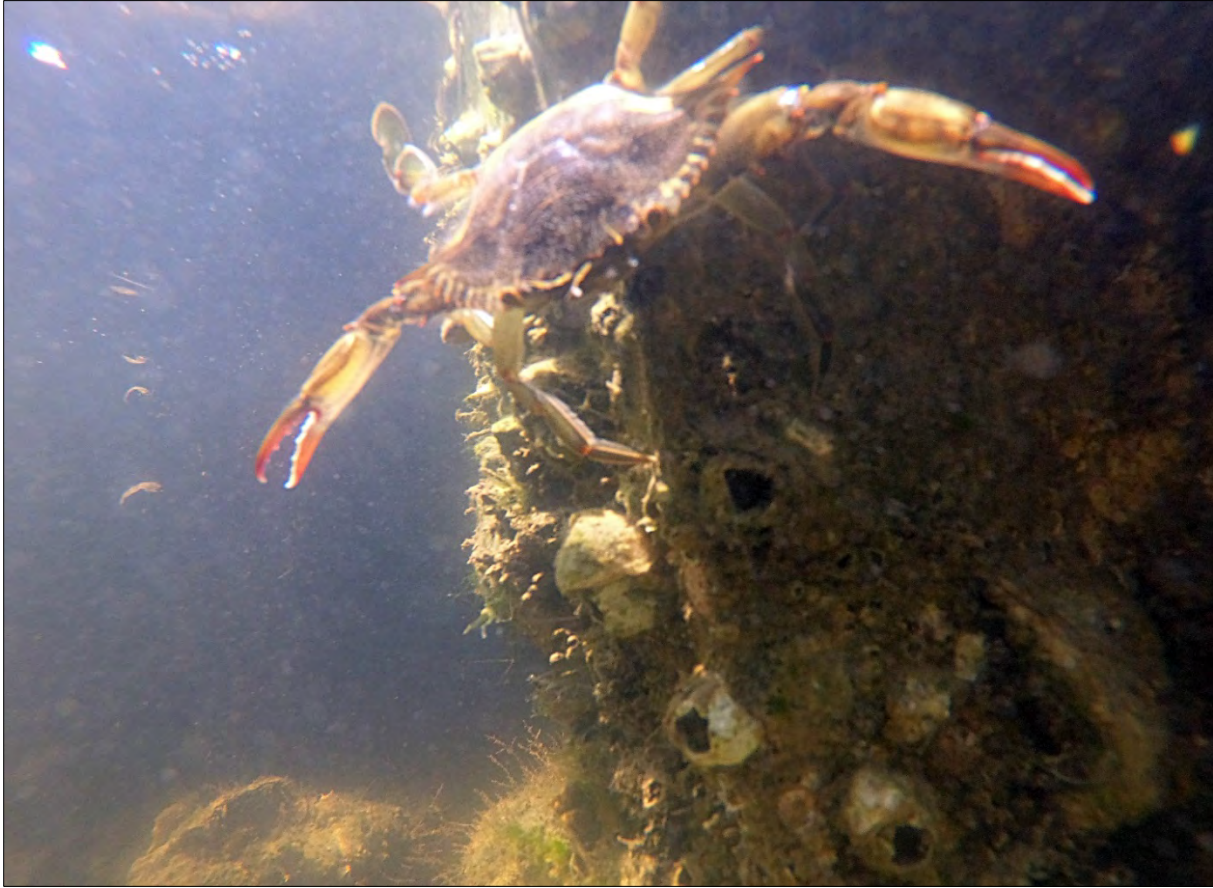
Image III-1. Blue crab (*Callinectes sapidus*) on wavebreak structure in the medium elevation strata.

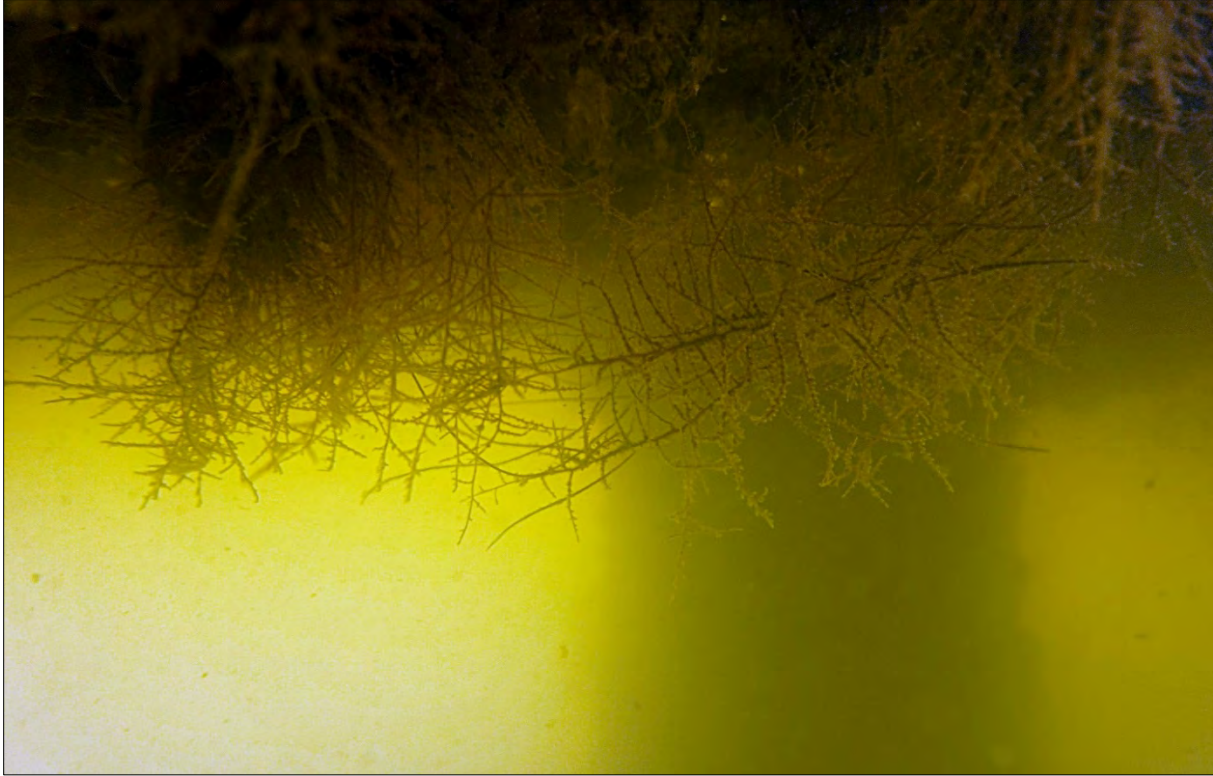
Image III-2. Hydroids colonizing the lower edge of the wavebreak structure. Note support piling in background.

Colonizing biota observed on concrete substrate continued to include barnacles, macroalgae (primarily unidentified green hair algae), hydroids, and oysters. For concrete stations, biotic colonization was now dominated by macroalgae (versus barnacles in 2018) for the majority of strata. Percent cover of barnacles declined as compared to the 2018 particularly in the low strata with maximum percent cover down to 30.26% and 34.14% for the north and south sides, respectively (down from 64.03% and 73.0% in 2018; **Table 7**). Percent cover of macroalgae increased since 2018, doubling or tripling its percent cover in some cases. Macroalgae percent cover was greater than barnacles in all strata on both the north and south sides, with a maximum percent cover of 78% for high strata on the north side and 75.57 on the south side. The small numbers of hydroids observed in 2018 were not found in 2019 while oysters were now present in low cover in all strata on the north side and in the middle and low strata on the south side with a high (south side, low strata) of 8.8%, a clear increase overall since 2018.

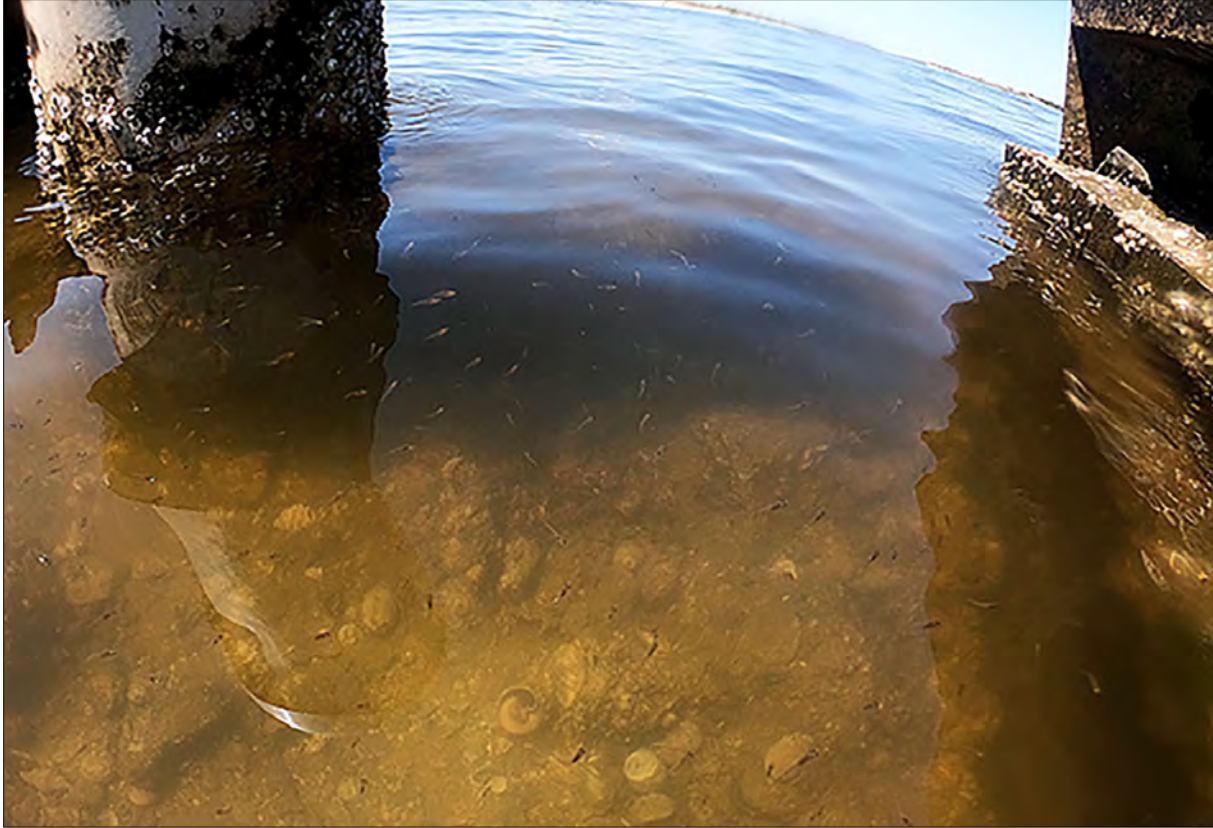
Image III-3. School of juvenile fish utilizing the shallow water column over a dropped wavebreak unit. Note the oyster colonization on the unit surface and discarded *Neverita* shell.

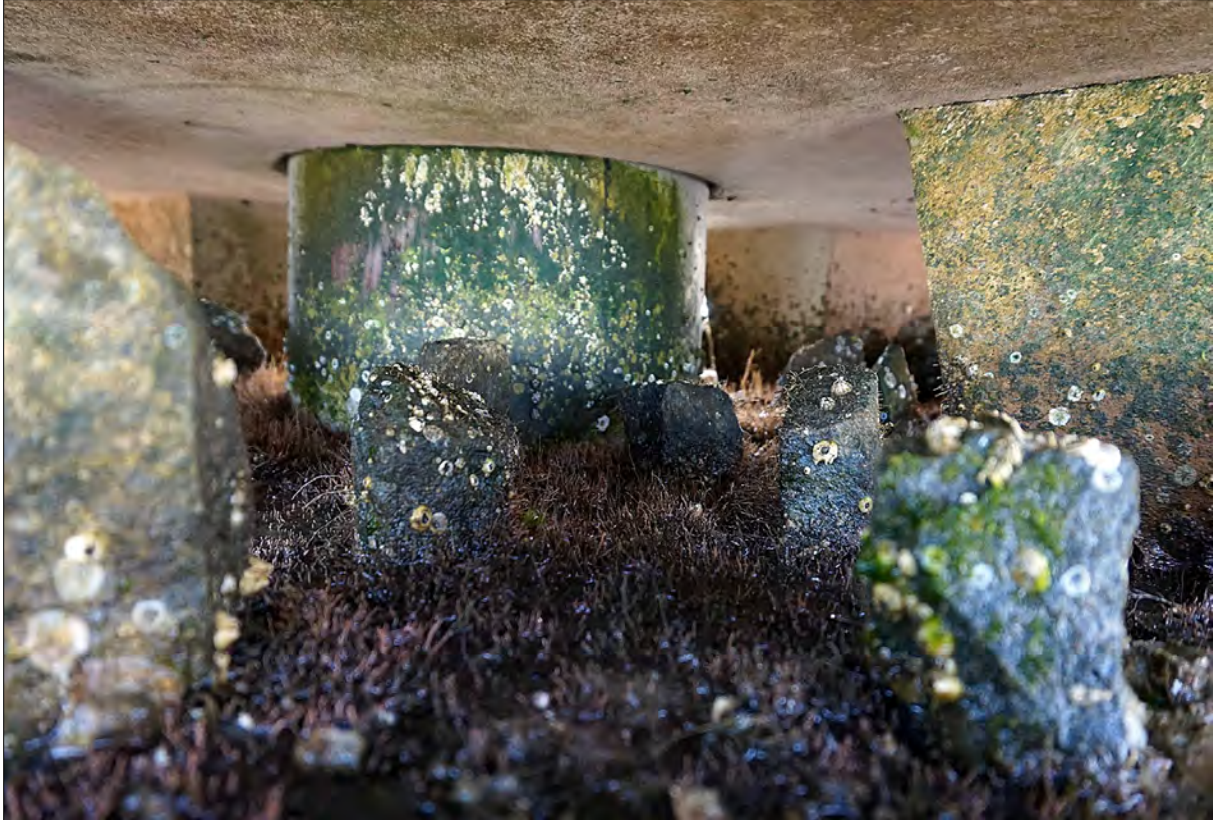
Image III-5. Turf algae colonizing the concrete surface among embedded rocks on a medium elevation portion of the wavebreak structure.

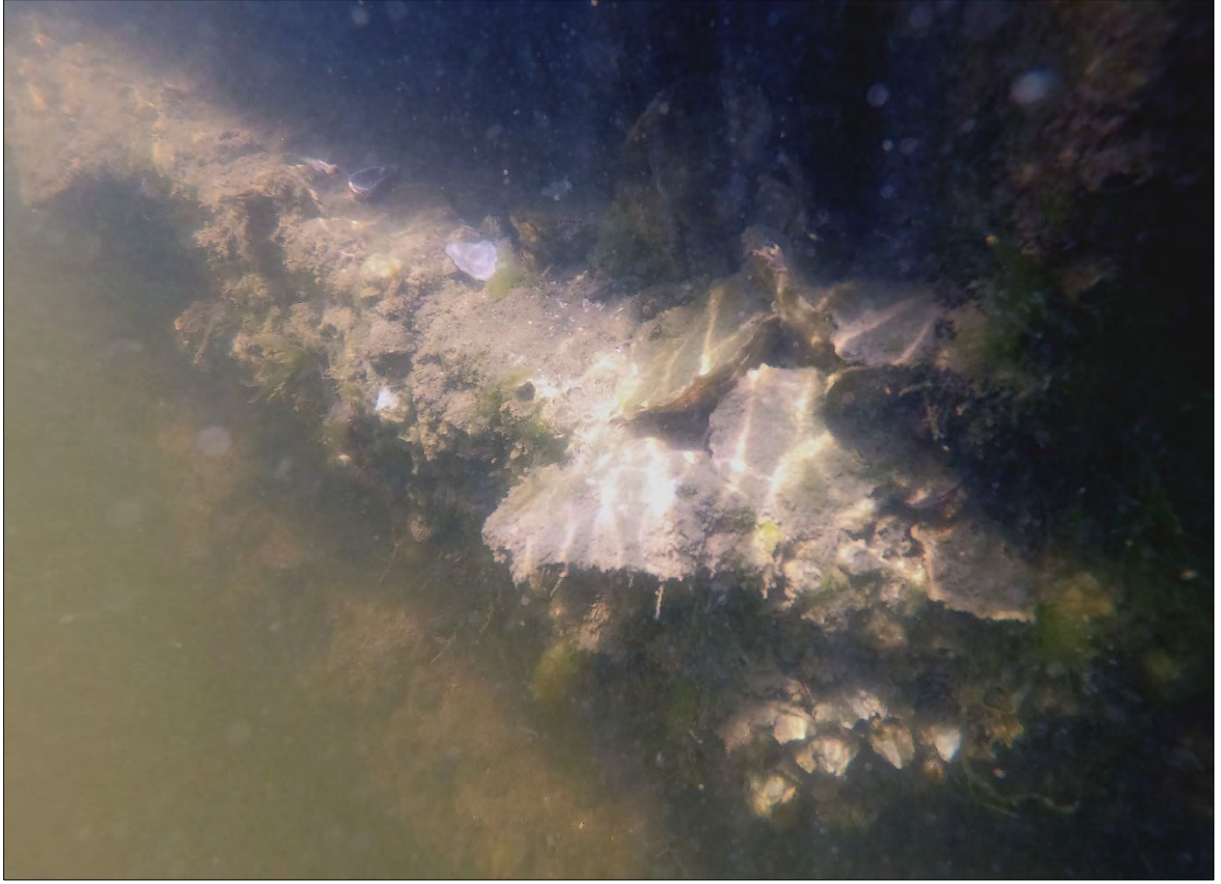
Image III-6. Oysters colonizing a rock on a medium elevation portion of the wavebreak structure.

Colonizing biota on rock substrate included barnacles and macroalgae and new since 2018, oysters; no hydroids were observed on either side of the structure. For rock stations, biotic colonization continued dominated by barnacles for the majority of strata, with maximum cover of 24.39% on low strata on the south side (**Table 8**). Unlike concrete, percent cover of macroalgae was generally low except for the low south strata which had the highest percent cover (53.66%) of any biota across strata and side thus far.

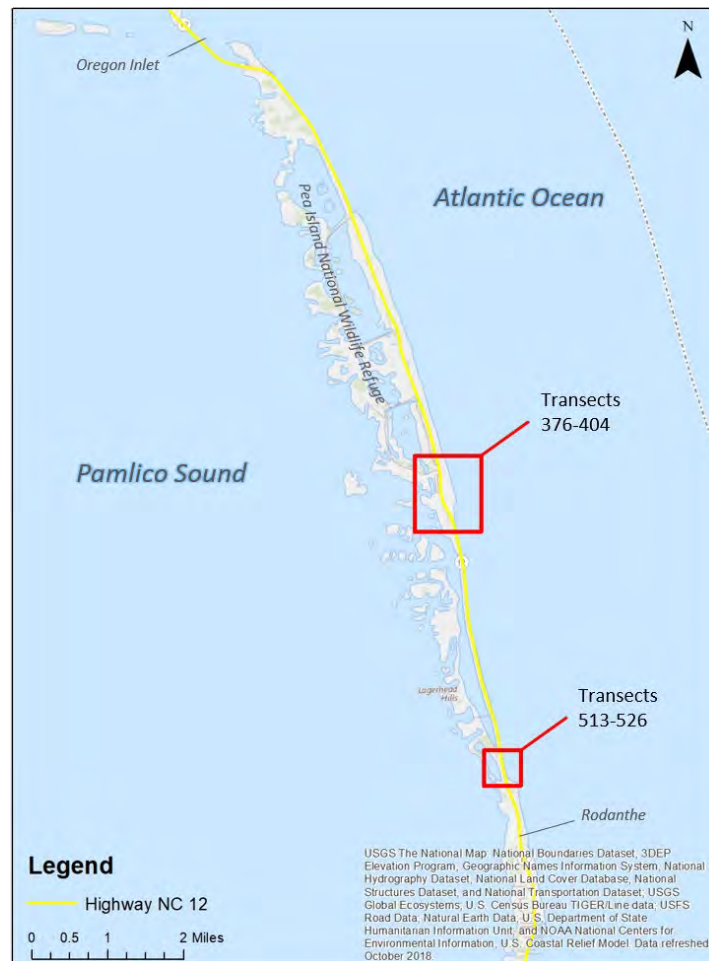
Figure 1 The regions outlined in red were altered due to changes in the edge of pavement (EOP) of Highway NC 12. These locations are near the Interim Bridge and the staging area for the new Jug Handle Bridge.
