ANNUAL REPORT FOR 2003

Paint Fork Creek Stream Mitigation Site (Brigmon Site)
Madison County
WBS Element 32573.4.1
TIP No. A-10WM

Prepared By:
Office of Natural Environment & Roadside Environmental Unit
North Carolina Department of Transportation
December 2003

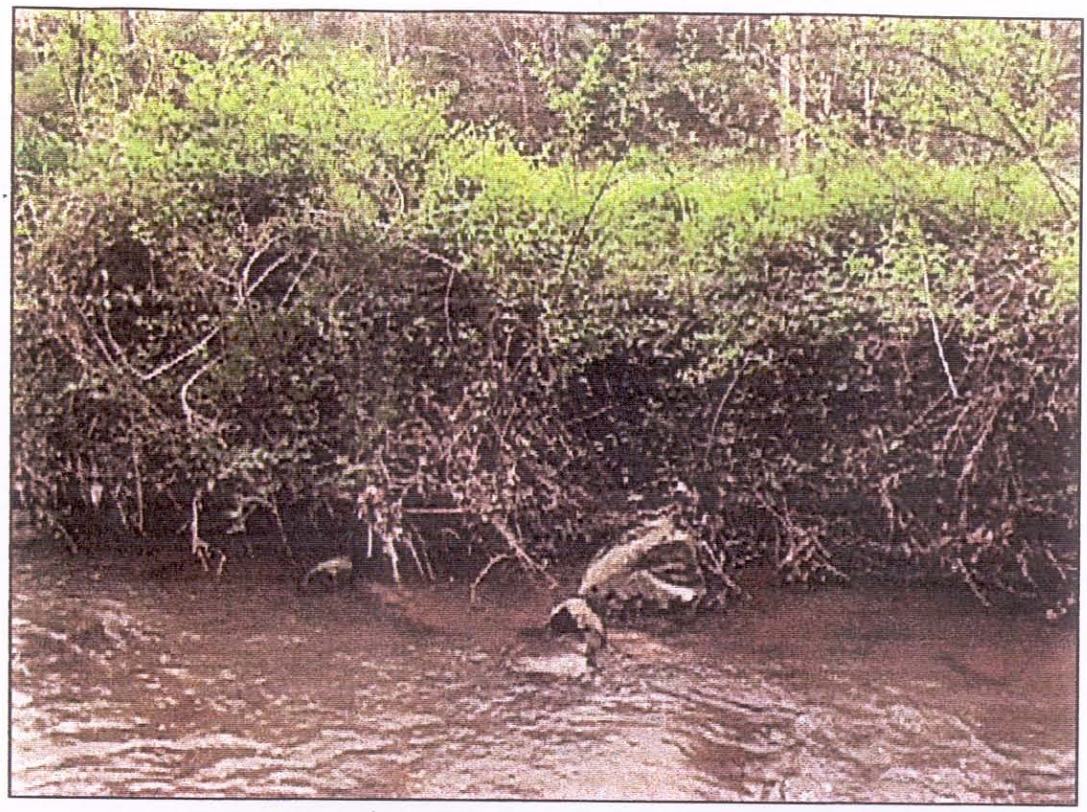
Top photo shows typical condition of stream banks at this site prior to construction.
Bottom photo shows typical construction methods used to address vertical bank conditions. Banks are sloped, fertilized, limed, seeded and erosion mating installed. Coir logs are pinned at the bankfull elevation and trees are planted behind this log to provide long-term stability.

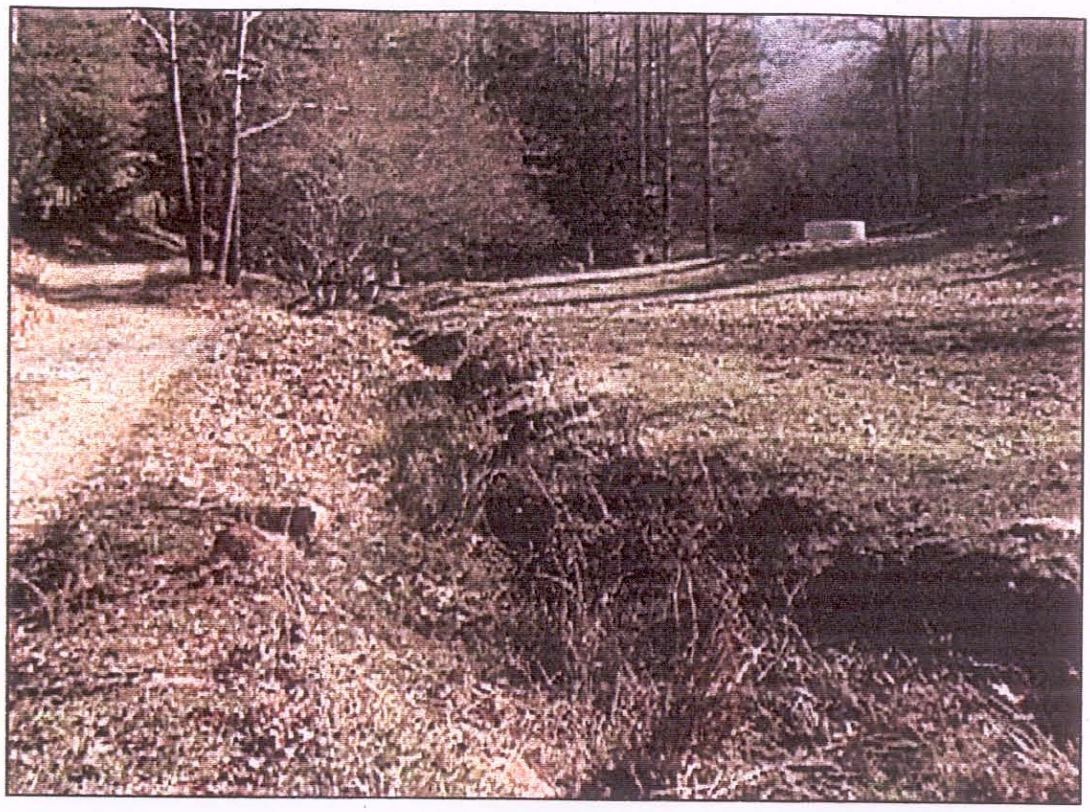
Top photo shows the lower end of the upper, unnamed tributary prior to construction. Bottom photo shows the same site after construction. Banks were sloped and seeded and livestock were fenced out of the site. Prior to construction, the two small unnamed tributaries at this site were major sources of sediment during high water periods.

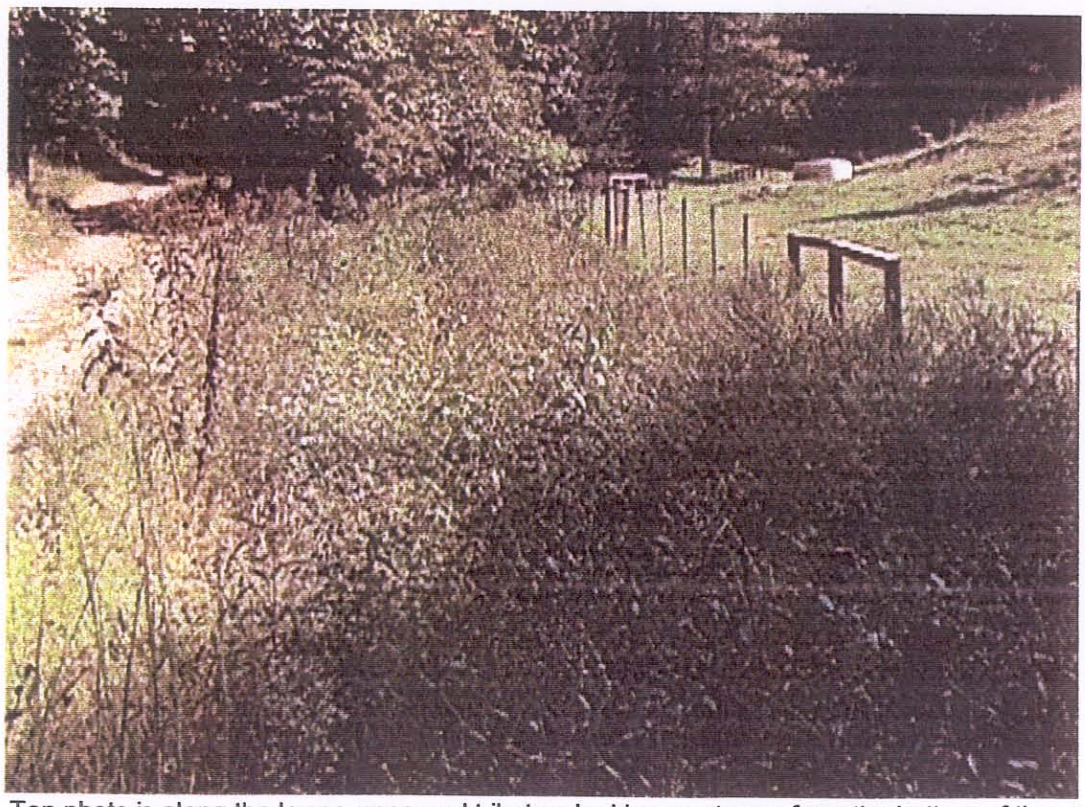
Big bend below driveway bridge. Top photo shows the existing conditions with erosion and auto parts as stabilizing material. Bottom photo shows removing auto parts and trash and installing root-wads and creating floodplain to match existing bench upstream.

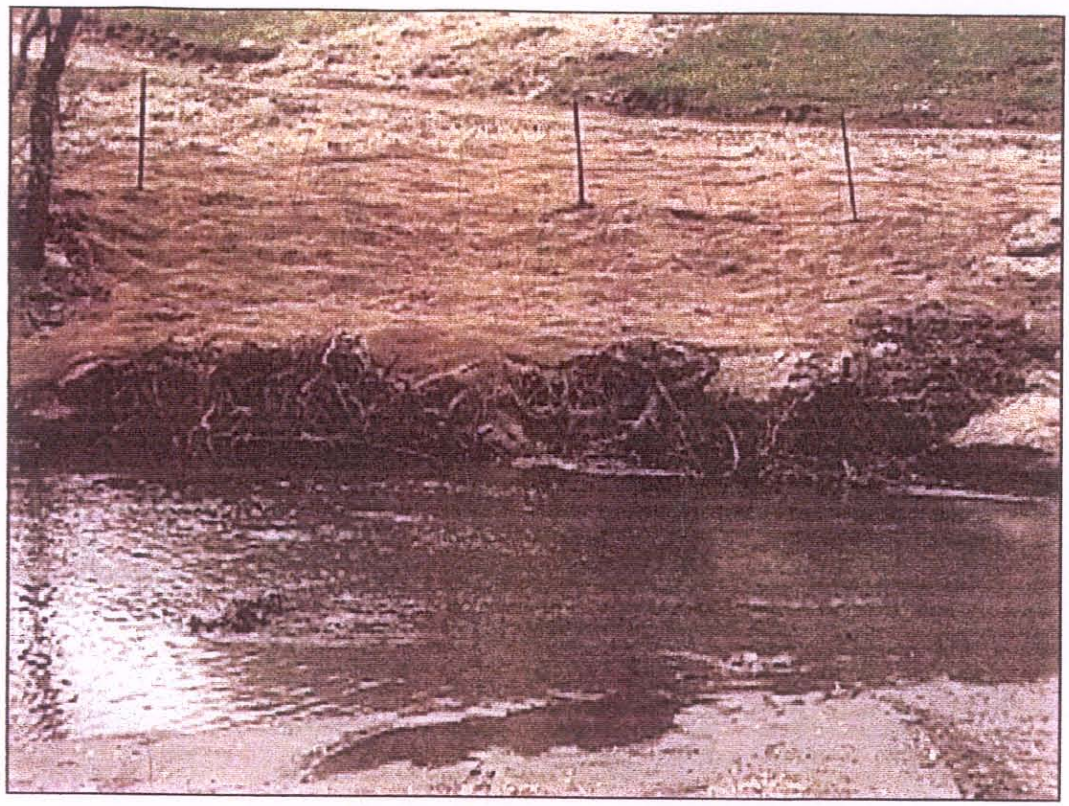
Top photo shows concave side of meander after construction and installation of erosion control material and root-wads. Bottom photo shows flood-plain bench matching the upstream bank with cover crop vegetation, trees and fence 3 months after construction.

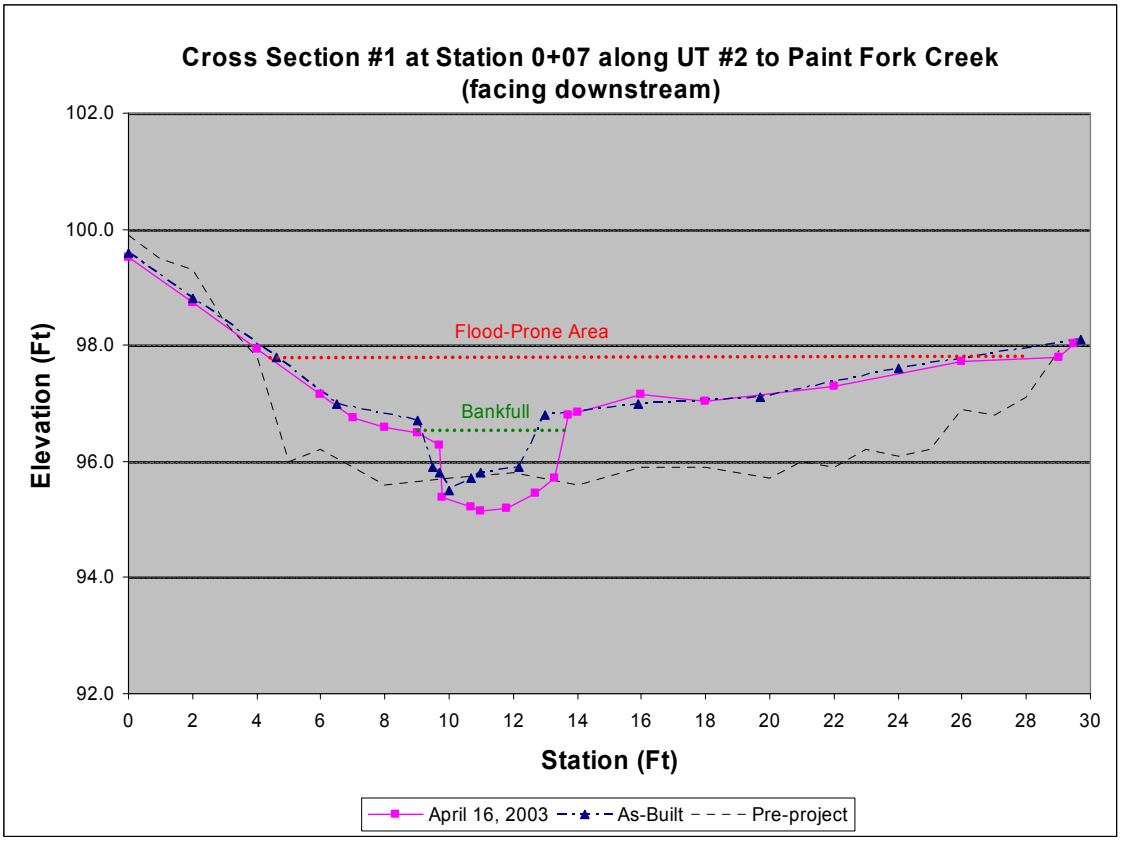
The majority of the cross sections along all three reaches remain intact. Cross Sections #1 and #3 appeared to be slightly degrading based on survey data from the as-built report. Cross Section #5 appeared to be slightly aggrading. Monitoring associated with these cross sections, as well as the other nine cross sections will continue through 2004. In addition, the

Cross Section #1 at Station 0+07
along Unnamed Tributary #2.
Tributary flows from left to right.

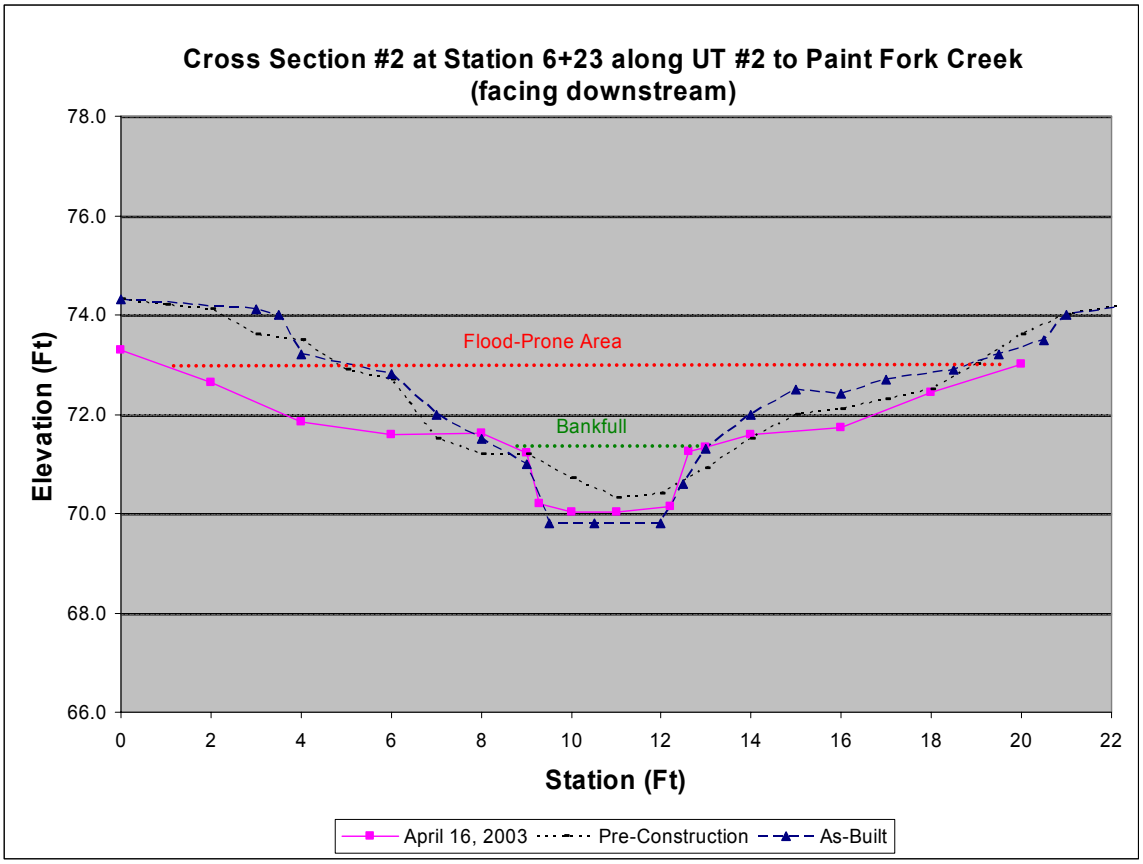
Cross Section #2 at Station 6+23 along
Unnamed Tributary #2. Tributary flows
from left to right.

Cross Section #2 at Station 6+23 along UT #2 to Paint Fork Creek
(facing downstream)
Elevation (Ft)
78.0
76.0
74.0
72.0
70.0
68.0
66.0
Flood-Prone Area
Bankfull
0
2
4
6
8
10
12
14
16
18
20
22
Station (Ft)
April 16, 2003
Pre-Construction
As-Built

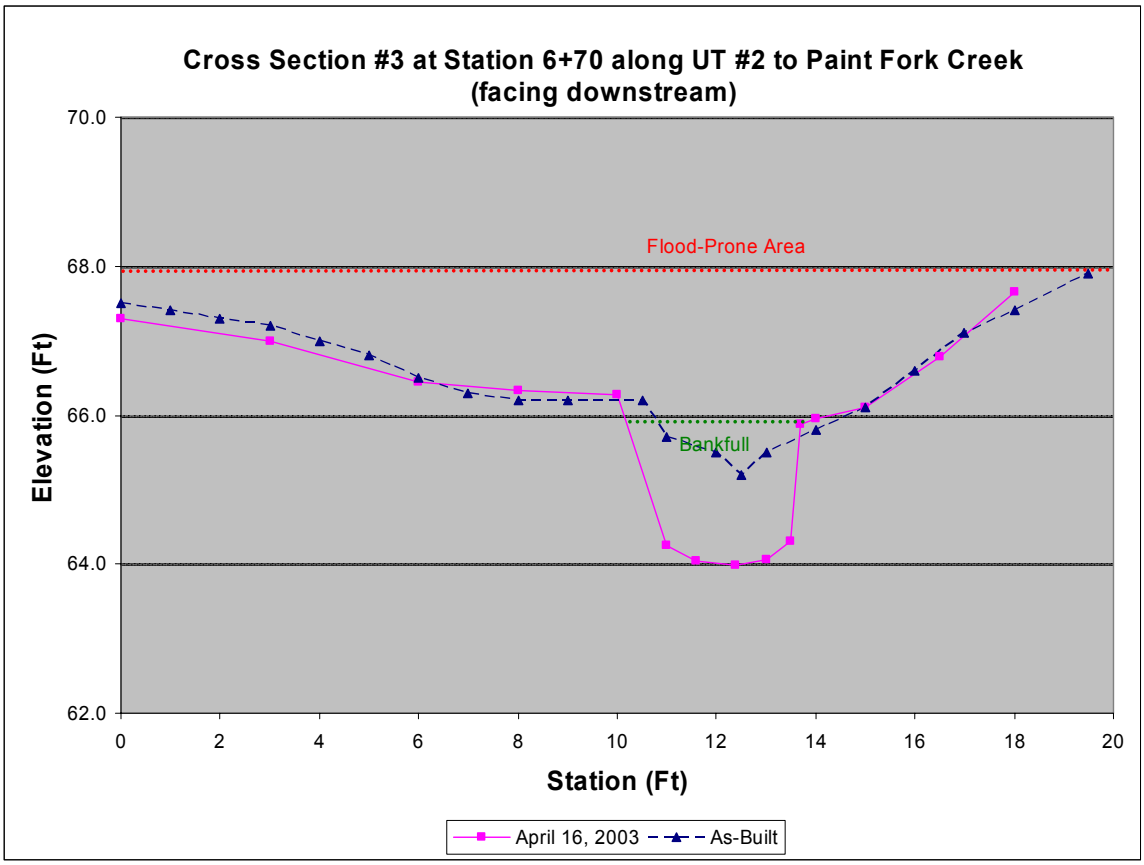
Cross Section #3 at Station 6+70 along
Unnamed Tributary #2. Tributary flows
from left to right.

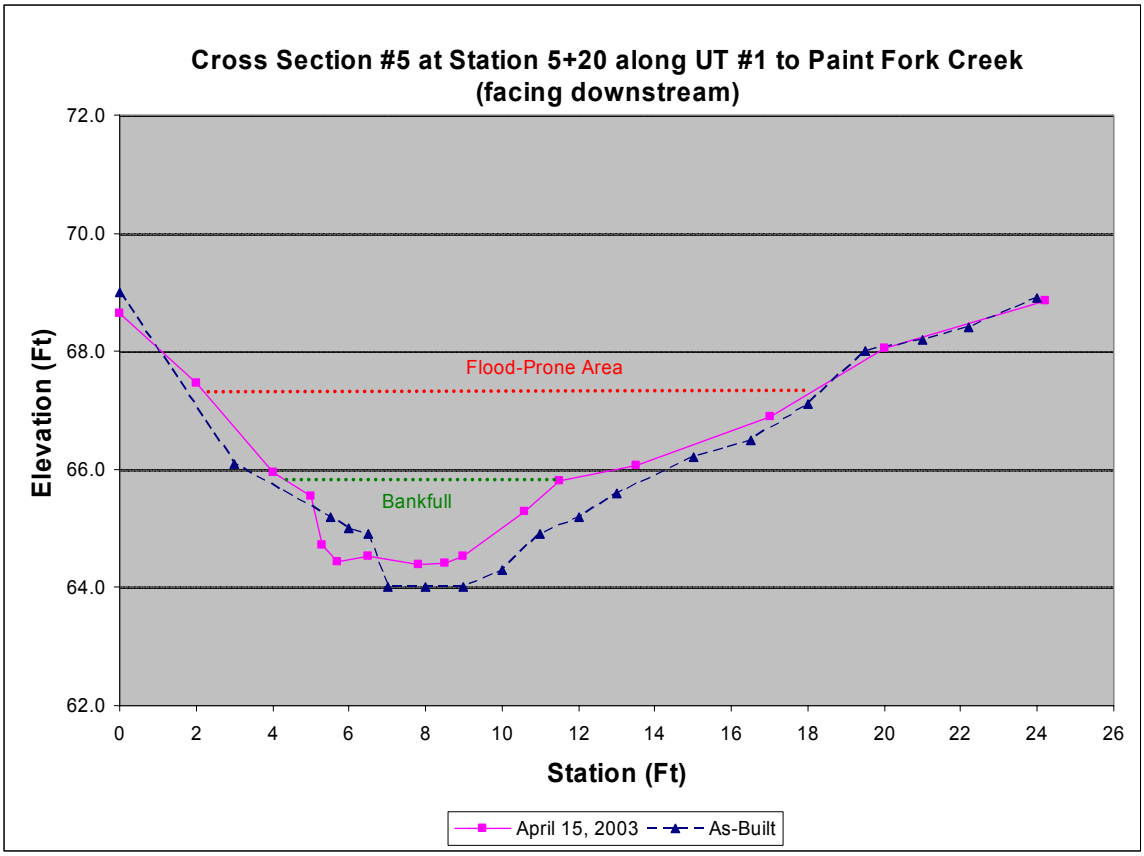
Cross Section #5 at Station 5+20 along
Unnamed Tributary #1. Tributary flows
from right to left.

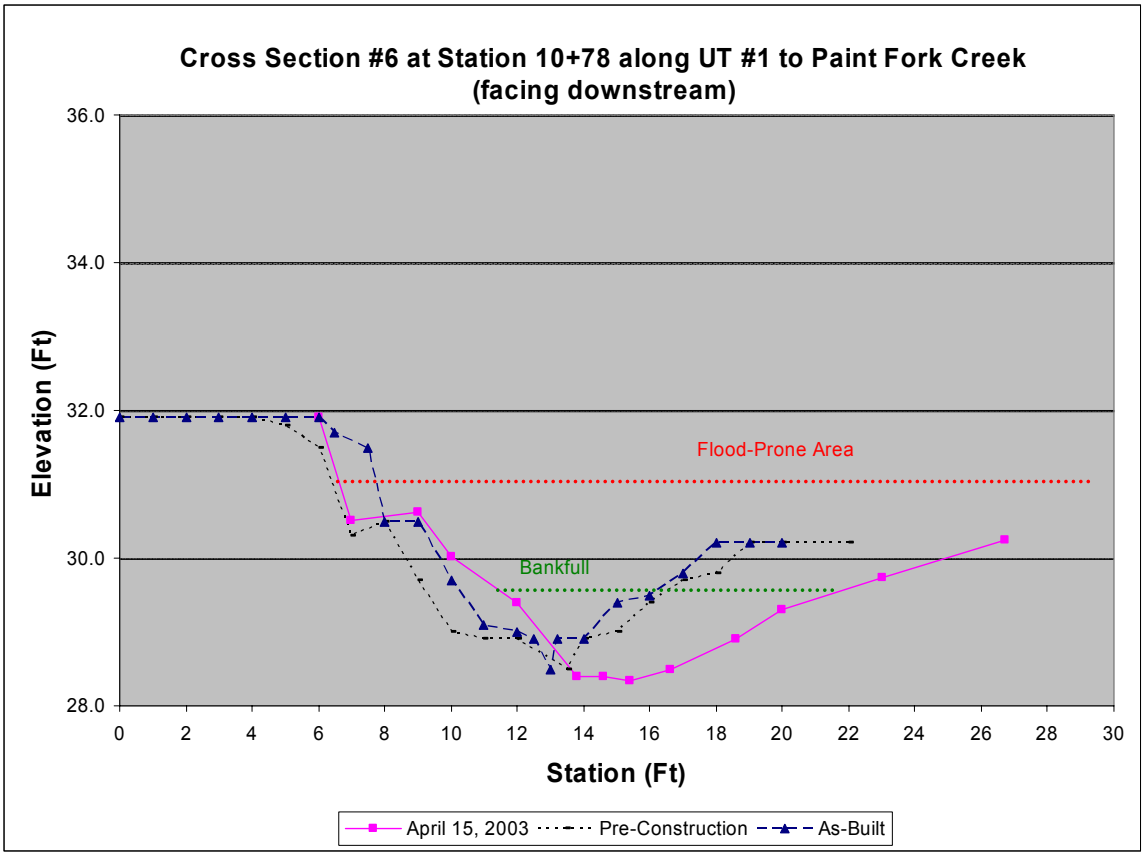
Cross Section #6 at Station 10+78 along Unnamed Tributary #1. Tributary flows from left to right.

Cross Section #6 at Station 10+78 along UT #1 to Paint Fork Creek
(facing downstream)
Elevation (Ft)
36.0
34.0
32.0
30.0
28.0
0
2
4
6
8
10
12
14
16
18
20
22
24
26
28
30
Station (Ft)
Flood-Prone Area
Bankfull
April 15, 2003
Pre-Construction
As-Built

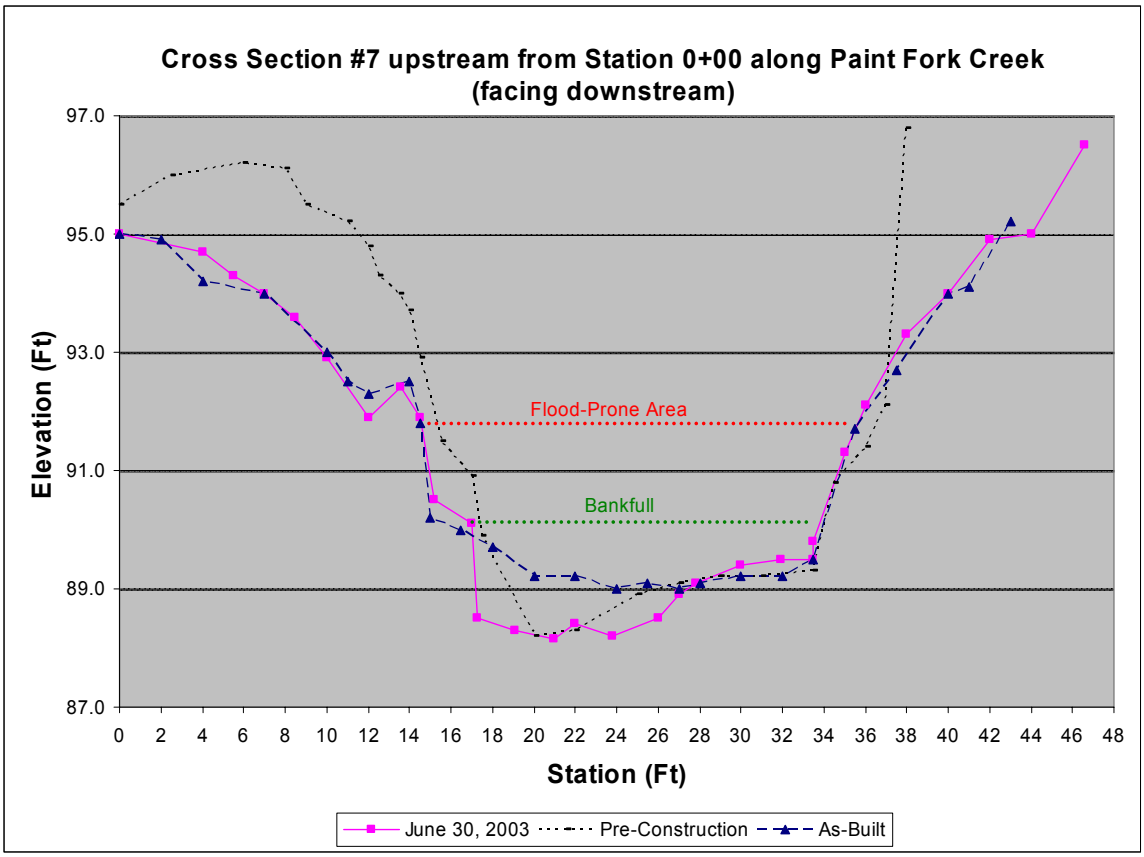
Cross Section #7 upstream from Station 0+00 along Paint Fork Creek. Paint Fork Creek flows from right to left.

Cross Section #7 upstream from Station 0+00 along Paint Fork Creek
(facing downstream)
Elevation (Ft)
97.0
95.0
93.0
91.0
89.0
87.0
Flood-Prone Area
Bankfull
0 2 4 6 8 10 12 14 16 18 20 22 24 26 28 30 32 34 36 38 40 42 44 46 48
Station (Ft)
June 30, 2003
Pre-Construction
As-Built

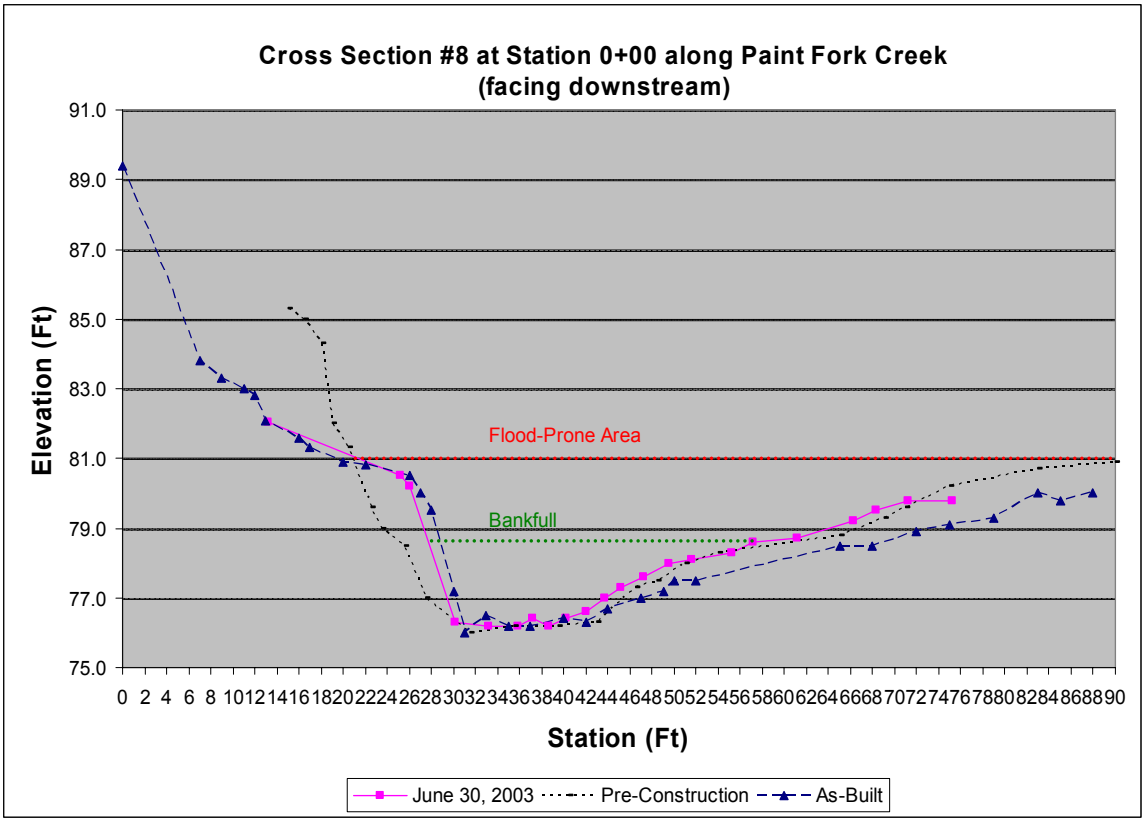
Cross Section #8 at Station 0+00 along Paint Fork Creek. Paint Fork Creek flows from left to right.

Cross Section #8 at Station 0+00 along Paint Fork Creek
(facing downstream)
Elevation (Ft)
91.0
89.0
87.0
85.0
83.0
81.0
79.0
77.0
75.0
Flood-Prone Area
Bankfull
0 2 4 6 8 10 12 14 16 18 20 22 24 26 28 30 32 34 36 38 40 42 44 46 48 50 52 54 56 58 60 62 64 66 68 70 72 74 76 78 80 82 84 86 88 90
Station (Ft)
June 30, 2003
Pre-Construction
As-Built

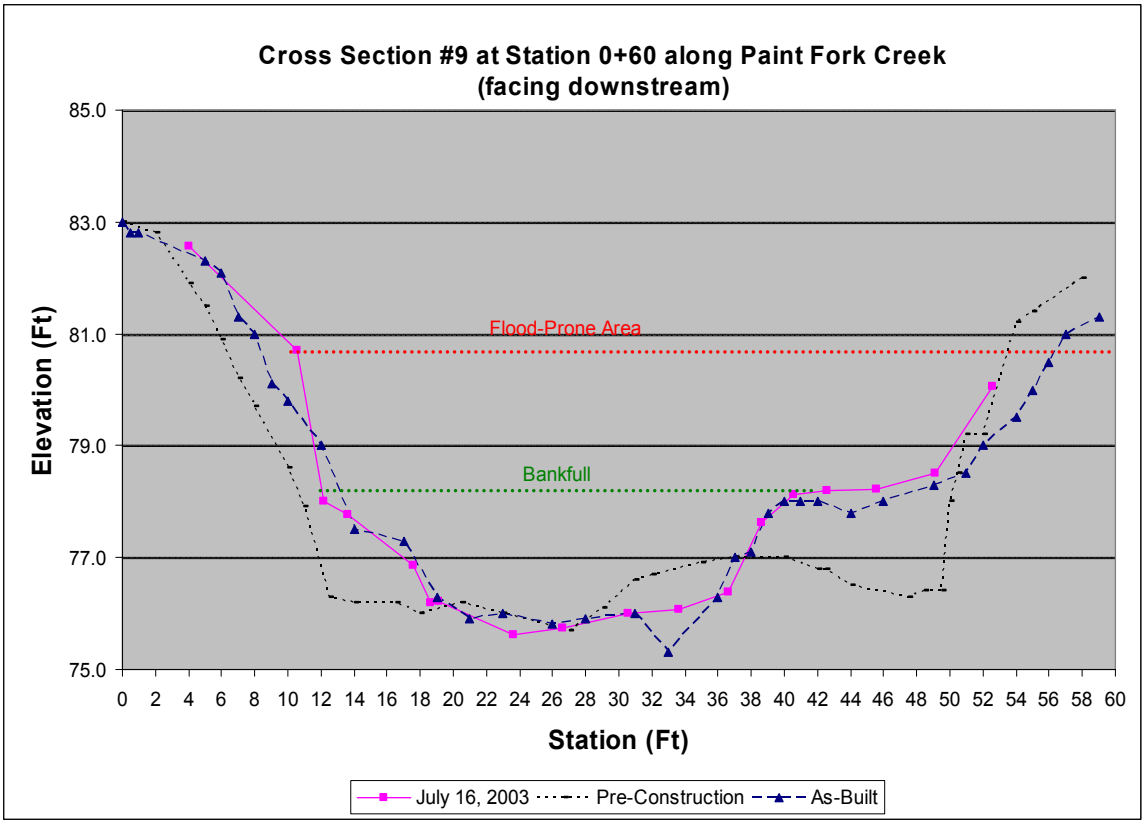
Cross Section #9 at Station 0+60 along Paint Fork Creek. Facing upstream.

Cross Section #9 at Station 0+60 along Paint Fork Creek
(facing downstream)
Elevation (Ft)
85.0
83.0
81.0
79.0
77.0
75.0
Flood-Prone Area
Bankfull
0 2 4 6 8 10 12 14 16 18 20 22 24 26 28 30 32 34 36 38 40 42 44 46 48 50 52 54 56 58 60
Station (Ft)
July 16, 2003
Pre-Construction
As-Built

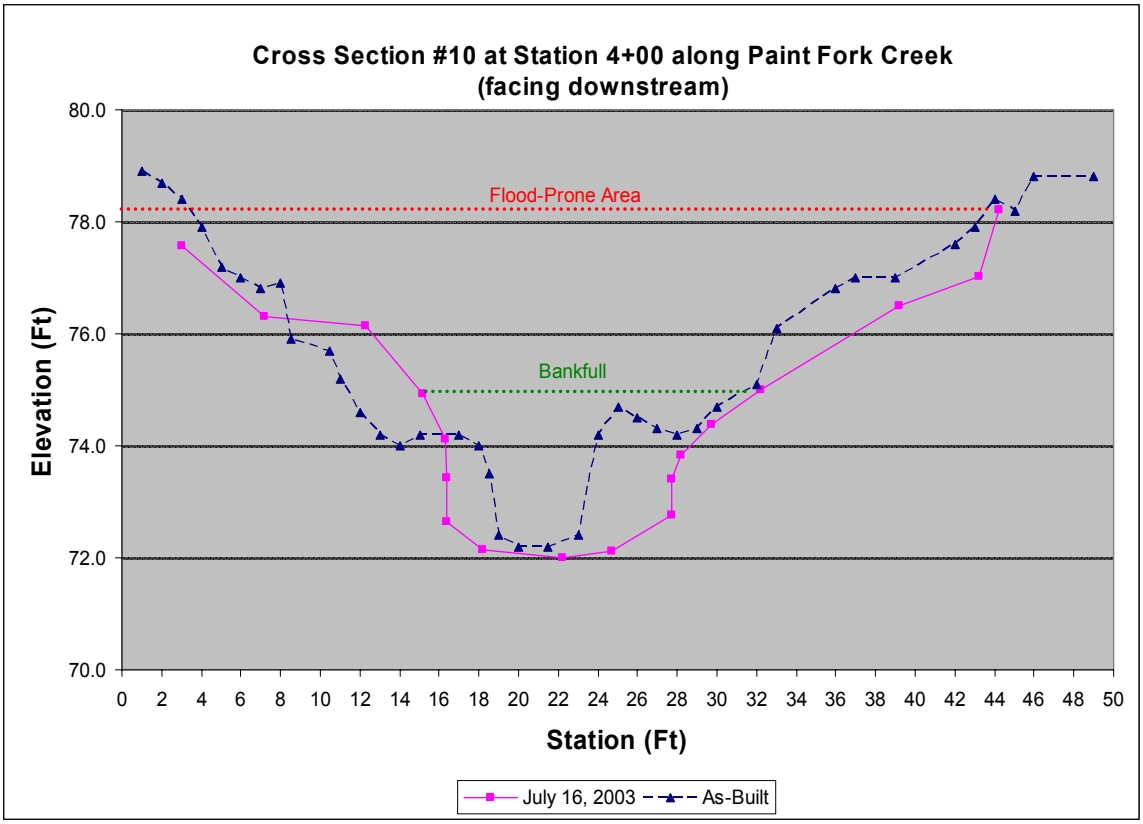
Cross Section #10 at Station 4+00 along Paint Fork Creek. Paint Fork Creek flows from left to right.

- Cross Section #10 at Station 4+70. Active erosion was noted along left side of cross vane arm. This area should be assessed during the next monitoring period to determine remedial actions, if necessary.

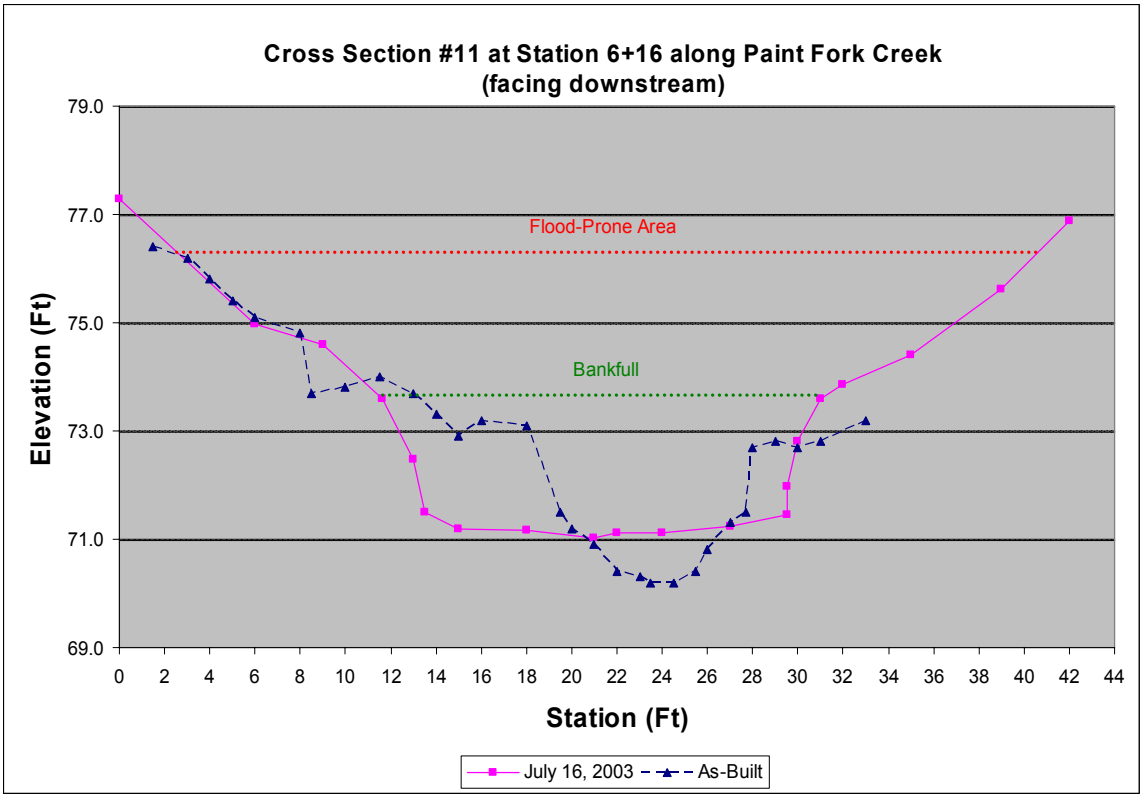
- Cross Section #11 at Station 6+16. Active erosion was noted along cross vane arms on both sides of channel. This erosion has led to undercutting of the vane arms; however, the cross vane continues to maintain the thalweg in the middle of the channel through this section. This area should be assessed during the next monitoring period to determine remedial actions, if necessary.

Cross Section #11 at Station 6+16
along Paint Fork Creek. Paint Fork
Creek flows from left to right.

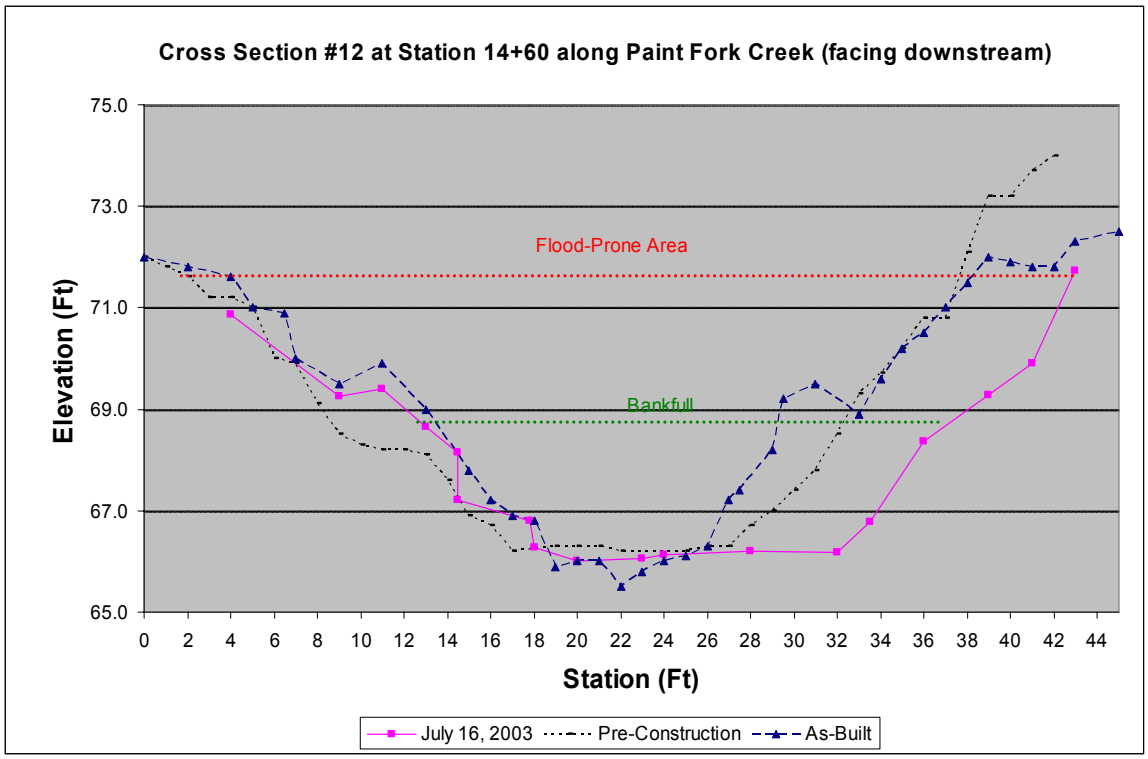
- Station 14+67. The existing elevation of the header rock at a cross vane immediately downstream of Cross Section #12 is higher than the adjacent vane arms, which has resulted in the formation of a center bar immediately upstream of the vane. Active erosion was noted along both arms of the vane. This area should be assessed during the next monitoring period to determine remedial actions, if necessary.

Facing Downstream from Cross Section #12 at Station 14+60 along Paint Fork Creek

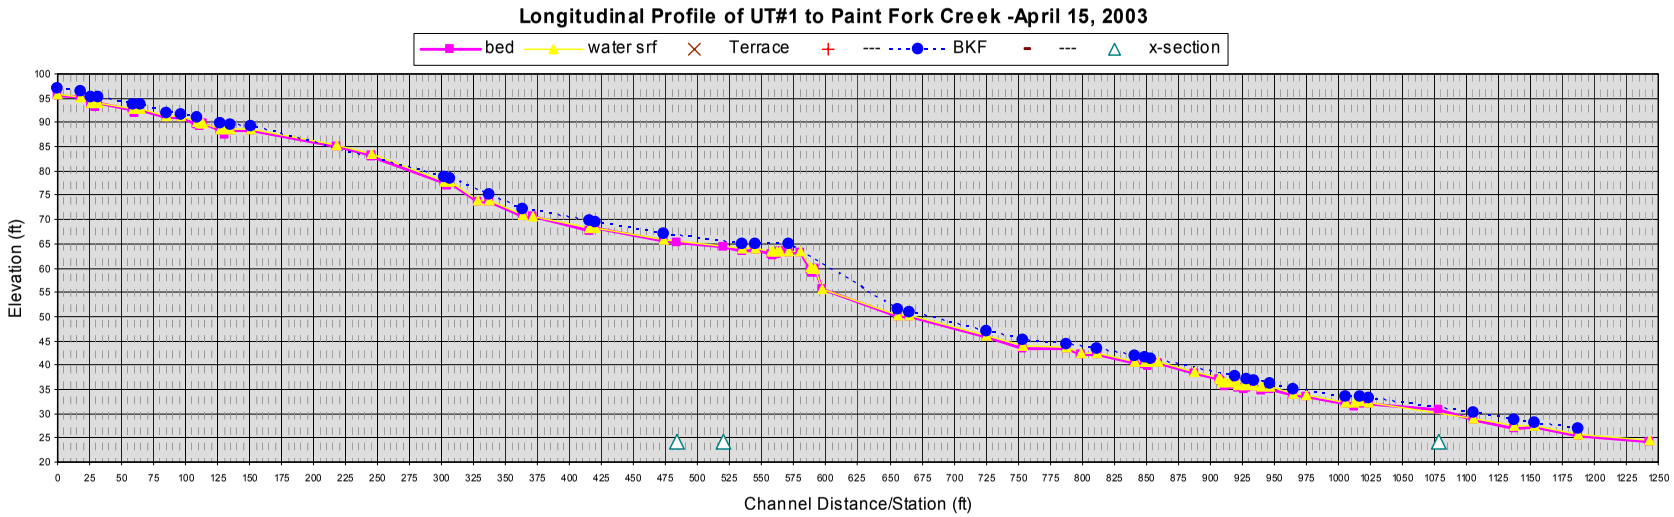
Longitudinal Profile of UT#1 to Paint Fork Creek -April 15, 2003
bed
water srf
Terrace

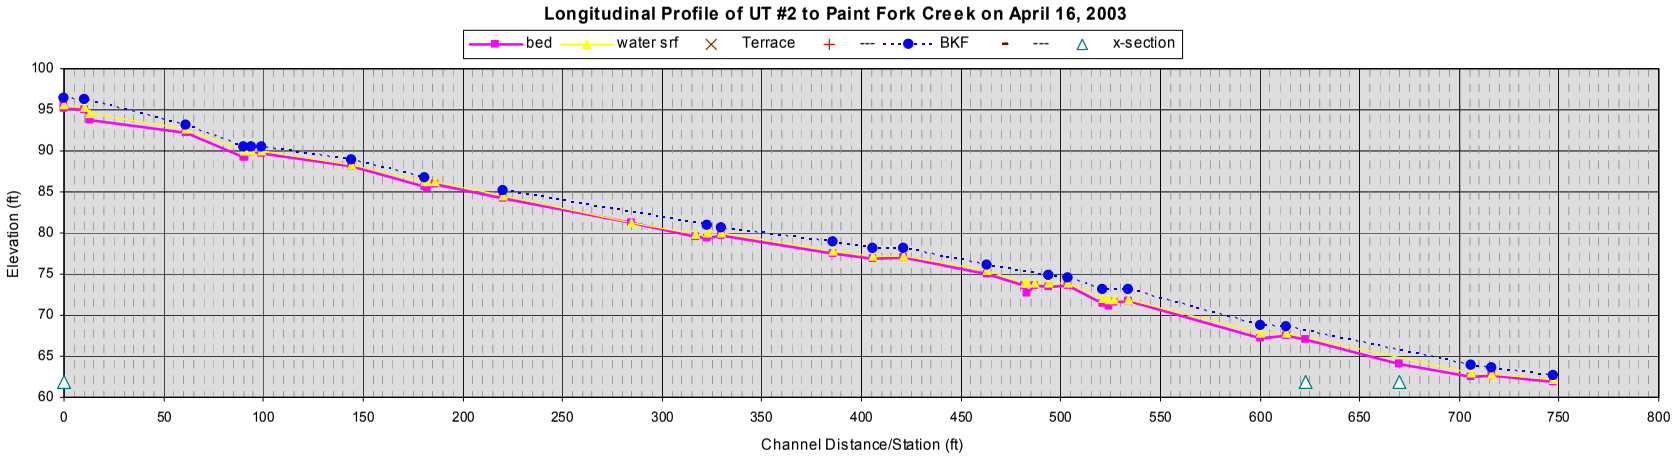
Longitudinal Profile of UT #2 to Paint Fork Creek on April 16, 2003
bed
water srf
Terrace

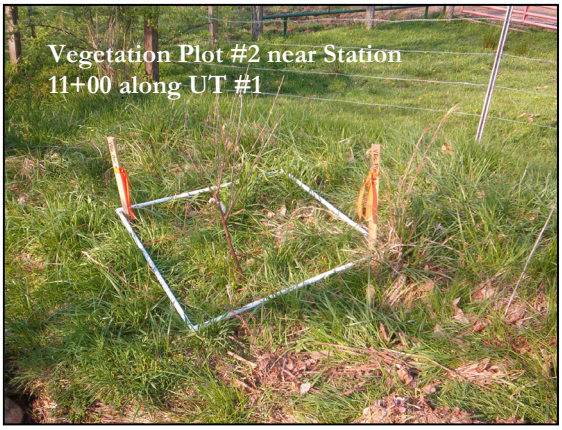
Vegetation Plot #2 near Station
11+00 along UT #1

Plot 2. Fescue (*Festuca* sp.) and several weedy species were observed in and immediately adjacent to the vegetation plot. No other woody stems were noted within five feet of the vegetation plot.

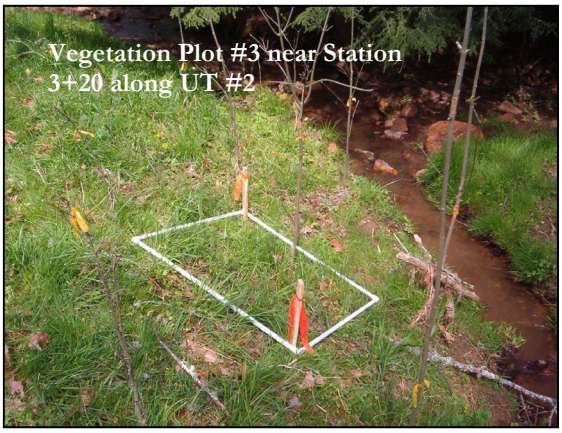
Vegetation Plot #3 near Station
3+20 along UT #2

Plot 3. Fescue and jewelweed (*Impatiens capensis*) were observed in and immediately adjacent to the vegetation plot. In addition, four green ash were noted within five feet of the vegetation plot.

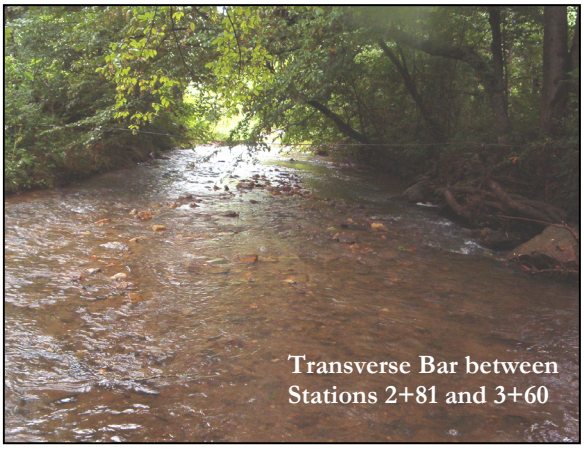
- Approximately 500 feet upstream of Station 0+00. Scour was observed around rootwad on left bank.
- Stations 2+81 to 3+60. The formation of a transverse bar was observed in the middle of channel through the riffle section. Two potential cutoff areas were observed. This bar may develop into center bar. This area should be assessed during the next monitoring period to determine remedial actions, if necessary.

Transverse Bar between Stations 2+81 and 3+60

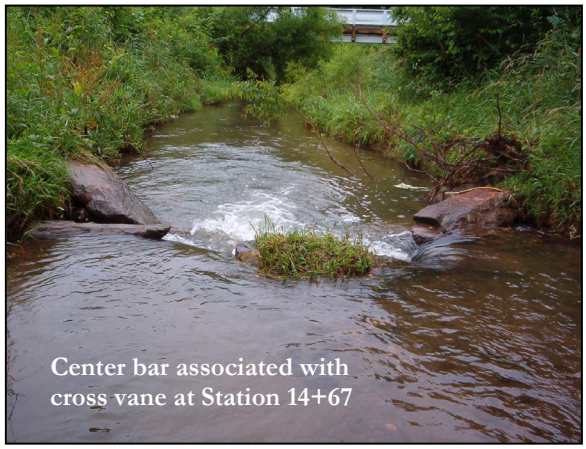
Center bar associated with cross vane at Station 14+67
