Monitoring Data Record

Project Title: R-2000G (I-540) COE Action ID: 199920387
Stream Name: UT Neuse River (Site 10) DWQ Number: 030114
City, County and other Location Information: I-540, Wake County (Sta.460+53 -L- to 459+80 -L- RT.)
Date Construction Completed: April 2005 Monitoring Year: (3) of 5
Ecoregion: 8 digit HUC unit 03020201
USGS Quad Name and Coordinates:
Rosgen Classification: Proposed Reach: E5b
Length of Project: 312' Urban or Rural: Urban Watershed Size:
Monitoring DATA collected by: M. Green and J. Young Date: 1/7/09
Applicant Information:
Name: NCDOT Roadside Environmental Unit
Address: 1425 Rock Quarry Road Raleigh, NC 27610
Telephone Number: (919) 861-3772 Email address: mlgreen@dot.state.nc.us
Consultant Information:
Name:
Address:
Telephone Number: Email address:
Project Status: Complete

PROJECT: 8.U401712 (R-2000G)
I-540 NORTHERN WAKE EXPRESSWAY

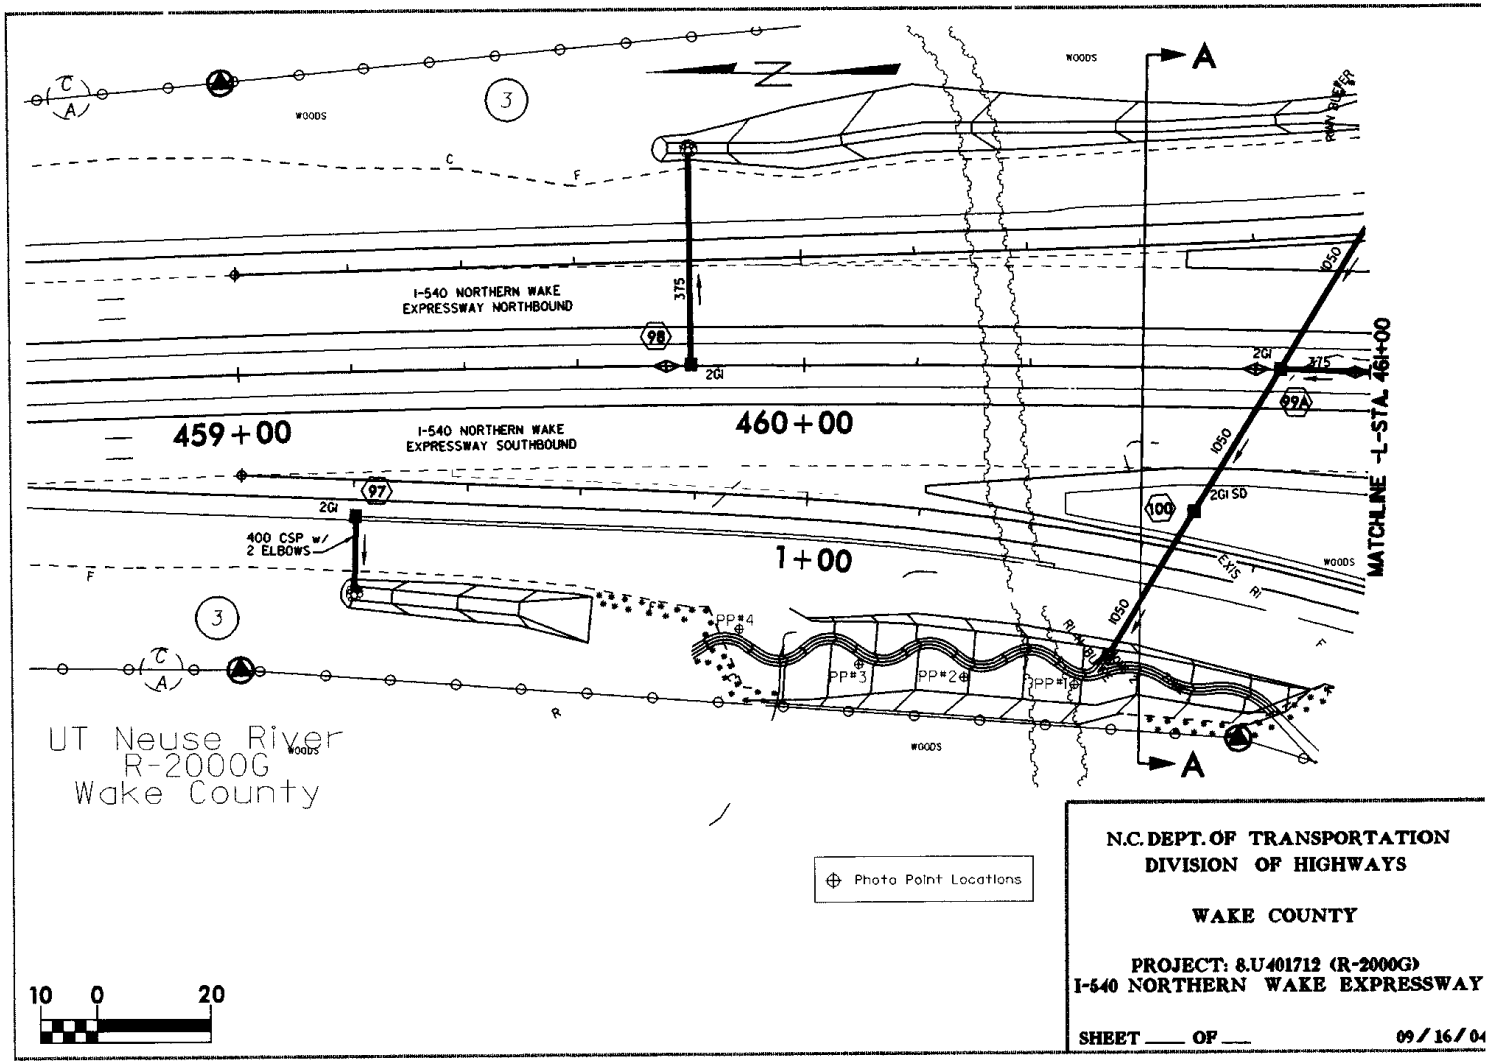
Year 3 Winter – January 2009

Other Information relative to site photo reference: A site map is included with this report showing the photo point locations.

The stream is stable for the Year 3 Winter Evaluation. A bankfull event has occurred since the last monitoring evaluation. NCDOT will continue to monitor this stream relocation.
