# Maintenance Rating Program

## Triangle Expressway

2026 Second Quarter Report

NCTA Triangle Expressway Roadway Maintenance Performance Rating Program; Q2, FY 2026 Rating

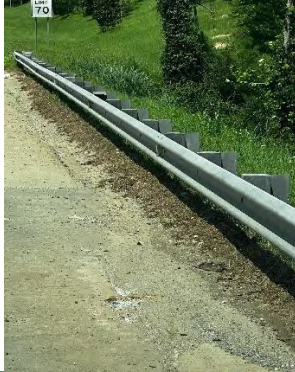
| # | Material Type | Object ID | Failure Type | Photo | GIS Reference Page |
|---|---|---|---|---|---|
| 1 | Other | CG_325 | Settlement | | A9 |

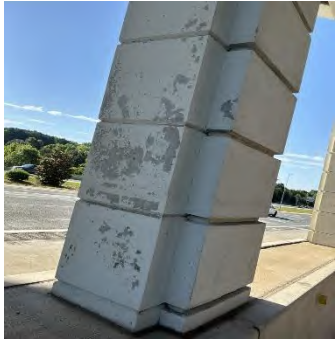
| # | Material Type | Object ID | Failure Type | Photo | GIS Reference Page |
|---|---|---|---|---|---|
| 1 | Overhead Support | DS_146 | Spalling | | A18 |

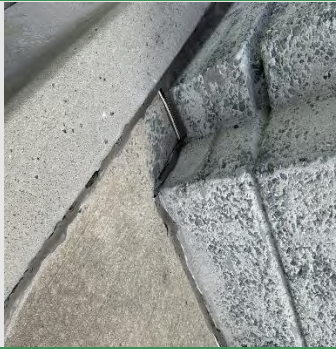
| # | Material Type | Object ID | Failure Type | Photo | GIS Reference Page |
|---|---|---|---|---|---|
| 2 | Gantry Support | DS_217 | Unsealed Crack/ Joint | | A21 |

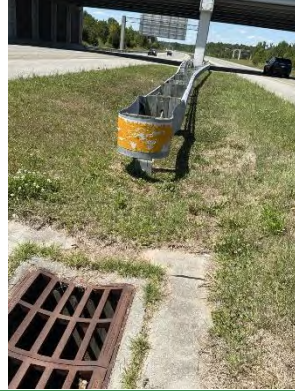
| # | Material Type | Object ID | Failure Type | Photo | GIS Reference Page |
|---|---|---|---|---|---|
| 1 | Gating Attenuator | IA_44 | Functional Damage | | A30 |

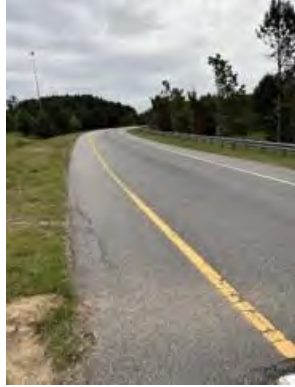
| # | Material Type | Object ID | Failure Type | Photo | GIS Reference Page |
|---|---|---|---|---|---|
| 1 | Asphalt | LS_183 | Unsealed Cracks | | A17 |

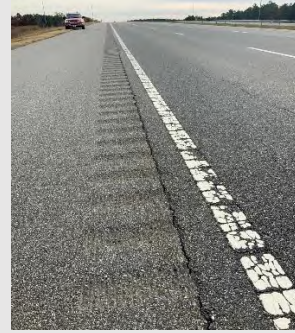
| # | Material Type | Object ID | Failure Type | Photo | GIS Reference Page |
|---|---|---|---|---|---|
| 2 | Asphalt | LS_244 | Unsealed Cracks | | A31 |

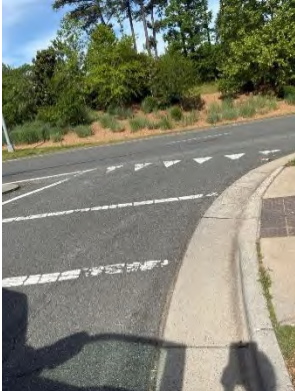
| # | Material Type | Object ID | Failure Type | Photo | GIS Reference Page |
|---|---|---|---|---|---|
| 1 | Yield Bar | PS_146 | Daytime Assessment/<br>Nighttime Reflectivity | | A31 |

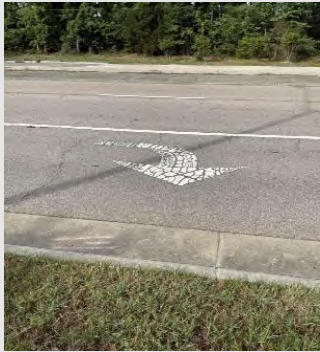
| # | Material Type | Object ID | Failure Type | Photo | GIS Reference Page |
|---|---|---|---|---|---|
| 2 | Right Turn | PS_383 | Daytime Assessment | | A1 |

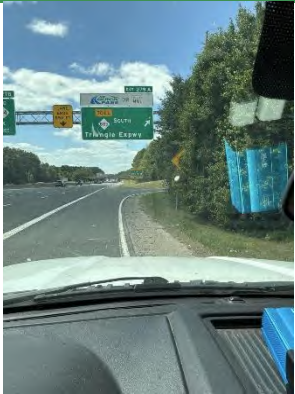
| # | Material Type | Object ID | Failure Type | Photo | GIS Reference Page |
|---|---|---|---|---|---|
| 1 | Tree and Brush | TB_2 | Sight Distance | | A28 |

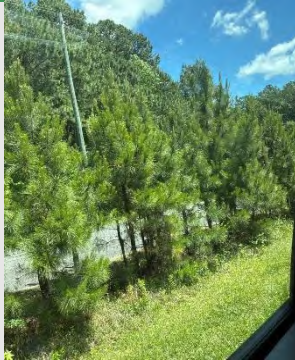
| # | Material Type | Object ID | Failure Type | Photo | GIS Reference Page |
|---|---|---|---|---|---|
| 2 | Tree and Brush | TB_52 | Sight Distance | | ORA |
