Maintenance Rating Program

Triangle Expressway

2025 Second Quarter Report

NCTA Triangle Expressway Roadway Maintenance Performance Rating Program; Q2, 2025 Rating

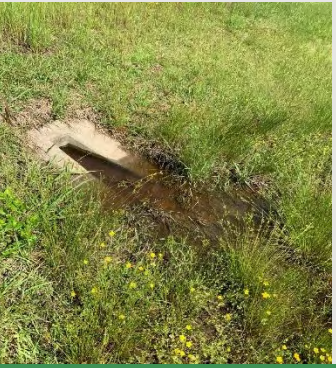
A10
2	Shoulder Drain	MDP_41	Obstruction

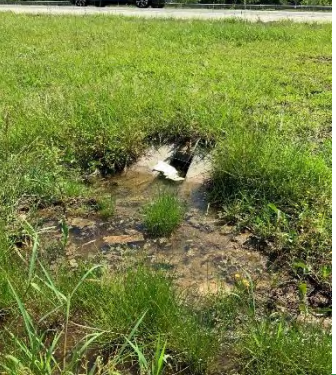
A11
3	Shoulder Drain	MDP_95	Obstruction

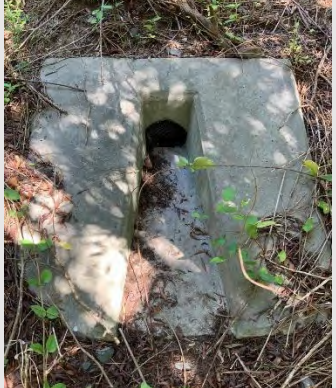
A18
4	Shoulder Drain	MDP_199	Obstruction
