Maintenance Rating Program

Triangle Expressway

November 2025

2025 Third Quarter Report

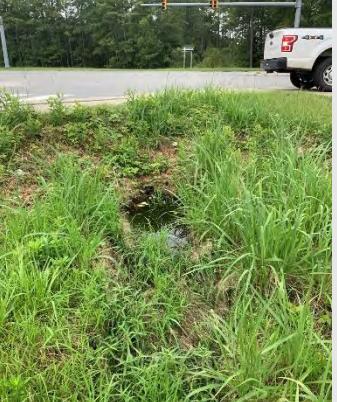
A26
2	Drainage Pipe	DP_414	Obstruction

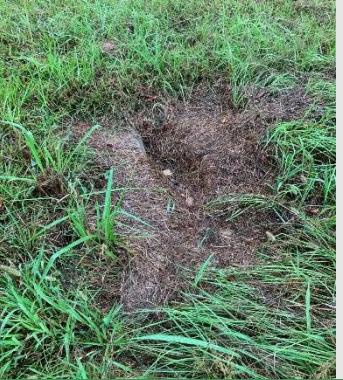
A9
2	Shoulder Drain	MDP_27	Obstruction

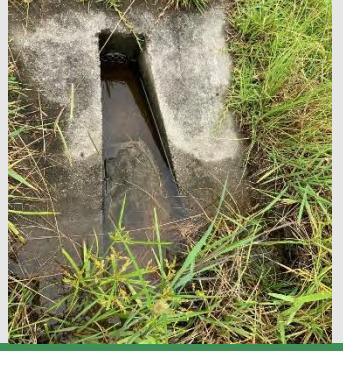
A15
4	Shoulder Drain	MDP_131	Obstruction

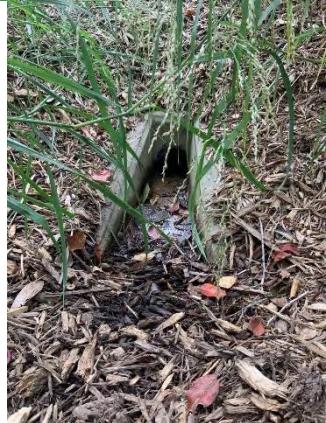
5	Shoulder Drain	MDP_150	Rodent Screen

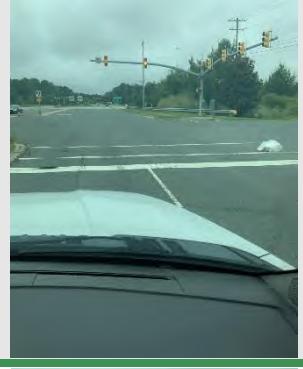
A13
2	Ped Xing	PS_528	Daytime Assessment / Nighttime Reflectivity

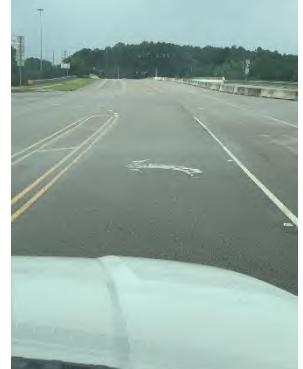
A30
3	Left Turn	PS_583	Daytime Assessment / Nighttime Reflectivity
