# Maintenance Rating Program

Triangle Expressway

2025 Fourth Quarter Report

### NCTA Triangle Expressway Roadway Maintenance Performance Rating Program; Q4, 2025 Rating

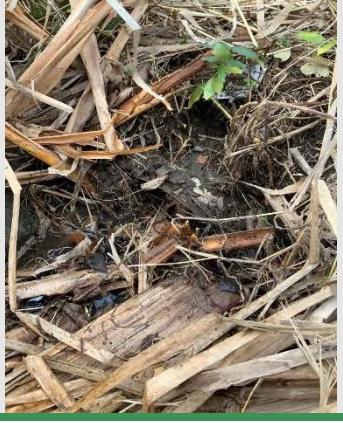
A26

A25
2	Drain	DP_61	Obstruction

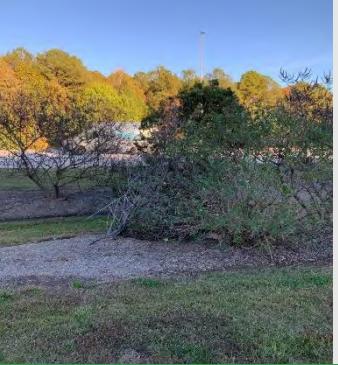
A13

A20
2	Plant Bed	PB_119	Health

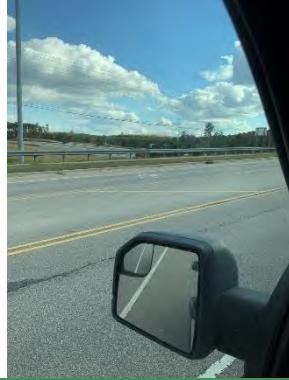
A26
4	Thru Lane	PS_626	Nighttime Reflectivity	No Photo Available	A13

A27
3	Thru and Right	PS_582	Daytime Assessment / Nighttime Reflectivity
