NORTH CAROLINA
Turnpike Authority

Triangle Expressway

2016 Fourth Quarter and Annual Report

NCTA Triangle Expressway Roadway Maintenance Performance Rating Program; Q4, 2016 Rating

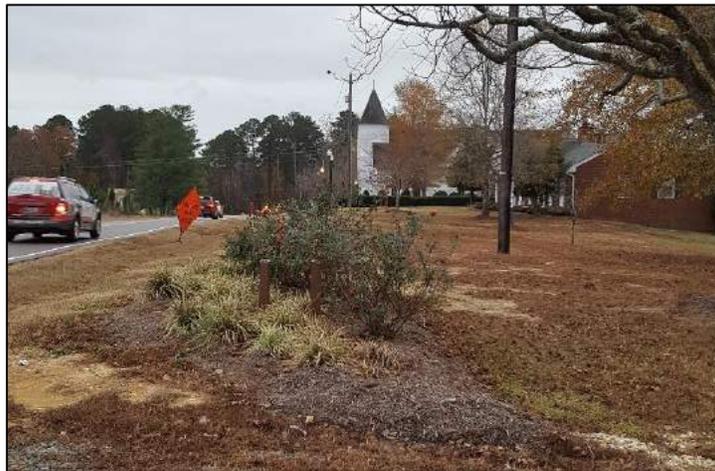
Figure 5: Green Level West Historic District Signs, Landscape Areas

As part of each quarterly inspection, assessors visit the four Green Level Historic District signs to conduct a visual inspection of each sign and ensure they are in good standing. During this quarter, the sign located near the intersection of Green Level Church Road and Green Level West Road was excluded from the inspection inventory due to inaccessibility to the sign because of construction work in the area. The three signs included in the inspection inventory were only inspected for landscape appearance because two of the three signs were vandalized and the other sign was temporarily removed to be used as a sample to replace the vandalized signs. All landscaped areas at the location of the signs were found to be well maintained (**Figure 5**). NCTA is in the process of replacing all signs.

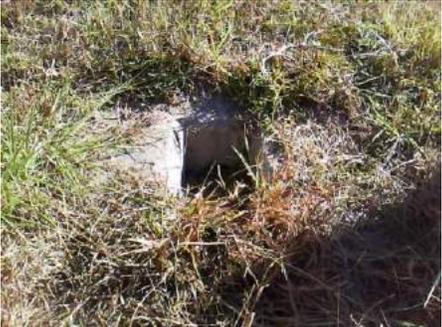
A photograph showing a shoulder drain opening in a grassy area. The drain is partially blocked by a large clump of tall, green grass growing over it.	A11
2	Shoulder Drain	MDP_29	Obstruction

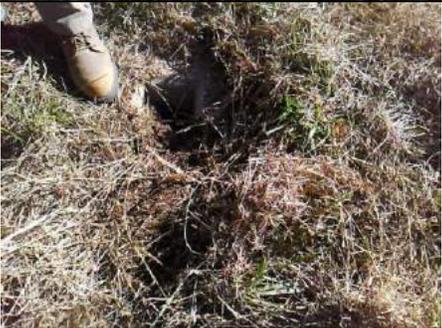
A photograph of a shoulder drain opening. The drain is almost completely obscured by a dense, tangled mass of dry, brownish grass and weeds.	A15
3	Shoulder Drain	MDP_41	Obstruction

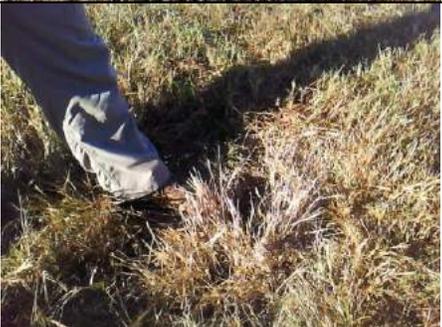
A photograph showing a shoulder drain opening. The drain is heavily obstructed by a thick layer of dry, brown grass and weeds. A person's boot is visible in the foreground, stepping on the vegetation.	A18
4	Shoulder Drain	MDP_61	Obstruction

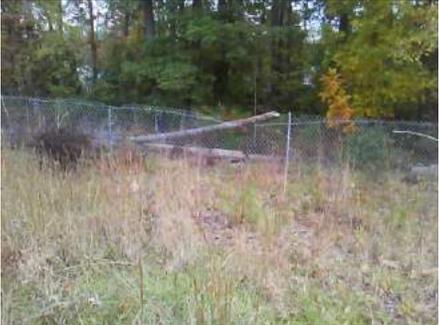
A25
2	Chain Link	FN_243	Fence Height

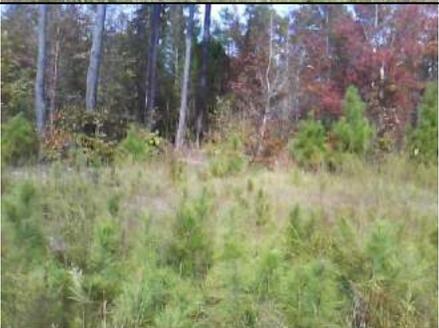
A47
3	Woven	FN_367	Fence Height

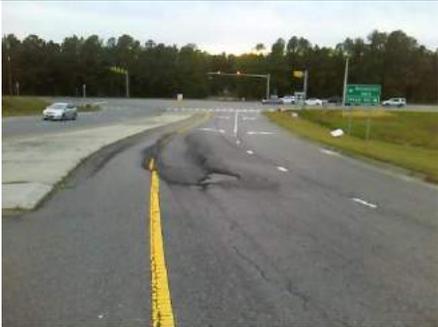
A47
2	Asphalt	LS_305	Payment Flushing

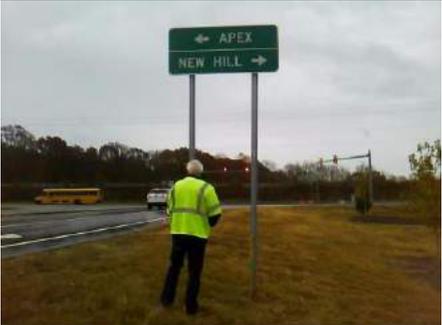
A29
2	Mileage to City	SN_806	Height Requirement

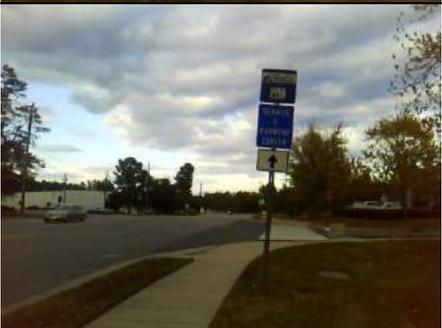
A36
3	Other	SN_1023	Leaning

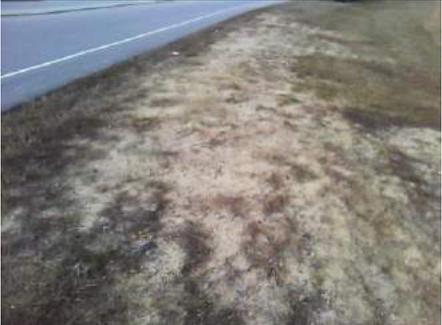
A27, A28
2	Turf	TF_225	Bareground

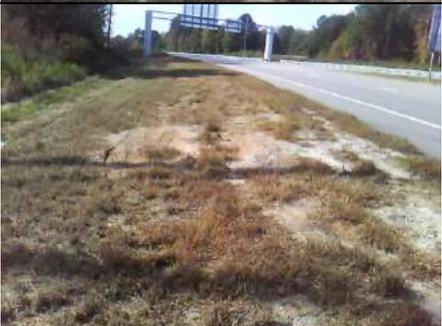
A28
3	Turf	TF_344	Bareground

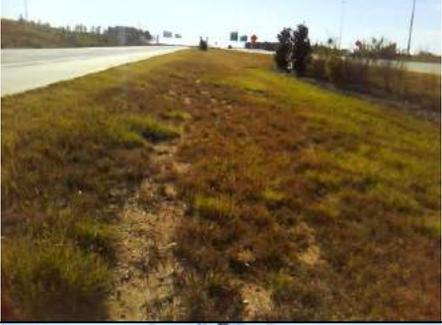
A39, A40
6	Turf	TF_398	Bareground

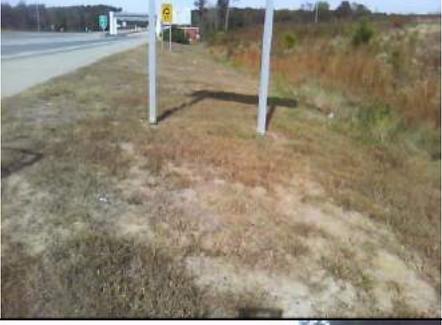
A38
7	Turf	TF_431	Bareground

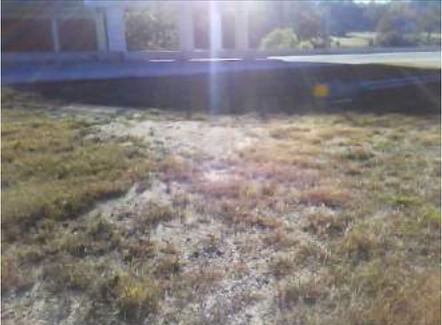
A21, A22
10	Turf	TF_672	Bareground

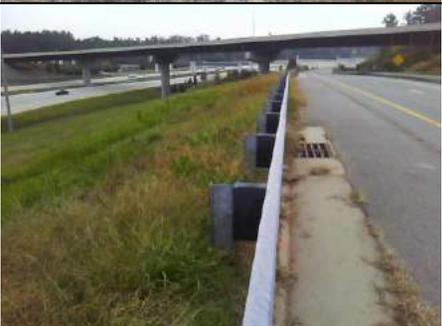
A28, A30
11	Turf	TF_777	Height

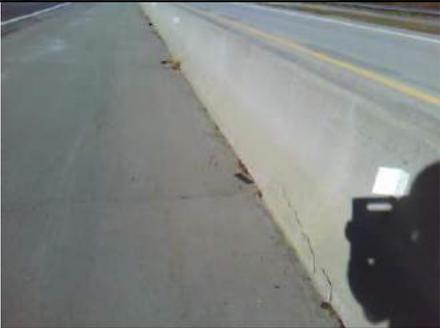
A45
3	Wall	WL_80	Paint Scaling
