NORTH CAROLINA
Turnpike Authority

Maintenance Rating Program

Triangle Expressway

2017 Second Quarter Report

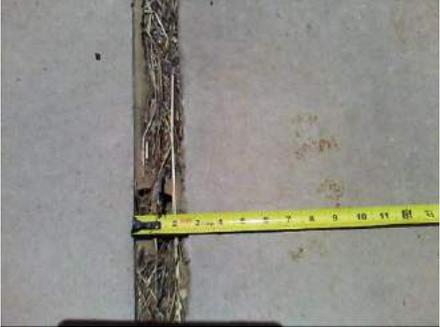
A24
2	Valley	CG_41	Misalignment

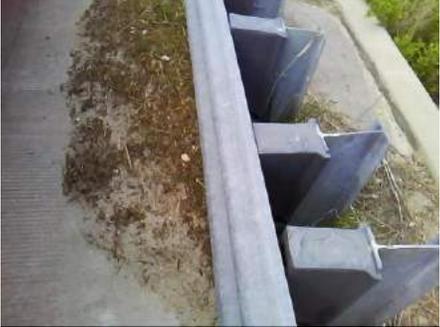
A18
3	Valley	CG_51	Material Accumulation

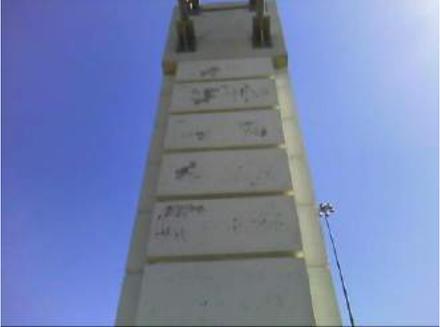
A5
2	Overhead Sign Support	DS_255	Paint Scaling

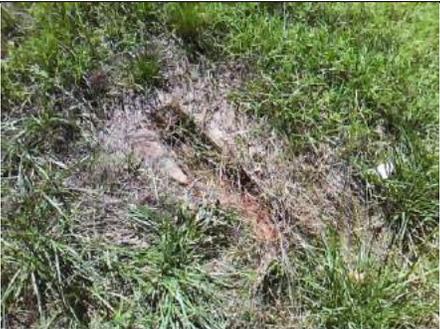
A42
2	Shoulder Drain	MDP_16	Obstruction

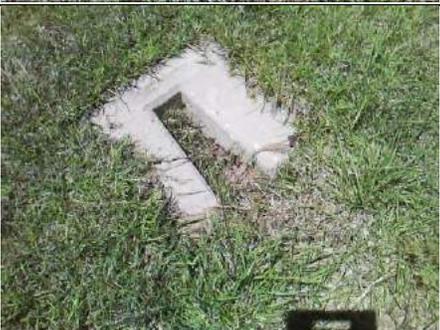
A12
3	Shoulder Drain	MDP_36	Obstruction

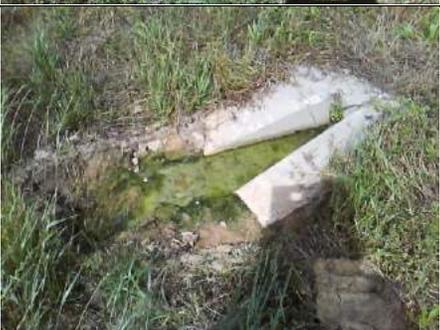
A16
4	Shoulder Drain	MDP_86	Erosion

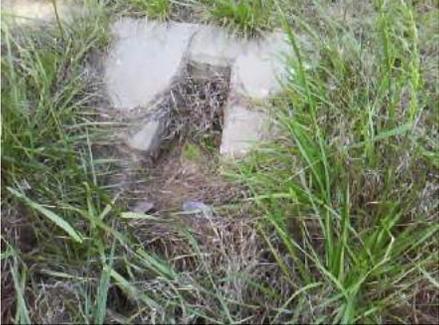
A photograph showing a concrete shoulder drain partially blocked by a dense clump of tall green grass and weeds.	A24
6	Shoulder Drain	MDP_119	Erosion

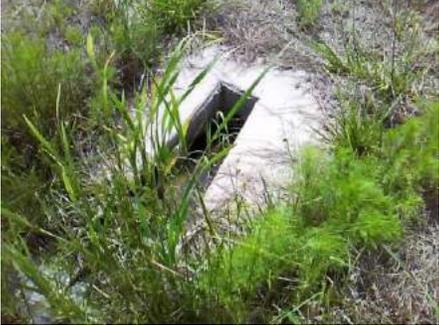
A photograph showing a concrete shoulder drain with significant soil erosion on either side, and tall grasses growing in the eroded areas.	A32
7	Shoulder Drain	MDP_122	Obstruction

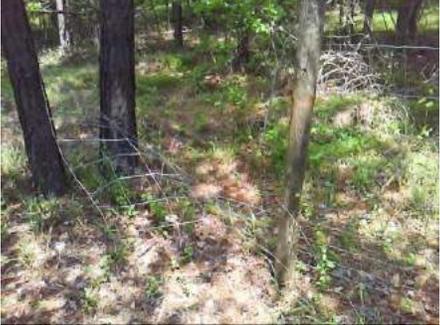
A2
2	Woven	FN_353	Fence Height

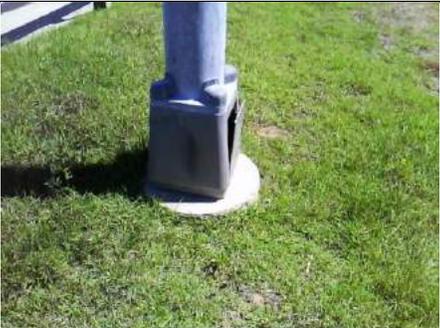
A10
2	Single Roadway	HL_129	Functional Damage	Not Available for Nighttime Failure.	A7
3	Single Roadway	HL_193	Part Damage

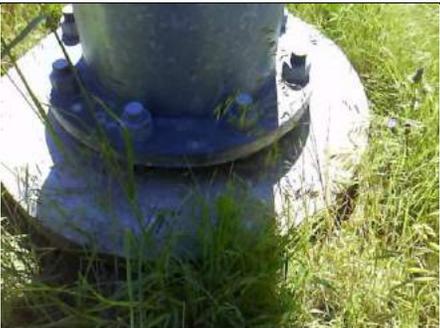
A46
4	Underpass Lighting	HL_197	Functional Damage	Not Available for Nighttime Failure.	A43, A44
5	High Mast	HL_206	Missing Part

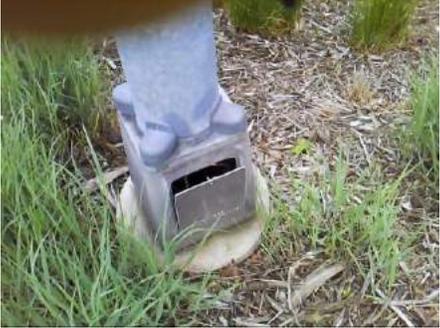
A6
6	Single Roadway	HL_215	Part Damage

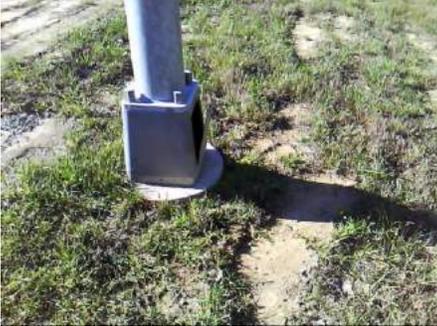
#	Material Type	Object ID	Failure Type	Photo	GIS Reference Page
8	Single Roadway	HL_333	Part Damage

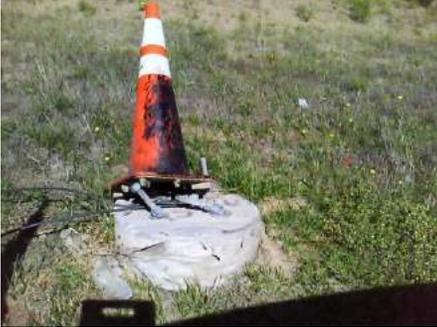
A30
9	Single Roadway	HL_337	Functional Damage, Part Damage, Missing Part

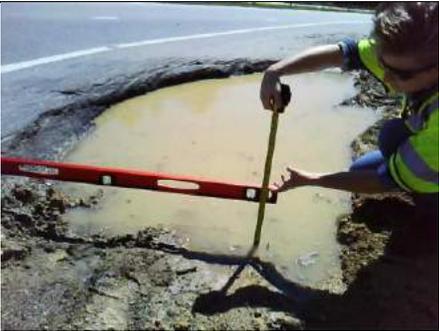
A20
2	Asphalt	LS_585	Shoulder Drop Off

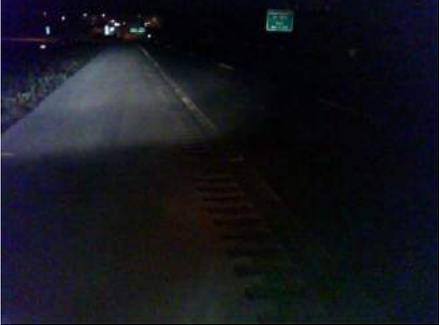
A30
2	Concrete	LS_410	Missing Line

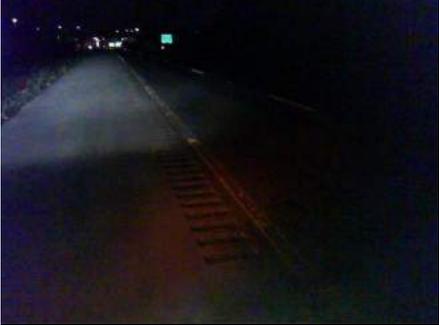
A30
3	Concrete	LS_412	Missing Line

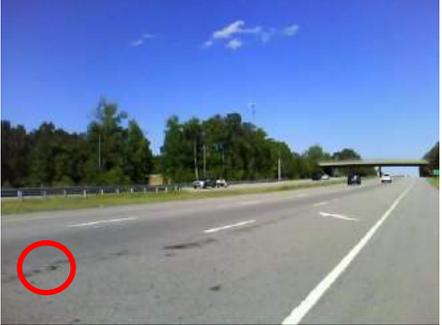
#	Material Type	Object ID	Failure Type	Photo	GIS Reference Page
1	Asphalt	LS_556	Marker Reflectivity	Not Available for Nighttime Failure.	A39
2	Asphalt	LS_592	Missing Markers

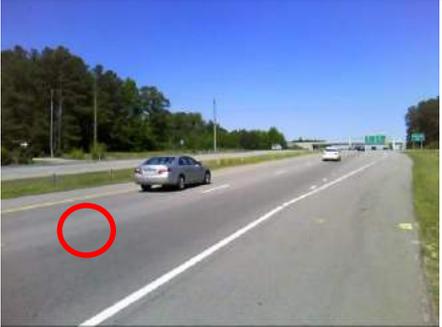
A28
3	Asphalt	LS_595	Missing Markers, Continuous Markers

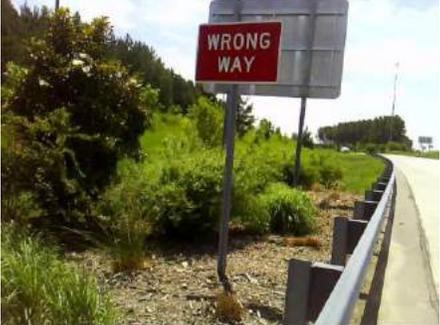
A12
2	Wrong Way	SN_147	Height Requirement

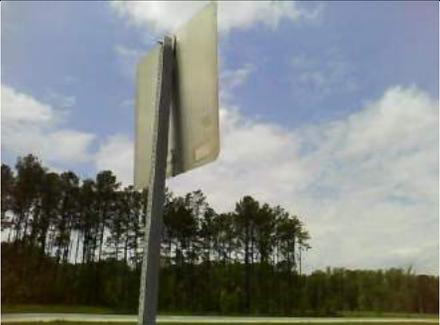
A26
3	Do Not Enter	SN_619	Missing Part

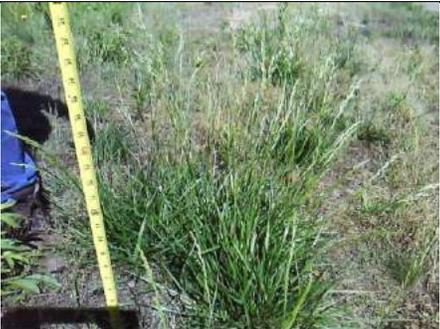
A20
2	Turf	TF_80	Height

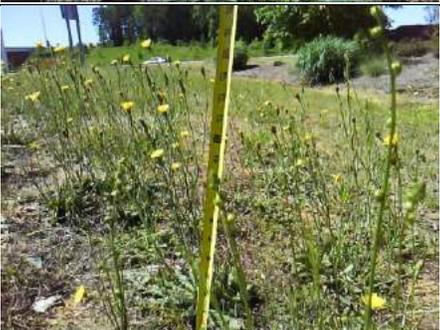
A28
3	Turf	TF_93	Height

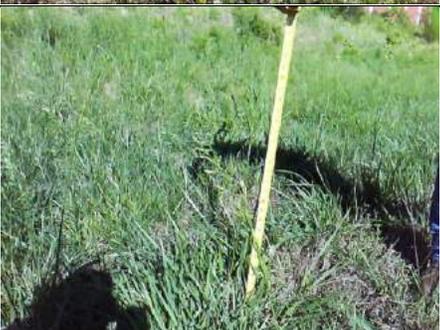
A28
4	Turf	TF_113	Height

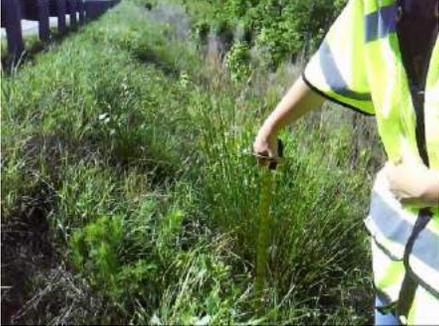
#	Material Type	Object ID	Failure Type	Photo	GIS Reference Page
5	Turf	TF_120	Height

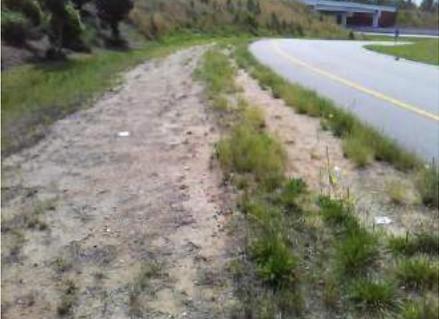
A27
7	Turf	TF_231	Bare Ground

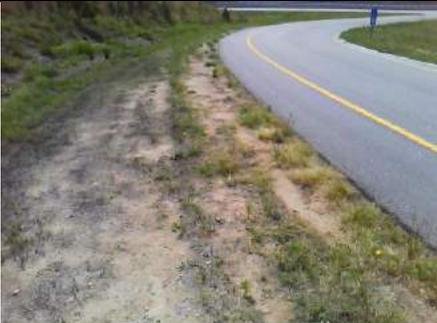
#	Material Type	Object ID	Failure Type	Photo	GIS Reference Page
8	Turf	TF_232	Bare Ground

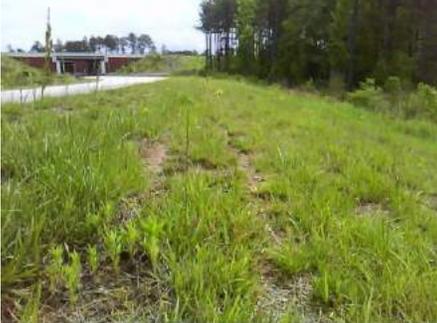
A39
9	Turf	TF_343	Height

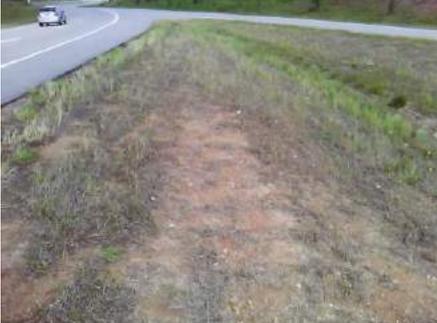
A38
10	Turf	TF_373	Bare Ground

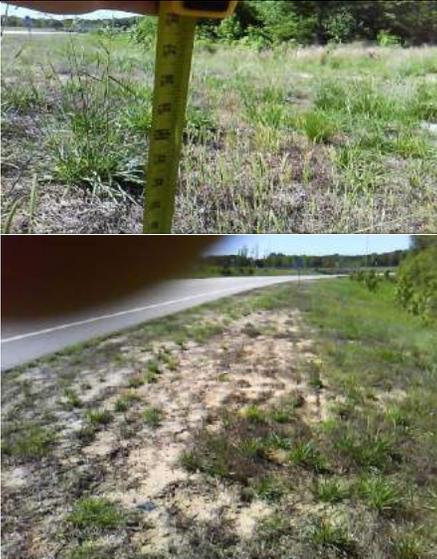
A39
11	Turf	TF_386	Height, Bare Ground

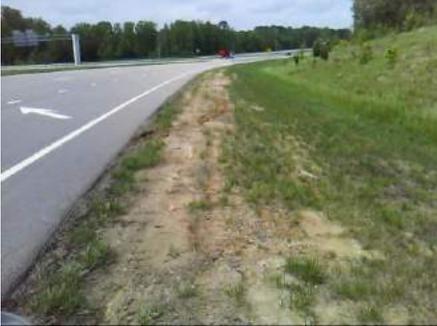
#	Material Type	Object ID	Failure Type	Photo	GIS Reference Page
12	Turf	TF_393	Bare Ground

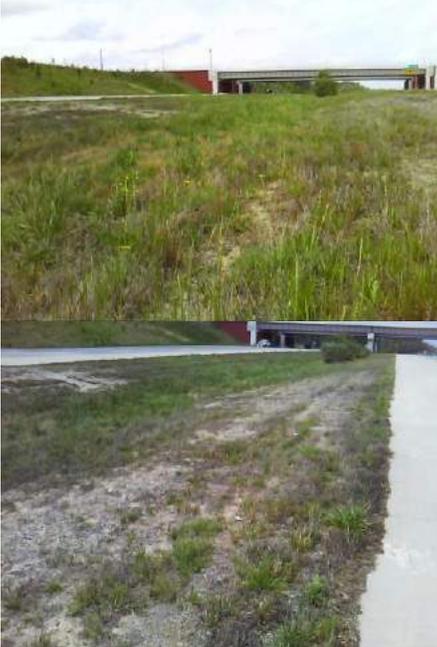
A39
13	Turf	TF_410	Height, Bare Ground

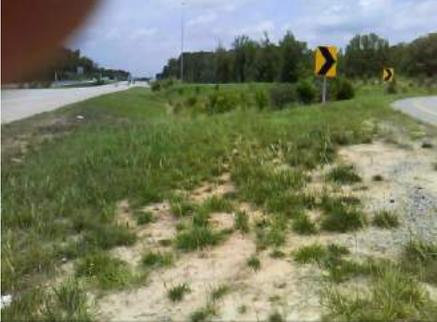
A36
14	Turf	TF_430	Height

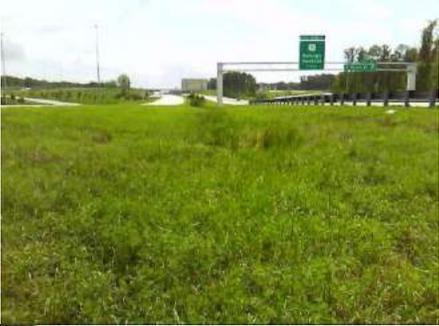
#	Material Type	Object ID	Failure Type	Photo	GIS Reference Page
15	Turf	TF_438	Height

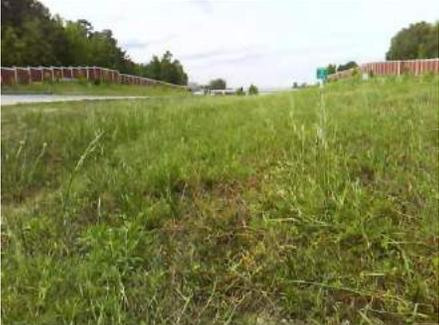
A34
16	Turf	TF_483	Height

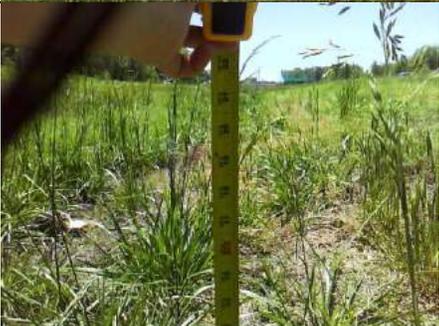
A31
17	Turf	TF_590	Height

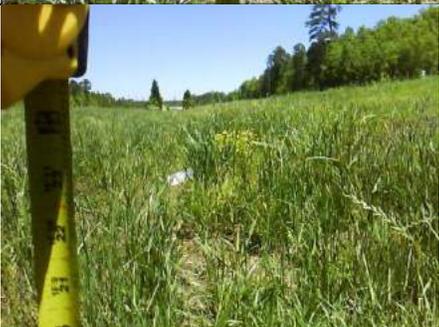
A19
18	Turf	TF_625	Height

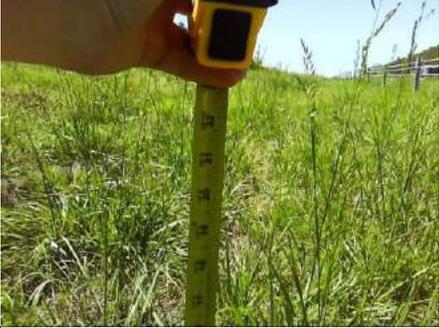
#	Material Type	Object ID	Failure Type	Photo	GIS Reference Page
19	Turf	TF_667	Height

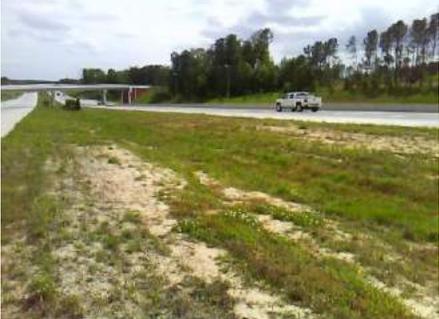
A12
20	Turf	TF_671	Bare Ground

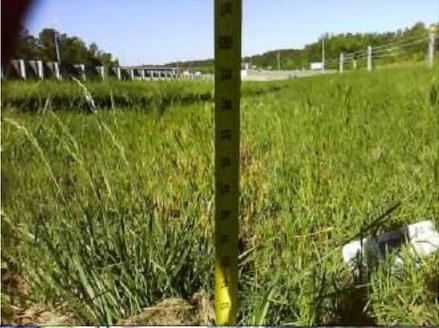
A29
21	Turf	TF_812	Height

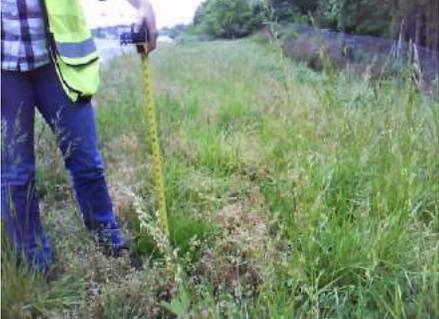
A4
22	Turf	TF_884	Height

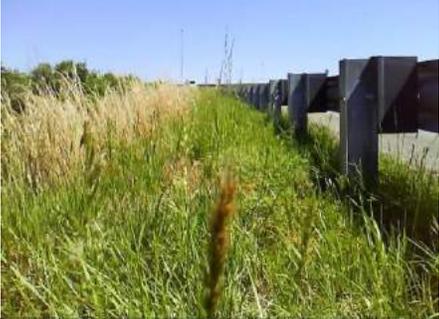
A42
25	Turf	TF_983	Height
