Maintenance Rating Program

Triangle Expressway

2018 First Quarter Report

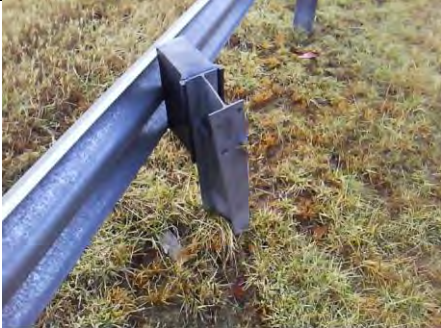
#	Material Type	Object ID	Failure Type	Photo	GIS Reference Page
1	Guardrail	BR_12	Functional Damage

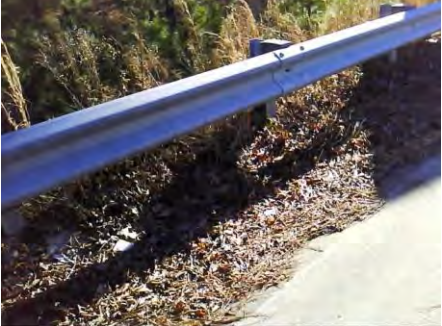
#	Material Type	Object ID	Failure Type	Photo	GIS Reference Page
1	Valley	CG_22	Material Accumulation

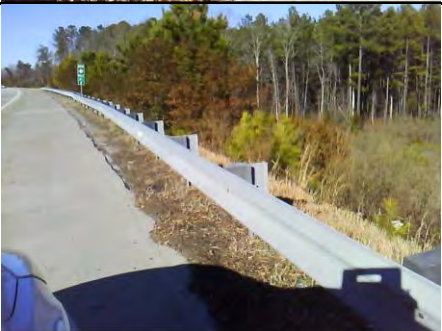
A21, A22
2	Valley	CG_59	Material Accumulation

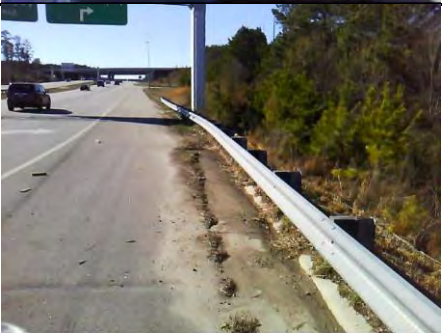
A22
3	Valley	CG_283	Material Accumulation

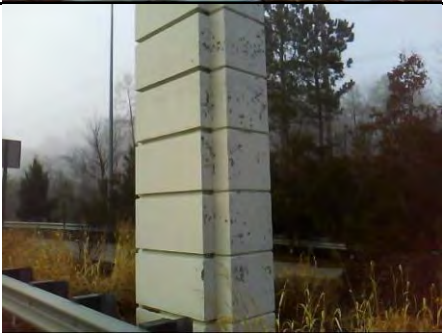
A20
2	Gantry Support	DS_145	Paint Scaling

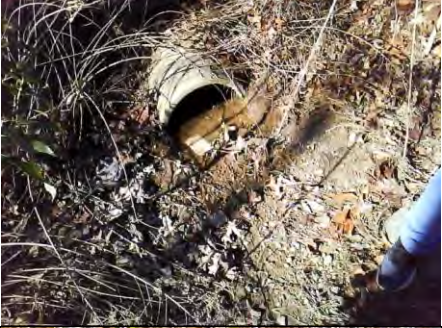
A23
2	Cross Pipe	DP_989	Obstruction

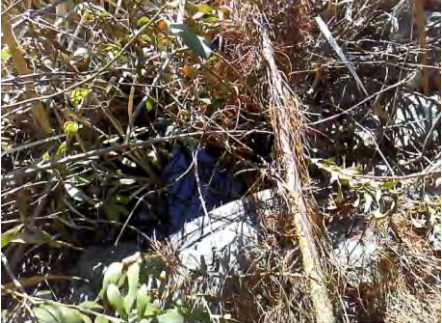
A29
3	Cross Pipe	DP_1038	Obstruction

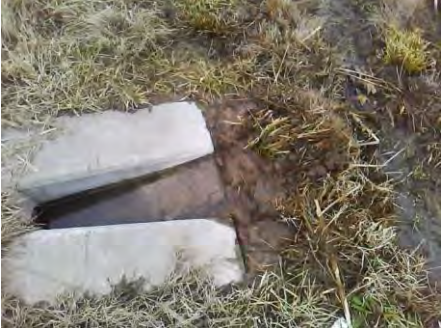
A12
2	Shoulder Drain	MDP_1003	Obstruction

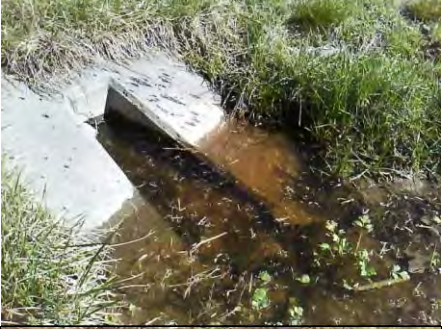
A15
3	Shoulder Drain	MDP_1007	Obstruction

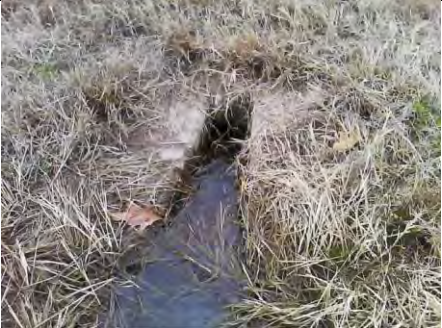
#	Material Type	Object ID	Failure Type	Photo	GIS Reference Page
5	Shoulder Drain	MDP_1035	Obstruction

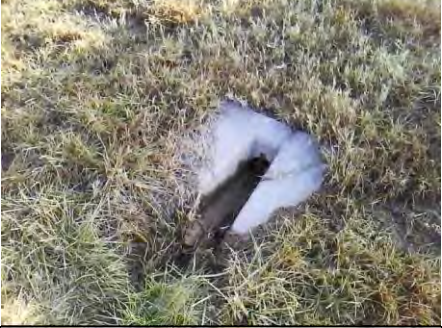
A21
6	Shoulder Drain	MDP_1040	Obstruction

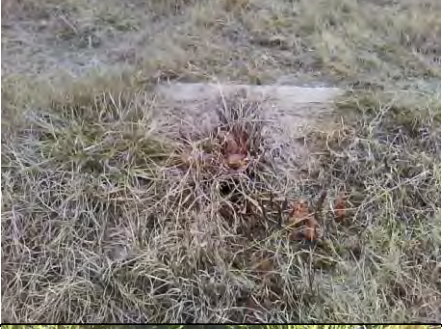
A21, A22
7	Shoulder Drain	MDP_1060	Obstruction

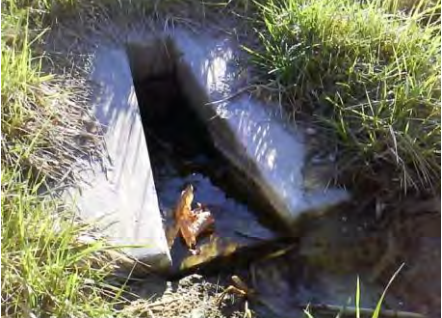
A25
8	Shoulder Drain	MDP_1075	Obstruction, Erosion

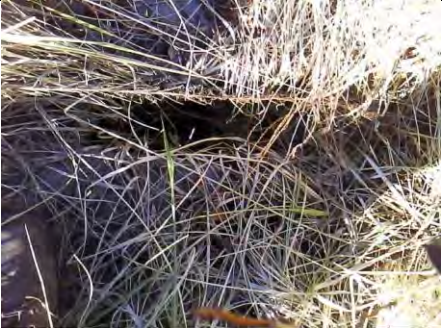
#	Material Type	Object ID	Failure Type	Photo	GIS Reference Page
9	Shoulder Drain	MDP_1106	Obstruction

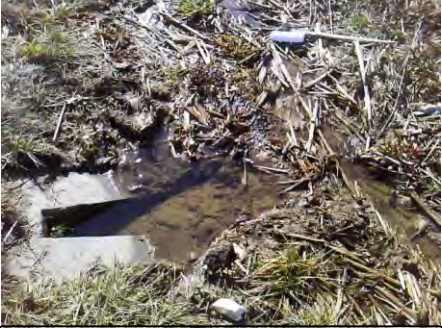
A35, A36
10	Shoulder Drain	MDP_1112	Obstruction

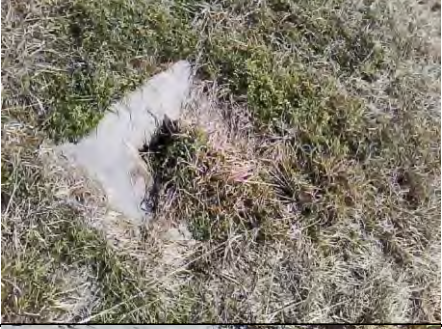
A37
11	Shoulder Drain	MDP_1125	Obstruction

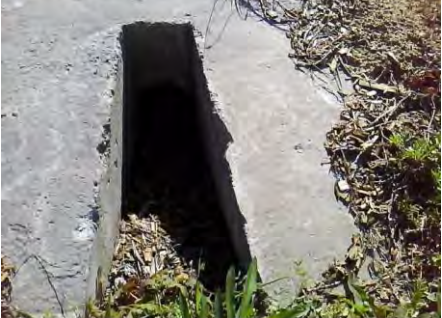
A40
12	Shoulder Drain	MDP_1161	Missing Rodent Screen

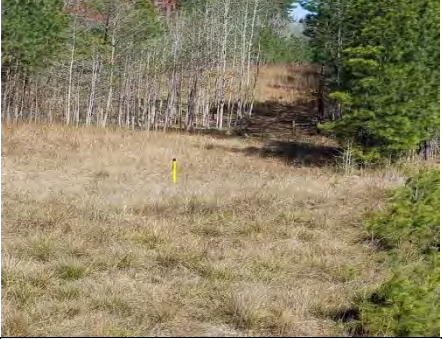
A16
2	Woven	FN_326	Open Gate

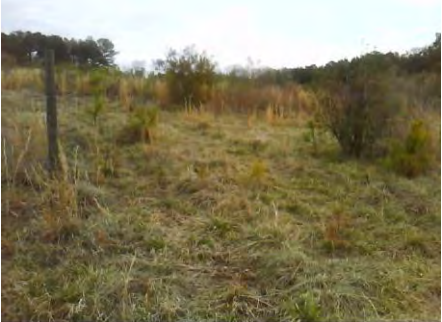
A39
3	Woven	FN_409	Fence Hole

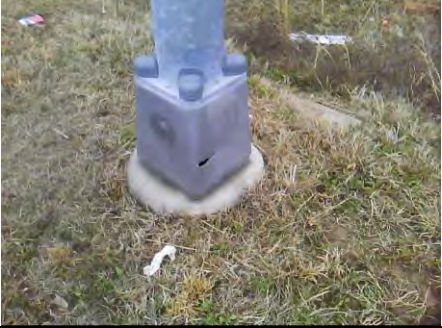
A10, A11
2	Single Roadway	HL_77	Part Damage

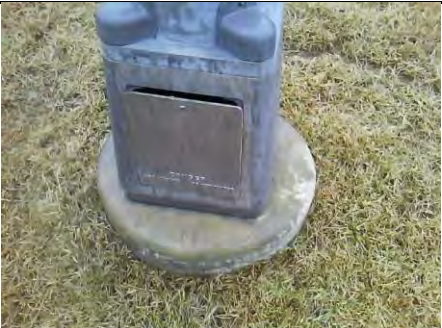
A48
3	Single Roadway	HL_89	Functional Damage	Not Available for Nighttime Failure.	A53
4	Single Roadway	HL_136	Part Damage

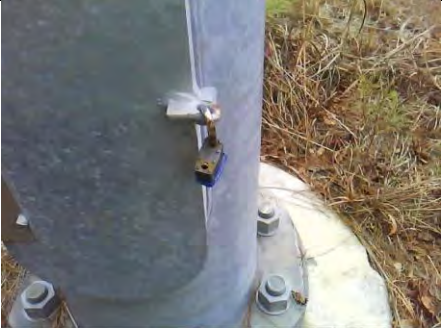
#	Material Type	Object ID	Failure Type	Photo	GIS Reference Page
9	Single Roadway	HL_236	Part Damage

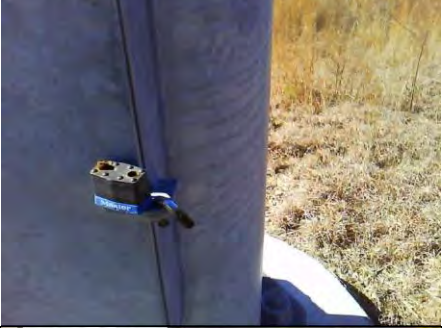
A40
10	High Mast	HL_237	Part Damage

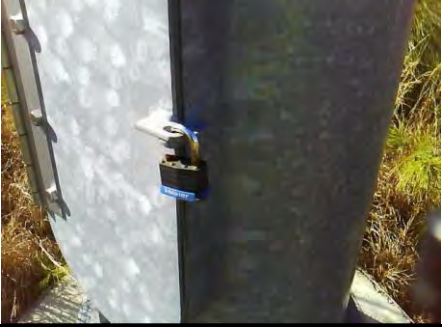
A38
11	High Mast	HL_272	Part Damage

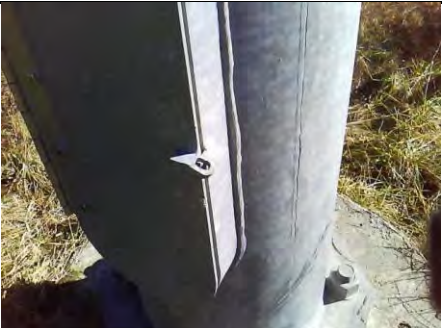
A38, A40
12	High Mast	HL_278	Functional Damage	Not Available for Nighttime Failure.	A45, A46, A47
13	High Mast	HL_292	Functional Damage, Missing Part

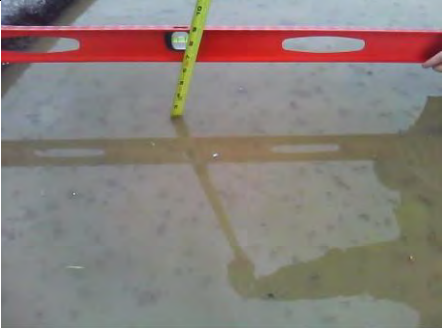
#	Material Type	Object ID	Failure Type	Photo	GIS Reference Page
1	Asphalt	LS_1249	Shoulder Drop Off

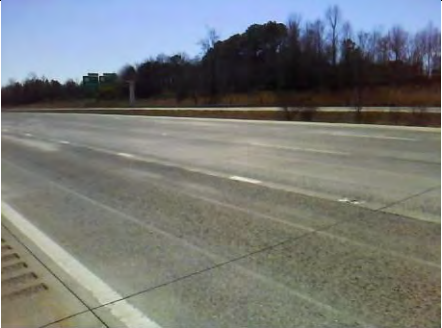
#	Material Type	Object ID	Failure Type	Photo	GIS Reference Page
5	Concrete	LS_445	Line Missing

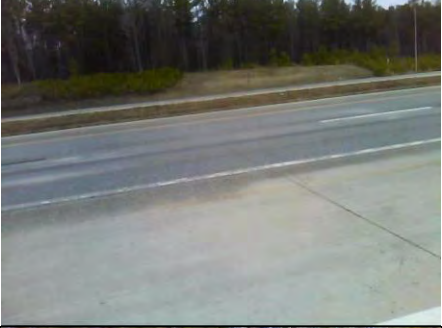
A36, A37
6	Concrete	LS_490	Line Width

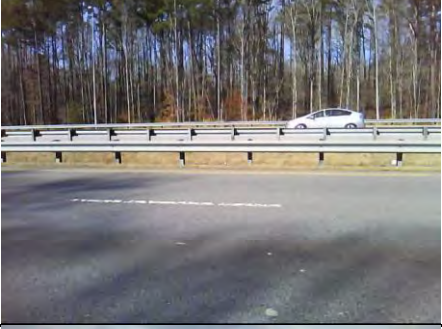
A45
7	Asphalt	LS_547	Line Width

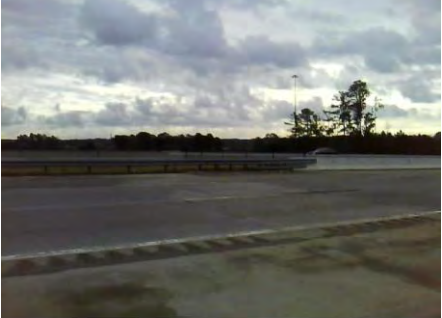
A41
8	Concrete	LS_1200	Line Missing

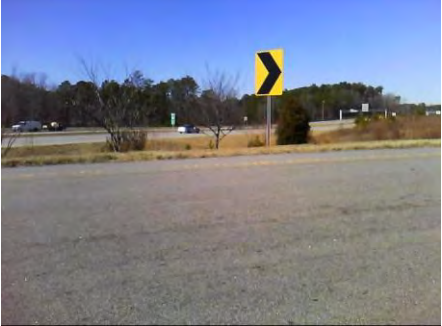
#	Material Type	Object ID	Failure Type	Photo	GIS Reference Page
10	Concrete	LS_1220	Line Width	 	A32
9	Asphalt	LS_1255	Nighttime Visibility, Line Missing

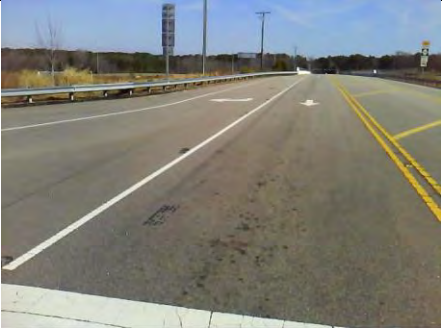
#	Material Type	Object ID	Failure Type	Photo	GIS Reference Page
1	Asphalt	LS_572	Missing Markers

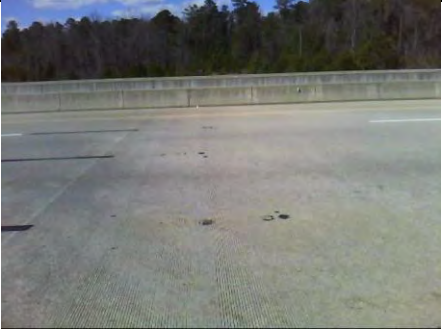
A36, A37
2	Asphalt	LS_631	Nighttime Reflectivity	Not Available for Nighttime Failure.	A7, A8
3	Concrete	LS_636	Missing Markers

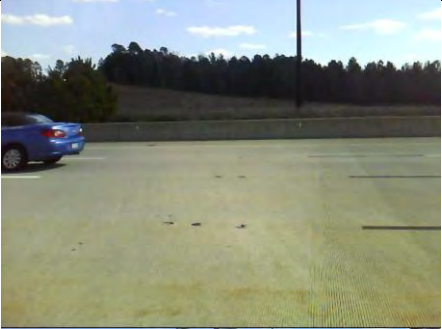
A8
4	Concrete	LS_638	Missing Markers

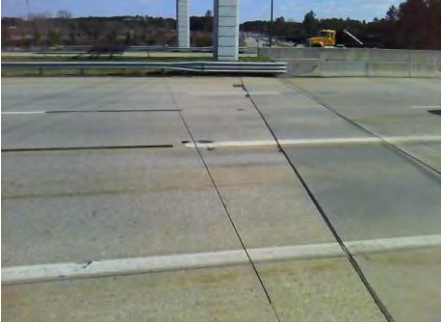
A9
5	Concrete	LS_644	Missing Markers

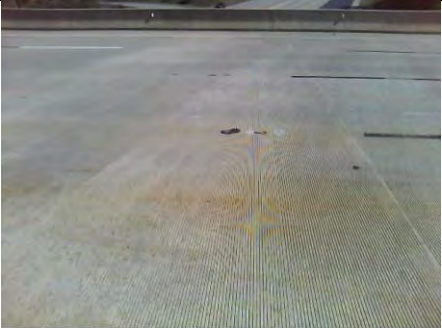
#	Material Type	Object ID	Failure Type	Photo	GIS Reference Page
6	Concrete	LS_646	Missing Markers

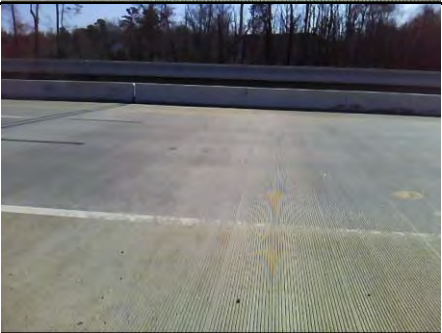
A10, A11
7	Concrete	LS_1220	Missing Markers

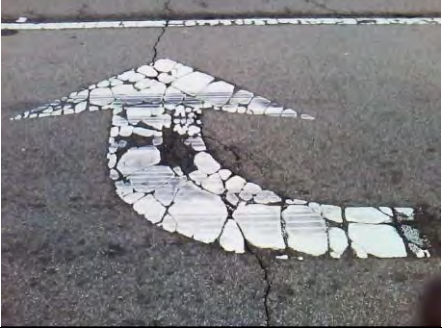
#	Material Type	Object ID	Failure Type	Photo	GIS Reference Page
1	Right Turn	PS_1	Day Time Assessment

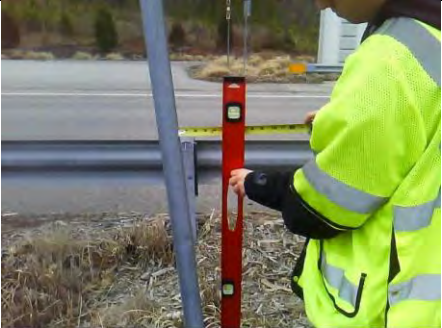
#	Sign Type	Object ID	Failure Type	Photo	GIS Reference Page
1	OneWay	SN_415	Leaning

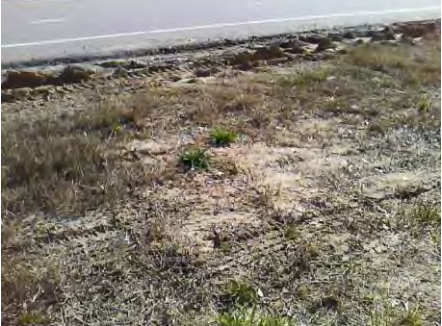
#	Material Type	Object ID	Failure Type	Photo	GIS Reference Page
1	Turf	TF_128	BareGround

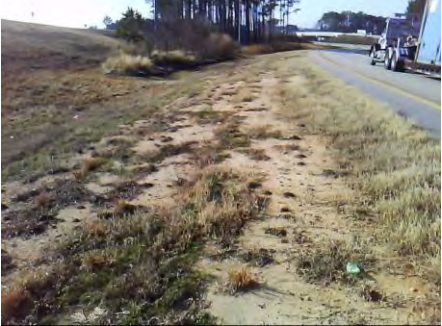
A36
2	Turf	TF_205	BareGround

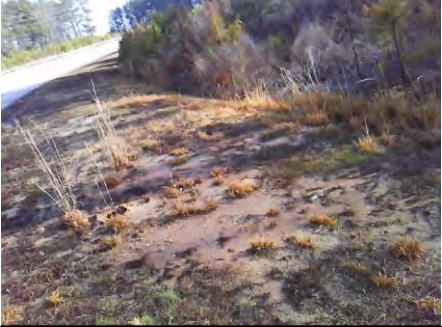
A27, A28, A29
3	Turf	TF_220	BareGround

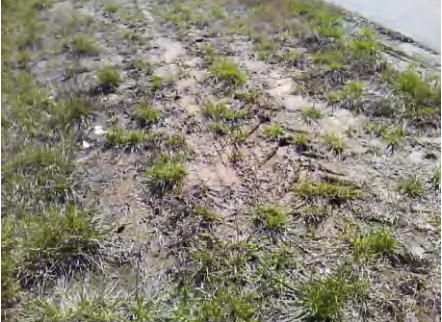
A28
4	Turf	TF_391	BareGround

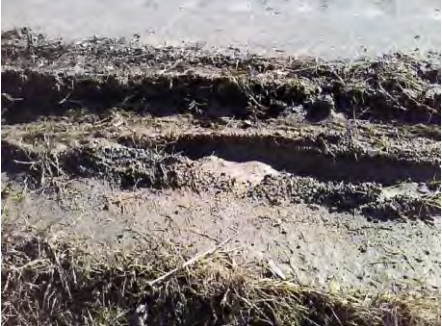
#	Material Type	Object ID	Failure Type	Photo	GIS Reference Page
5	Turf	TF_416	BareGround

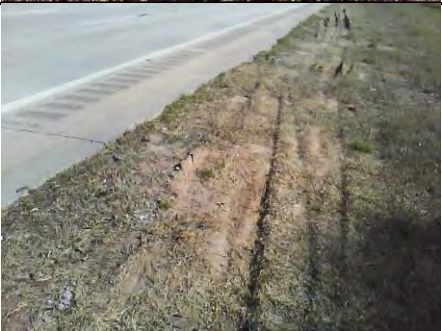
A35, A36
6	Turf	TF_565	BareGround

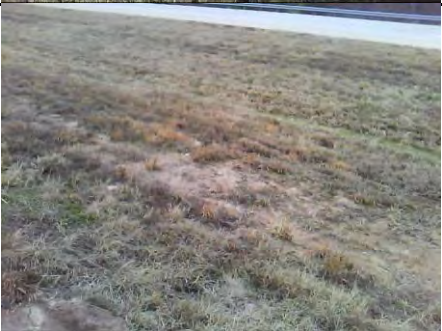
A21, A22
7	Turf	TF_610	BareGround

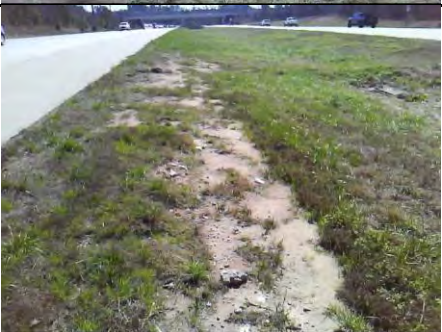
A17
8	Turf	TF_647	BareGround

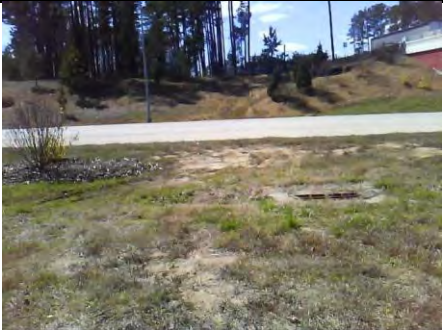
#	Material Type	Object ID	Failure Type	Photo	GIS Reference Page
9	Turf	TF_656	BareGround

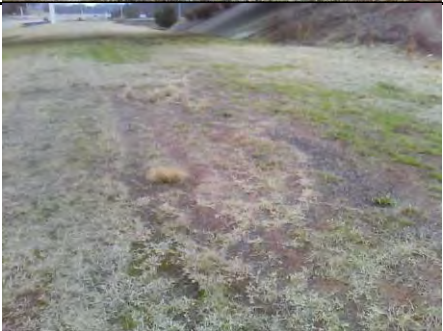
A21, A22
10	Turf	TF_756	BareGround

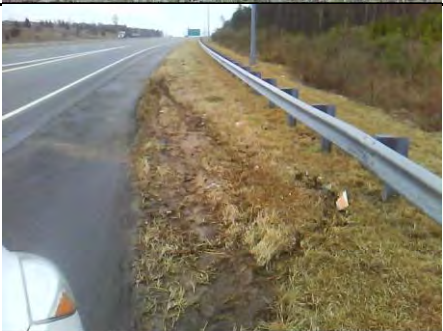
A6
11	Turf	TF_851	BareGround

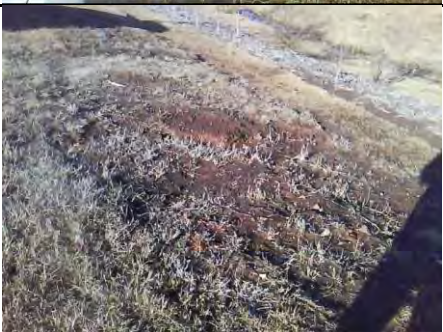
A54, A55
12	Turf	TF_894	BareGround

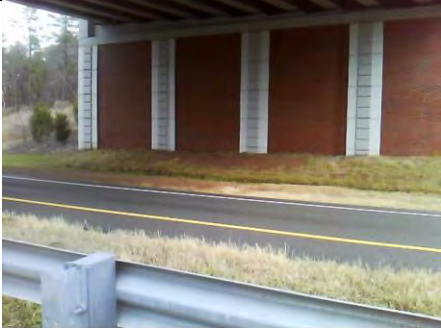
#	Material Type	Object ID	Failure Type	Photo	GIS Reference Page
13	Turf	TF_956	Bare Ground

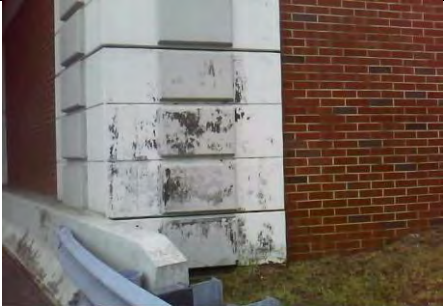
#	Material Type	Object ID	Failure Type	Photo	GIS Reference Page
1	MSE Wall	WL_5	Paint Scaling
