NORTH CAROLINA
Turnpike Authority

Maintenance Rating Program

Triangle Expressway

2018 Fourth Quarter and Annual Report

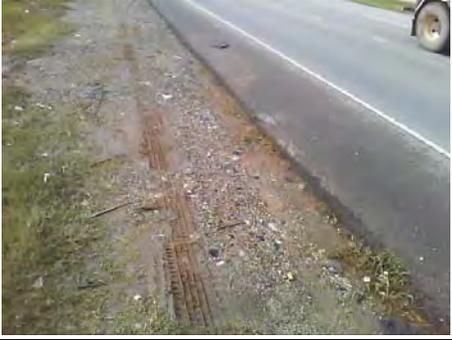
A9
2	Turf	TF_460	Bare Ground

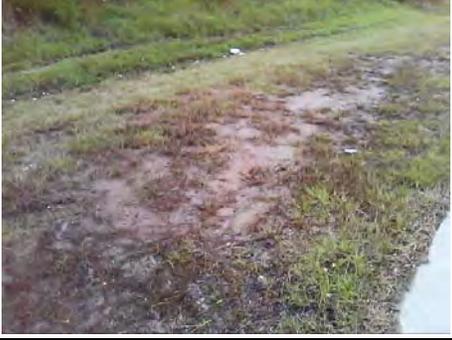
A1
3	Turf	TF_600	Bare Ground

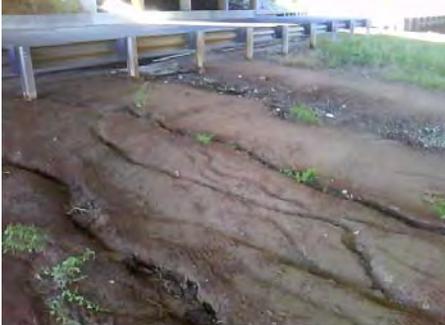
A31
6	Turf	TF_1000	Bare Ground
