NORTH CAROLINA
Turnpike Authority

Maintenance Rating Program

Triangle Expressway

2019 First Quarter Report

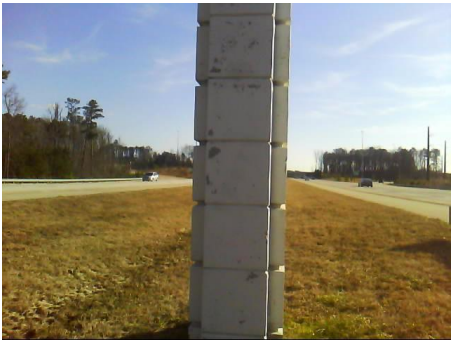
A11
2	Overhead Sign Support	DS_50	Paint Scaling

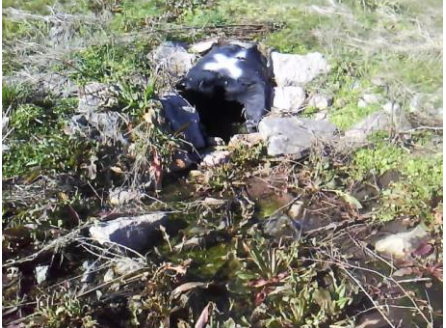
#	Material Type	Object ID	Failure Type	Photo	GIS Reference Page
1	Cross Pipe	DP_699	Pipe Damage

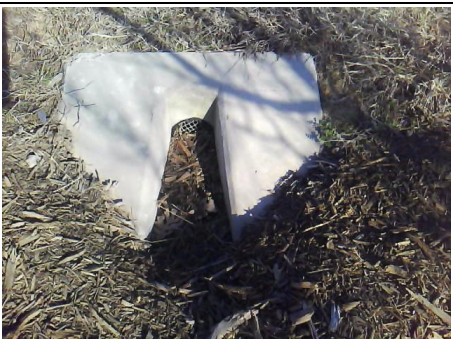
A13
4	Shoulder Drain	MDP_57	Obstruction

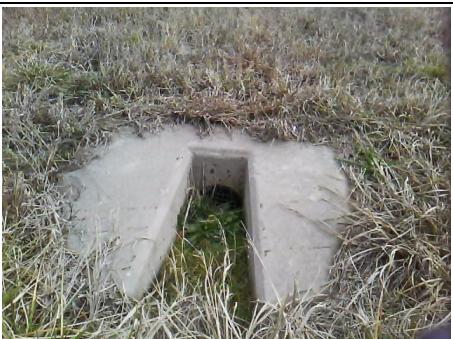
A39
12	Shoulder Drain	MDP_215	Obstruction

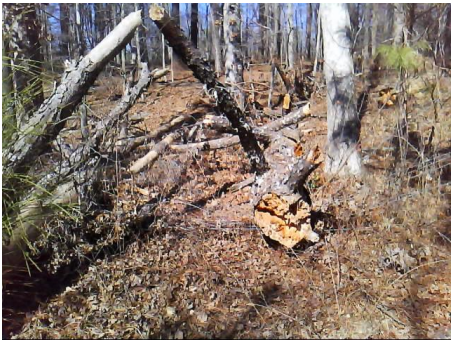
A8
2	Woven	FN_430	Fence Hole

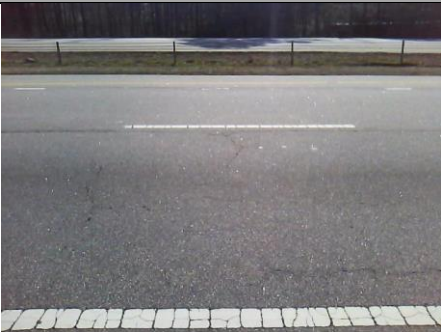
#	Material Type	Object ID	Failure Type	Photo	GIS Reference Page
1	Asphalt	LS_554	Pavement Cracking

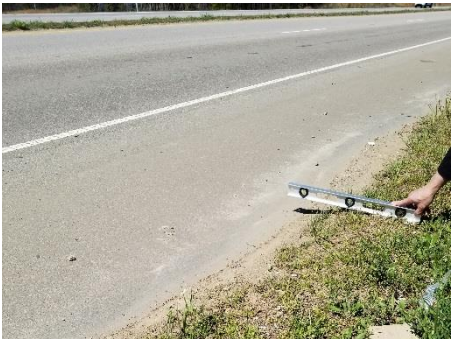
A13
2	Asphalt	LS_391	Shoulder Build-Up

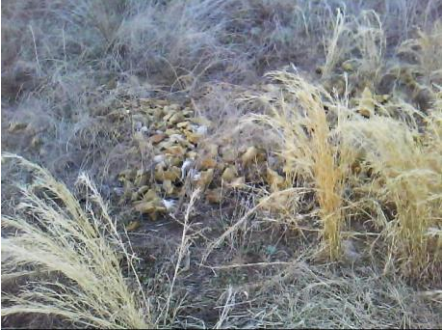
#	Material Type	Object ID	Failure Type	Photo	GIS Reference Page
1	Asphalt	LS_377	Litter

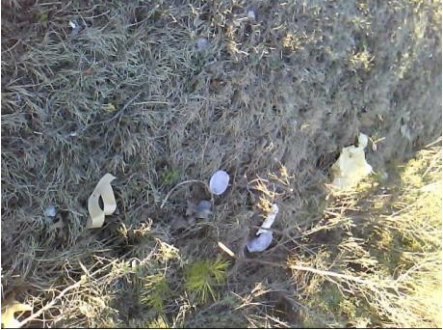
A32
2	Asphalt	LS_391	Litter

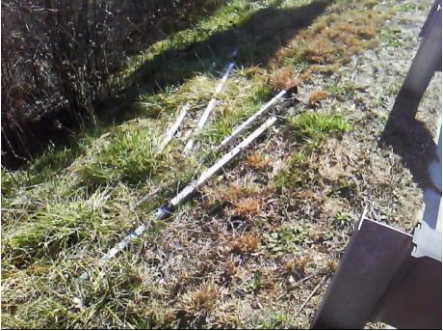
A32
3	Concrete	LS_431	Litter

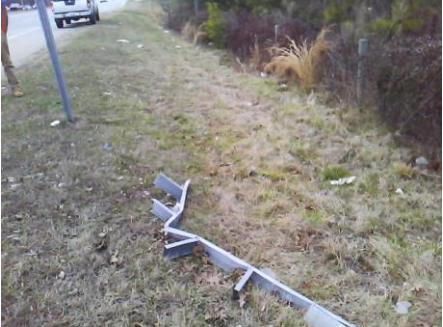
A23
4	Asphalt	LS_727	Litter

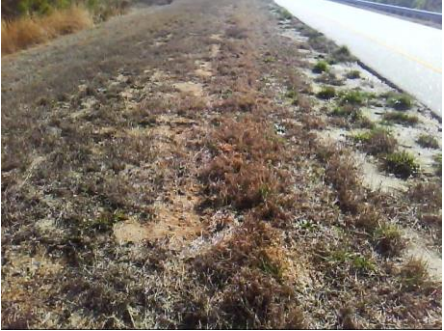
#	Material Type	Object ID	Failure Type	Photo	GIS Reference Page
1	Turf	TF_103	Bare Ground	 	A17
2	Turf	TF_249	Bare Ground	 	A33
3	Turf	TF_338	Bare Ground

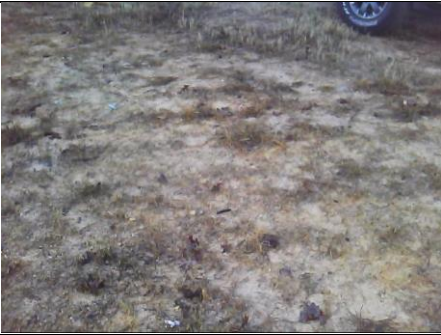
#	Material Type	Object ID	Failure Type	Photo	GIS Reference Page
5	Turf	TF_459	Bare Ground	 	A32
6	Turf	TF_494	Bare Ground	 	A19
7	Turf	TF_643	Bare Ground	 	A9
8	Turf	TF_1026	Bare Ground
