NORTH CAROLINA
Turnpike Authority

Maintenance Rating Program

Triangle Expressway

2020 Third Quarter Report

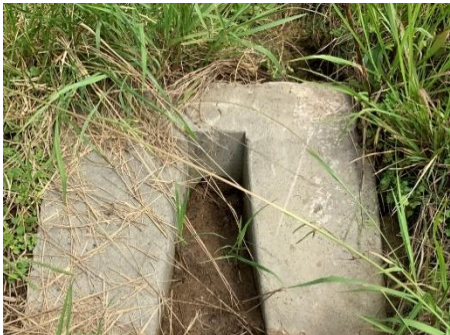
A28
4	Shoulder Drain	MDP_205	Obstruction

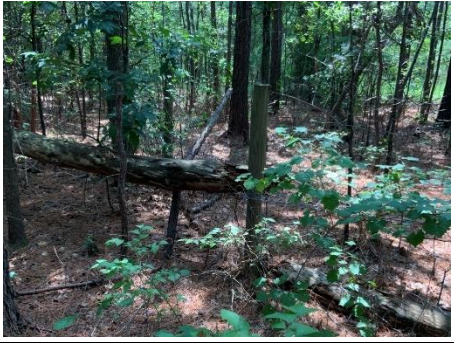
A2
2	Woven	FN_303	Fence Height

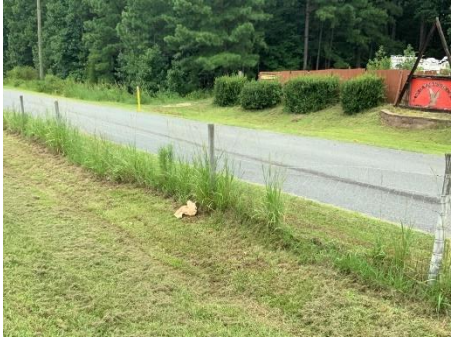
A1
3	Woven	FN_502	Fence Height

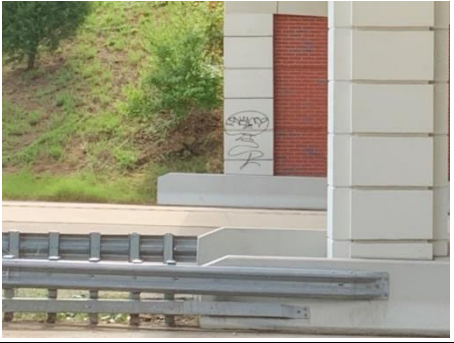
A9
2	Bridge Wall	GR_2	Graffiti

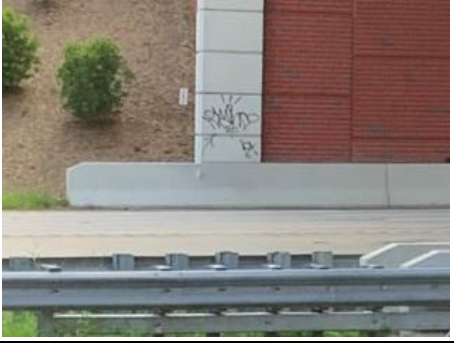
A9
3	Bridge Wall	GR_3	Graffiti

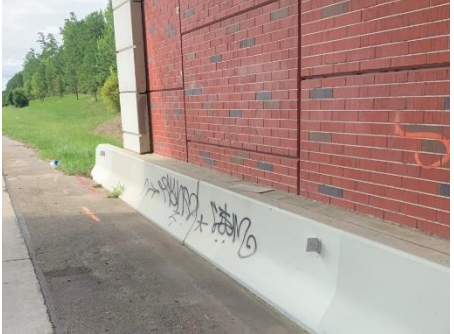
A10
4	Bridge Wall	GR_4	Graffiti

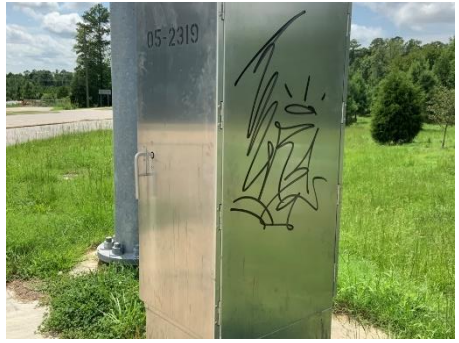
A11
6	Signal Cabinet	GR_6	Graffiti

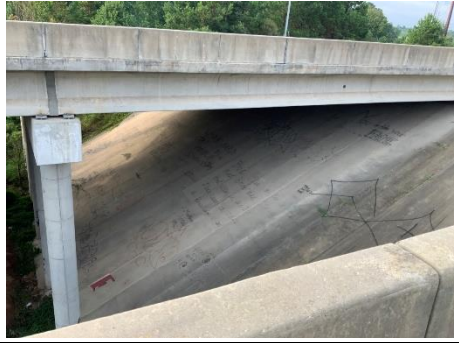
A14
7	Bridge Wall	GR_7	Graffiti

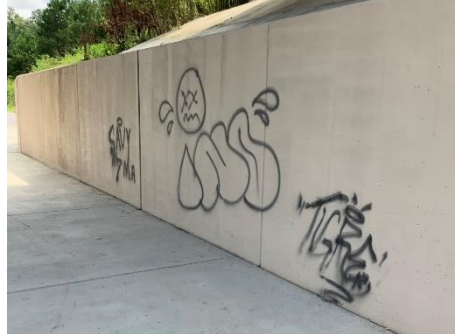
A6
8	Bridge Wall	GR_8	Graffiti

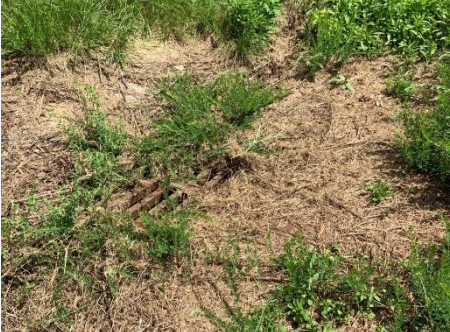
A3
4	Drop Inlet	IN_635	Obstruction

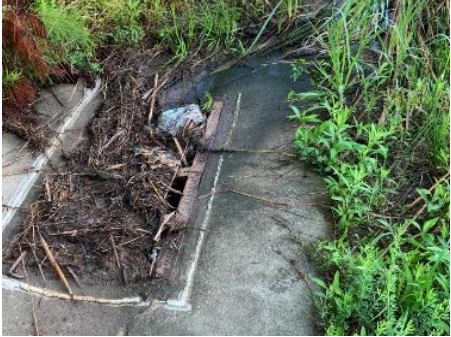
A20
6	Drop Inlet	IN_802	Obstruction

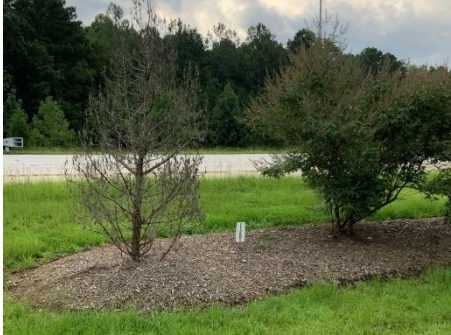
A35
2	Plant Bed	PB_120	Health

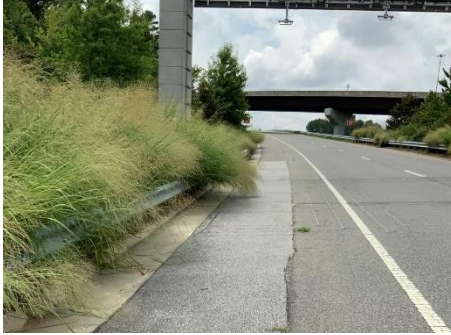
A14
3	Plant Bed	PB_224	Health

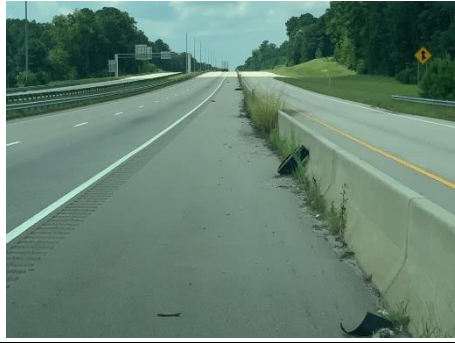
A31
2	Asphalt	LS_537	Litter

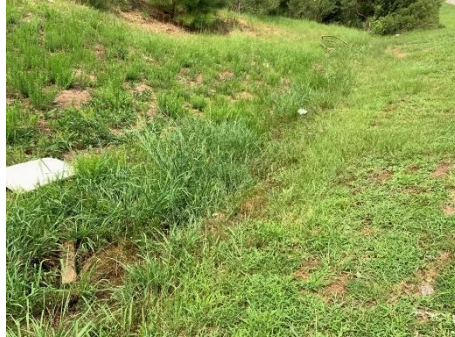
A27
3	Asphalt	LS_682	Litter

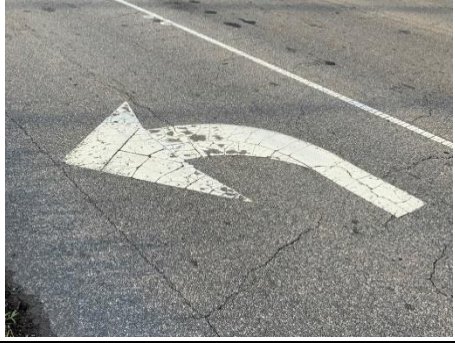
A19
3	Left Turn	PS_394	Nighttime Reflectivity

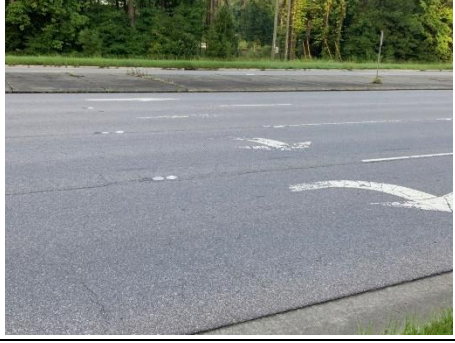
A1
4	Right Turn	PS_417	Daytime Assessment & Nighttime Reflectivity

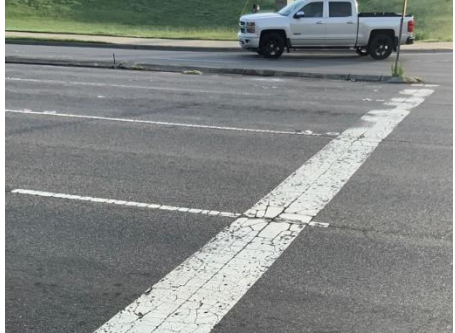
A1
11	Stop Bar	PS_429	Nighttime Reflectivity

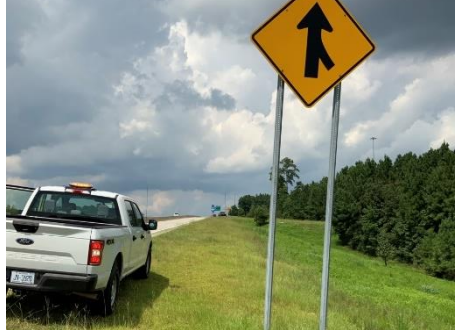
A25
4	Merge	SN_999	Height Requirement

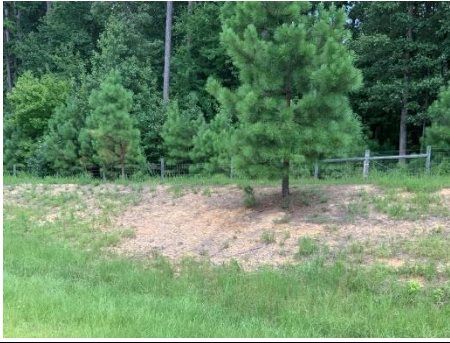
A19
2	Turf	TF_119	Bare Ground

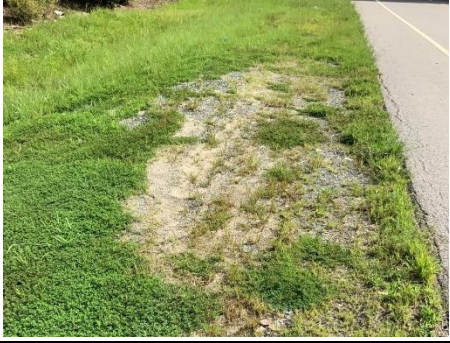
A24
3	Turf	TF_232	Bare Ground

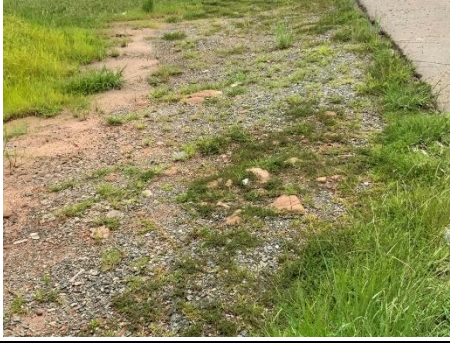
A24
7	Turf	TF_841	Bare Ground

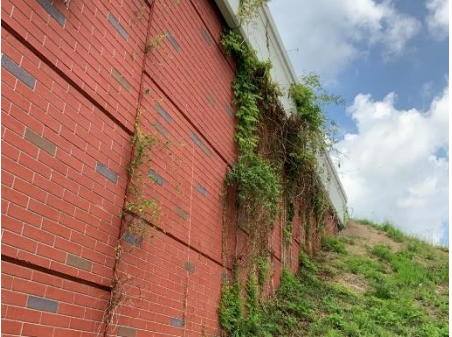
A19, A20
3	Bridge Wall	WL_62	Vegetation
