NORTH CAROLINA
Turnpike Authority

Maintenance Rating Program

Triangle Expressway

2016 First Quarter Report

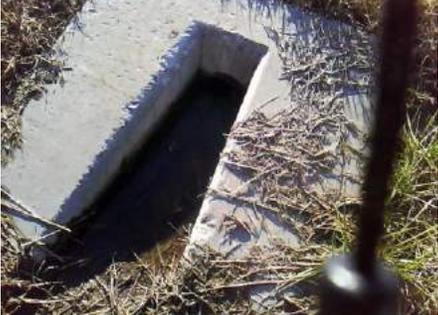
A photograph showing a concrete shoulder drain with significant soil erosion on either side, particularly on the right side where the concrete is exposed.	A59
2	Shoulder Drain	MDP_30	Obstruction

A photograph of a concrete shoulder drain that is almost completely blocked by a large, dark, irregular mass of debris or vegetation.	A16
3	Shoulder Drain	MDP_31	Obstruction

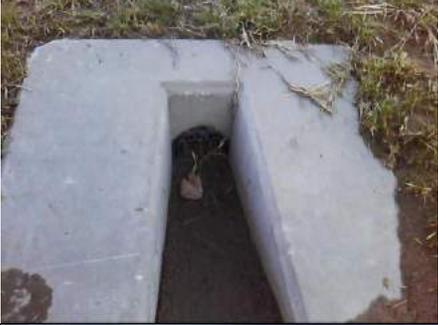
A photograph of a concrete shoulder drain with a large, dark, irregular mass of debris or vegetation blocking the opening.	A17
4	Shoulder Drain	MDP_38	Obstruction

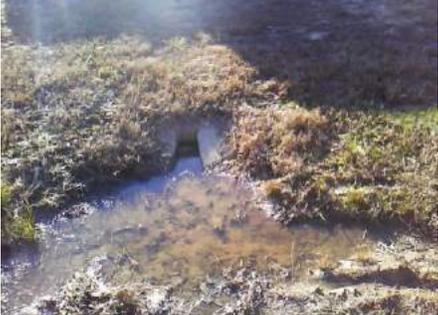
A photograph of a concrete shoulder drain that is almost completely blocked by a large, dark, irregular mass of debris or vegetation.	A18

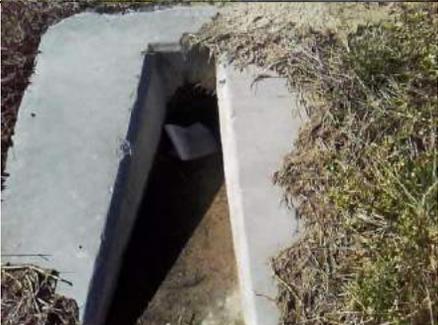
A photograph showing a concrete shoulder drain with a significant amount of soil eroded away from its edges, leaving a deep, irregular hole in the surrounding ground.	A18, A19
6	Shoulder Drain	MDP_88	Obstruction

A close-up photograph of a shoulder drain where a large, dark, irregular mass of debris or vegetation is completely blocking the opening of the drain.	A28
7	Shoulder Drain	MDP_112	Obstruction

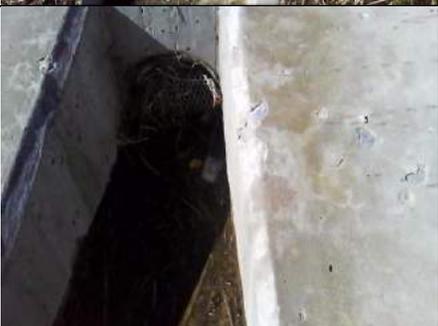
A photograph showing a shoulder drain that is almost entirely blocked by a dense, dark mass of vegetation and debris, with only a small opening visible.	A33
8	Shoulder Drain	MDP_140	Obstruction

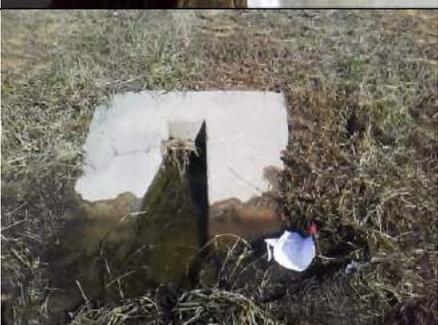
A photograph of a shoulder drain where a large, dark, irregular mass of debris or vegetation is completely blocking the opening of the drain. A white object is visible on the ground to the right of the drain.	A40

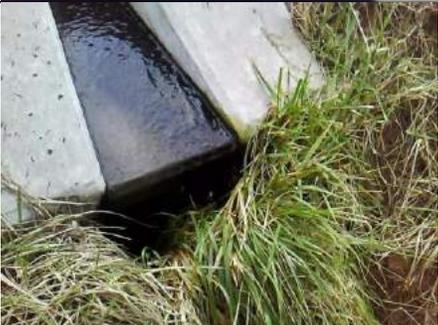
A47
10	Shoulder Drain	MDP_169	Erosion

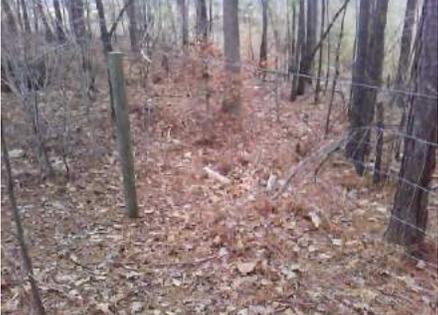
A9, A10, A11
2	Woven	FN_258	Fence Height

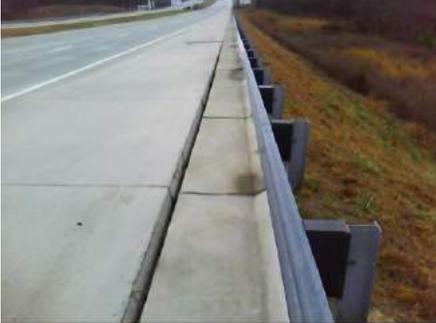
A4
2	Concrete	LS_486	Paved Shoulder Joint Separation

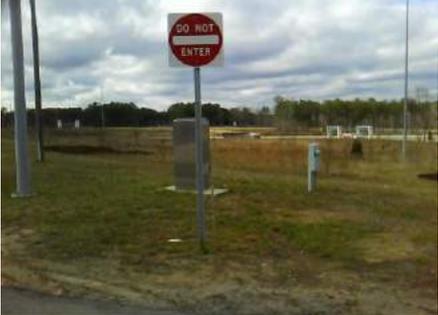
A11, A12
2	Do Not Enter	SN_807	Height Requirement

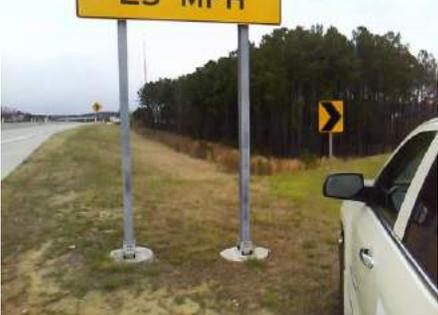
A39
3	Exit	SN_833	Height Requirement

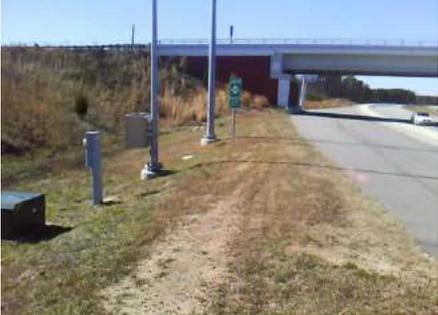
A49, A50
2	Turf	TF_101	Bareground

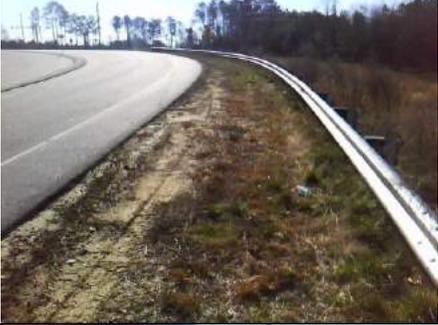
A46
3	Turf	TF_102	Bareground

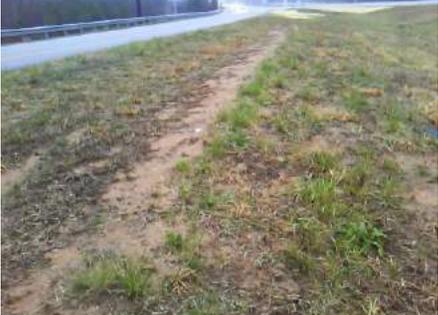
A43, A44
6	Turf	TF_197	Bareground

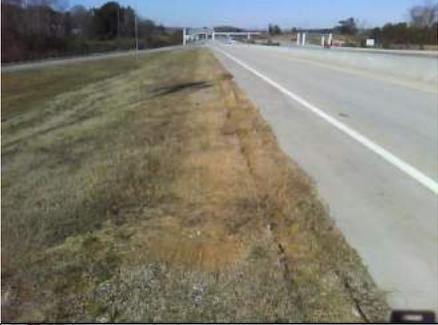
A22, A23
7	Turf	TF_209	Bareground

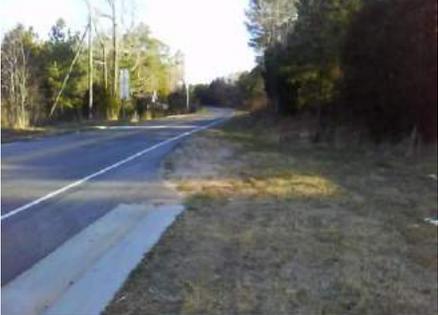
A55, A56
10	Turf	TF_275	Bareground

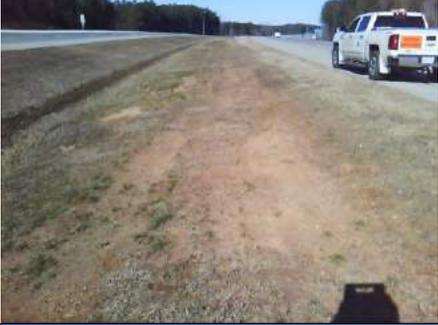
A39
11	Turf	TF_334	Bareground

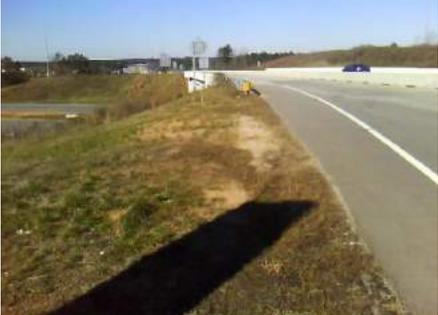
A38, A39, A40
14	Turf	TF_455	Bareground

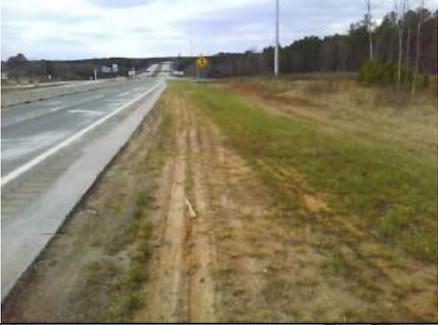
A49, A50
15	Turf	TF_469	Bareground

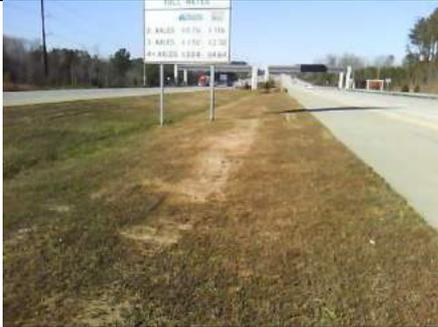
A29, A30, A31
18	Turf	TF_592	Bareground

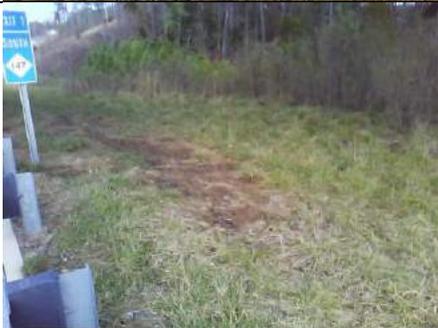
A21
19	Turf	TF_776	Bareground
