NORTH CAROLINA
Turnpike Authority

Maintenance Rating Program

Triangle Expressway

2016 Second Quarter Report

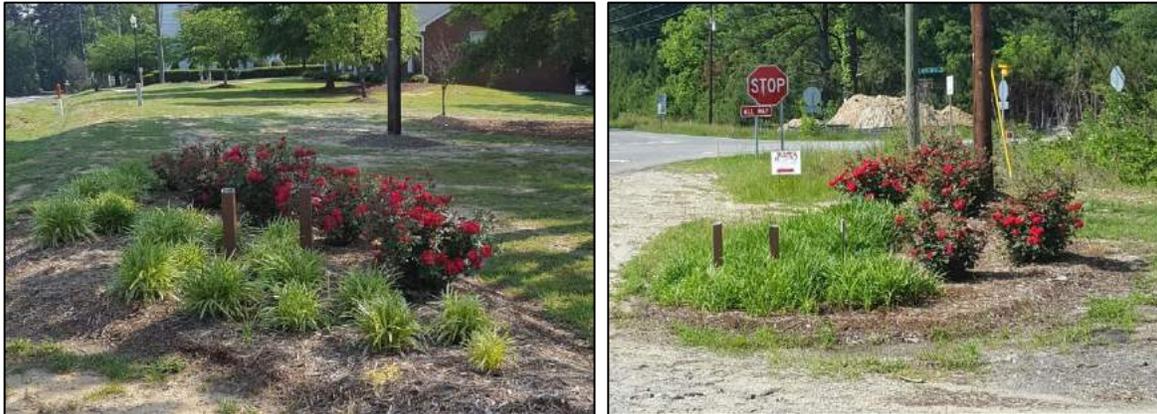
Figure 6: Green Level West Historic District Signs, Vandalized

However, during the inspection it was noticed that two of the four signs were vandalized and appeared to be cut off at the post. *Figure 6* shows the posts where these signs used to be mounted on. These posts are located at Green Level Church Road, near the Green Level Baptist Church (left) and near the intersection of Green Level Church Road and Green Level West Road (right). NCTA is in the process of replacing these signs.

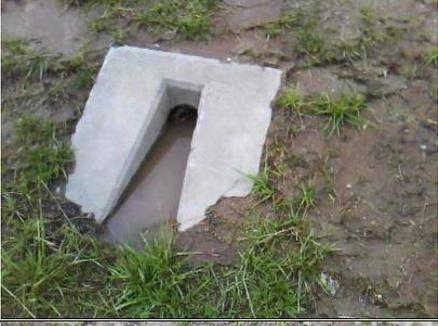
A19
3	Shoulder Drain	MDP_55	Obstruction

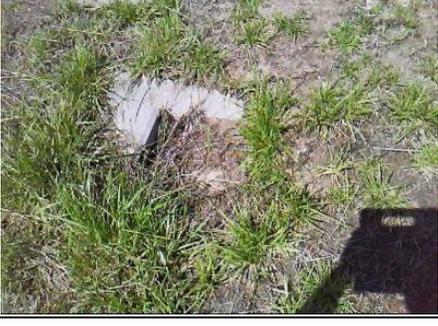
A21
4	Shoulder Drain	MDP_114	Obstruction

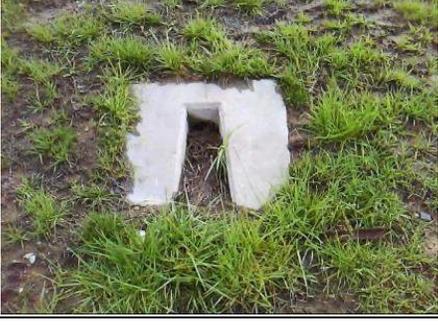
A41, A43
8	Shoulder Drain	MDP_152	Obstruction

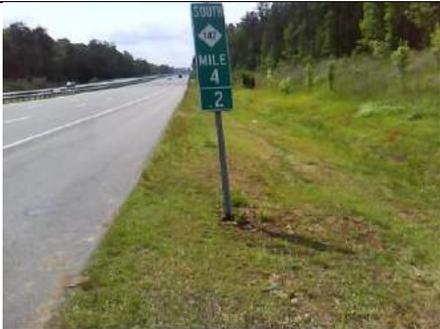
A10, A12
2	Mile Post	SN_553	Leaning

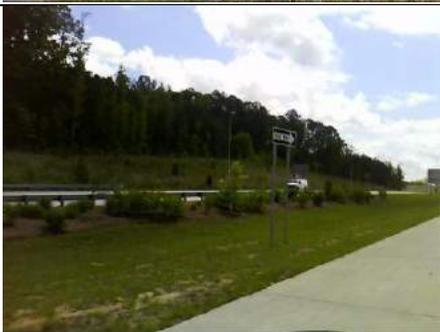
A48
3	One Way	SN_671	Height Requirement

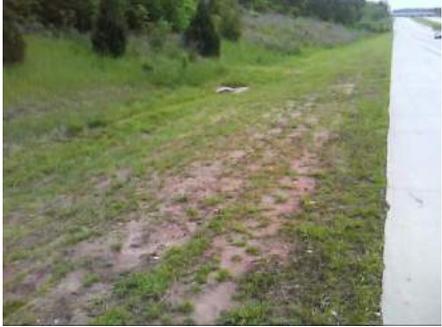
A13
2	Turf	TF_51	Bareground

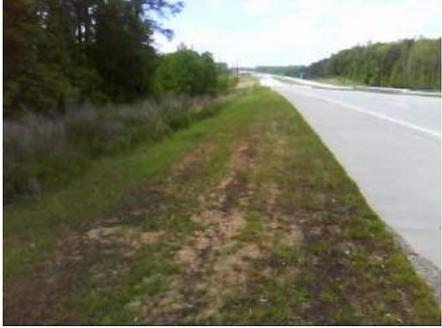
A16
3	Turf	TF_76	Bareground

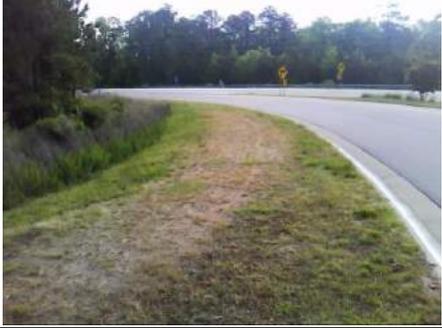
A25, A26
4	Turf	TF_80	Bareground

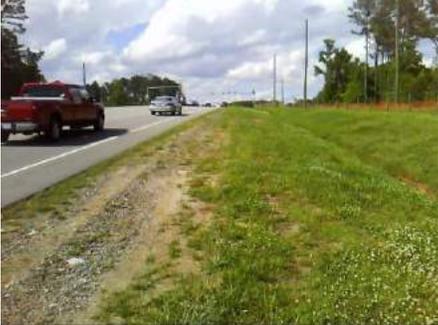
A41, A43
6	Turf	TF_107	Bareground

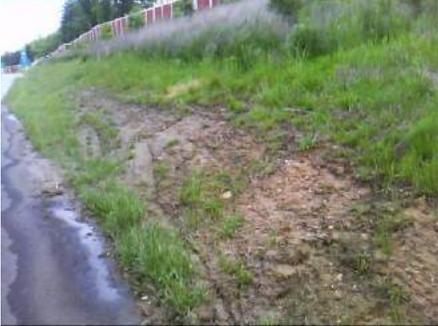
A30, A32
7	Turf	TF_116	Bareground

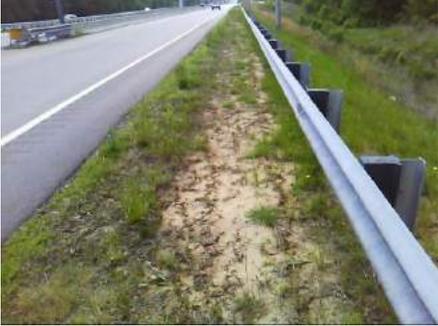
A35, A36
8	Turf	TF_140	Bareground

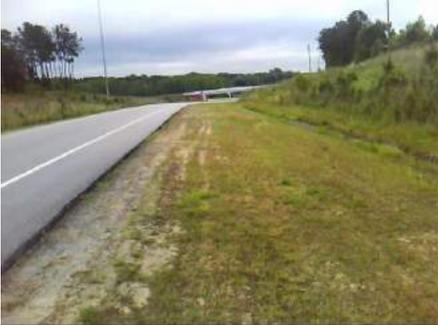
A42, A43
10	Turf	TF_164	Bareground

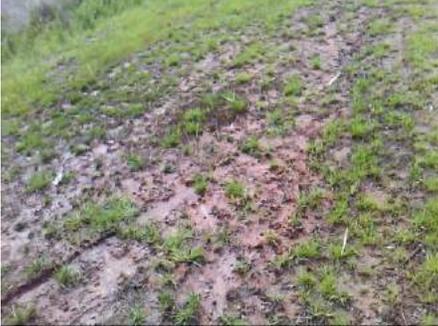
A30, A31, A32
11	Turf	TF_190	Bareground

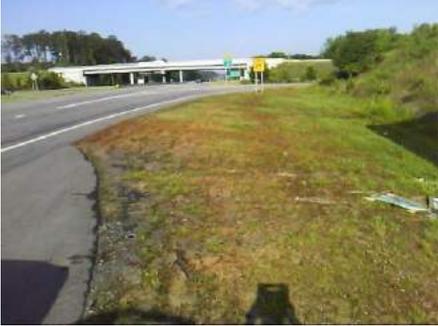
A43
12	Turf	TF_213	Bareground

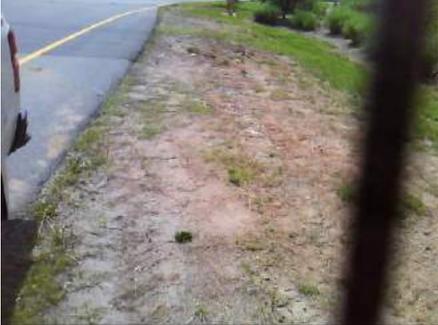
A42, A43
14	Turf	TF_261	Bareground

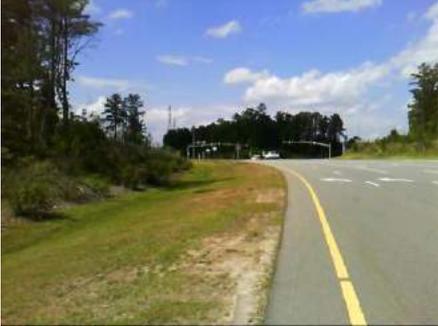
A51, A52
15	Turf	TF_268	Bareground

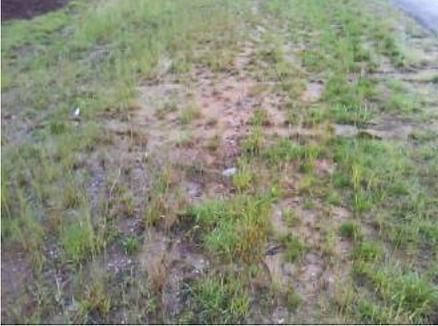
A53
16	Turf	TF_299	Bareground

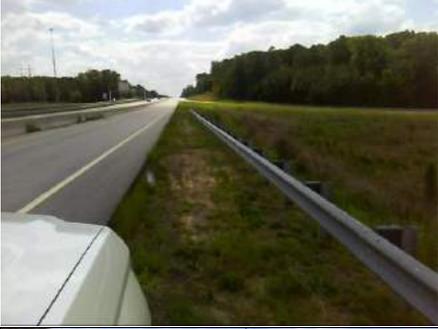
A43, A44
18	Turf	TF_379	Bareground

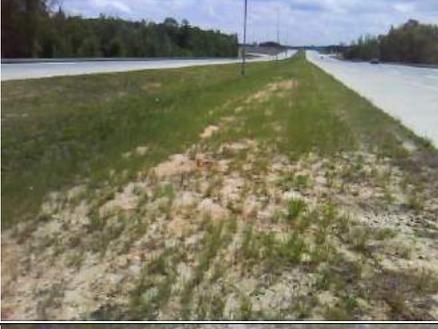
A42
19	Turf	TF_403	Bareground

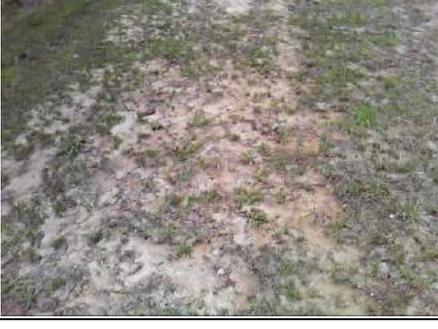
A40, A41
20	Turf	TF_404	Bareground

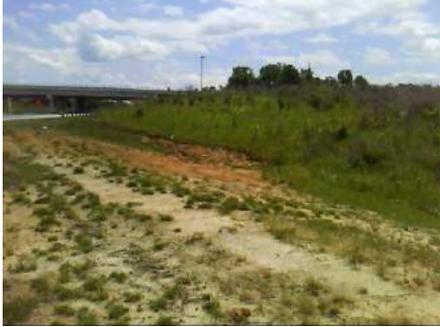
A35, A36
22	Turf	TF_474	Bareground

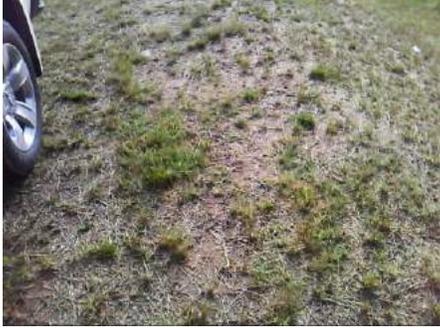
A38, A39, A40
23	Turf	TF_502	Bareground

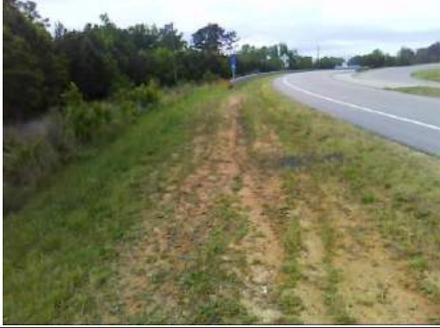
A30, A31, A32
24	Turf	TF_513	Bareground

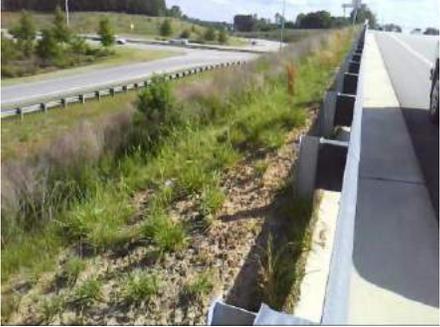
A31
26	Turf	TF_523	Height and Bareground

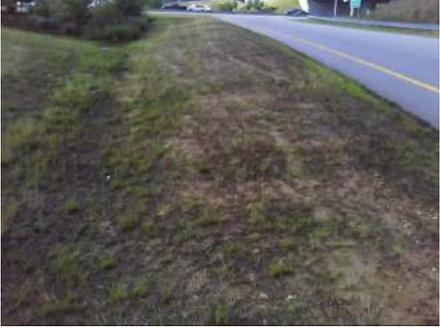
A30
27	Turf	TF_526	Bareground

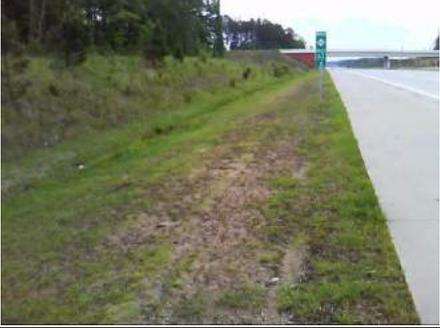
A30
28	Turf	TF_615	Bareground

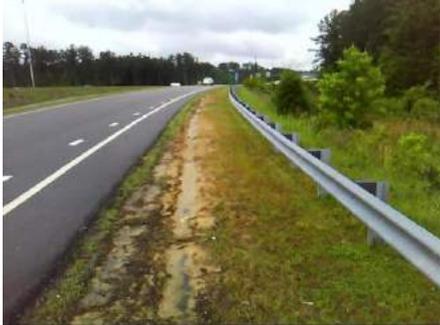
A24, A25
30	Turf	TF_679	Bareground

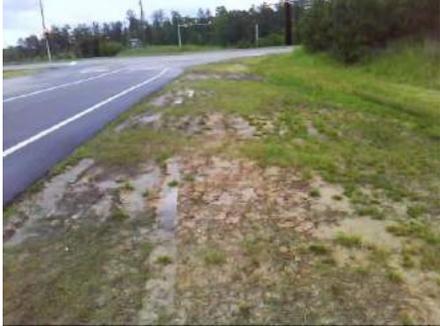
A12
31	Turf	TF_693	Bareground

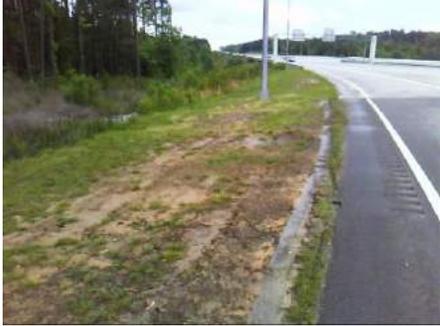
A11, A12
32	Turf	TF_696	Bareground

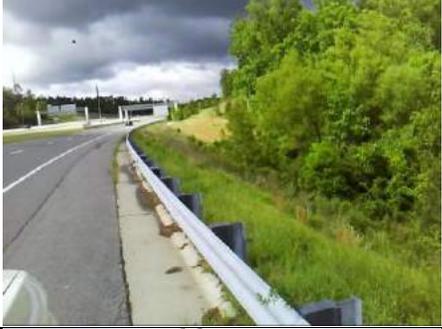
A6, A7
34	Turf	TF_743	Height

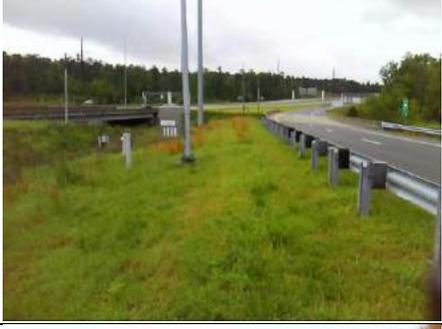
A6, A7
35	Turf	TF_758	Height

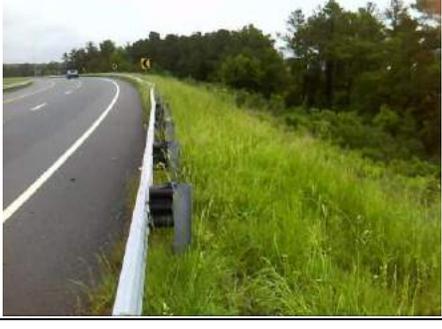
A6
36	Turf	TF_766	Height

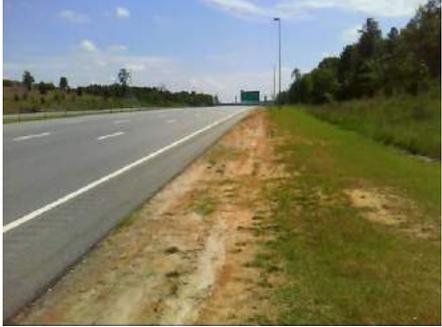
A5
38	Turf	TF_857	Bareground

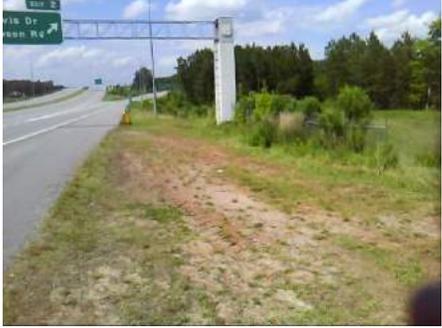
A53, A54
39	Turf	TF_872	Bareground

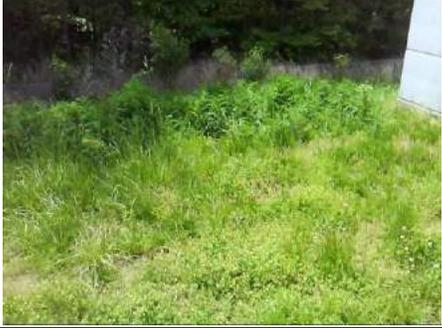
A53, A54
40	Turf	TF_884	Height
