NORTH CAROLINA
Turnpike Authority

Maintenance Rating Program

Triangle Expressway

2016 Third Quarter Report

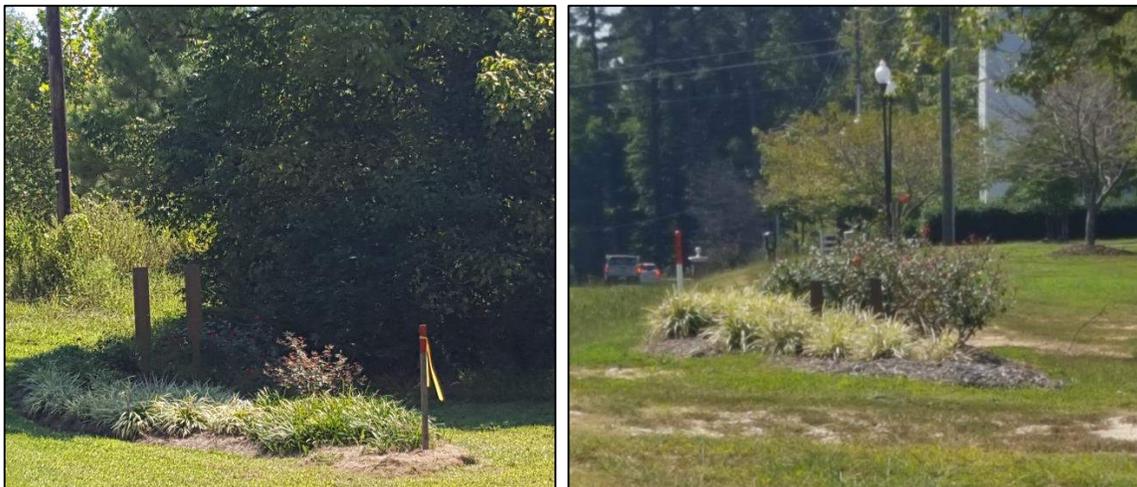
Figure 6: Green Level West Historic District Signs, Landscape Areas

As part of each quarterly inspection, assessors visit the four Green Level Historic District signs to conduct a visual inspection of each sign and ensure they are in good standing. During this quarter, the sign located near the intersection of Green Level Church Road and Green Level West Road was excluded from the inspection inventory due to inaccessibility to the sign because of construction work in the area. The three signs included in the inspection inventory were only inspected for landscape appearance because two of the three signs were vandalized and the other sign was temporarily removed to be used as a sample to replace the vandalized signs. All landscaped areas at the location of the signs were found to be well maintained (*Figure 6*). NCTA is in the process of replacing all signs.

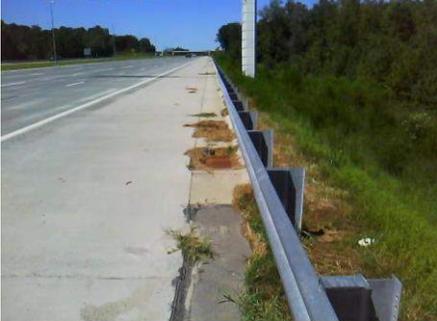
A6, A53
2	Valley	CG_201	Obstruction

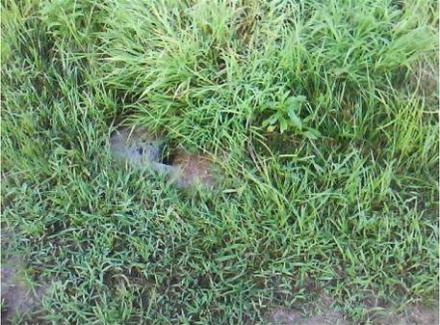
A49
2	Shoulder Drain	MDP_34	Obstruction

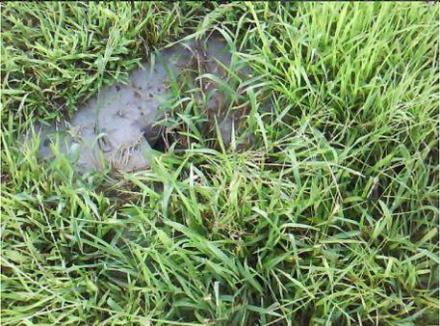
A17
3	Shoulder Drain	MDP_56	Obstruction

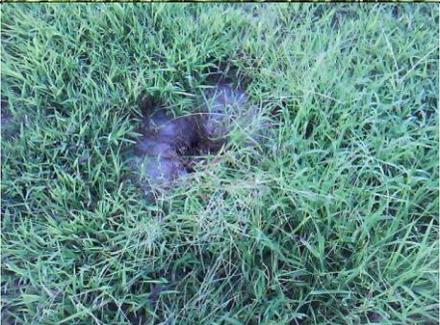
A21
4	Shoulder Drain	MDP_63	Obstruction

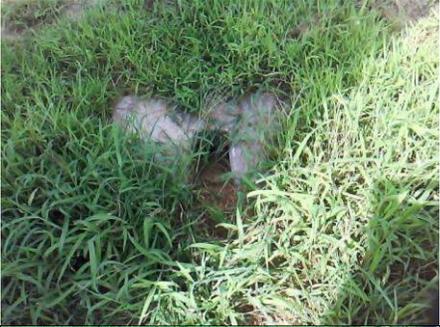
A28
6	Shoulder Drain	MDP_131	Obstruction

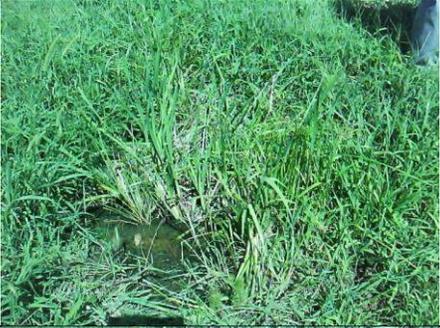
A37
7	Shoulder Drain	MDP_147	Obstruction

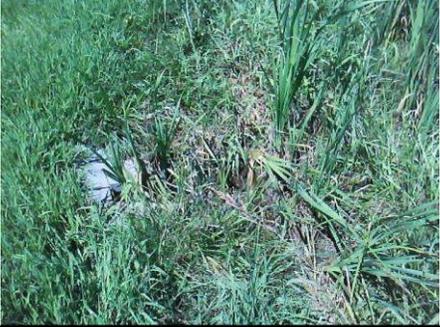
A41
8	Shoulder Drain	MDP_150	Obstruction

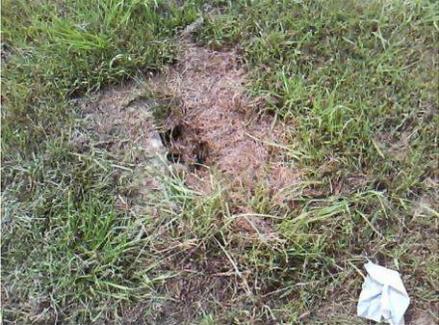
A42, A43
10	Shoulder Drain	MDP_179	Obstruction

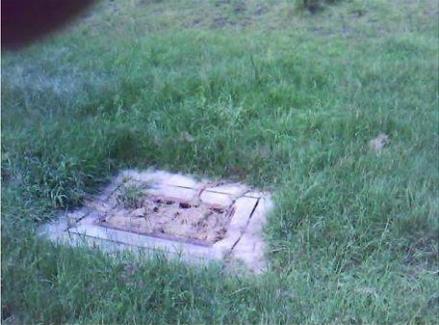
A7
2	Inlet	IN_274	Obstruction

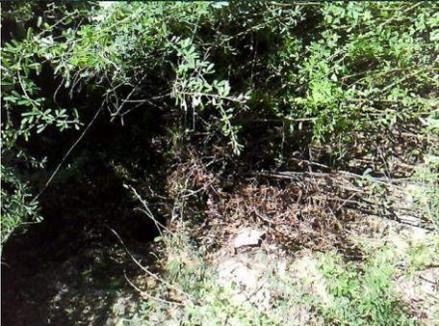
A7
3	Inlet	IN_655	Obstruction

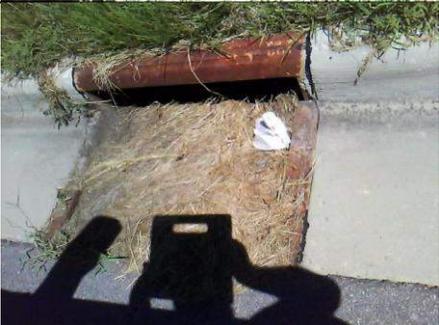
A37, A38, A39
4	Inlet	IN_897	Obstruction

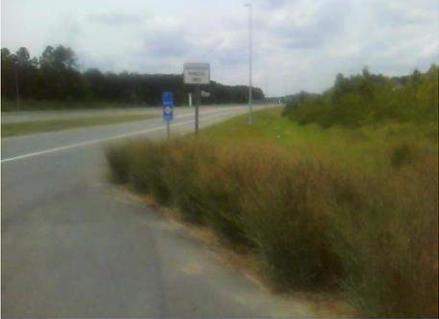
A22, A24
2	Authorized Vehicles	SN_326	Height Requirement

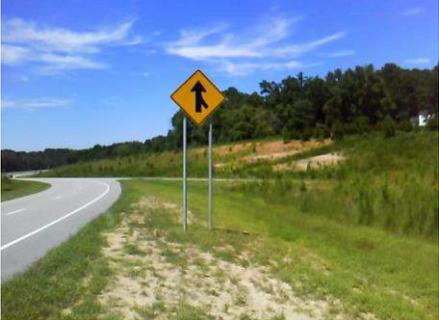
A49
3	Merge	SN_764	Height Requirement

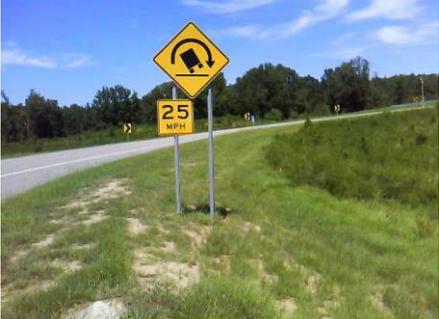
A41, A43
4	Speed Limit Ramp	SN_796	Leaning

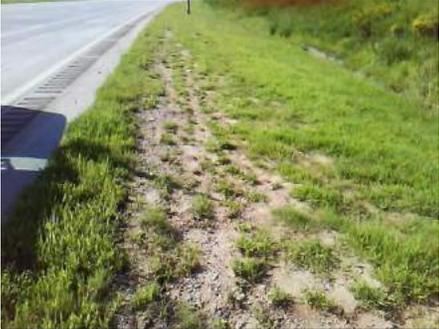
A9, A10
2	Turf	TF_45	Bareground

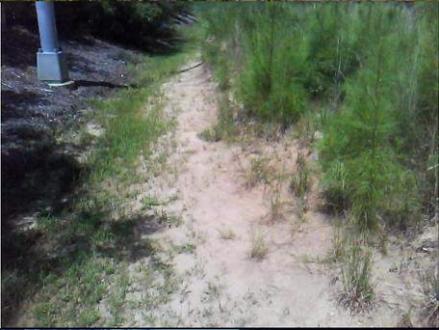
A22, A23, A24
3	Turf	TF_53	Bareground

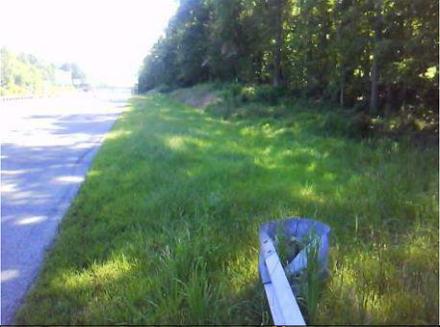
A32
6	Turf	TF_187	Height

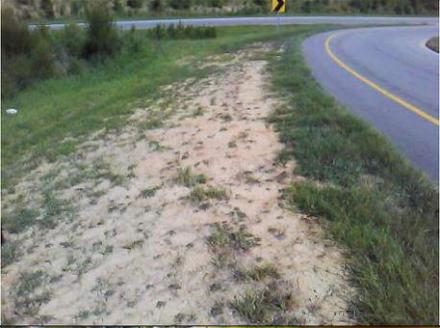
A44
7	Turf	TF_205	Bareground

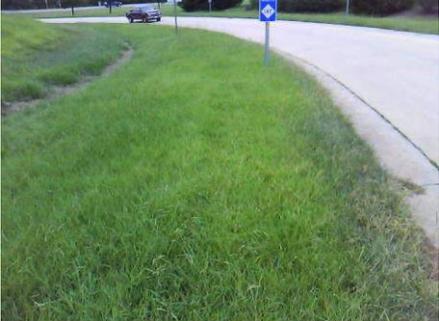
A30
10	Turf	TF_252	Height

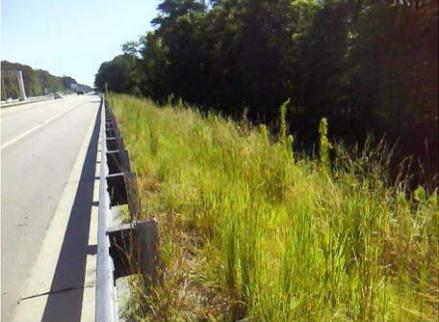
A45
11	Turf	TF_367	Height

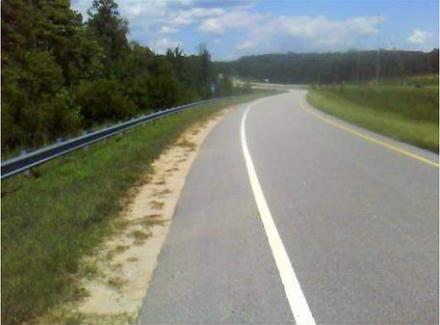
A41
14	Turf	TF_413	Bareground

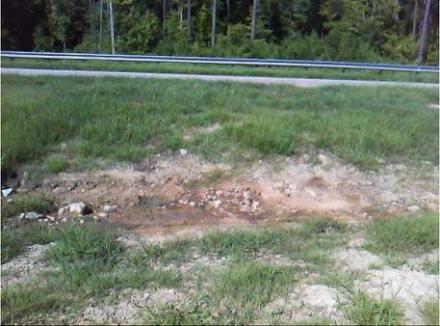
A38
15	Turf	TF_417	Bareground

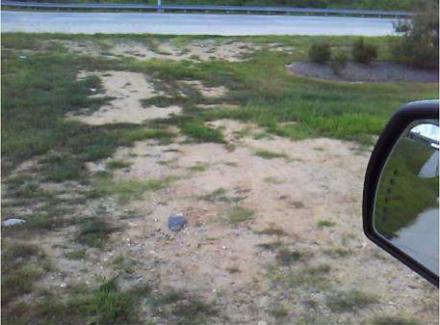
A38, A39, A40
18	Turf	TF_489	Bareground

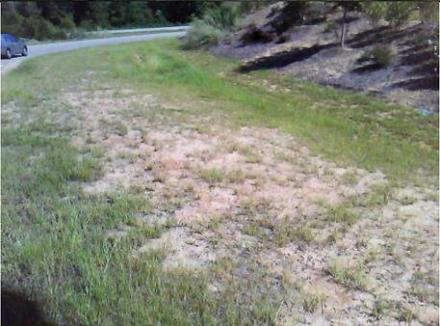
A33
19	Turf	TF_506	Bareground

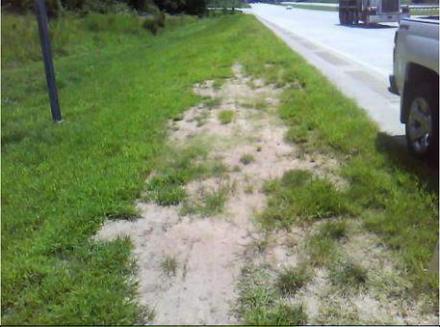
A29, A30, A31
22	Turf	TF_587	Bareground

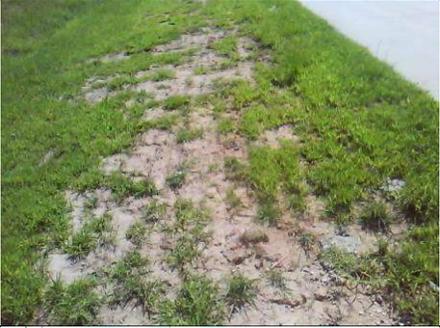
A21, A22, A23
23	Turf	TF_591	Bareground

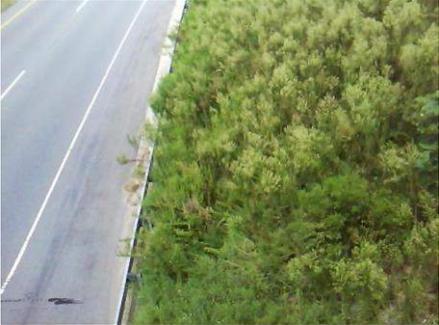
A6, A7
26	Turf	TF_750	Height

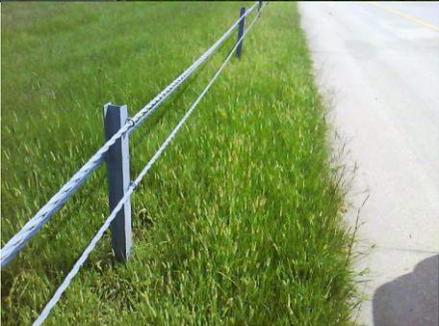
A6
27	Turf	TF_832	Height

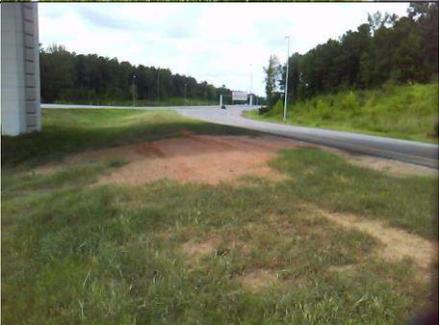
A2, A3
28	Turf	TF_985	Bareground
