NORTH CAROLINA
Turnpike Authority

Maintenance Rating Program

Triangle Expressway

2015 Fourth Quarter and Annual Report

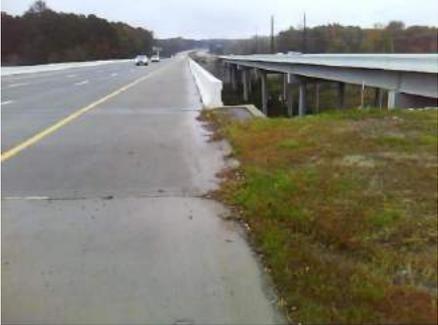
A23, A24
3	Valley	CG_52	Material Accumulation

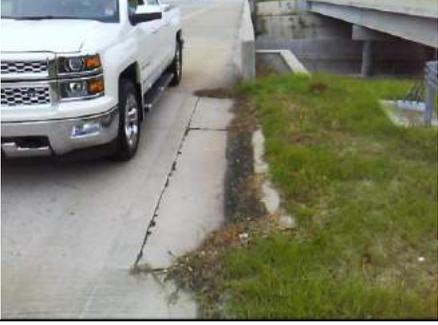
A23
4	Valley	CG_64	Material Accumulation

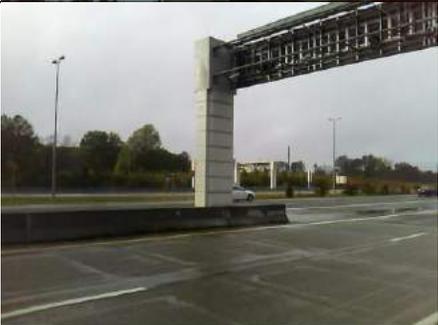
A47
2	Gantry Support	DS_293	Paint Scaling

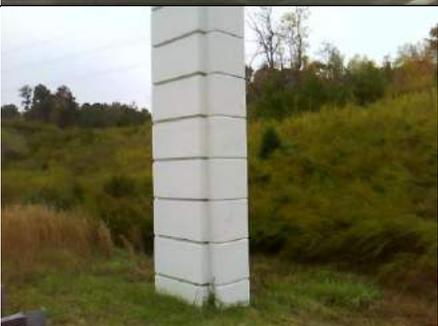
A28
3	Overhead Sign Support	DS_305	Paint Scaling

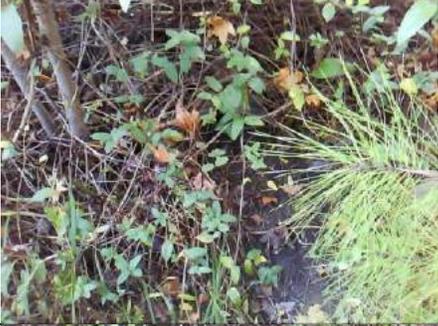
A52, A53
3	Drain	DP_306	Obstruction

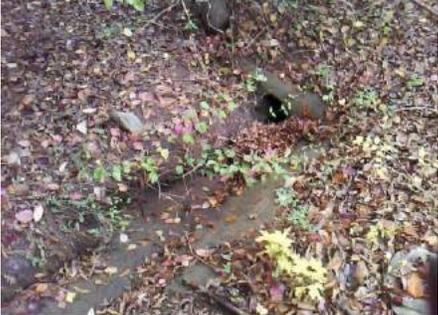
A8
4	Drain	DP_584	Erosion

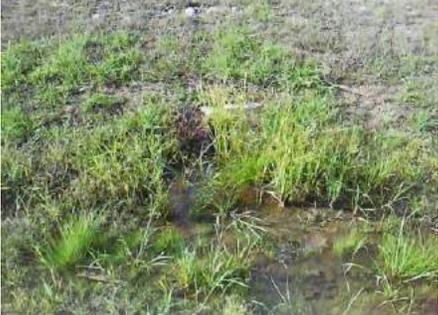
A57
2	Shoulder Drain	MDP_11	Obstruction

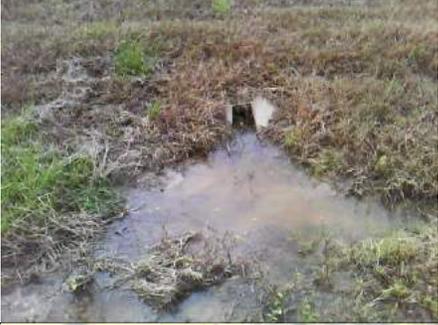
A12
3	Shoulder Drain	MDP_38	Obstruction

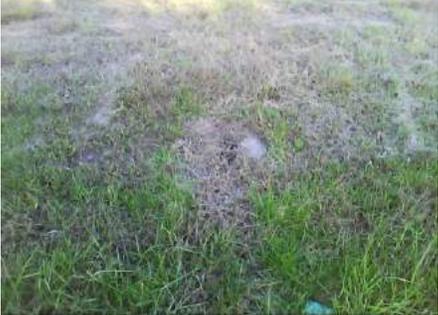
A18
4	Shoulder Drain	MDP_63	Obstruction

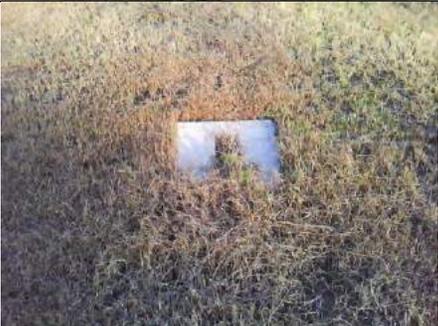
A24
6	Shoulder Drain	MDP_75	Obstruction

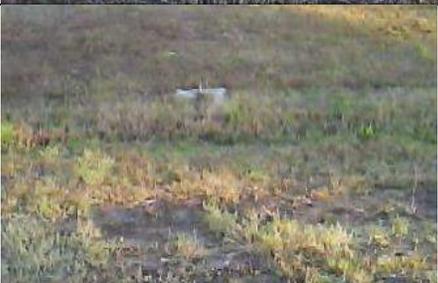
A25
7	Shoulder Drain	MDP_86	Obstruction

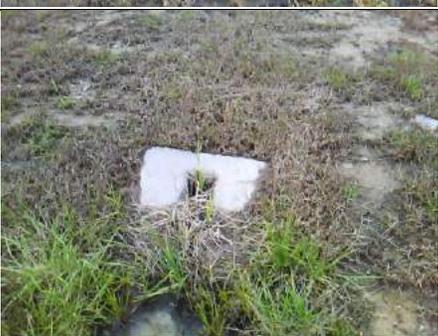
A26
8	Shoulder Drain	MDP_103	Obstruction

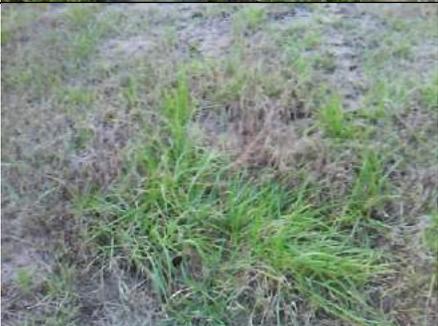
A31
9	Shoulder Drain	MDP_114	Obstruction

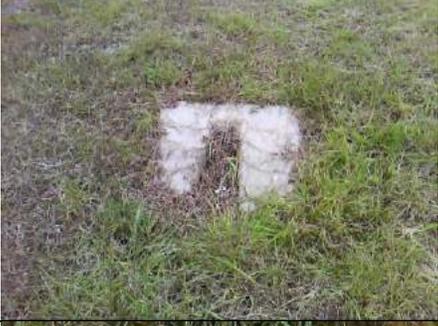
A38
11	Shoulder Drain	MDP_152	Obstruction

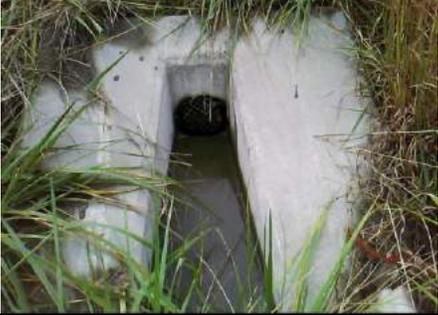
A41
12	Shoulder Drain	MDP_167	Obstruction

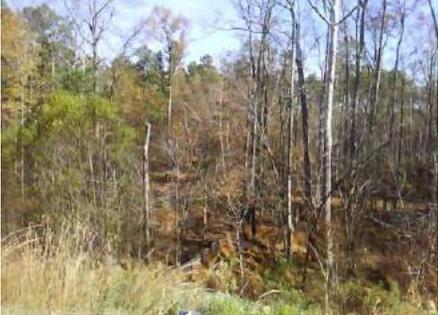
A6, A57
2	Chain Link	FN_247	Opened Gate

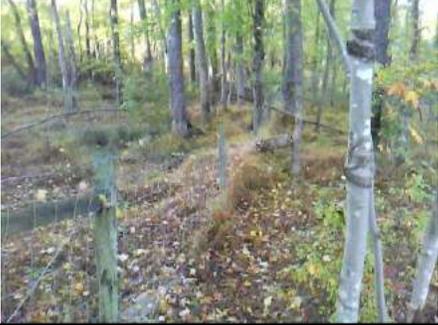
A51, A52
3	Woven	FN_251	Hole Height

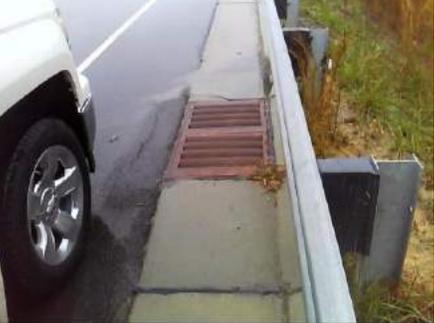
A30
2	Inlet	IN_956	Erosion

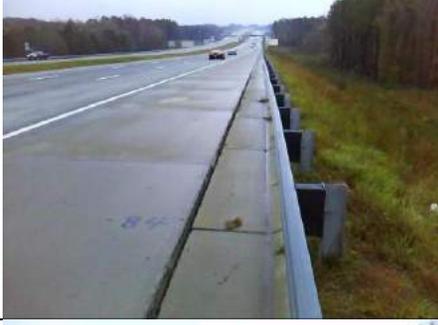
A54, A55
3	Concrete	LS_484	Paved Shoulder Joint

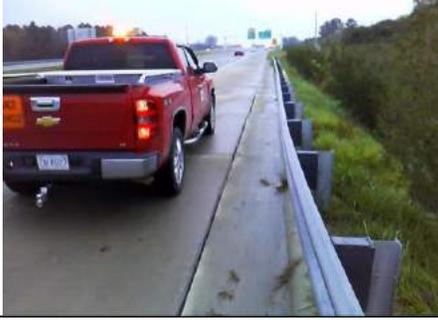
A45
4	Concrete	LS_492	Paved Shoulder Joint

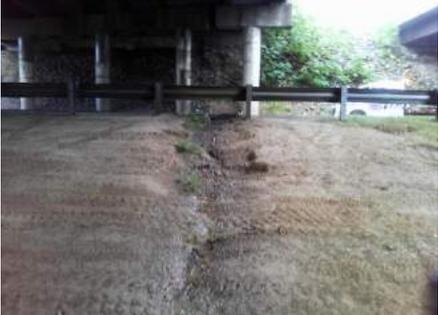
A17, A18
2	Asphalt	LS_246	Shoulder Drop Off and Elevation Deviation

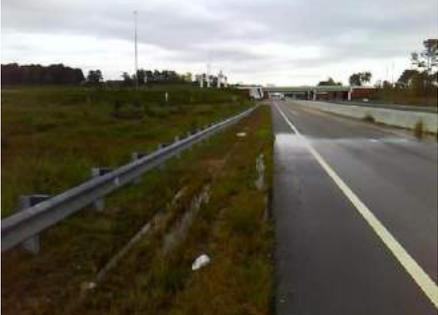
A49
3	Asphalt	LS_564	Shoulder Drop Off

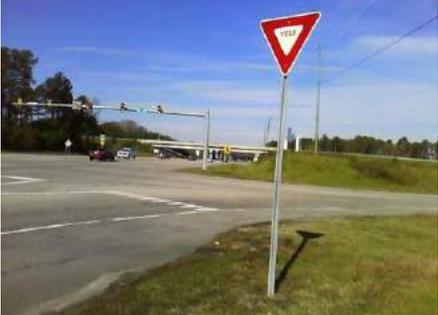
A20, A21
2	Yield	SN_205	Height Requirement

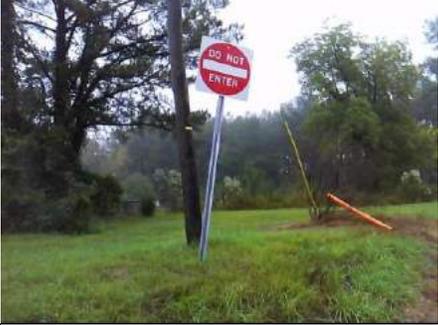
A11, A12
3	Do Not Enter	SN_477	Leaning

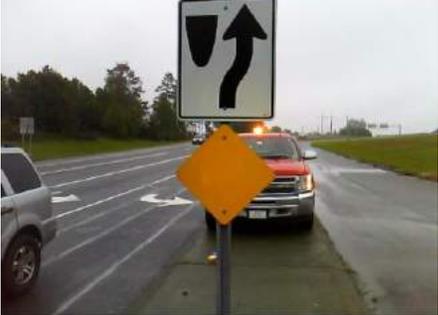
A3
4	Keep Right	SN_494	Height Requirement

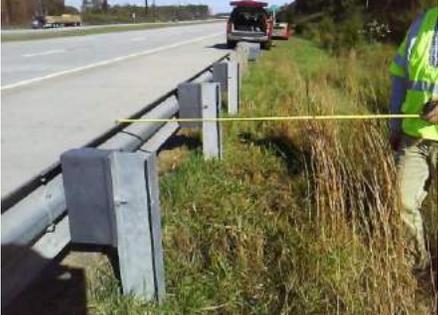
A20, A21
2	Turf	TF_60	Height

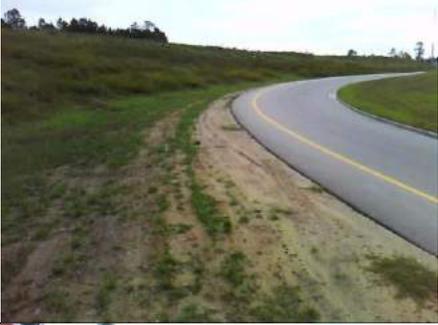
A24, A25
3	Turf	TF_96	Bareground

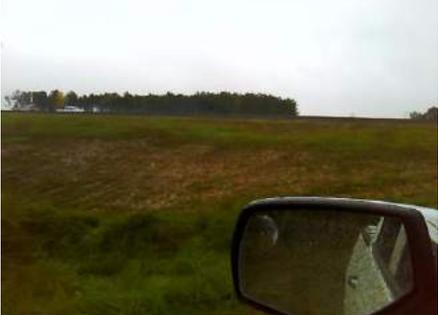
A22
6	Turf	TF_209	Bareground

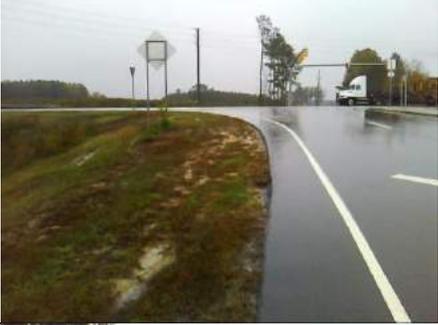
A28, A29, A30
7	Turf	TF_226	Bareground

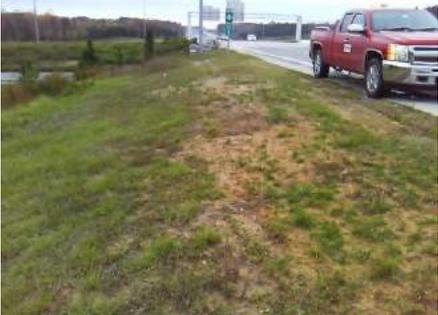
A41
10	Turf	TF_239	Bareground

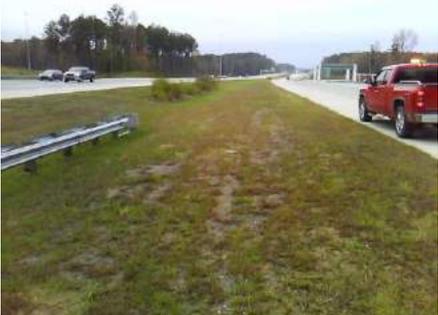
A41
11	Turf	TF_434	Bareground

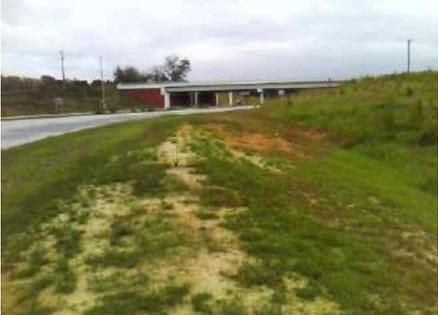
A36, A37
14	Turf	TF_475	Bareground

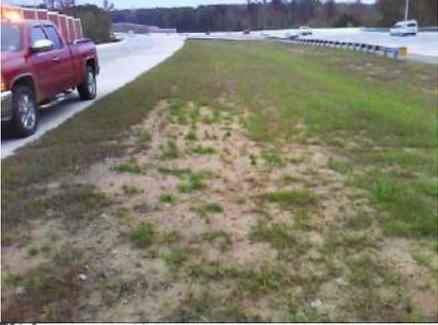
A37
15	Turf	TF_483	Bareground

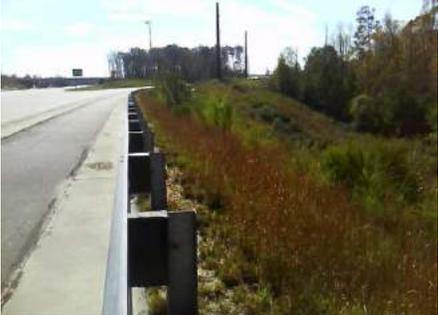
A25, A26
18	Turf	TF_585	Height

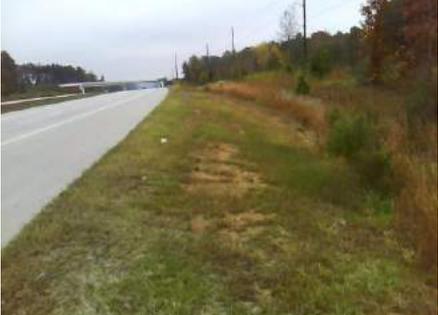
A21, A22
19	Turf	TF_617	Bareground

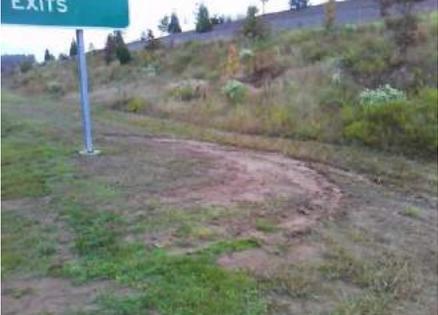
A56
23	Turf	TF_894	Bareground

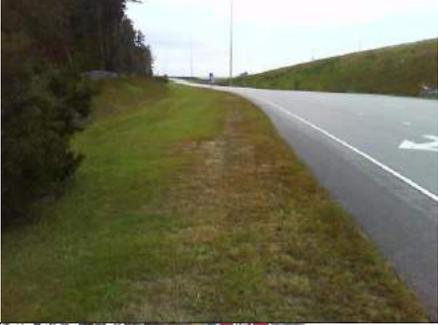
A54, A55
24	Turf	TF_908	Bareground
