NORTH CAROLINA
Turnpike Authority

Maintenance Rating Program

Triangle Expressway

2014 Third Quarter Report

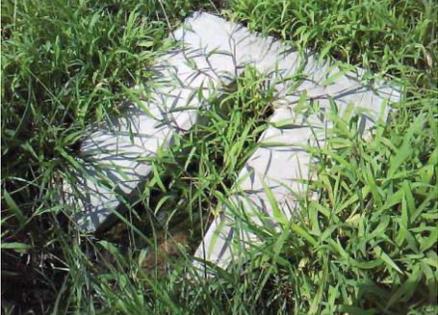
A11
2	Shoulder Drain	MDP_70	Obstruction

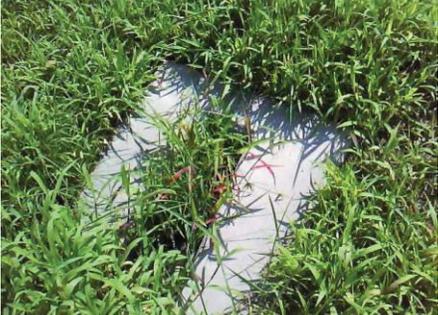
A23
3	Shoulder Drain	MDP_75	Obstruction

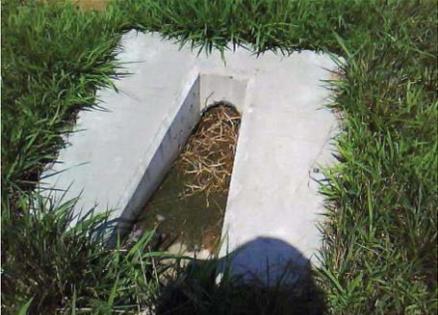
A24
4	Shoulder Drain	MDP_80	Obstruction

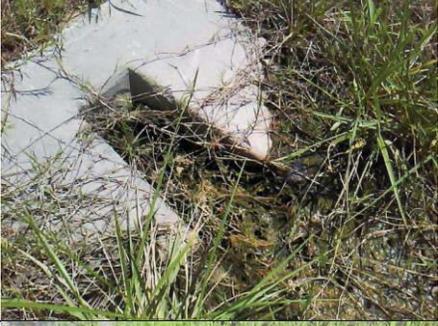
A37
6	Shoulder Drain	MDP_140	Obstruction

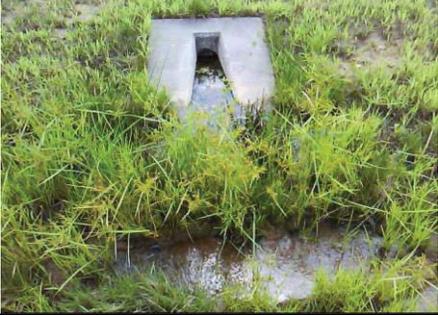
A37
7	Shoulder Drain	MDP_157	Obstruction

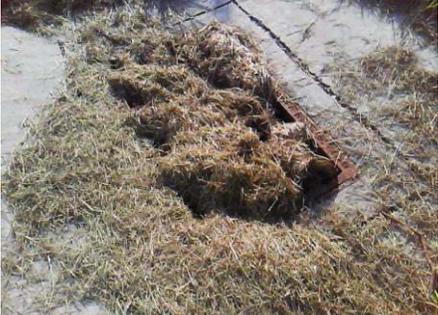
A24
2	Inlet	IN_292	Obstruction

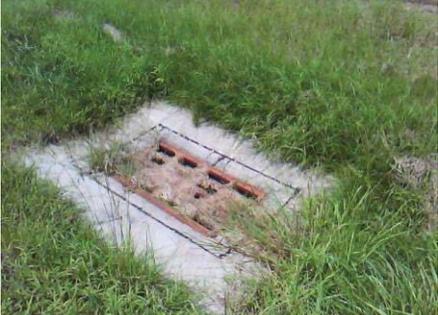
A8, A9
3	Inlet	IN_365	Obstruction

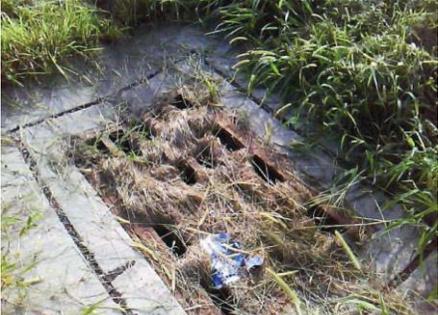
A4
4	Inlet	IN_482	Obstruction

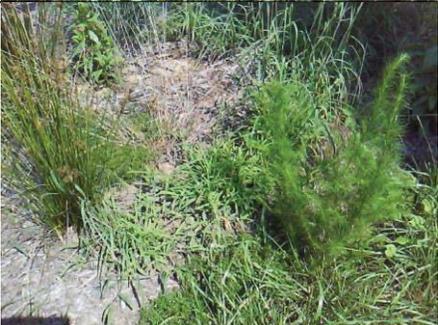
A35
2	Plant Bed	PB_26	Covered by Weed

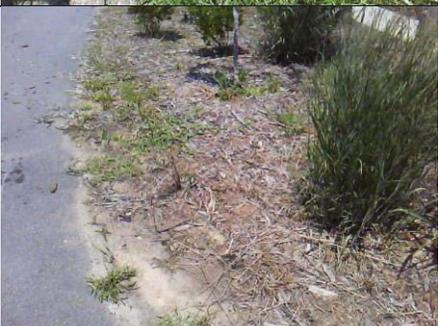
A35
3	Plant Bed	PB_145	Unhealthy

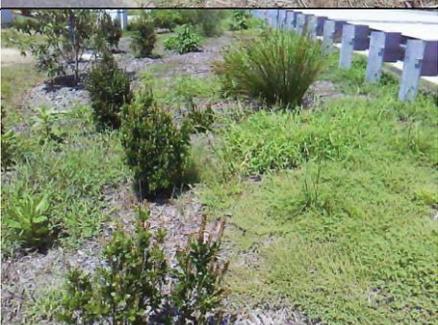
A20
4	Plant Bed	PB_149	Unhealthy and Covered by Weed

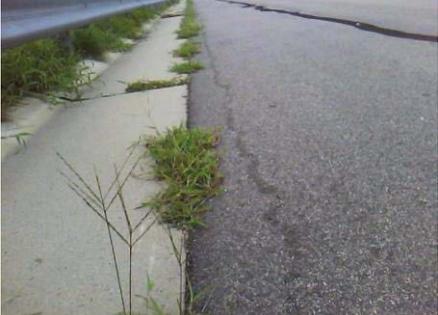
A11, A12
2	Asphalt	LS_197	Paved Shoulder Joint

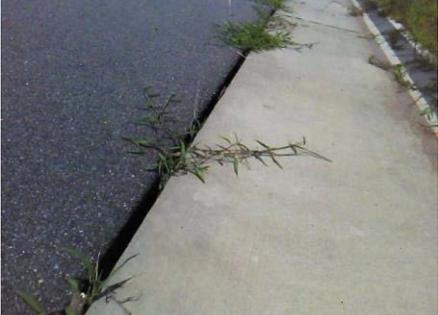
A6
3	Asphalt	LS_224	Paved Shoulder Joint

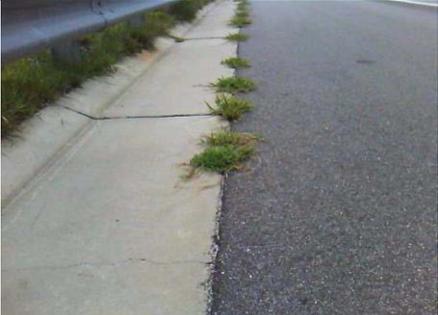
A52
4	Asphalt	LS_235	Paved Shoulder Joint

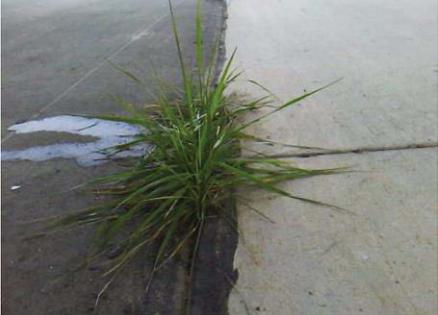
A6
6	Concrete	LS_476	Paved Shoulder Joint

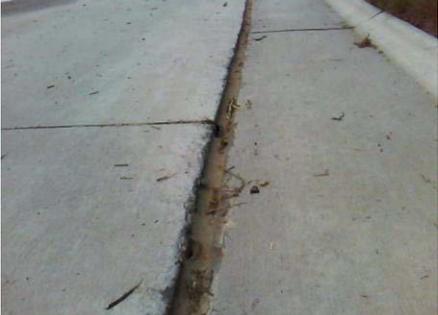
A43
7	Concrete	LS_493	Paved Shoulder Joint

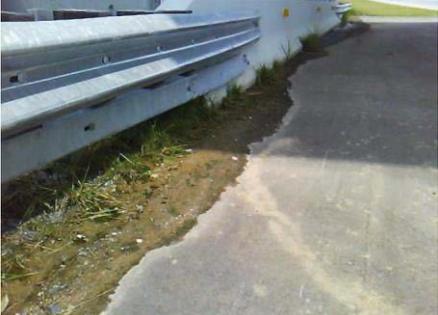
A39
2	Unpaved Shoulder	LS_476	Buildup

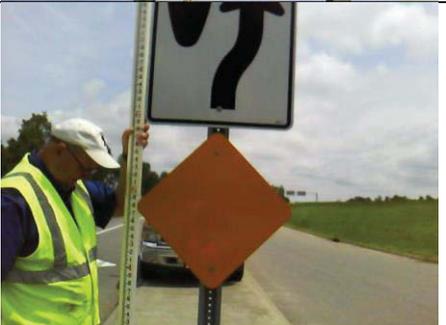
A21
2	Other	SN_494	Height Requirement

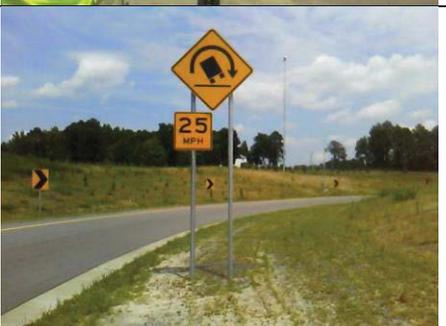
A2
3	Speed Limit Ramp	SN_735	Height Requirement

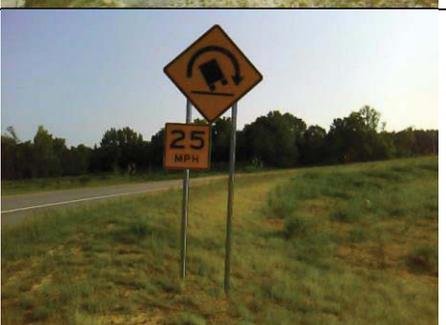
A40
4	Speed Limit Ramp	SN_796	Leaning

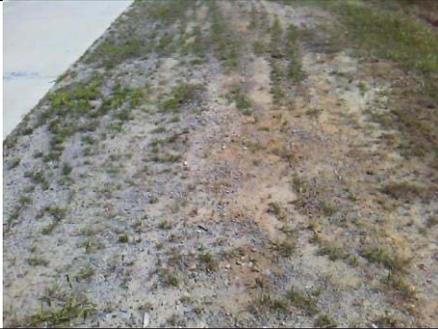
A27, A28, A29
2	Turf	TF_117	Bareground

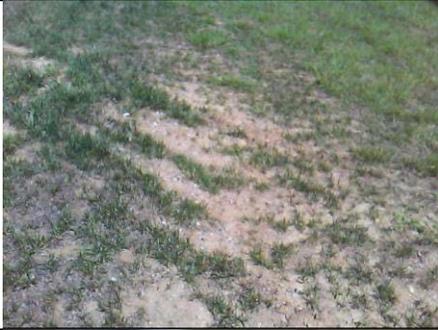
A34
3	Turf	TF_118	Bareground

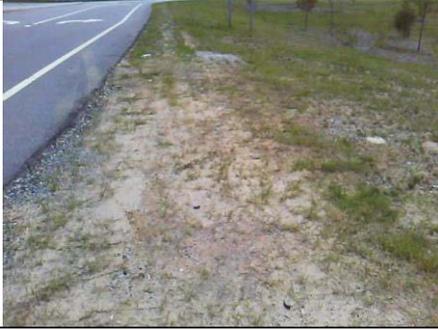
A34
4	Turf	TF_130	Bareground

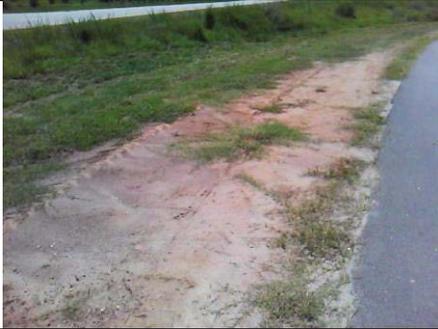
A36
6	Turf	TF_178	Bareground

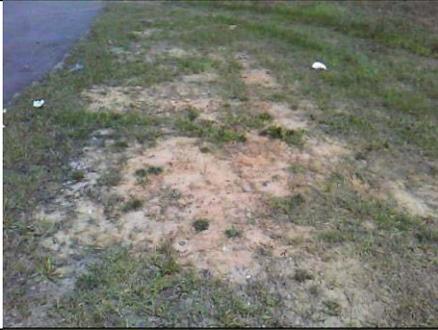
A10, A11
7	Turf	TF_181	Bareground

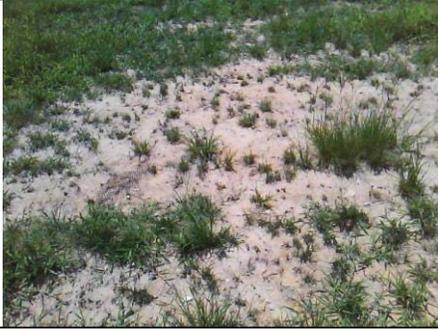
A28, A29
8	Turf	TF_197	Bareground

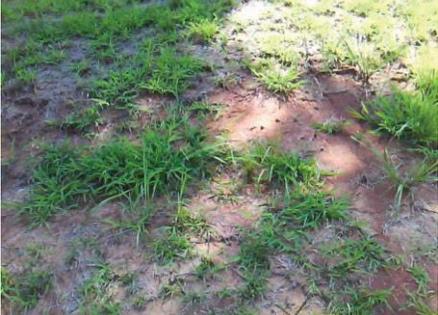
A35, A36
10	Turf	TF_278	Bareground

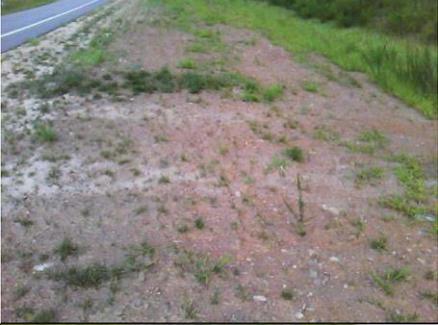
A10, A11
11	Turf	TF_299	Bareground

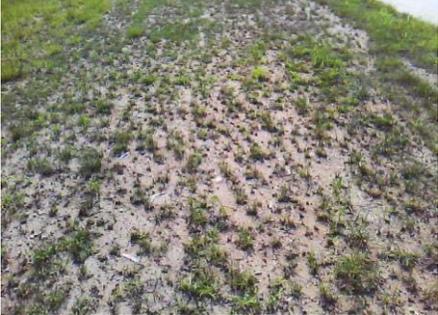
A46
12	Turf	TF_305	Bareground

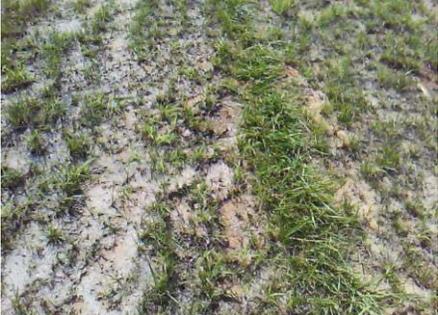
A43, A44
14	Turf	TF_341	Bareground

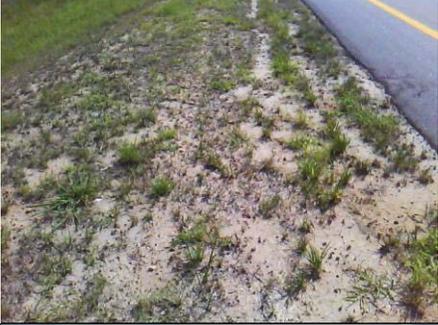
A39, A40
15	Turf	TF_384	Bareground

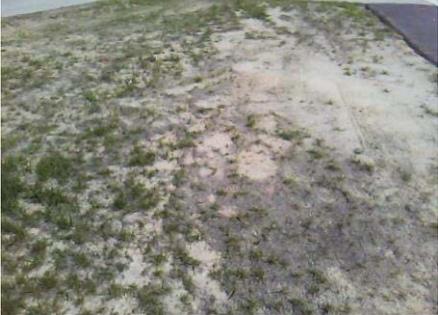
A39
16	Turf	TF_420	Bareground

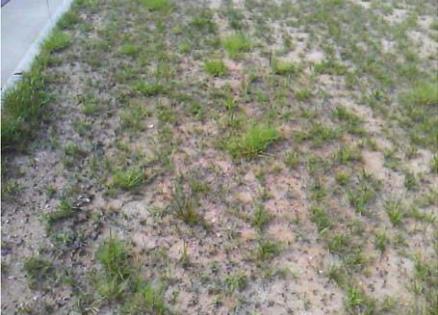
A35, A36
18	Turf	TF_455	Bareground

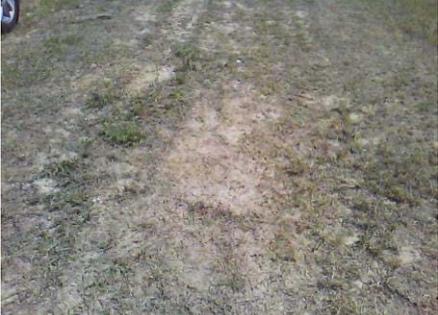
A46
19	Turf	TF_499	Bareground

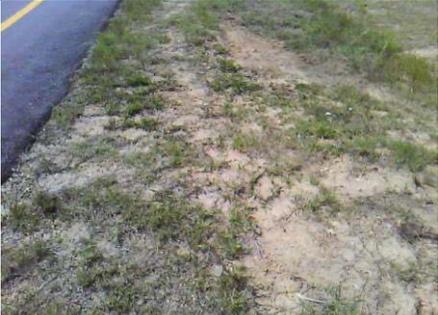
A30
20	Turf	TF_517	Bareground

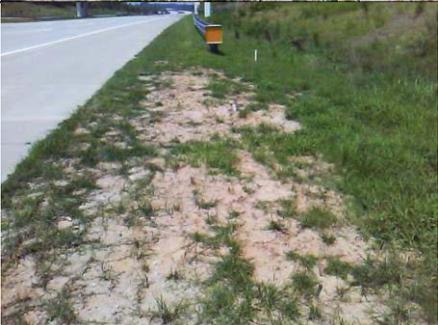
A24, A25
22	Turf	TF_621	Bareground

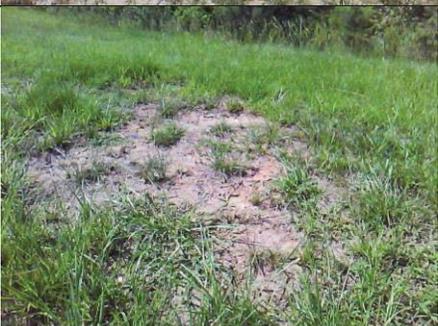
A16, A17
23	Turf	TF_971	Bareground

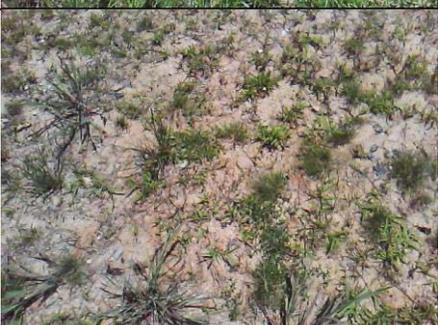
A10, A11
24	Turf	TF_1006	Bareground
