# Maintenance Rating Program

Triangle Expressway

2023 Fourth Quarter Report

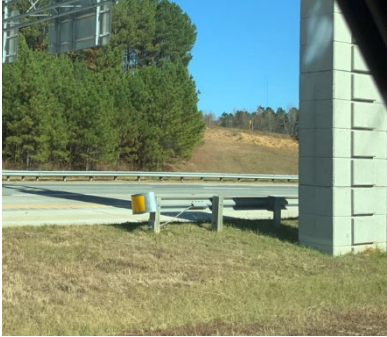
#	Material Type	Object ID	Failure Type	Photo	GIS Reference Page
1	Guardrail	BR_43	Functional Damage

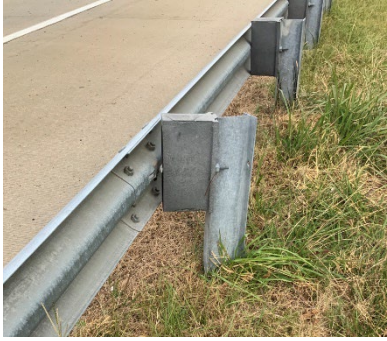
A10
3	Guardrail	BR_318	Twisted Post

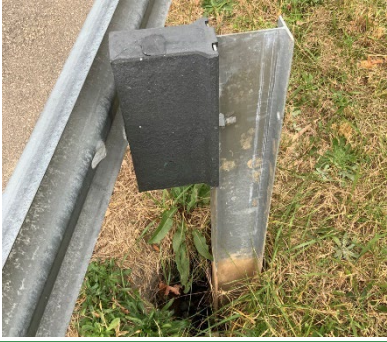
A1
4	Guardrail	BR_543	Twisted Post

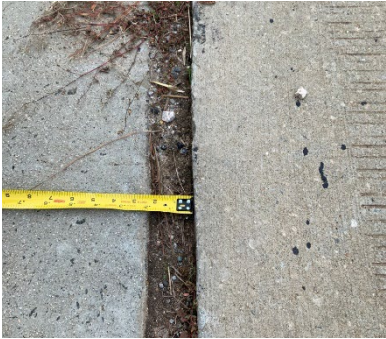
#	Material Type	Object ID	Failure Type	Photo	GIS Reference Page
1	Curb and Gutter	CG_174	Misalignment

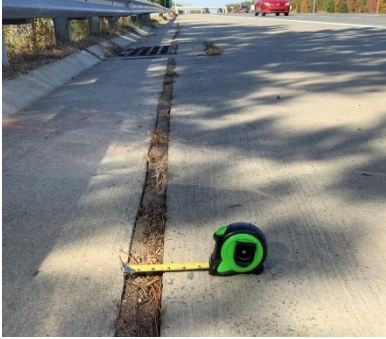
A1
2	Curb and Gutter	CG_191	Misalignment

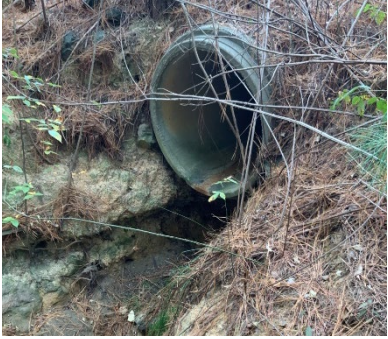
#	Material Type	Object ID	Failure Type	Photo	GIS Reference Page
1	Drain	DP_1130	Eroded Area

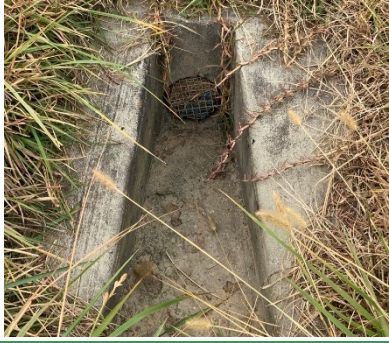
A13
2	Shoulder Drain	MDP_90	Obstruction

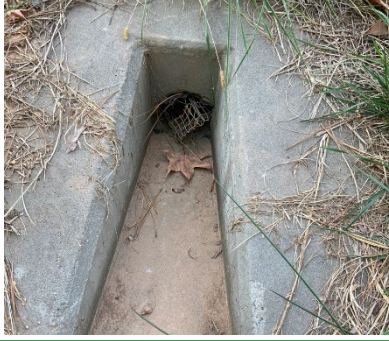
A17
3	Shoulder Drain	MDP_163	Rodent Screen

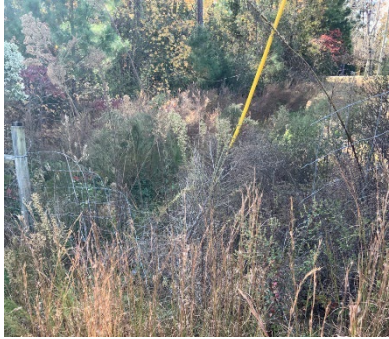
A26
2	Woven	FN_172	Hole

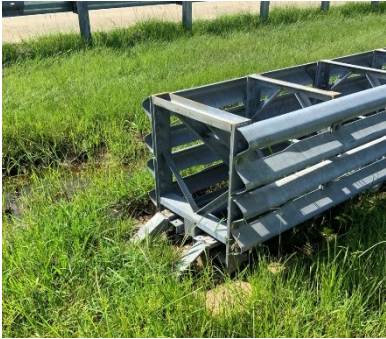
#	Material Type	Object ID	Failure Type	Photo	GIS Reference Page
1	Impact Attenuator	IA_12	Missing Parts

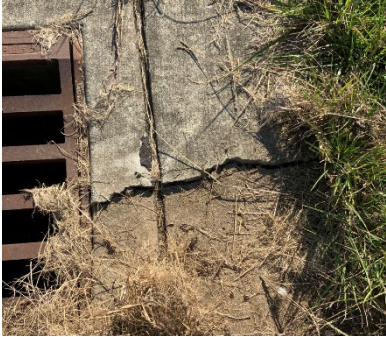
#	Material Type	Object ID	Failure Type	Photo	GIS Reference Page
1	Inlet	IN_368	Surface Damage

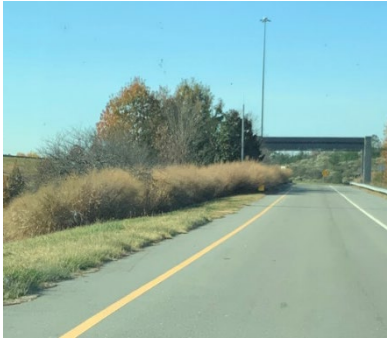
#	Material Type	Object ID	Failure Type	Photo	GIS Reference Page
1	Plant Bed	PB_228	Overgrown

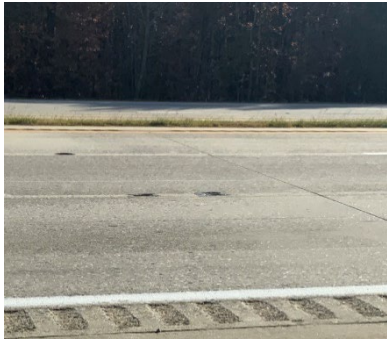
#	Material Type	Object ID	Failure Type	Photo	GIS Reference Page
1	Concrete	LS_165	Pothole

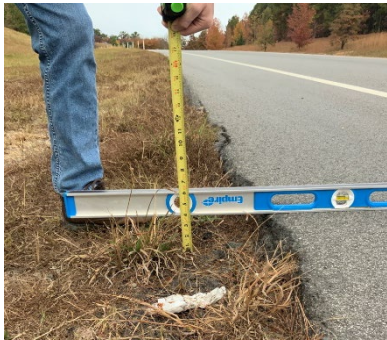
#	Material Type	Object ID	Failure Type	Photo	GIS Reference Page
1	Asphalt	LS_57	Drop off

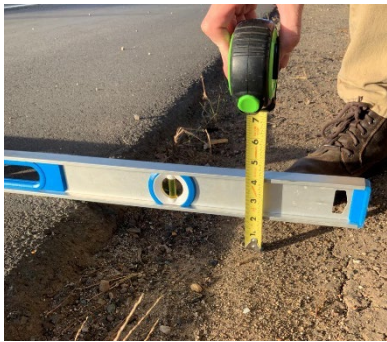
A17
2	Asphalt	LS_259	Drop off

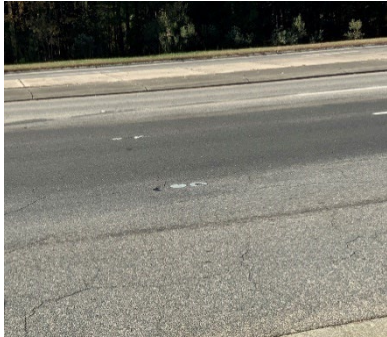
A1

#	Material Type	Object ID	Failure Type	Photo	GIS Reference Page
1	Asphalt	LS_499	Nighttime Reflectivity	Not Available for Nighttime Failures	A23
2	Asphalt	LS_523	Nighttime Reflectivity	Not Available for Nighttime Failures	A24
3	Asphalt	LS_723	Nighttime Reflectivity	Not Available for Nighttime Failures	A6
4	Asphalt	LS_736	Markers Missing

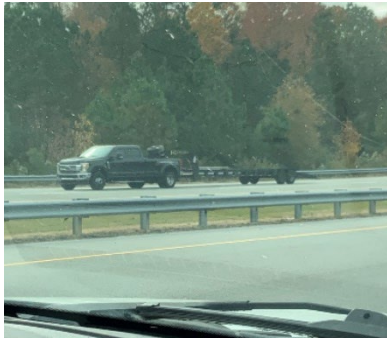
A17

A24
2	Asphalt	LS_559	Missing, Nighttime Reflectivity

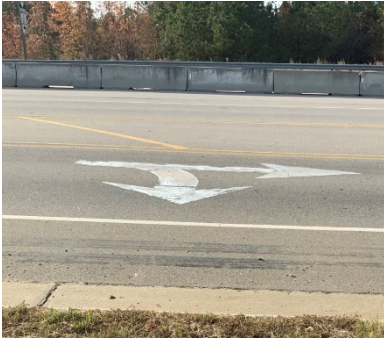
A26

#	Material Type	Object ID	Failure Type	Photo	GIS Reference Page
1	Thru and Right	PS_581	Nighttime Reflectivity

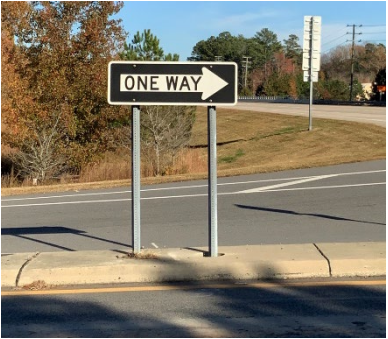
A13

#	Sign Type	Object ID	Failure Type	Photo	GIS Reference Page
1	One Way	SN_322	Height

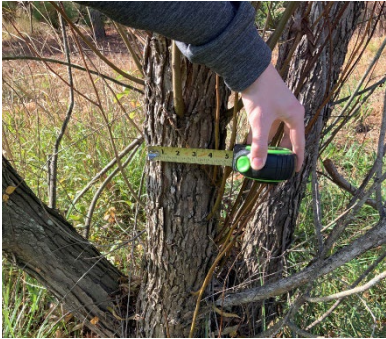
A13

#	Material Type	Object ID	Failure Type	Photo	GIS Reference Page
1	Tree and Brush	TB_303	Lateral Clearance

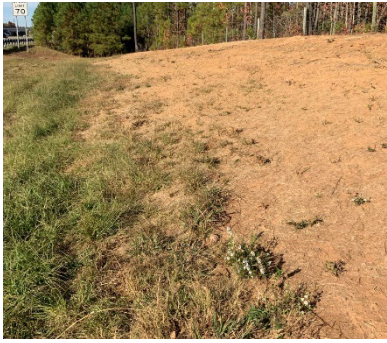
A11
3	Turf	TF_852	Bare Ground

A23
2	Turf	TF_597	Bare Ground
